Independent Tree Surveys Ltd

Tree Survey Report Old Kilcullen Heritage Trail Old Kilcullen Co. Kildare

December 2023

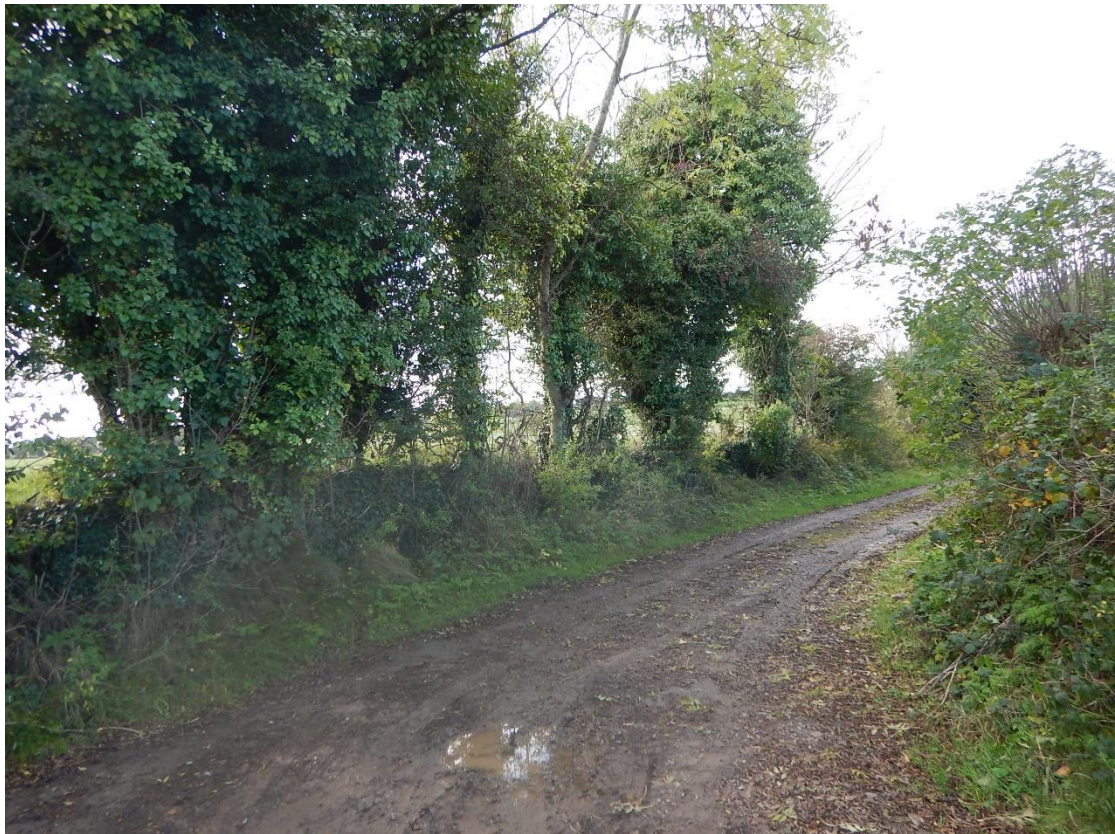
1. Last part of the lane passable by vehicles – to the west of the proposed walking track, back towards Hacklow

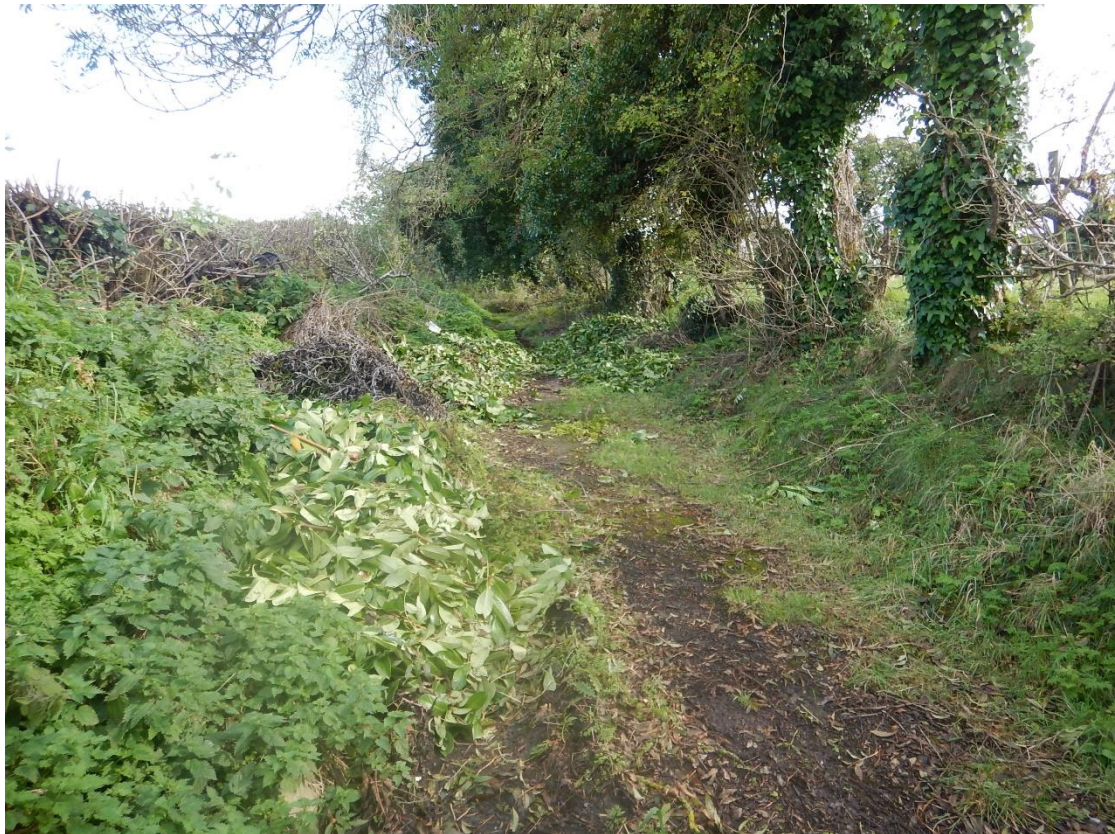
The old laneway has been impassable to vehicular traffic for some years, and an amount of green waste and other material has been dumped along the western end of the walking track route. There are the remains of old hard surfacing still in place along parts of the laneway, but the lane is uneven in places (especially towards the east), with woody tree roots visible on the soil surface. The route has been kept partially open by walkers and horse riders but has extensive vegetation growth extending into the path from the hedges H1 and H2 to the north and south.

2. Western end of the walking track route with green waste dumped next to hedge H1 on the left

The green waste and other material that has accumulated along the western end of the route should be cleared away to an appropriate facility. This work should be done with care to avoid damage to the adjacent hedgerow plants and should avoid digging down into the soil at the base of the hedge.

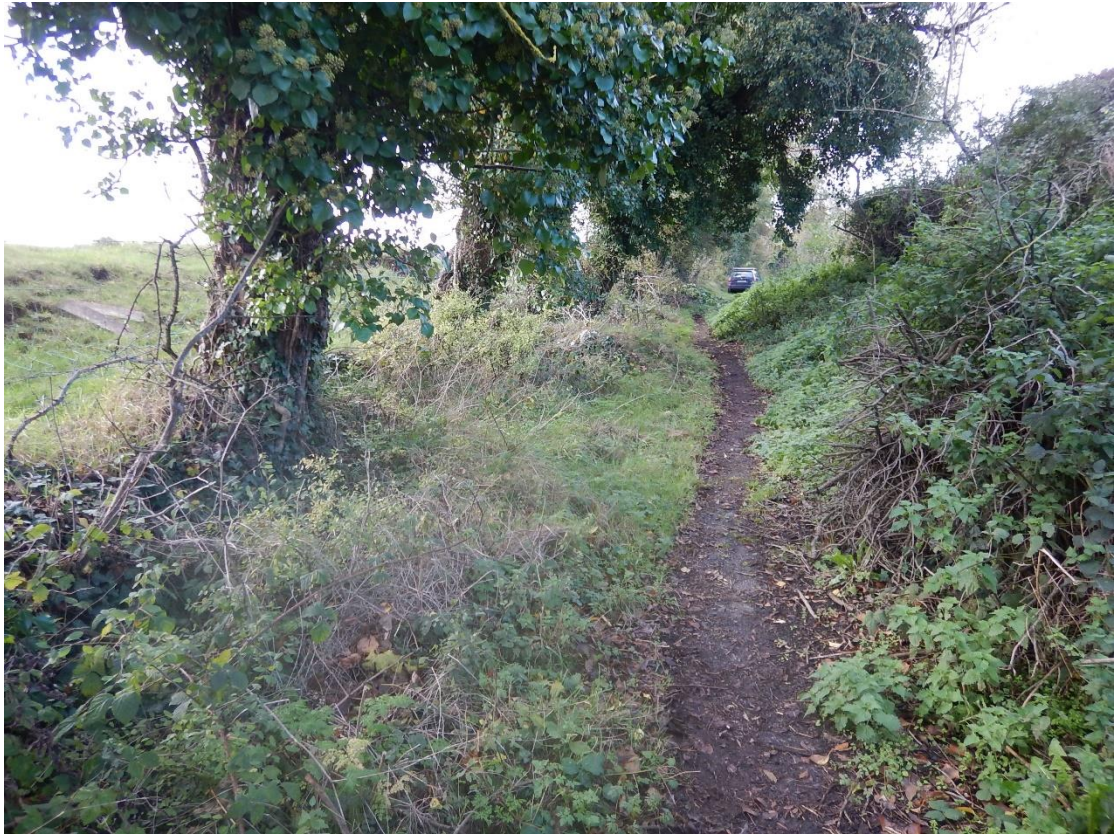
3. Western end of route facing west, with hedge H1 on the right and fragmented hedge H2 on the left

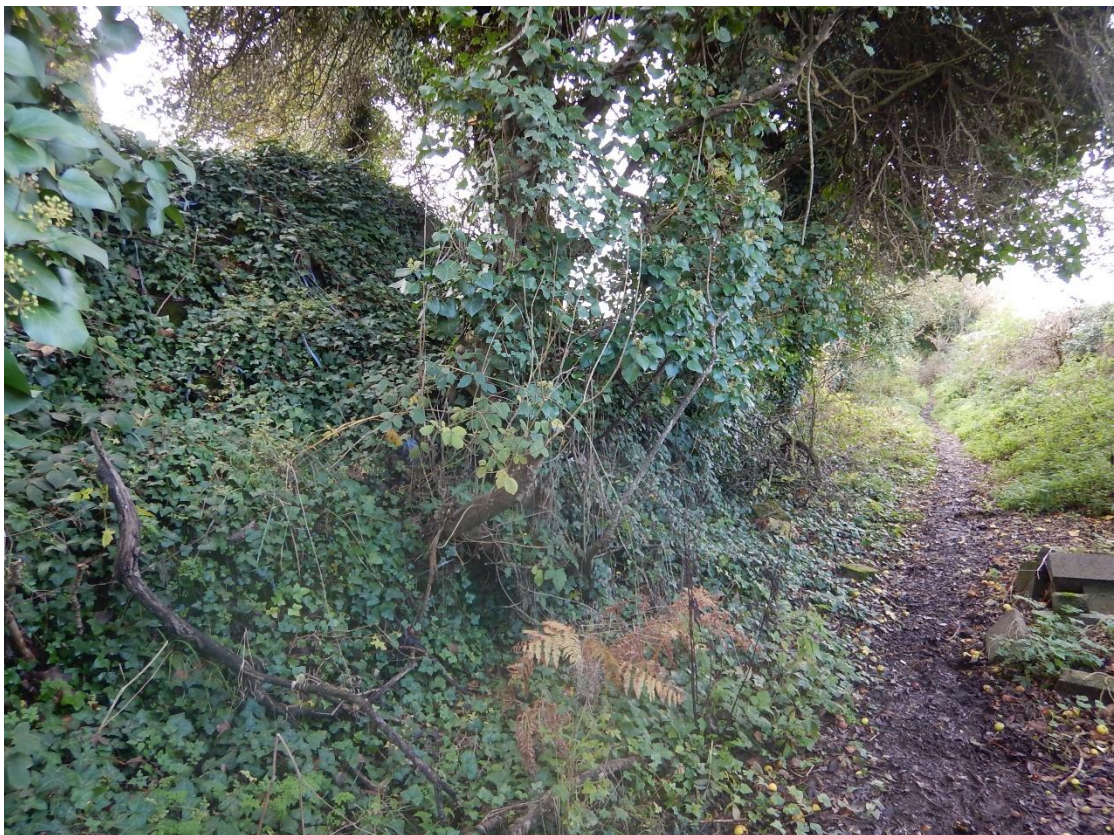
4. Western end of the central part of the route – facing west, with quarry site on left

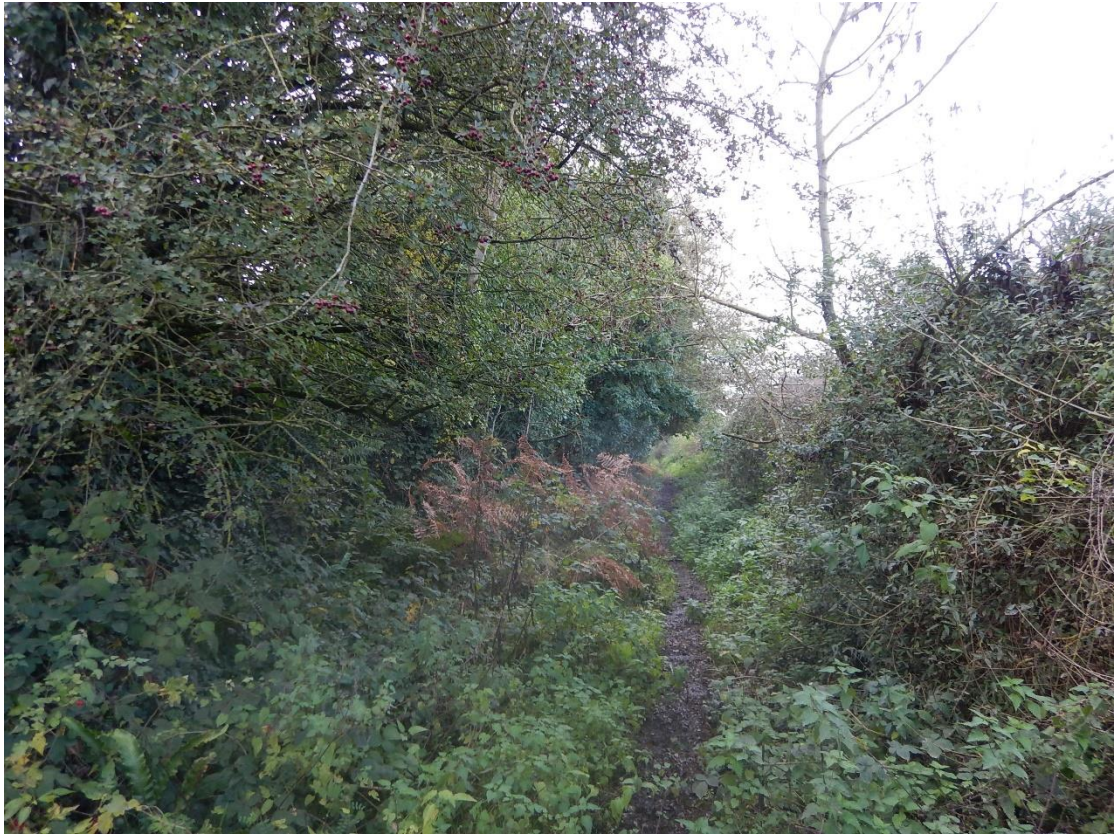
5. Dense growth from both hedges in the central part of the route (facing west)

Dead stems and branching from hedgerow trees and bushes, along with undergrowth such as Brambles and suckering should be cut back from both sides of the track route to improve the clearance and to facilitate the new 3m wide gravel track. This should be a combination of mechanised hedge trimming for the bushes and undergrowth and then proper pruning and coppicing of branches and stems from trees and coppice stools by professional tree workers. The cuttings and brash should be chipped on-site for use as mulch or removed to a suitable facility. This work should be done before the machinery etc. arrives on site to begin the build up of gravel etc. for the track.

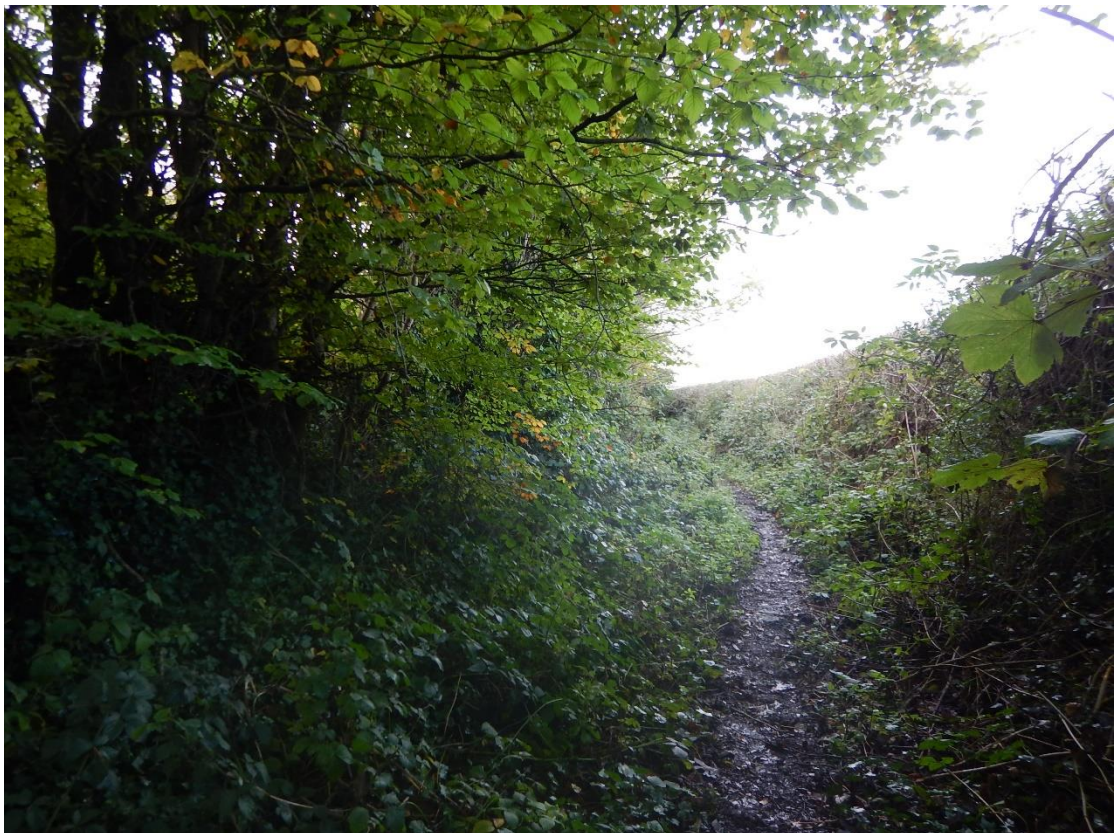
6. Young Beech tree growing out of the bank in the central part of hedge H2 on the left. Note trimmed top to hedge H1 to the right

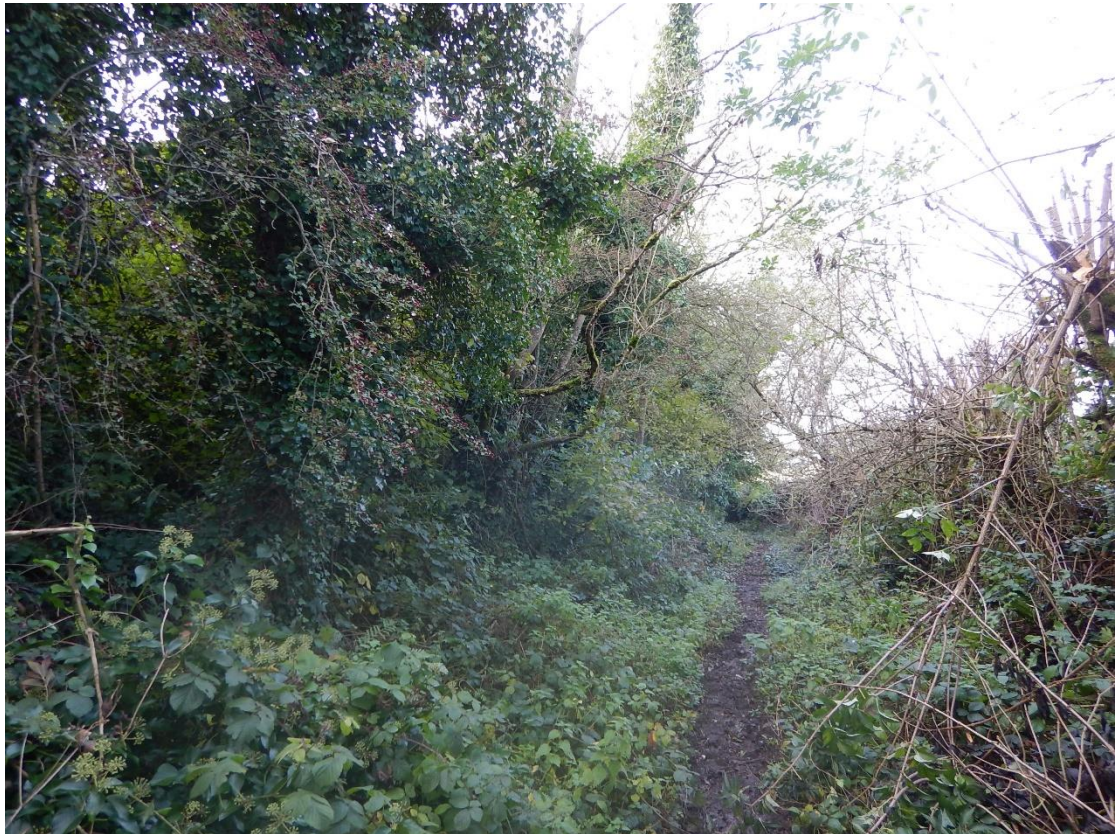
7. More dense growth from hedges into track route – facing west, with hedge H2 and quarry site on the left

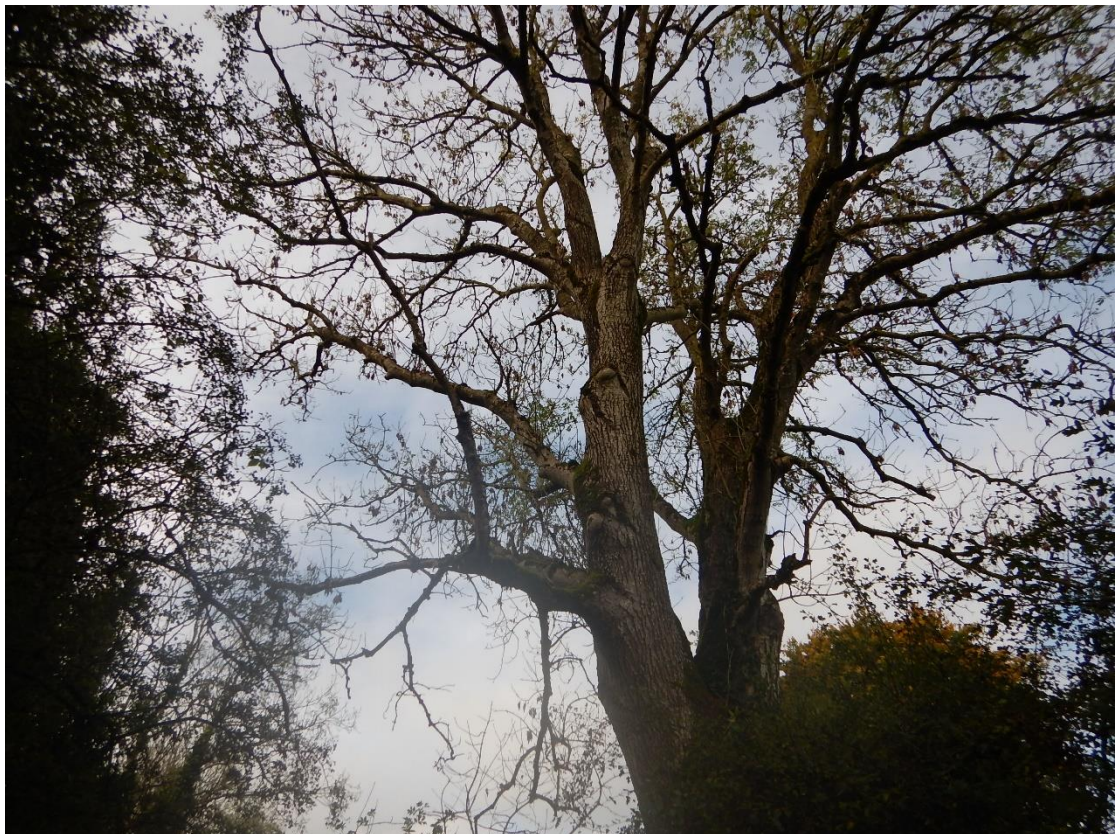
The hedge includes a single mature Ash tree (labelled T9 on the survey drawing and shown in photo 8 below) located at the junction of another hedge running north. This is a medium sized tree around 18m tall but is in poor condition due to infection by Ash dieback disease.

8. Mature Ash tree T9 growing out of hedge H1

The Ash trees along the route should be subject to regular inspection to monitor the progress and severity of Ash dieback disease. If the trees suffer extensive dieback or die, they should be coppiced (cut to stump) without undue delay.

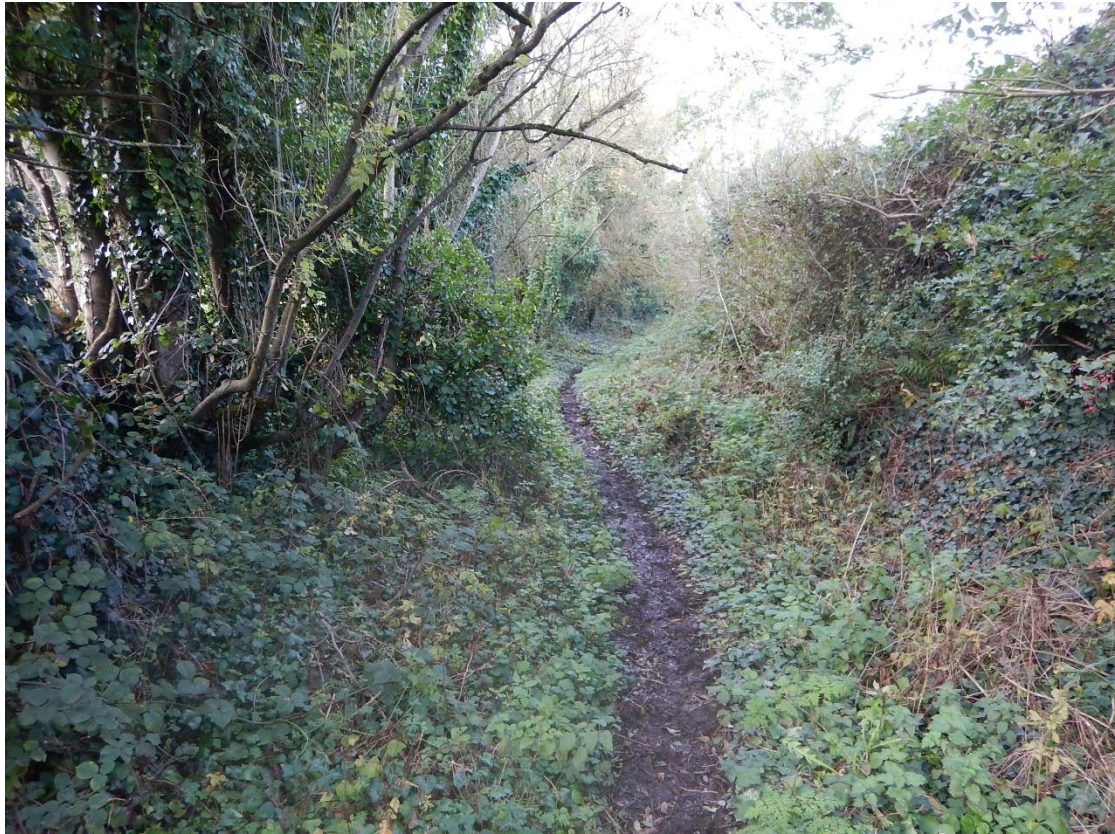
9. Multi-stemmed bushes growing out of hedge H2 on the left (facing west)

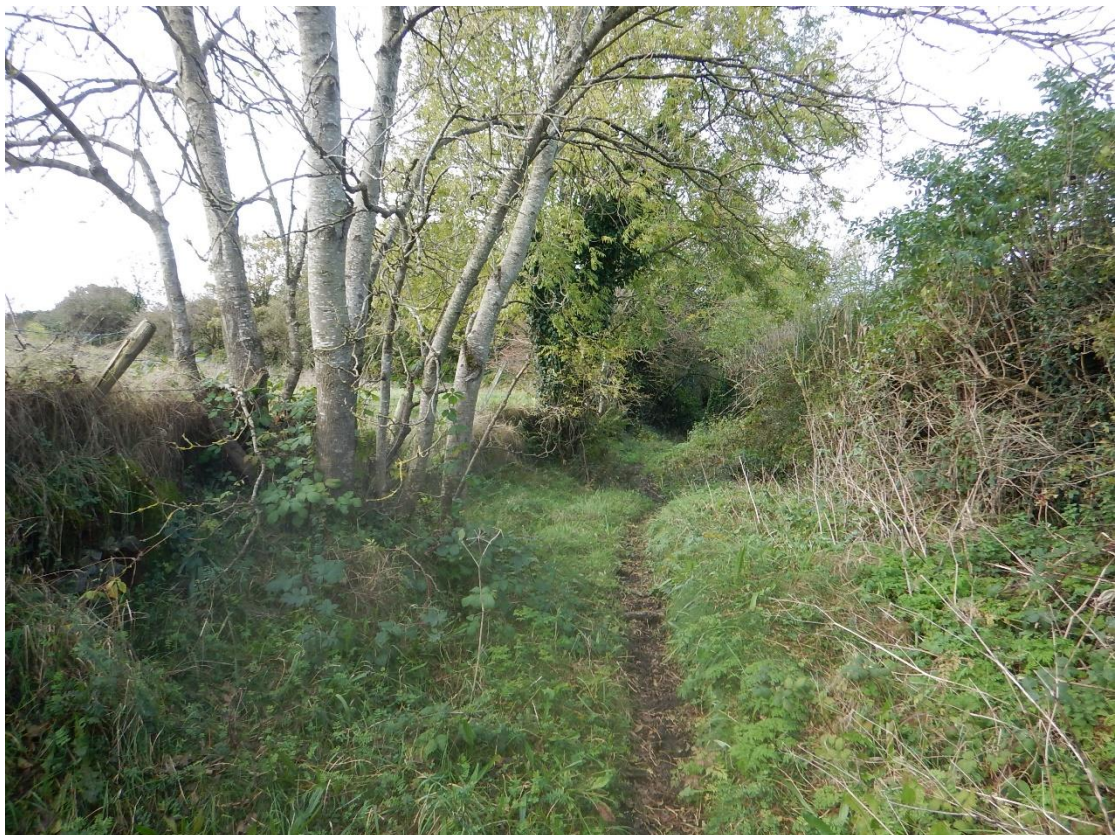
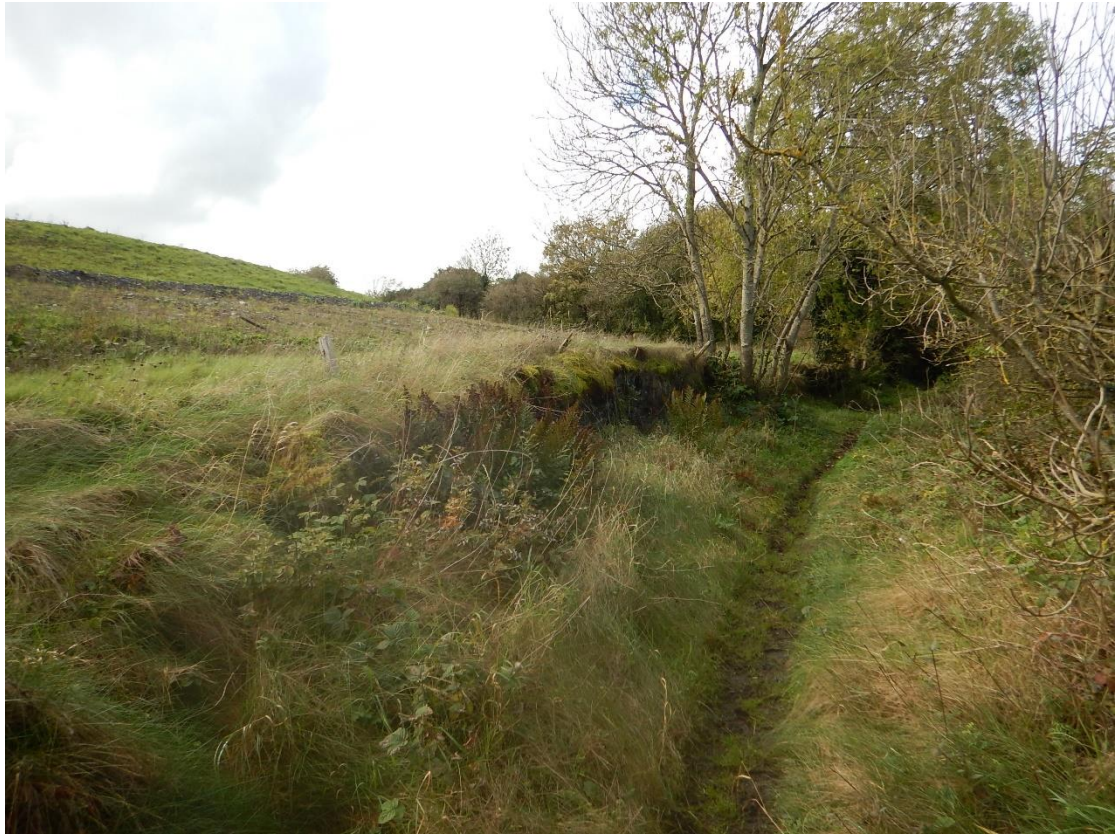
The eastern part of hedge H2 extends from the quarry yard to the junction of the old lane with Halverstown Cross. This section of the hedge is very fragmented, with some extended gaps between the semi-mature and early mature Ash trees; all of which were suffering from Ash dieback to some degree.

10. Gaps in fragmented eastern part of hedge H2 on left

11. Gaps in fragmented eastern part of hedge H2 on left

New native hedgerow plants (such as Hazel, Hawthorn, Blackthorn, Holly, Spindle etc.) should be planted into the gaps along hedge H2 to reinforce the hedge and to replace any Ash trees that succumb to Ash dieback disease.

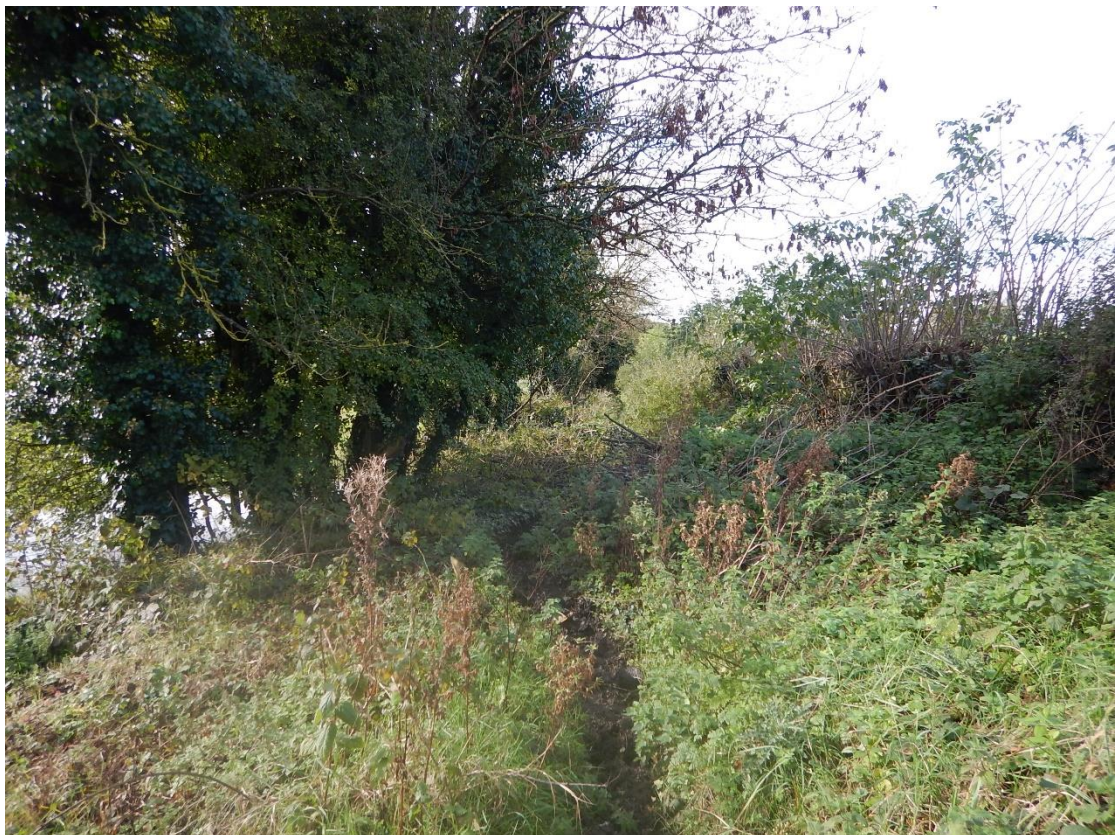
12. Overgrowth in the eastern end of hedges H2 (left) and H1 (right)

The hedges will need to be clipped back at once a year to maintain a suitable clearance from the new track.

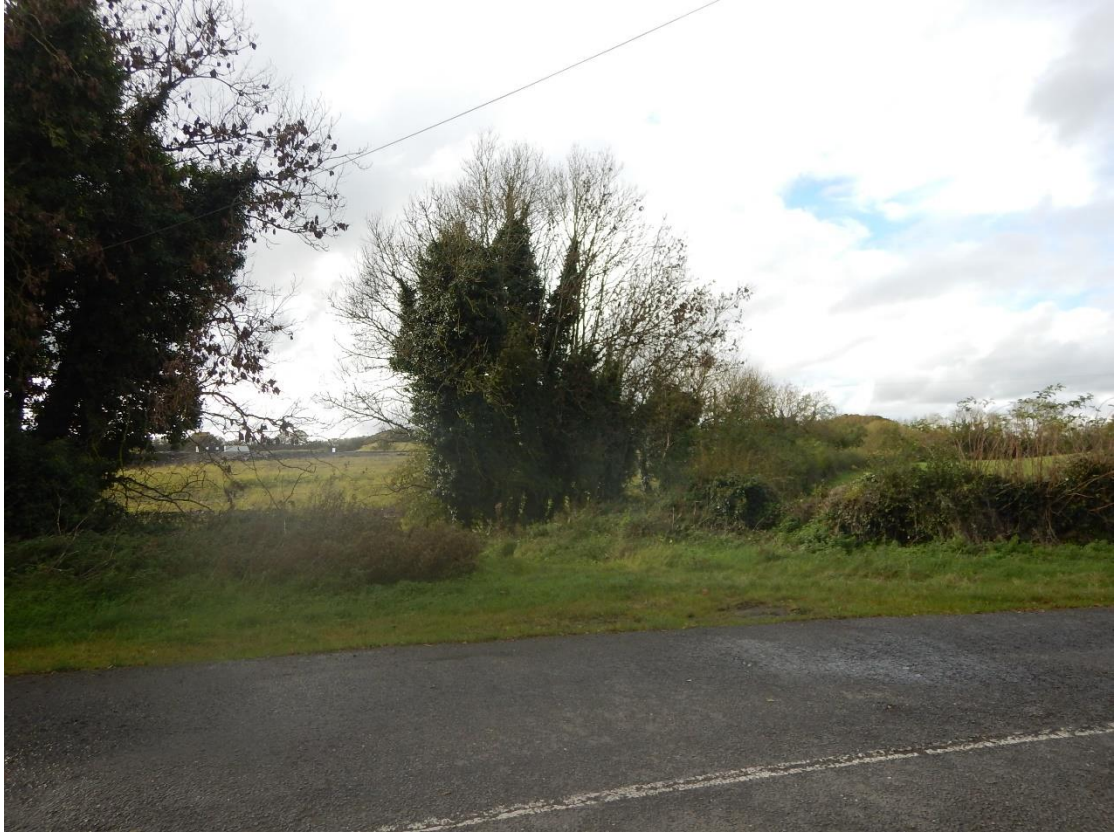
13. Far eastern end of the walking track route as it meets Halverstown cross

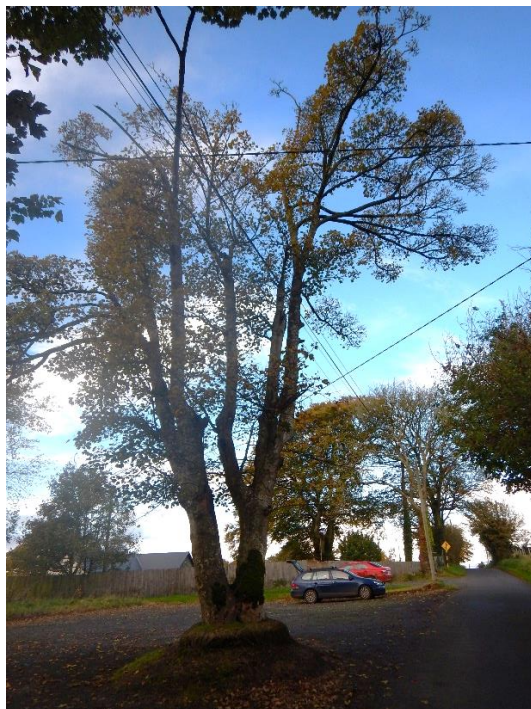
Species	Sycamore (<i>Acer pseudoplatanus</i>)
Tree Number	T12
BS5837 Category	C2 (low value)
Age Class	Mature
Height (m)	13m
Stem Diameter (mm)	550mm + 550mm at 1.5m above ground level
RPA (m) radius	9.3m
Physiological Condition	Poor: Sparse foliage, with some dieback of upper crown. Some dead branches.
Structural Condition	Poor/Fair: Some decay in old wounds likely to have weakened branches.

Sycamore seen from south

The tree has been heavily pruned in the past, with both stems having been topped at around 4m, before producing new growth; there is some wood decay evident in some of the old wounds. The tree has been crown lifted over the road and to the north and south, presumably to create clearance from the telecom and ESB overhead service wires. The tree crown is now somewhat sparse, with poor foliage density and some branch dieback.

The Sycamore tree is in relatively poor condition and some remedial pruning is recommended:

- Prune to reduce the tree crown by 3-4m down to appropriate branch unions.
- Prune to remove dead and weak branches.
- Prune to shorten branching in the western side of the crown by 1-2m.
- The tree should be subject to regular inspection (every 1-3 years) by a qualified arborist.

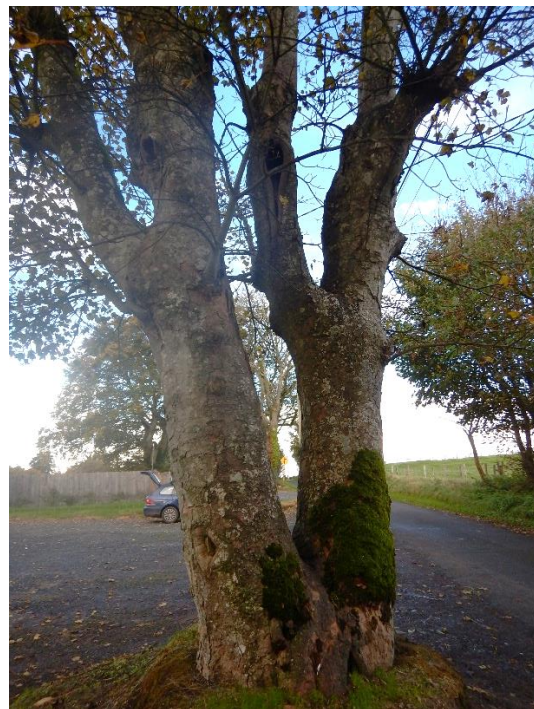
Close up of tree base and main stems

The Sycamore is twin stemmed from close to ground level and is growing out of a raised mound surrounded by compacted road surfacing. The mound has the appearance of being formerly enclosed in a raised bed of some kind, with the retaining structure now removed. Some woody roots are visible on the soil surface of the mound.

Wood decay is visible in old wounds to scaffold branches at 3m and 6m on the western stem, with a branch off the east stem snapped or cut at 8m. Some small old wounds to the lower stem and tree base; mostly occluded. Decay cavities on both stems between 3-5m.

Ground preparation to establish a new hedgerow to the north of the tree should be started away from the raised mound upon which the tree is growing and be kept as a narrow and as shallow as is practicable, using hand digging in the section within the nominal root protection area (RPA) of the tree. Any significant tree roots encountered (especially those > 25mm diameter) should be left intact and undamaged. Planting into a linear ridge of topsoil above the existing ground level should be seriously considered, although it is likely that the underlying compacted ground will need to be broken up beneath this new ridge to aid drainage and future root growth from the new hedgerow plants. The surrounding surfacing within the nominal root protection area (RPA) of the tree should be left intact where practicable, however, where existing surfacing has to be replaced within the RPA of the Sycamore, the old sub-base should be re-used where possible.
