Title: **STAGE 1&2 ROAD SAFETY AUDIT**  
**For;**  
**Old Kilcullen Heritage Trail**

Client: **Dooley Cummins.**

Date: **February 2024**

Report reference: **2134R01**

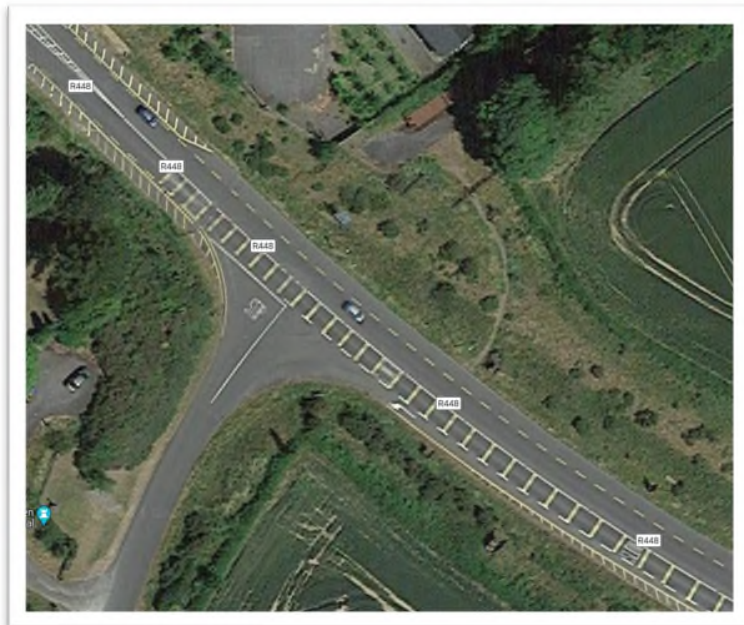
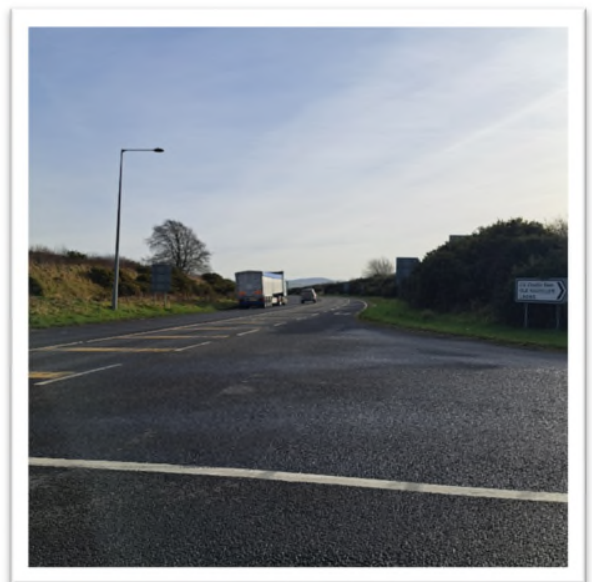
Drawing R448 Northern tie-in.

The R448 is a busy regional road and has a dedicated left turning lane into the L6080. It is also a very wide junction. This will lead to high turning speeds into the L6080 which could lead to collisions with pedestrians on the carriageway adjacent to the memorial. The Audit Team feel that the proposed gateway treatment and signage will reduce speed but from a high starting point and possibly not sufficiently.

It is recommended that the left turn lane be removed and that the junction mouth be narrowed.

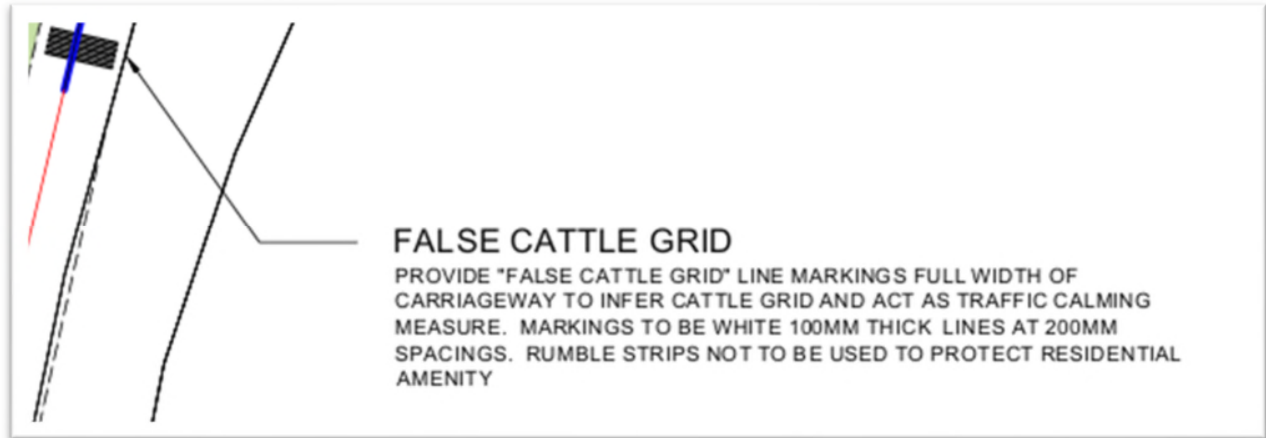
False cattle grids.

The Audit Team are concerned that the false cattle grids will be ineffective at calming traffic after an initial 'bed in' period. The route is used by local traffic only and drivers will be familiar with the area and know

that the grids are false. In addition, the road markings will fade in time and may not be renewed at a regular enough interval to be as effective as when initially installed.

It is recommended that alternative measures be proposed to provide traffic calming.

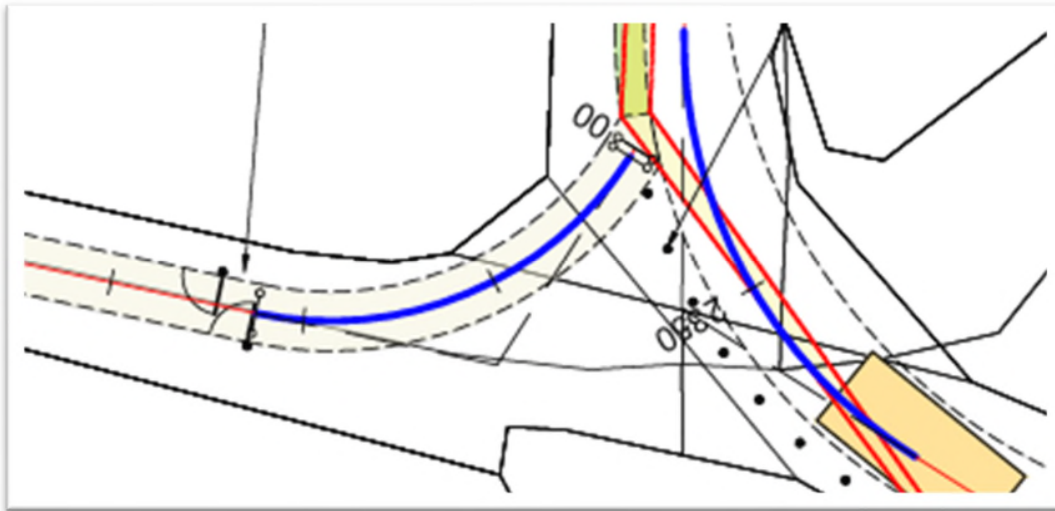
Drawing 01/094 Rev 0, Walking track.

Drivers will need to be advised that they cannot turn into the walking track. The gates may not be obvious from the L6080 due to the layout/geometry of the track.

It is recommended that 'no entry' signage or similar be provided at a location easily seen by drivers on the L6080.

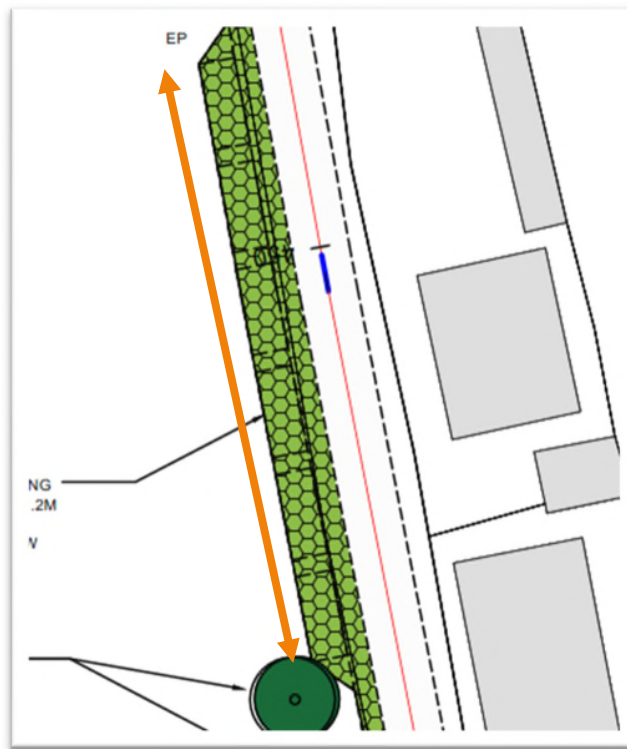
Drawing 01/02 Rev 0, Parallel parking spaces.

The parallel parking spaces have a grassed area to the rear. There is a risk that vehicle occupants when they exit their vehicles will slip and fall in wet or icy conditions.

It is recommended that the reinforced grassed area be extended to the rear of the spaces and that a connection be provided to the carriageway.

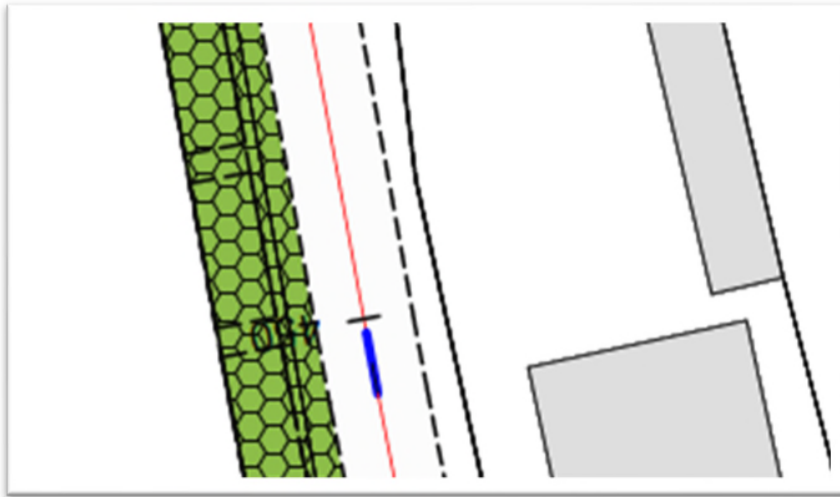
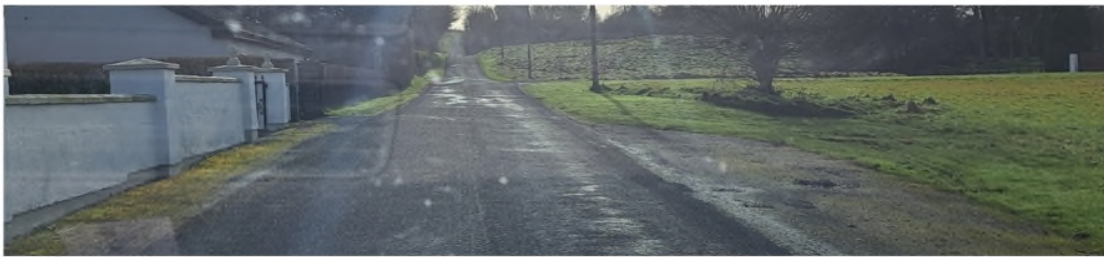
Drawing 01/02 Rev 0, Parallel parking spaces.

When drivers are parking or getting out of the parking spaces there is a risk that over that time a vehicle will approach from either side and there will not be space to pass. This could lead to reversing movements and risks of collisions with pedestrians.

It is recommended that a passing bay be incorporated into the design adjacent to the proposed parking spaces. It is noted that an existing parking area/passing bay exists at this location.

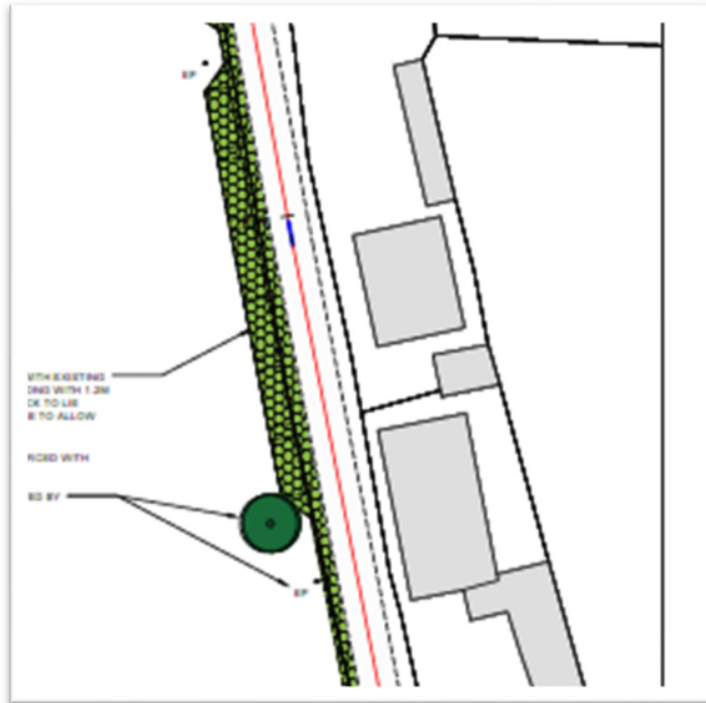
Drawing 01/02 Rev 0, Parallel parking spaces.

There is a risk that parked cars opposite the residences on the opposite side of the L6080 may lead to inaccessibility for larger vehicles. This could lead to material damage of parked vehicles.

It is recommended that a swept path analysis be carried out for the largest vehicles using the private accesses to ensure that the movements can be carried out (e.g. fuel delivery, agricultural machinery) when the parking spaces are occupied.
