Arborist Associates Ltd.

An Arboricultural Assessment of the Trees on the Site Area at “Beaufort”, Sallins Road, Naas West, Naas, Co. Kildare.

Prepared for: McAuley Place

Date: 4th March 2026

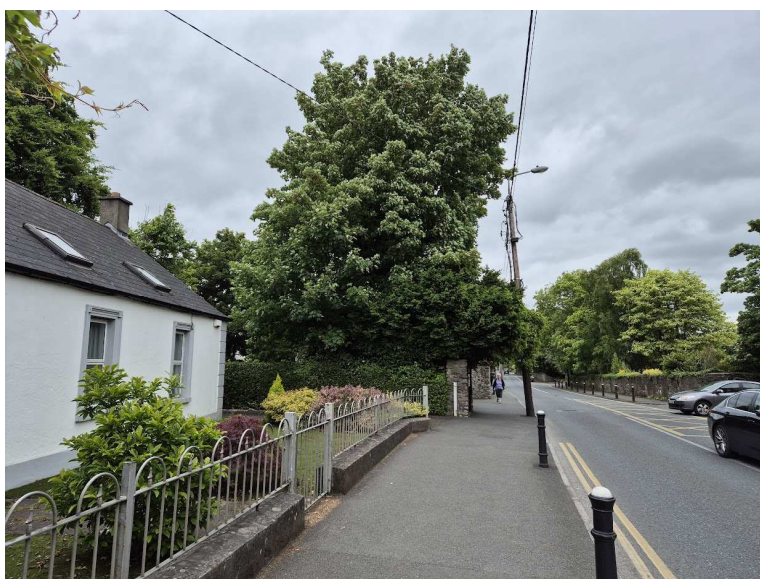
Photograph 1 shows the area to the front of 'Beaufort House' and Tree Nos.1 & 2.

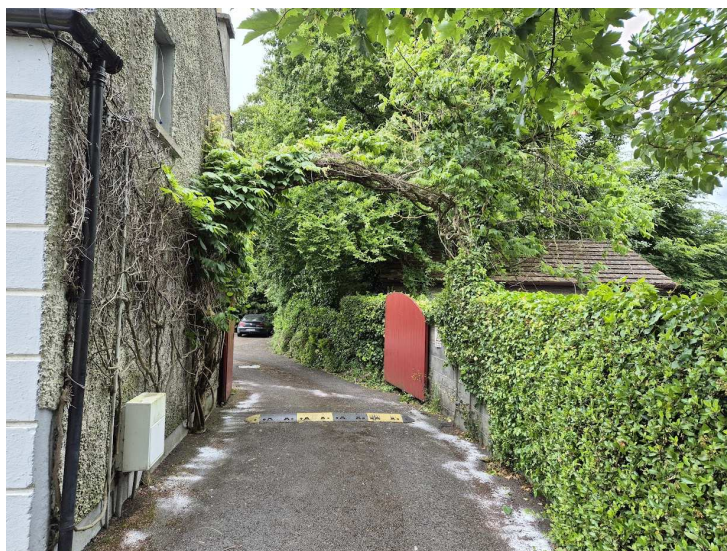
Photograph shows the existing rear access driveway along northern boundary wall.

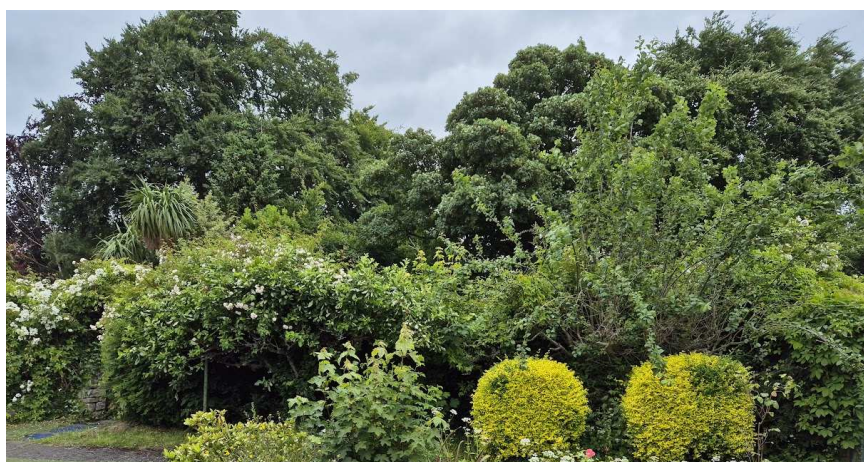
Photograph shows Tree Nos.4-10 along the site's northern boundary.

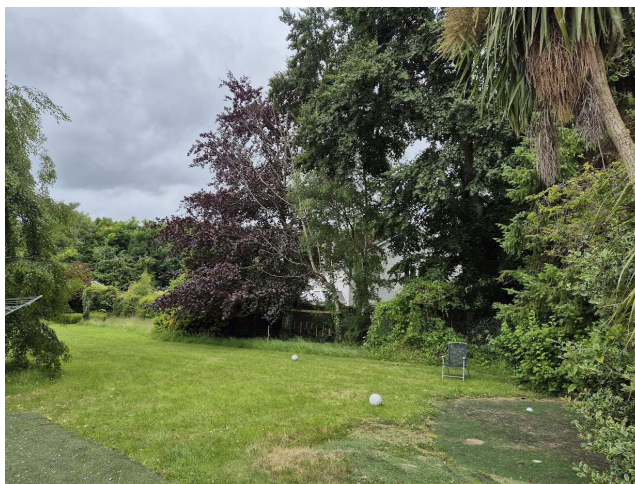
Photograph shows the trees on the site side of the northern boundary to the rear of the houses.

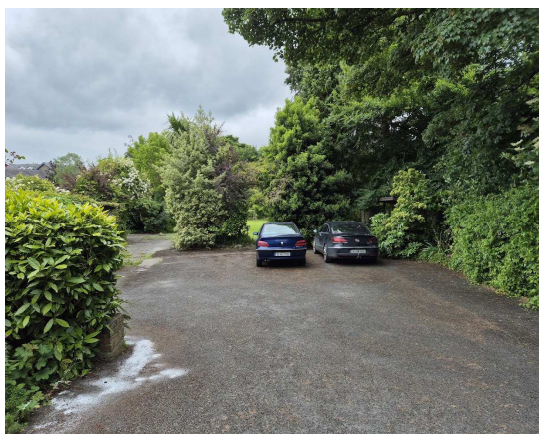
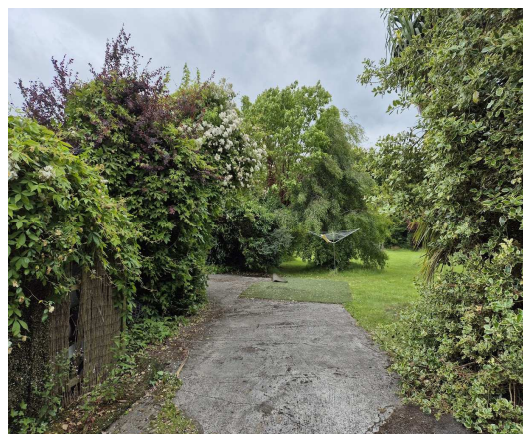
Photograph shows the tree vegetation cordoning off the lawn area to the rear of the houses from the car parking area.

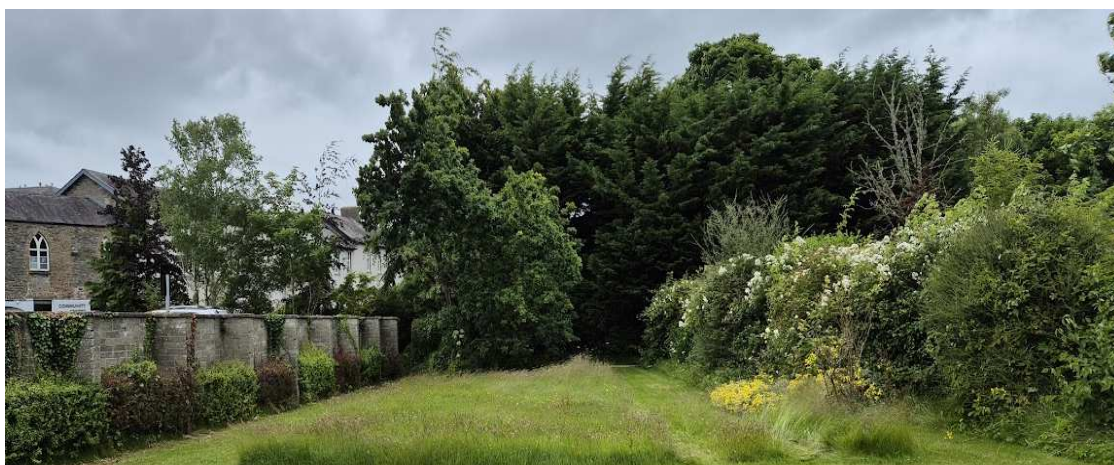
Photograph shows the tree vegetation along the rear (west) boundary of the grounds looking down the garden area from the rear of the house.

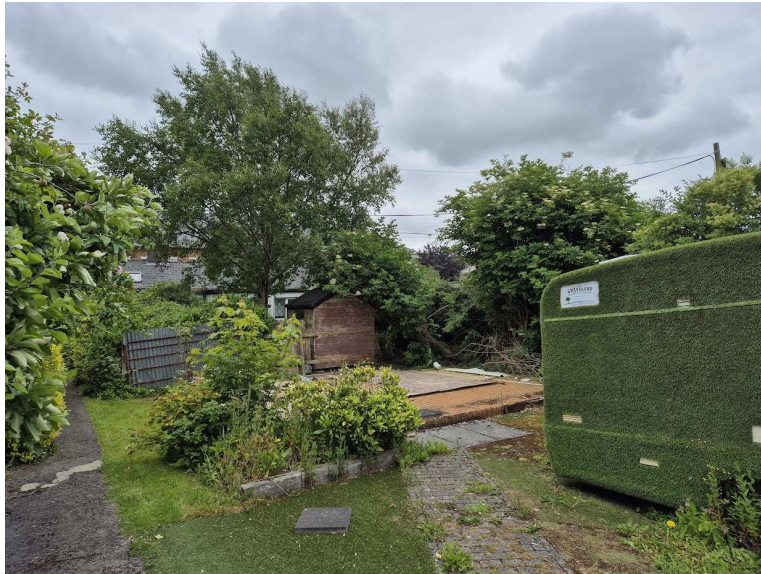
Photograph shows the area to the rear of the house looking back up the garden.
