ASBESTOS SURVEY REPORT

(Refurbishment / Demolition Survey)

**Location: Beaufort Site,
Sallins Road, Naas, Co. Kildare**

Report No. PE24-653

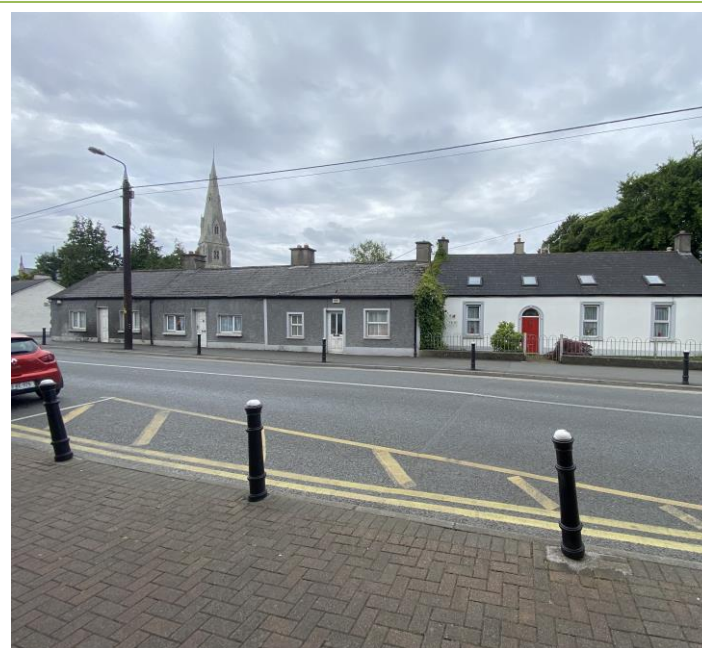
MATERIAL ASSESSMENT		PRIORITY ASSESSMENT
Product type	Cement slates	Normal occupant activity	N/A
Extent of damage	Weathered	Likelihood of disturbance	N/A
Surface treatment	None	Human exposure potential	N/A
Asbestos type	Chrysotile & Amosite	Maintenance activity	N/A
	Material assessment score: N/A	TOTAL SCORE: N/A	Priority assessment score: N/A

The cement slates identified on the front pitch of the original roof contain Chrysotile (white) and Amosite (brown) asbestos fibres. Asbestos cement products usually contain between 10-15% asbestos fibres, bound in Portland cement.

The cement slates should be removed by an asbestos removal contractor and disposed of as asbestos waste before the demolition works commence.

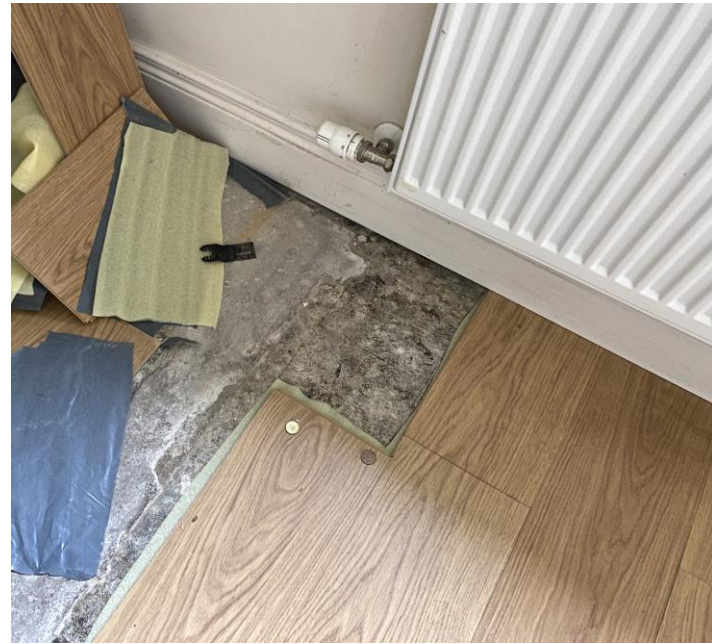
MATERIAL ASSESSMENT		PRIORITY ASSESSMENT
Product type	Bitumen adhesive	Normal occupant activity	N/A
Extent of damage	Medium	Likelihood of disturbance	N/A
Surface treatment	Well bound material	Human exposure potential	N/A
Asbestos type	Chrysotile	Maintenance activity	N/A
	Material assessment score: N/A	TOTAL SCORE: N/A	Priority assessment score: N/A

The bitumen adhesive identified on the floors in the rear extension contain Chrysotile (white) asbestos fibres. Bitumen adhesives contain a small quantity of asbestos fibres.

The bitumen adhesive should be removed by an asbestos removal contractor and disposed of as asbestos waste before the demolition works commence.

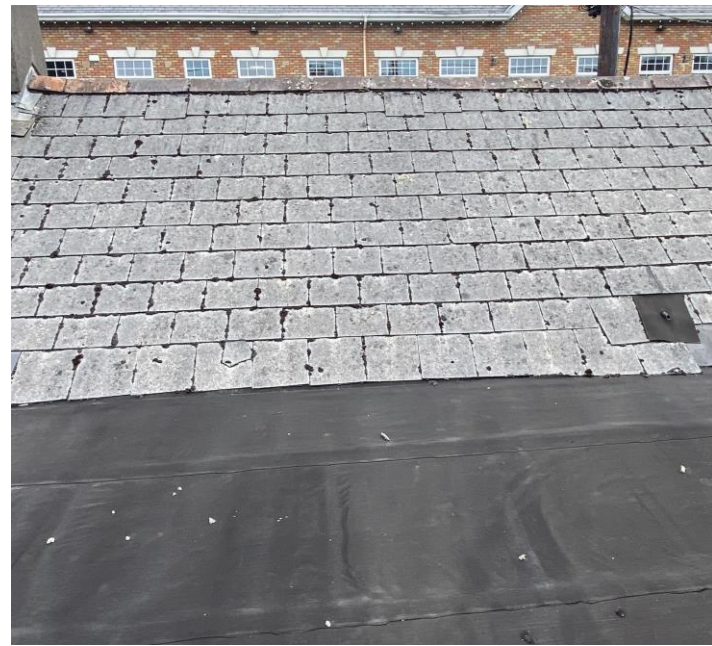
MATERIAL ASSESSMENT		PRIORITY ASSESSMENT
Product type	Cement slates	Normal occupant activity	N/A
Extent of damage	Weathered	Likelihood of disturbance	N/A
Surface treatment	None	Human exposure potential	N/A
Asbestos type	Chrysotile & Amosite	Maintenance activity	N/A
	Material assessment score: N/A	TOTAL SCORE: N/A	Priority assessment score: N/A

The cement slates identified on the main roof contain Chrysotile (white) and Amosite (brown) asbestos fibres. Asbestos cement products usually contain between 10-15% asbestos fibres, bound in Portland cement.

The cement slates should be removed by an asbestos removal contractor and disposed of as asbestos waste before the demolition works commence.

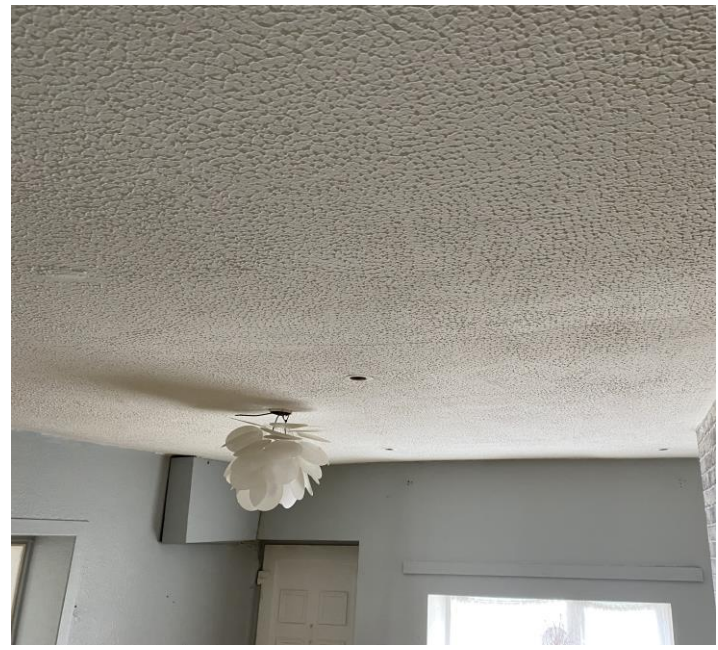
MATERIAL ASSESSMENT		PRIORITY ASSESSMENT
Product type	Textured coating	Normal occupant activity	N/A
Extent of damage	Low	Likelihood of disturbance	N/A
Surface treatment	Painted	Human exposure potential	N/A
Asbestos type	Chrysotile	Maintenance activity	N/A
	Material assessment score: N/A	TOTAL SCORE: N/A	Priority assessment score: N/A

The textured coating identified on the ceiling in the living room contains Chrysotile (white) asbestos fibres. Asbestos textured coating usually contains between 3-5% asbestos fibres.

The textured should be removed by an asbestos removal contractor and disposed of as asbestos waste before the demolition works commence.

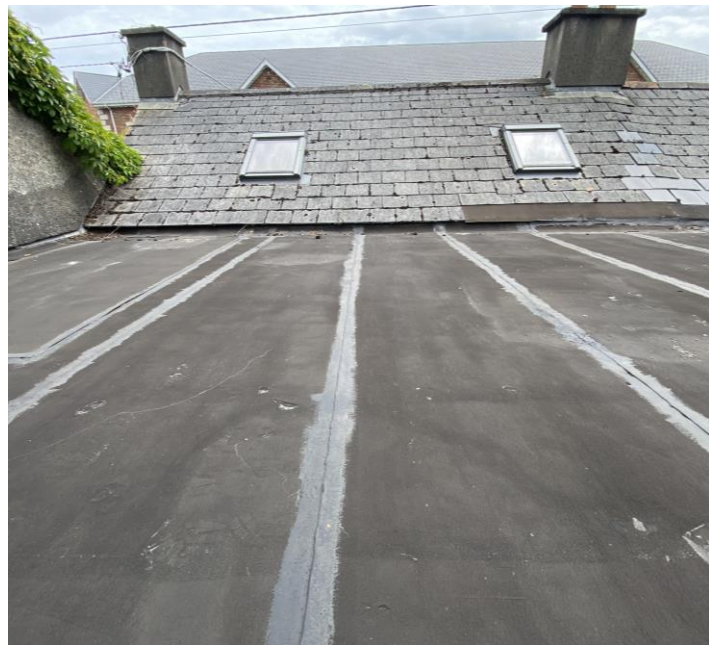
MATERIAL ASSESSMENT		PRIORITY ASSESSMENT
Product type	Cement slates	Normal occupant activity	N/A
Extent of damage	Weathered	Likelihood of disturbance	N/A
Surface treatment	None	Human exposure potential	N/A
Asbestos type	Chrysotile & Amosite	Maintenance activity	N/A
	Material assessment score: N/A	TOTAL SCORE: N/A	Priority assessment score: N/A

The cement slates identified on the main roof contain Chrysotile (white) and Amosite (brown) asbestos fibres. Asbestos cement products usually contain between 10-15% asbestos fibres, bound in Portland cement.

The cement slates should be removed by an asbestos removal contractor and disposed of as asbestos waste before the demolition works commence.

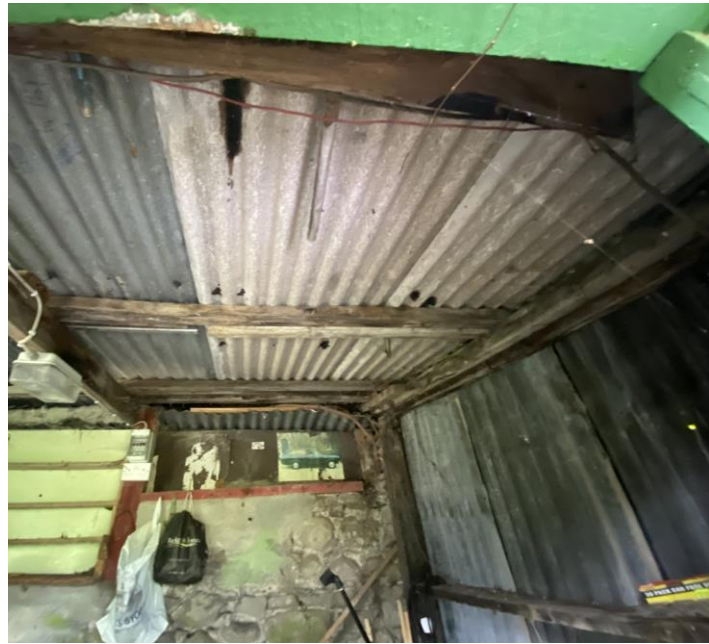
MATERIAL ASSESSMENT		PRIORITY ASSESSMENT
Product type	Cement sheeting	Normal occupant activity	N/A
Extent of damage	Medium	Likelihood of disturbance	N/A
Surface treatment	None	Human exposure potential	N/A
Asbestos type	Chrysotile	Maintenance activity	N/A
	Material assessment score: N/A	TOTAL SCORE: N/A	Priority assessment score: N/A

The cement sheeting identified on the on the roof of the rear shed & concreted into the ground outside it contains Chrysotile (white) asbestos fibres. Asbestos cement products usually contain between 10-15% asbestos fibres, bound in Portland.

The cement sheeting should be removed by an asbestos removal contractor and disposed of as asbestos waste before the demolition works commence.

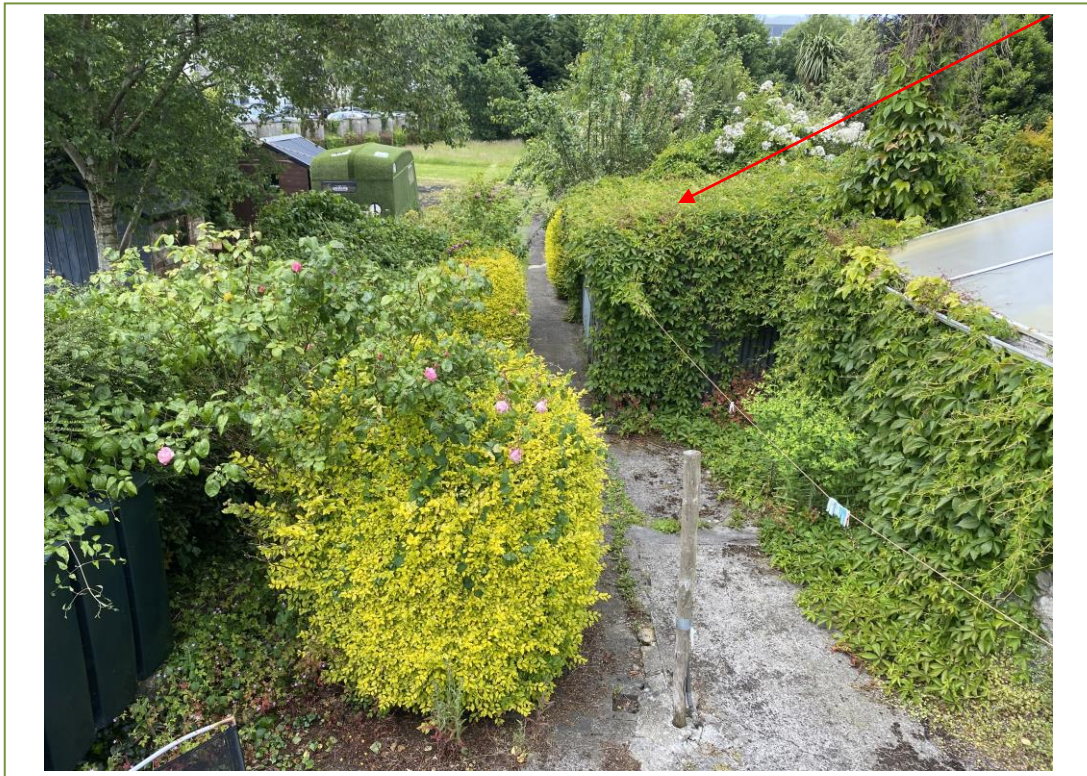
The garage roof is currently overgrown

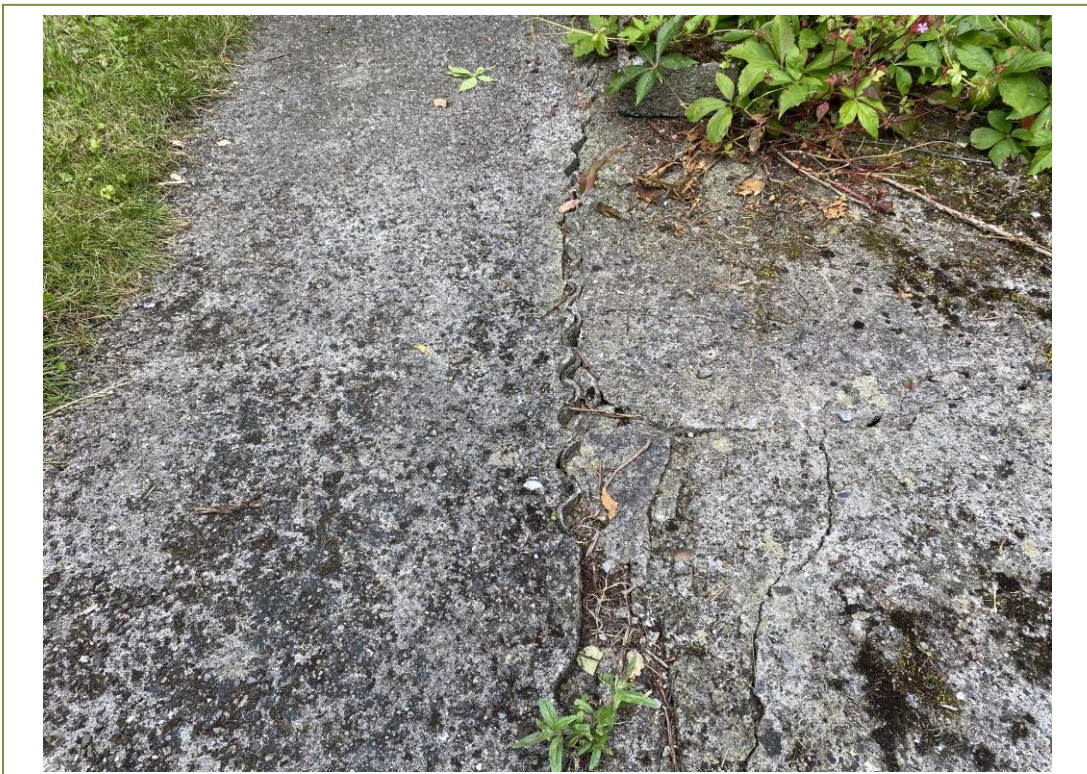
Small area of cement sheeting concreted into the ground

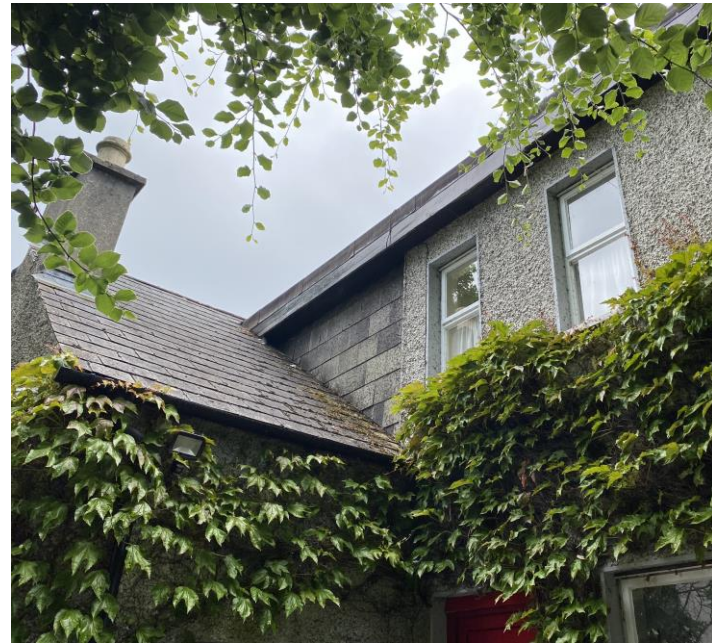
MATERIAL ASSESSMENT		PRIORITY ASSESSMENT
Product type	Cement slates	Normal occupant activity	N/A
Extent of damage	Weathered	Likelihood of disturbance	N/A
Surface treatment	None	Human exposure potential	N/A
Asbestos type	Amosite, Chrysotile & Crocidolite	Maintenance activity	N/A
	Material assessment score: N/A	TOTAL SCORE: N/A	Priority assessment score: N/A

The cement slates identified on the main roof area of the house contain Amosite (brown), Chrysotile (white) and Crocidolite (blue) asbestos fibres. Asbestos cement products usually contain between 10-15% asbestos fibres, bound in Portland cement.

The cement slates may be left in situ and managed in place. However, if the forthcoming refurbishment works are likely to disturb the main roof area of the house, the cement slates should be removed by an asbestos removal contractor and disposed of as asbestos waste before the demolition works commence.

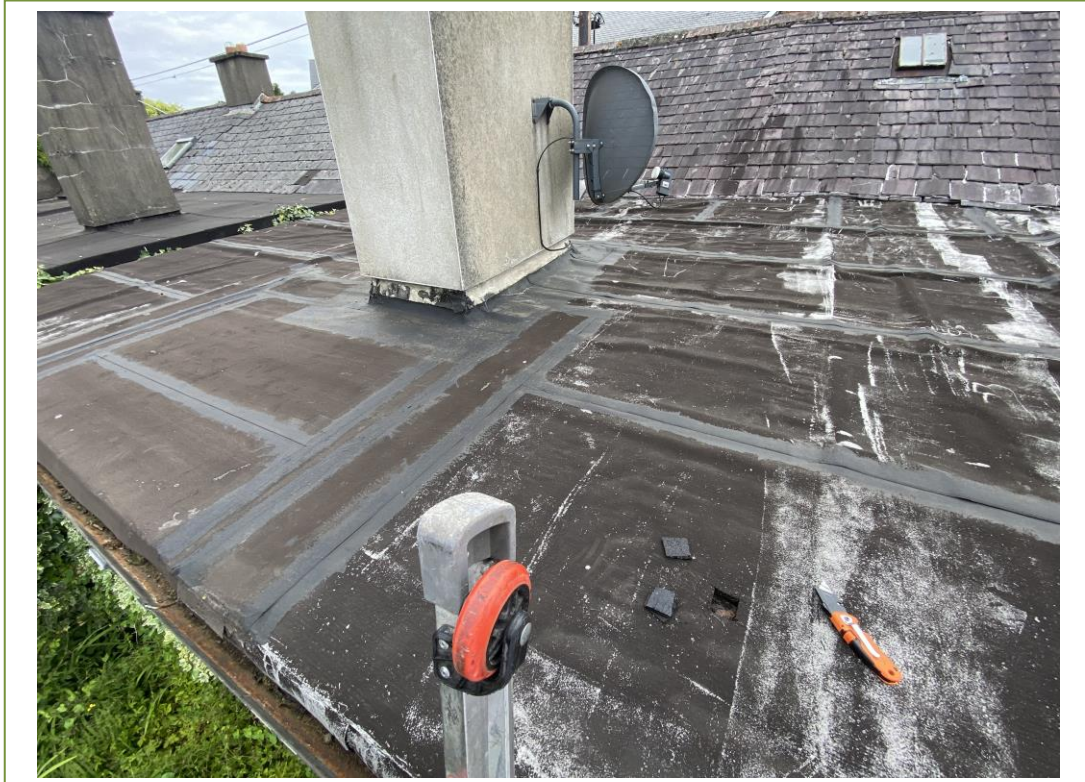
Felt sampled from the flat roof areas

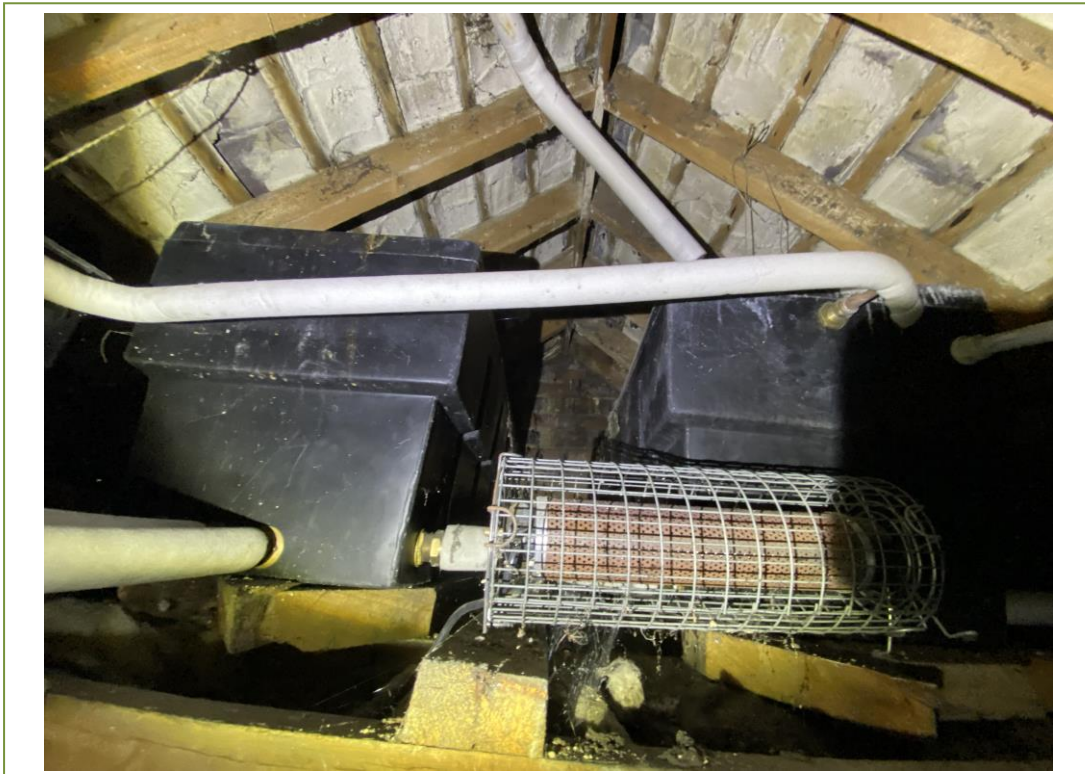
Plastic water tanks

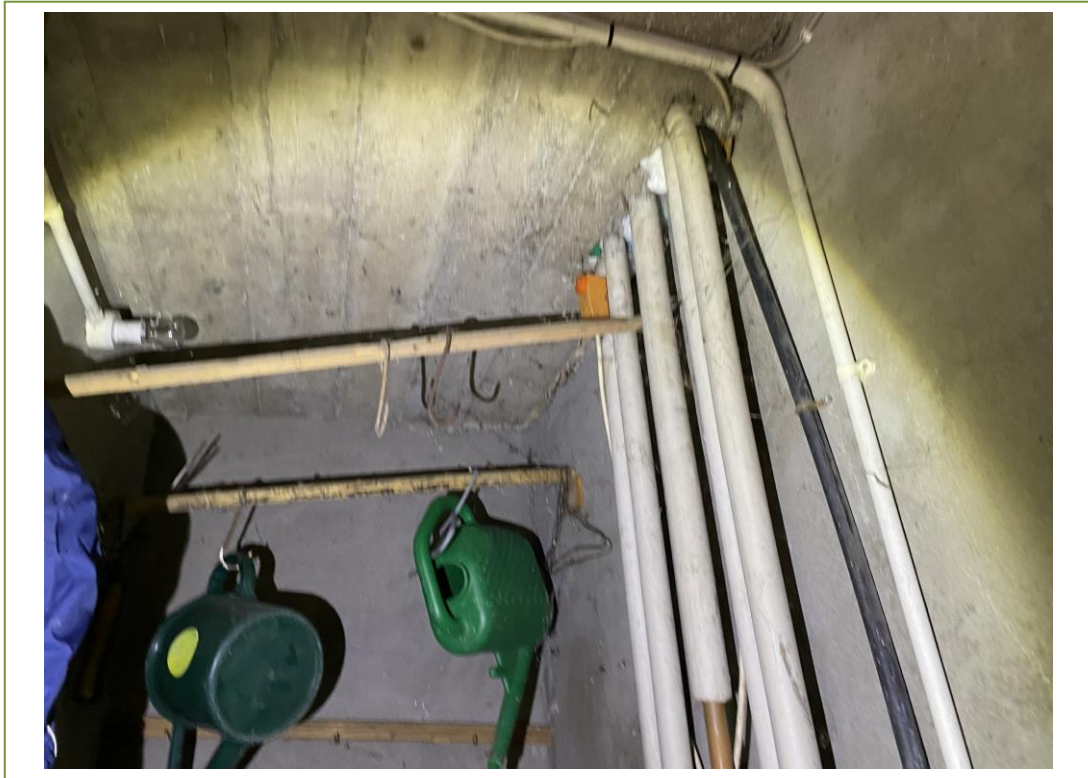
Concrete ceiling in the boiler room of Beaufort House

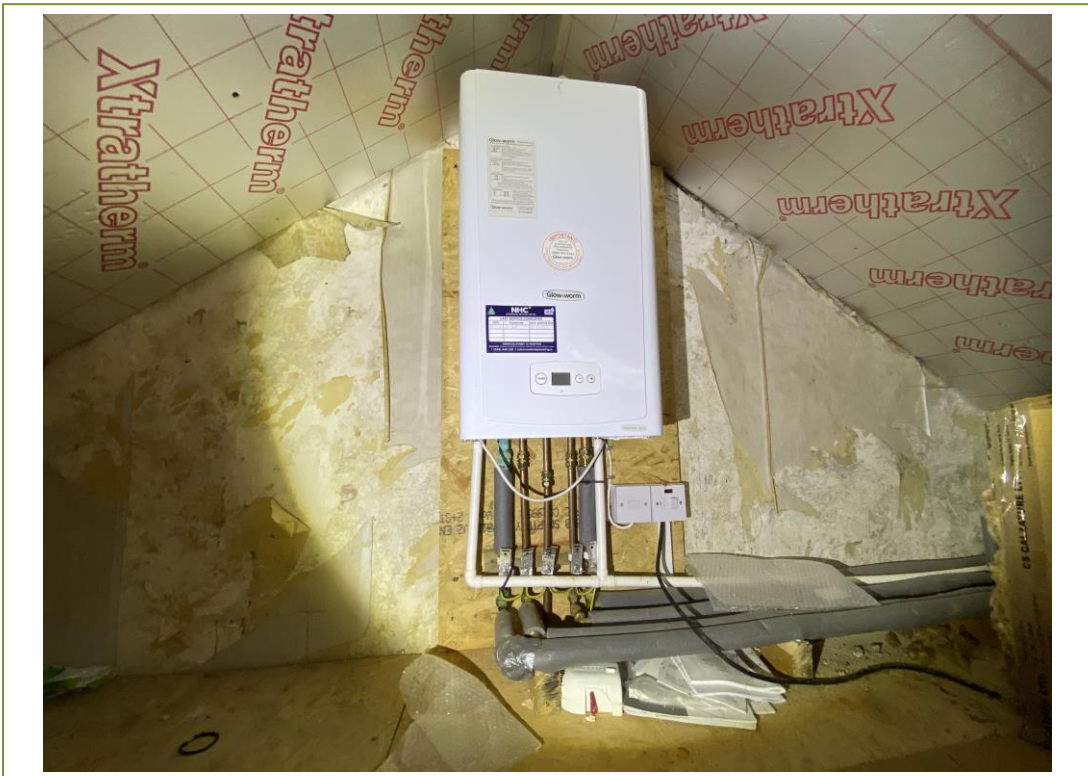
Gas boiler

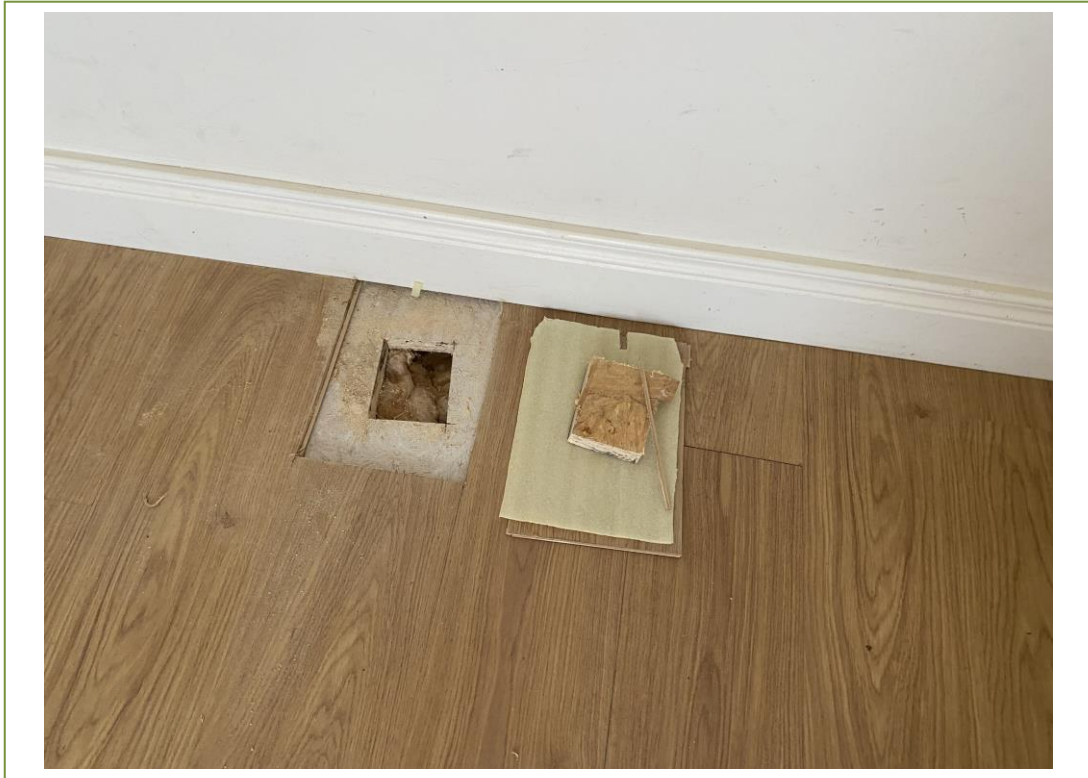
Timber floors

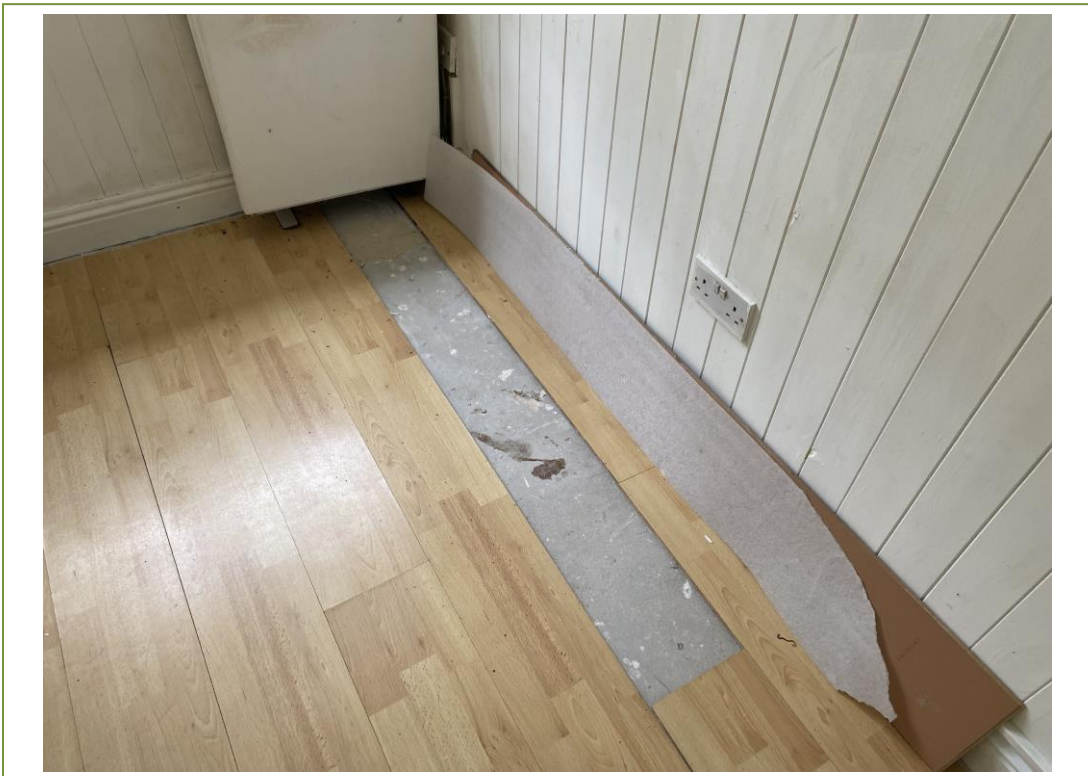
Bare concrete floors

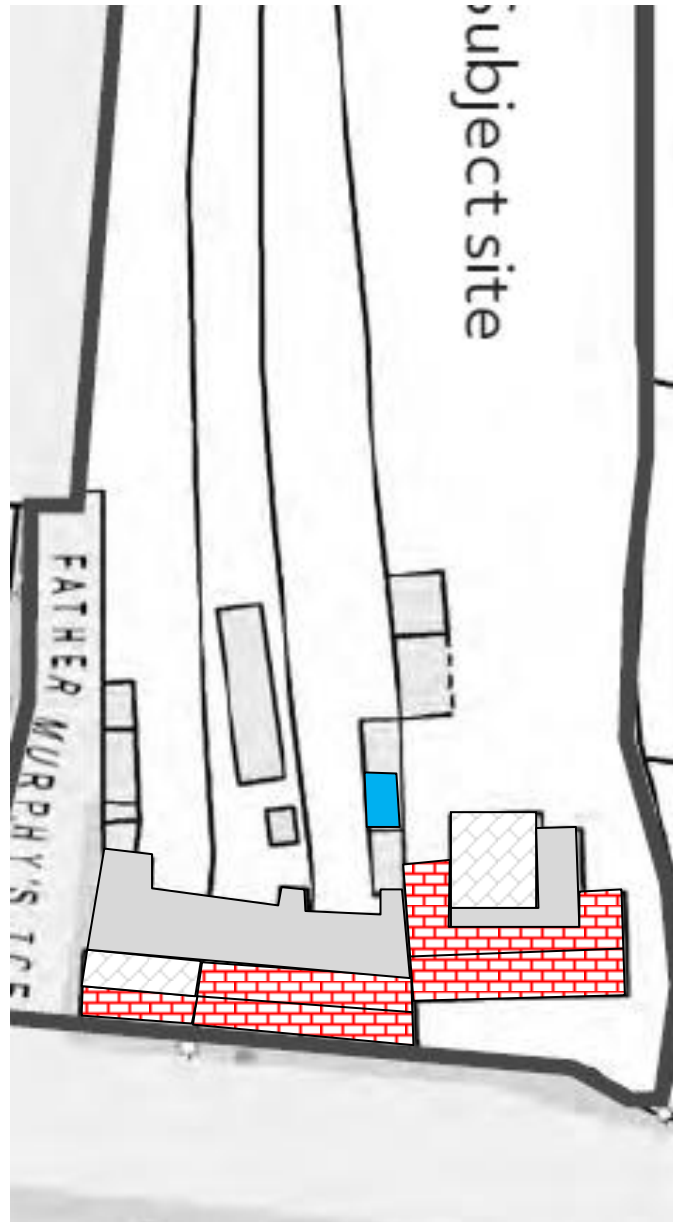
ROOF PLAN

Areas where asbestos cement slates were identified

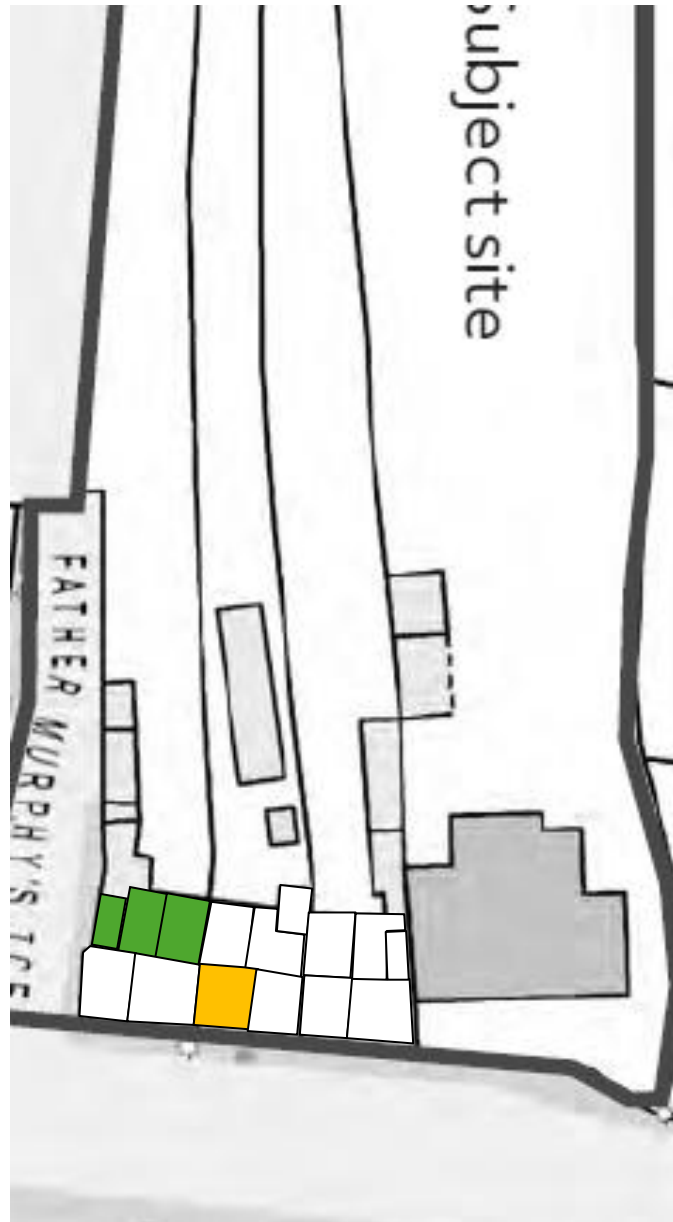
GROUND FLOOR PLAN

Areas where asbestos containing bitumen adhesive was identified
