Architectural Heritage Impact Assessment Report

No. 13, No. 18, Beaufort Cottage and Beaufort, Sallins Road, Naas, Co. Kildare

McCauley Daye O'Connell Architects

10 March 2026

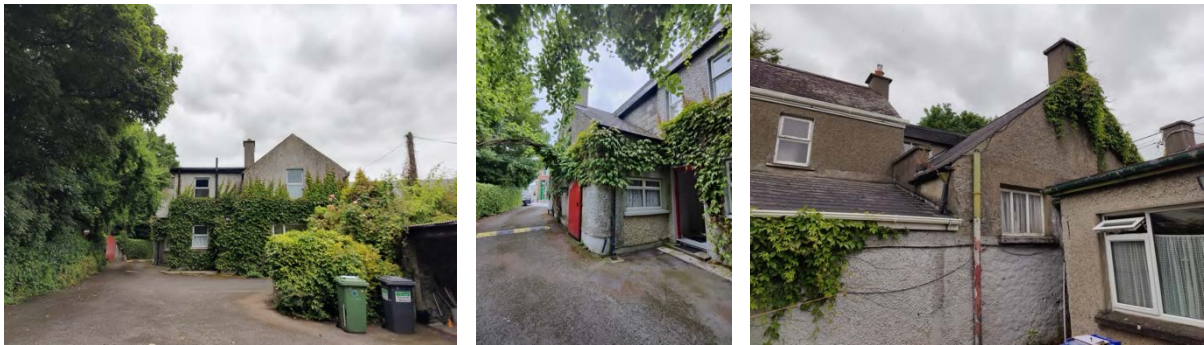
Above Left: Photograph showing the elevation of Beaufort. Above Middle: View of the north side of Beaufort. Above Right: View of the south side of Beaufort taken from the garden of the adjoining Beaufort Cottage.

Beaufort appears to have originally been a wide-fronted single-storey house, with attic conversion and rear extensions added in various phases. There is a two-storey gable-fronted building at the back which does not tie into the front roof. Single storey lean-to extensions have been rationalised and partially subsumed into a two-storey low-pitched extension which joins the earlier buildings together and contains a staircase, entrance hall, utility and bathrooms. Walls to the side and back are covered in a dash render and overgrown. Windows are narrow framed aluminium casements or uPVC. Rainwater goods, soffits and fascia's to the back are white uPVC. Doors and gates are painted timber.

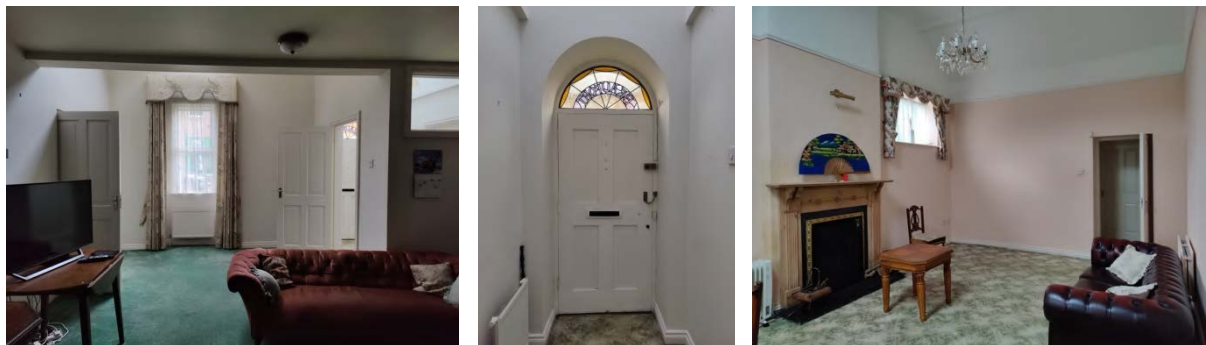
Above: Photographs showing the interior of Beaufort taken in July 2024.
Left: front room (South), Centre: Entrance Hall, Right front room (North)

There is little surviving historic character internally with floor, wall and ceiling finishes all modern and in good condition. The thickness of the internal partitions and the extent of alteration which was carried out when the attic storey was added suggest that most of the historic fabric has been lost or altered beyond recognition.

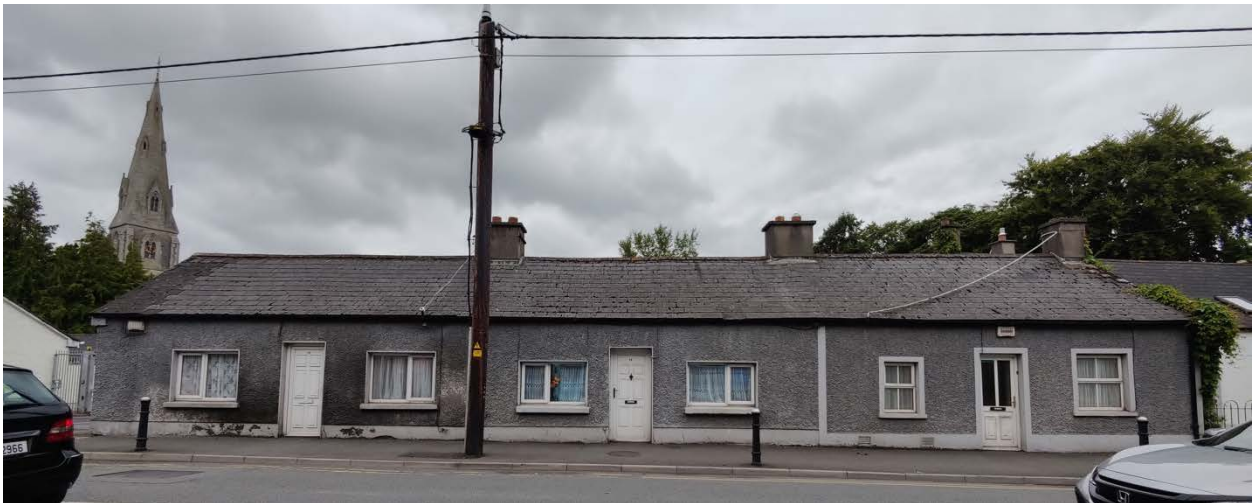
To the front, the walls are dash rendered with a smooth plaster plinth and door and window reveals. The windows openings are irregular square or horizontal rectangular openings with uPVC casements. The front doors are four or six-panel white uPVC. There are under floor vents to part of Beaufort Cottage.

Above: Photographs showing the front of 13, 18 Sallins Road and Beaufort Cottage taken in July 2024.

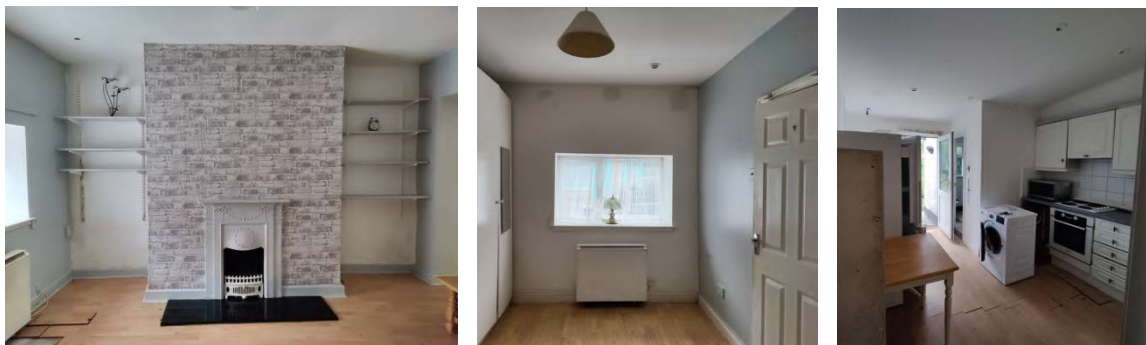
No. 13 Sallins Road has two rooms to the front and three in the extension at the back. Internally the fittings and finishes have been recently renewed and are in good condition. The walls and ceilings are modern plaster board to the front with sheeting added to the walls and ceilings at the back. The flooring is laminate over a concrete floor slab. Sanitary fittings, kitchens and internal joinery are modern replacements. There is a Victorian era cast iron fireplace in the front reception room, with a replacement polished marble hearth. Opening up has been carried out for an asbestos survey.

Above: Photographs showing the interior of 13 Sallins Road taken in July 2024. All wall, floor and ceiling finishes are modern replacements.

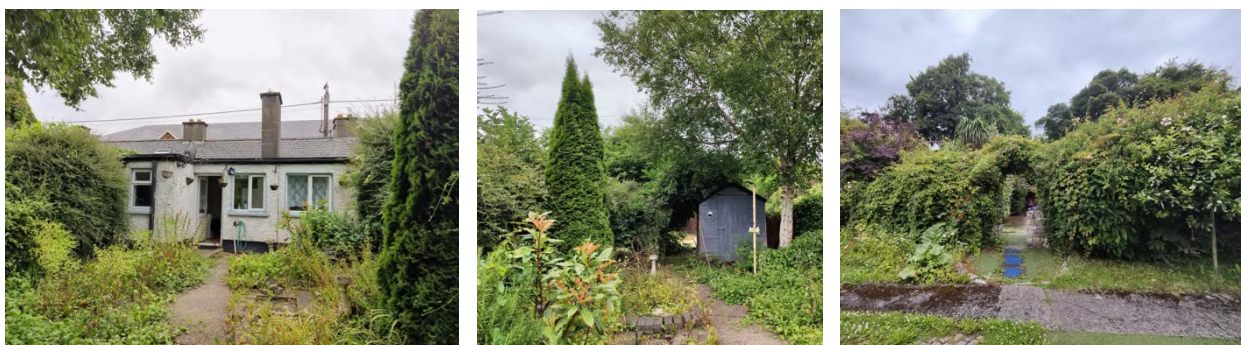
The back elevation of No. 13 is covered in a painted dash render with a smooth plaster plinth and concrete cills and reveals to the windows which are uPVC casements. Rainwater goods are black plastic. There is a tall chimney stack rising from the middle of the rear extension roof. It is rendered with a concrete cap. Ground surfaces to the back are concrete paths with brick kerbs and gravel filled beds. At the back of the cottage it is overgrown. There is a detached free-standing timber shed and a partially paved mixed terrace behind. The boundaries are make-shift mixed material.

Above: Photographs showing the back of 13 Sallins Road taken in July 2024.

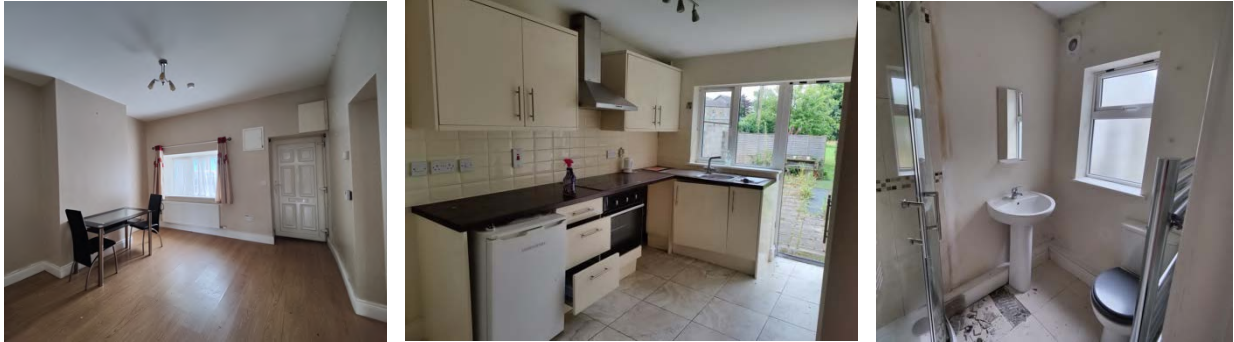
No. 18 Sallins Road (also reportedly known as Iris Cottage) has a living room and bedroom to the front, a kitchen and bedroom in the back extension and a small bathroom. Internal finishes are modern with modern plasterboard lining walls and ceilings and laminate or tile flooring which has been opened up to reveal a concrete floor slab below. All fixtures, fittings and finishes are modern with the exception of a small fireplace in the back room (Room 164), which comprises a simple black cast-iron surround with cast iron grate and raised hearth. It probably dates from the middle of the twentieth century.

Above: Photographs showing the interior of 18 Sallins Road taken in July 2024. All wall, floor and ceiling finishes are modern replacements.

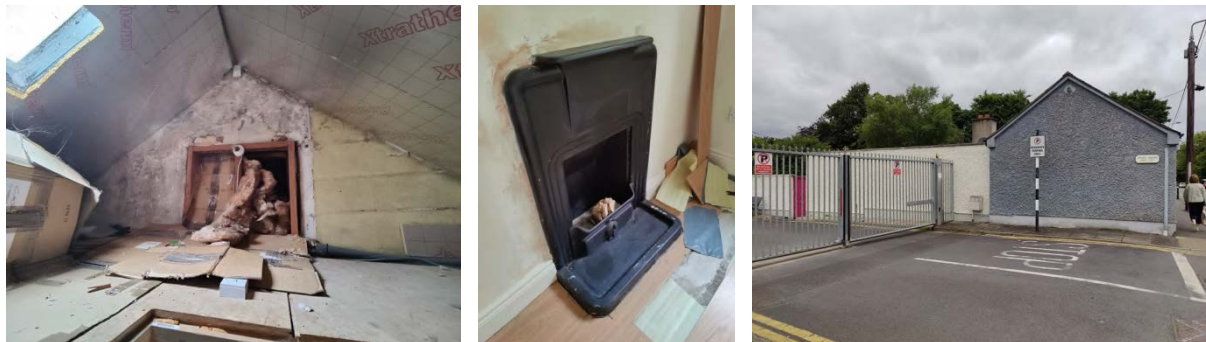
The front attic was accessed via a hatch in Room 162 suggesting that the roof has been replaced along the terrace. Insulation has been added along the slope, and plywood sheeting to the floor. The cross walls or party walls in the attic where viewed, are historic masonry with lime plaster.

Above Left: Attic of 18 Sallins Road. Centre: fireplace in the return of No. 18 is unusual and likely to be historic, Right: Existing gable

Historic fireplaces in Beaufort Cottage (Cast iron surround and grate in Room 141), No. 13 Sallins Road (Cast iron grate and surround in Room 141) and No. 18 Sallins Road (the surround in Room 164) should be carefully taken out and re-used in Beaufort, where the existing fireplaces are late twentieth century replacements, out of character with the historic cottage.

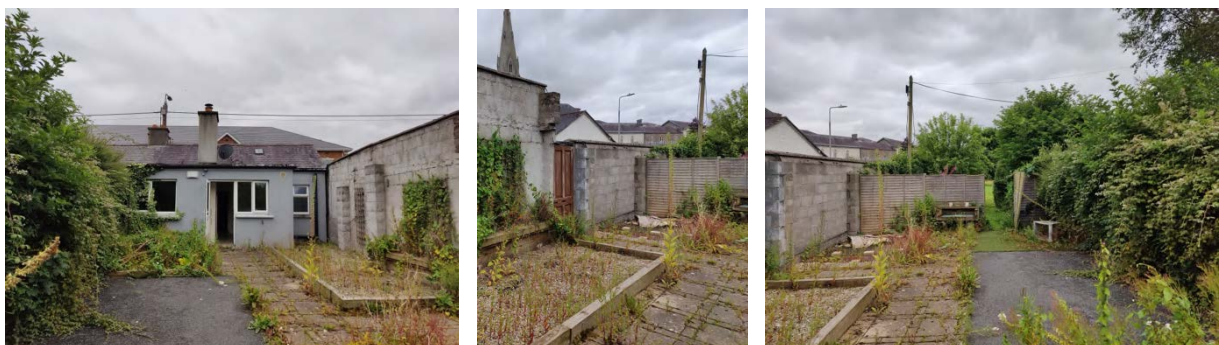
The private back garden is partially paved with timber kerbs and raised planters filled with pea gravel. Boundary walls are modern fairfaced concrete block.

Above: Photographs showing the back of 18 Sallins Road taken in July 2024.

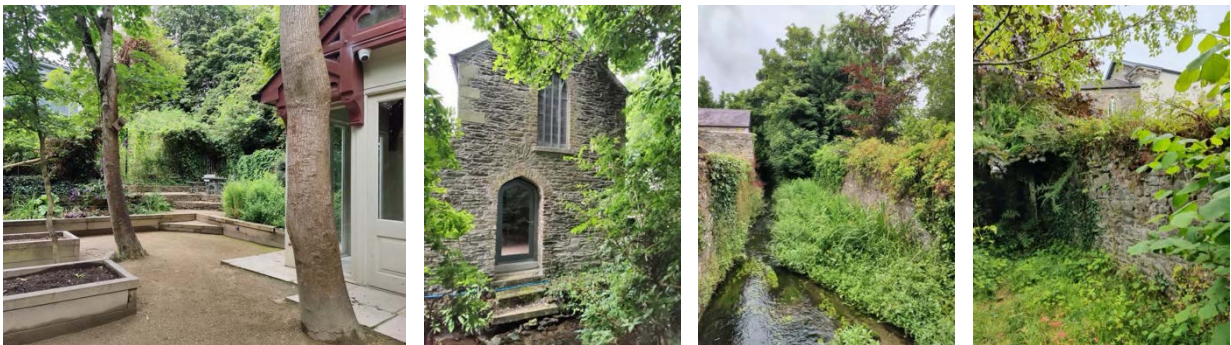
In the garden there are closely planted semi-mature trees, raised planters and sitting areas. The boundaries vary with some sections of historic rubble walling to the mill race at the southern end.

Above: Photographs showing the community garden in July 2024.
