## Accessibility audit of Riverbank Arts Centre, Newbridge, Co Kildare.

## **Access Audit** (Revision No. 1)

Prepared for:  
**Riverbank Arts Centre.**

11<sup>th</sup> August 2016

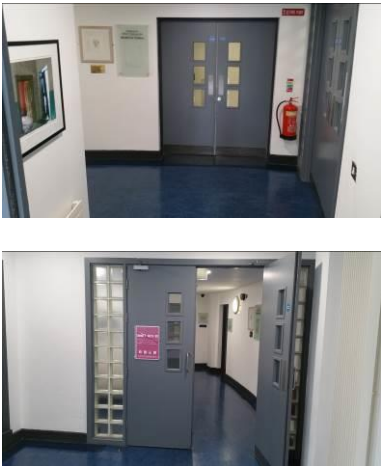
| 5 | Main Lower Ground Level Foyer | <p>The area was open and clear of any obstructions at the time of inspection. Lighting was adequate and there was a good visual contrast between walls and floor, and walls and doors.</p> <p>While signage indicating the room access from the foyer was noted, no signage indicating the location of stair/lift/box office was visible.</p> <p>A double door set provided access to the stair and lift. Both doors were operable at the time of inspection and the doors are rebated. Push plates are provided on both doors but no push signage.</p> <p>Both doors have vision panels at a height of 1020 – 2020mm. A clear opening of 800mm is provided via the leading door. The opening force of the leading door appeared heavy – an average reading of 55N – closed position to 30°, and 25N from 30° to 60°. (recommended max should be 30N &amp; 22.5N)</p> | | <p>Riverbank Arts Centre should consider, as part of any future upgrading works, the following;</p> <ul style="list-style-type: none"> <li>Signage indicating the location of key facilities should be provided. signage should be designed in accordance with TGD Part M 2010 section 1.6.3</li> <li>Testing and recalibration of existing door closers ensuring that the opening force are in accordance with TGD Part M 2010 section 1.2.4.2</li> <li>The provision of an additional low level vision panel in accordance with TGD Part M Diagram 10.</li> </ul> |

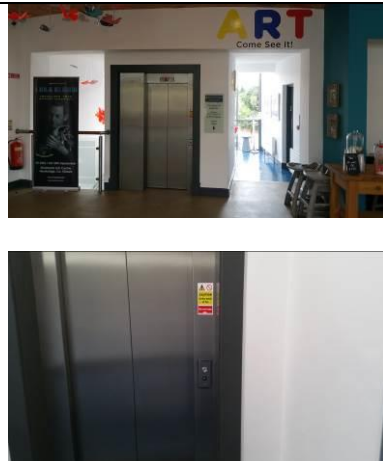
| 6 | Passenger lift | <p>The following was noted in relation to the design of the lift off the main foyer:</p> <ul style="list-style-type: none"> <li>No signage, including symbols, indicate the presence of the lift.</li> </ul> | | <p>Riverbank Arts Centre should consider, as part of any future upgrading works, the following;</p> |

| | <ul style="list-style-type: none"> <li>• The lift car was 1400mm by 1100mm.</li> <li>• Doors have an effective clear opening of 800mm.</li> <li>• There is poor warning sound indicating the arrival of the lift car although a faint sounder bell can be heard announcing its arrival.</li> <li>• There are no voice announcements within the lift car although an audible bell sounder indicates the arrival of the lift.</li> <li>• A visual indicator is provided on the landings.</li> <li>• A handrail is provided on one wall of the lift car and it has visual contrast with its surrounding.</li> <li>• Controls on the landings do not contrast well with their surroundings and are located approximately 900mm off the ground.</li> <li>• Controls within the lift car were centrally located and have raised numbering indicating the destination but no additional signage is provided. call buttons did not visually contrast with their background.</li> <li>• A half-length mirror is provided.</li> <li>• A clear unobstructed area is provided on the upper ground floor but the clear area on the lower ground floor is reduced to 1500mm by a door swing.</li> <li>• The floor inside the lift car is dark in colour which could cause difficulty for the visually impaired.</li> <li>• An emergency communication call button is provided within the lift car (not tested as part of this audit)</li> <li>• Lift call button on the lower ground floor is located 440mm from the returning wall at a height of 965.</li> </ul> | | <ul style="list-style-type: none"> <li>• Signage indicating the provision and location of the passenger lift should be provided to facilitate the finding of the lift. The lift installation should be reviewed to see if it can be upgraded to comply the latest accessibility standards where practicable (e.g. TGD Part M 2010 section 1.3.4.2 and diagram 13).</li> </ul> |

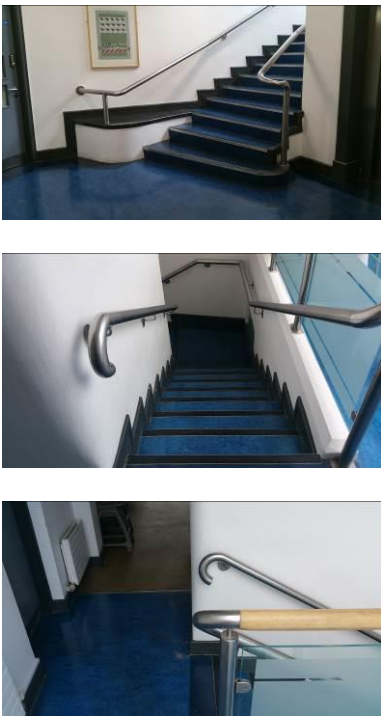
| 7 | Public Stairs | <p>The following was noted in relation to the design of the stairs:</p> <ul style="list-style-type: none"> <li>• The public stair is not in compliance with TGD Part M 2010 guidance on stairs suitable for ambulant disabled people.</li> <li>• The stair consists of 20 steps in 2 no flights. 12 steps &amp; 8 steps with a rise of 170 and a going of 320mm.</li> <li>• The bottom flight at 2040mm exceeds the maximum recommended rise of 1800mm. The bottom flight is widened on approach and includes 3 number of tapered steps at the bottom.</li> <li>• Between walls the bottom flight narrows 1670 to 1260mm at the quarter landing. The top flight achieves a width of 1060 (minimum recommendation 1200mm &amp; narrowing may cause difficulty when full occupancy theatre exits after performance.)</li> <li>• Continuous handrails are provided on both sides of the stair - the handrail is over sized at approximately 65mm and does not terminate correctly – 300mm extended past the stair.</li> <li>• The handrail is located 900mm above the pitch line. The clear width between the handrails narrows and on the top flight fall below the recommended minimum of 1000mm.</li> <li>• Visually contrasting nosing's are provided on all steps.</li> </ul> | | <p>Riverbank Arts Centre should investigate the possibility of making changes to the existing accommodation stairs and bring it, as far as is practicable, in line with best practice such as TGD Part M 2010 sections 1.3.4.1.2 &amp; 1.3.4.2. or alternatively as part of any major upgrading works consider the provision of an additional stair suitable designed to accommodate ambulant disabled persons in accordance with TGD Part M 2010 section 1.3.4.3.</p> |

| | | <ul style="list-style-type: none"> <li>The quarter landing measures 1060 x 1250mm.</li> <li>An adequate clear landing is provided at the bottom of the stair but at the top the clear area measures 1100mm and is further restricted by the radiator location.</li> </ul> | | |

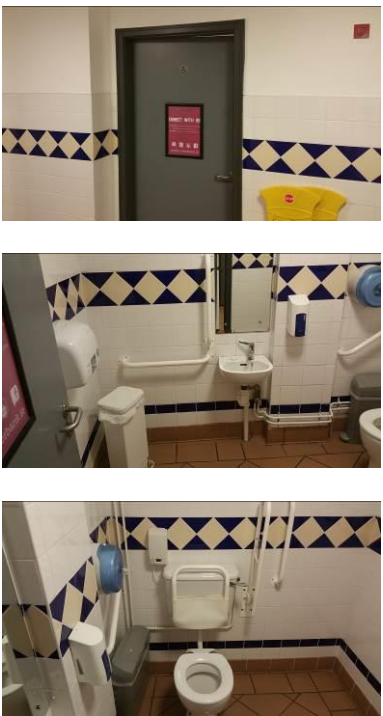
| 10 | Accessible W/C | <p>The following are some of the shortcomings in the design of the existing accessible WC on the ground floor:</p> <ul style="list-style-type: none"> <li>• The accessible W/C provided is not in compliance with the guidance given in TGD Part M 2010 in relation to provisions for wheelchair accessible W/C's</li> <li>• Min overall dims – 2380 x 1825mm.</li> <li>• The door opens inward and is located on the opposite side to the W/C. A clear opening of 860mm is provided. Privacy bolt may be difficult to operate to persons of limited dexterity.</li> <li>• Grab rails have no visual contrast with background or sanitary ware.</li> <li>• Alarm – pull cord is incorrectly located, does not extend to within 100mm of the ground, no bangles, no visual and audible indicators, no reachable reset, no visual and audible indicator easily seen outside.</li> <li>• Hand rinse basin located too far from W/C.</li> <li>• Handrails for rinse basin incorrectly located.</li> <li>• Hand drier, soap dispenser, paper towel, mirror incorrectly located.</li> <li>• Good visual contrast between floor and walls.</li> <li>• Lighting was adequate.</li> <li>• No coat hooks provided etc.</li> </ul> | | <p>Riverbank Arts Centre should review the design of the accessible WC and make sure that it is designed in accordance with section 1.4 of TGD M 2010 where practicable.</p> <p>Signage for the Accessible W/C should be included in the overall wayfinding strategy for Riverbank Arts Centre.</p> |

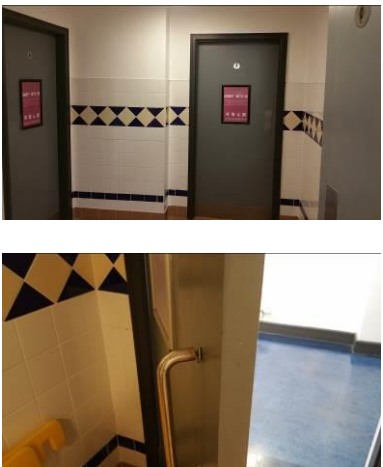
| 11 | W/C Lobby | <p>Overall dimensions of the lobby are 2490 x 3270mm approximately.</p> <p>The entrance door opens inward and has 3 x disk signs/symbols attached indicating male/female &amp; an accessible W/C. There is also a wall mounted sign outside the W/C lobby indicating toilets &amp; baby changing facilities. The door has a push plate to the outside and a pull handle internally – It was noted that the pull handle is loose and may prevent persons from exiting should it come away from the door.</p> <p>There is good visual contrast between the floor, walls and doors. Internal doors to W/C facilities are fitted with push plates and pull handles no vision panel are provided for privacy. on the external lobby door, no vision panel has been provided.</p> | | <p>Riverbank Arts Centre should consider the repair/replacement of the pull handle to the lobby exit door. Replacement pull handles should be designed and located in accordance with TGD Part M 2010 section 1.3.3.2(d)</p> <p>The opening force of all internal doors should be checked and recalibrated to be in accordance with guidance given in TGD Part M 2010 section 1.2.4.2</p> <p>Consideration in relation to the provision of adult changing places to ensure the needs of the widest range of abilities including persons requiring assistance.</p> |

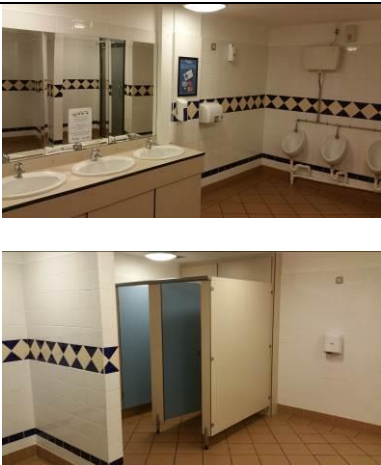
| 12 | Male Toilet | <p>The door opens inwards to a comfortable circulation space. A clear opening of 865mm is provided.</p> <p>There are 2 cubicles provided – both are standard and have no additional accessibility features such as grab rails, outward opening doors etc. Cubicle size is 1475 x 860mm.</p> <p>3 no. urinals are provided all at the same level – rim level 550mm above finished floor level. No additional accessibility aids are provided.</p> | | <p>When carrying out retrofits or repairs to the toilet facilities Riverbank Arts Centre should consider bringing the male toilet facilities in line with best practice. For example, ambulant disabled cubicles and ambulant disabled urinals should be fitted in accordance with TGD Part M 2010 section 1.4.6.2 &amp; 1.4.7.</p> |

| | | <p>3 no. wash hand basins in a single vanity unit are provided all are at a height of 860mm. lever action taps are provided. 3 no hand driers are provided all are located at 10355mm above floor level. It is noted that a baby changer is provided.</p> <p>A clear opening of 865mm is provided.</p> <p>A good visual contrast between the floors and the walls is provided but the visual contrast between sanitary ware and their background is considered poor.</p> | | |

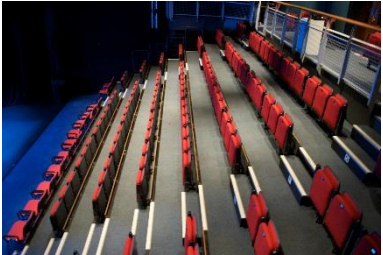
| 16 & 17 | Performance Area & Audience Seating | <p>The following was noted in relation to the performance and audience seating area:</p> <ul style="list-style-type: none"> <li>• The performance floor surface was dark in colour – requirement for performances etc. The performance area is slightly raised causing a threshold between floor levels. During normal operations there is a good visual contrast</li> </ul> | | <p>When carrying out retrofits or repairs to the toilet facilities Riverbank Arts Centre should consider bringing the audience and spectator facilities in line with the guidance given in TGD Part M 2010 section 1.5.3.</p> <p>Consideration should be given to the suitability of the existing seating and</p> |

| | | <p>between the main floor (light in colour) v's the performance area.</p> <ul style="list-style-type: none"> <li>• With the seating extended the circulation route at the front achieves 1600mm (excluding loose chairs) which is reduced to approximately 900mm when the seating is occupied.</li> <li>• 2 x designated wheelchair spaces are provided. Both to the front and in the corner – poor visibility and can be hampered by curtains etc. No facility for wheelchair users to be accompanied.</li> <li>• The designated wheelchair spaces are not provided with a sufficiently sized clear turning space causing difficulty for a wheelchair user to manoeuvre into position particularly in an occupied auditorium.</li> <li>• Visually contrasting nosing's are provided on stepped access routes to the raked seating – clear width 1000mm. The rise and goings to the raked seating are not consistent (rise varied from 180 -200mm and the goings alternate between an oversized tread and a tread of approximately 285-305mm).</li> <li>• Rows are clearly identified on the raked access route and seats are numbered.</li> <li>• It is noted that the audience are normally ushered to their seats by staff and that all audience members access the theatre through the lower ground floor level. The front row of seats is not fixed and act as a barrier for the fixed row behind – no barrier incorporated into the seating.</li> </ul> | | <p>the possibility of replacing same with seating facilities accessible to people with a wide range of abilities.</p> |

| | | <ul style="list-style-type: none"> <li>• It was noted that the closeness of the seating can causes comfort and access issues for all users.</li> <li>• It was noted that a hearing enhancement system is in place but no signage indicating its presence was observed.</li> </ul> | | |

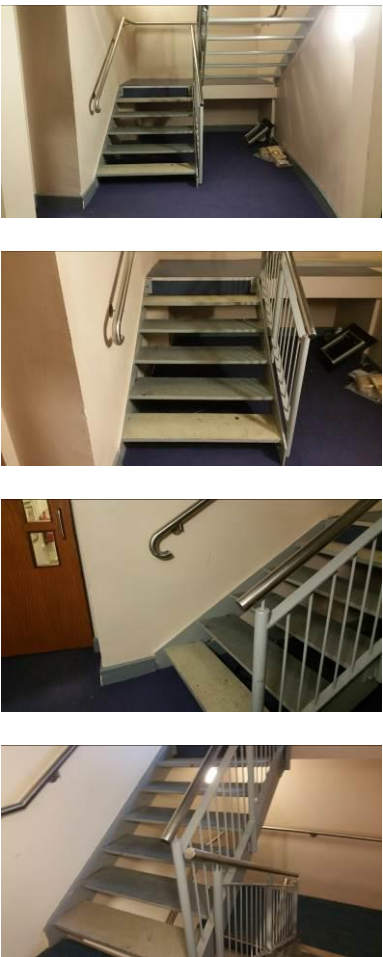
| 21 | Escape Stair | <p>The escape stair consists of 6 no. flights of steps. The first flight of 6 and the remaining all have 7 steps.</p> <p>The escape route it to the upper ground floor – 4 flights is the maximum travel require to place of safety. The final exit is not clearly indicated and signage would prevent people passing the exit in the case of an emergency.</p> <p>The stair width achieves 1170mm and a clear width between handrails of 1080mm. steps consist of a tread of 300 and an open riser of 180mm. there are no visually contrasting nosing's although it is noted that the first and last tread on each flight visually contrast with intermediate treads.</p> <p>Adequate unobstructed clear space is provided at the bottom of the stair and the final exit opens outward – not interfering with the landing space. A single step downward of 190mm is provided at the final exit. (clear opening at final exit is 700mm – obstructed by push bar.)</p> <p>There is a danger that persons with visual impairment may walk into the underside of the stair at lower ground floor level as no guarding etc. is provided.</p> <p>The door opening onto the lower ground floor, providing a clear opening of 865mm, opens against the light switches which could cause confusion.</p> <p>Landings provided achieve 2370 x 1500mm</p> | | <p>As part of any future upgrading works Riverbank Arts Centre should consider as far as in reasonably practical bring the escape stair in line with TGD Part M section 1.3.4.3.</p> <p>The location of the light switches behind the door should be considered as part of any refurbishment works. Replacement switches should be in accordance with TGD Part M 2010 section 1.5.7</p> <p>Signage should be incorporated into the final exit to avoid confusion.</p> <p>Signage indicating the restricted nature of the top three flights of the stair should be provided.</p> |

| | | <p>A continuous handrail is provided on the outside/wall side of the stair (except where interrupted with doors) the central handrail is not continuous. Handrails are located 900mm above the pitch line but are not terminated correctly – 300mm extended.</p> <p>Lighting appeared adequate at the time of inspection.</p> <p>It was noted that the ceiling height at the lower ground floor level achieves 2100mm excluding a beam etc. projecting below this level, this could cause a hazard re persons hitting their head. No cautionary signage etc. present.</p> <p>Access from the top 3 flights is to the children's store and the projection room. Neither are accessible to the public and are accessed by authorise personnel only, as such, these areas were not included in the accessibility audit.</p> | | |

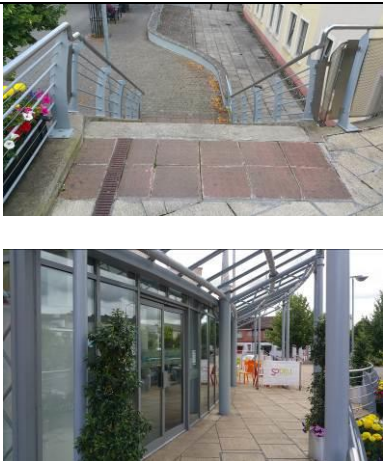
| | | <p>The upper ground floor plaza area is a level paved area partially covered by a glazed canopy at the entrance doors. Outdoor seating and screening is provided re the café but the route to the entrance doors was kept clear at the time of inspection. The glazed canopy is supported by pairs circular columns. Taping rails have been provided but there is no visual contrast between the entrance glazed façade and the columns which may be confusing for persons with visual impairment.</p> | | |

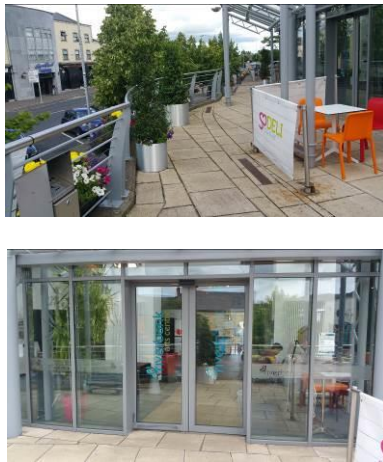
| 2. | Main entrance | <p>There are 4 x entrance doors provided from the upper ground floor plaza area to the main foyer/box office/café. 1 no automatic sliding door set and 3 x manually operated double door sets that open in either direction. A clear space of 1800x1800mm is provided on approach and exit.</p> <p>There was no visible signage indicating the location of the accessible entrance automatic doors. All four doors are contained in a glass façade and there is no visual contrasting band etc. around the doors making them easily identifiable. Manifestation on the glazed façade is located in one band only at a height of 930-1130mm and manifestations on the doors includes branding and is located at a height of 1260-1530mm.</p> <p>All manifestations are of the etched type and do not have any additional visually contrasting features. The average opening force recorded on the</p> | | <p>During any future upgrading works to the upper ground floor main entrance the following should be considered by Riverbank Arts Centre;</p> <ul style="list-style-type: none"> <li>• The provision of signage clearly indicating the accessible entrance into the building in accordance with TGD Part M 2010 section 1.6.3 &amp; BS 8300:2009</li> <li>• Additional manifestations should be incorporated into the entrance door and glass panel façade in accordance with TGD Part m 2010 section 1.2.4.1</li> <li>• The opening forces of all manually operated doors should be measured and</li> </ul> |

| | | <p>manually operated door was of 40N – closed position to 30°, and 55N from 30° to 60°. (recommended max should be 30N &amp; 22.5N).</p> <p>A clear ope on the automatic doors of 1440mm is achieved 790mm clear ope on the leading door of the manually operated entrance door sets. Pull handles are located on either side of the manually doors and they do not contrast with the doors.</p> | | <p>adjusted in accordance with best practice – TGD Part M 2010 section 1.2.4.2</p> <ul style="list-style-type: none"> <li>• The main assessable entrance should be framed with a high-contrast strip to ensure it is clearly identified by persons with a visual impairment. In accordance with TGD Part M 2010 section 1.2.4.1 (c)</li> <li>• The manually operated doors should have the visual contrast increased on pull handles or consideration for provision of visually contrasting push plates instead where appropriate.</li> <li>•</li> </ul> |
