HISTORIC BUILDING APPRAISAL

APPRAISAL OF HISTORIC RUINS

Sallins Amenity Lands, Osberstown, Co. Kildare

February 2021

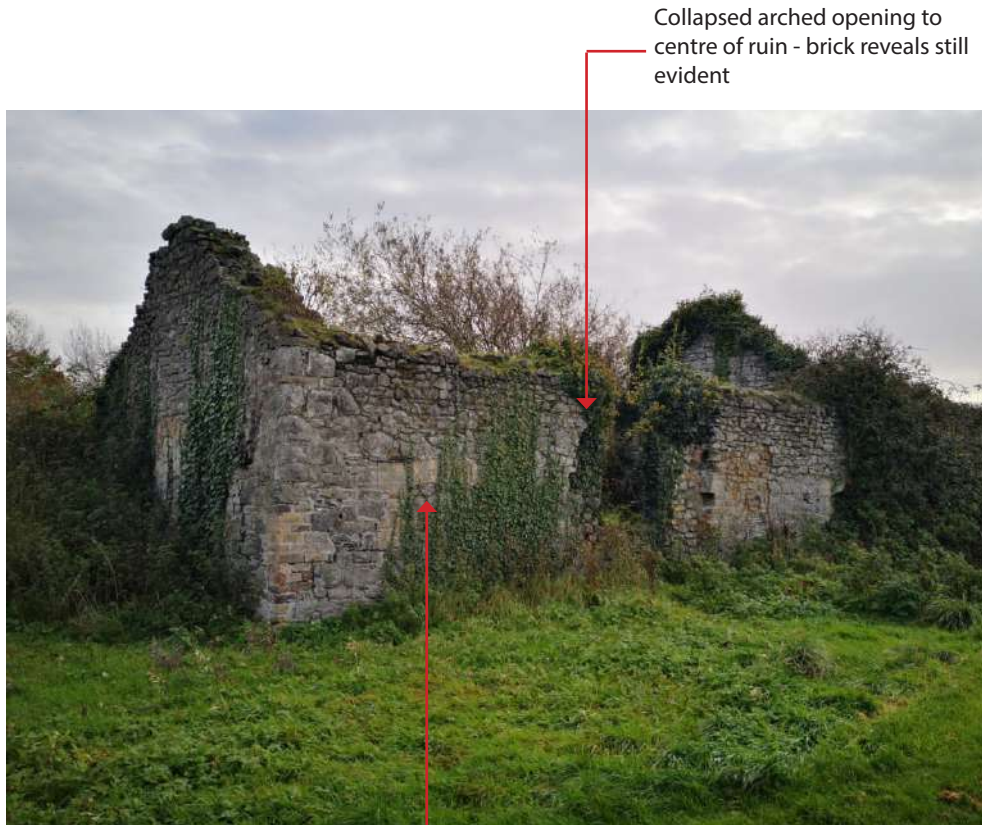
Collapsed arched opening to centre of ruin - brick reveals still evident

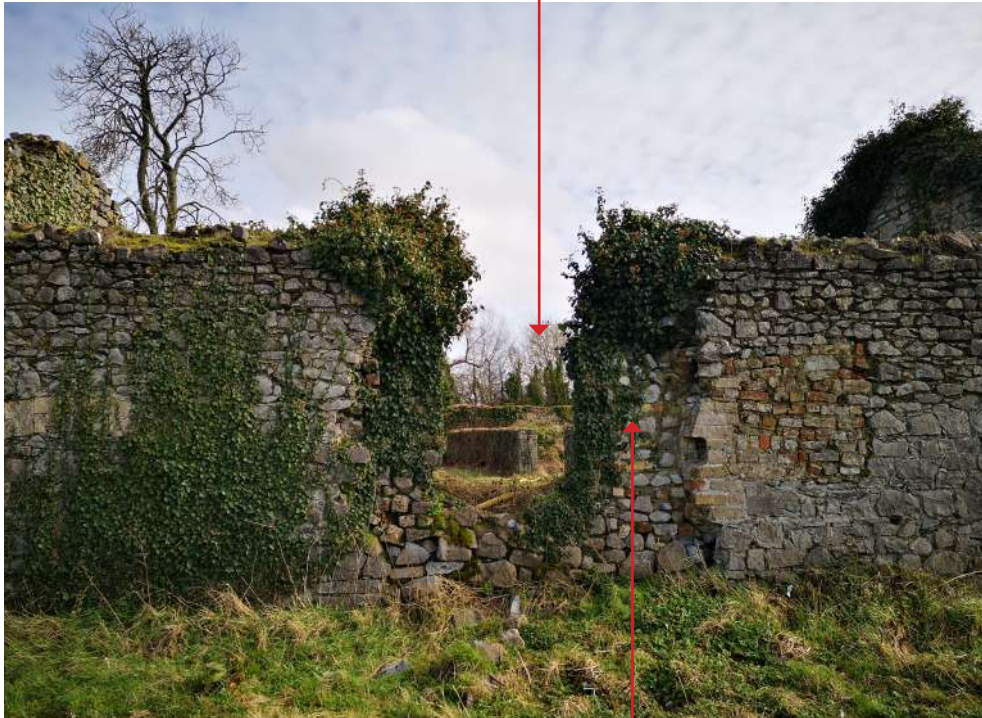
Collapsed at centre of north-west ruin

Outer face of rubble stone wall
missing

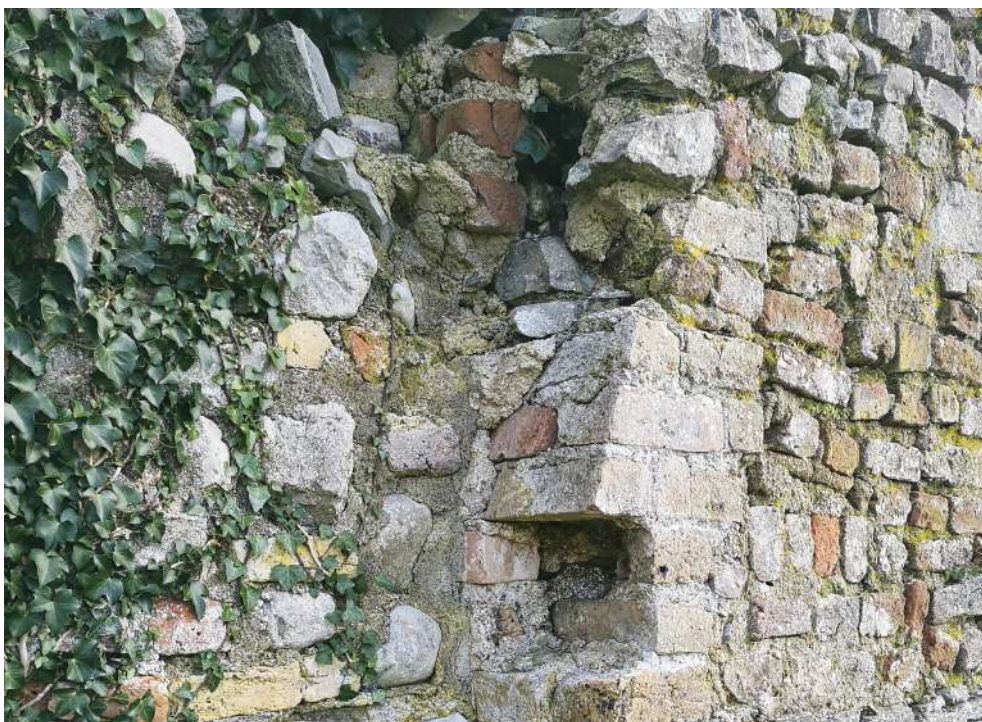
View of stonework and mortar to centre of
damaged rubble stone wall

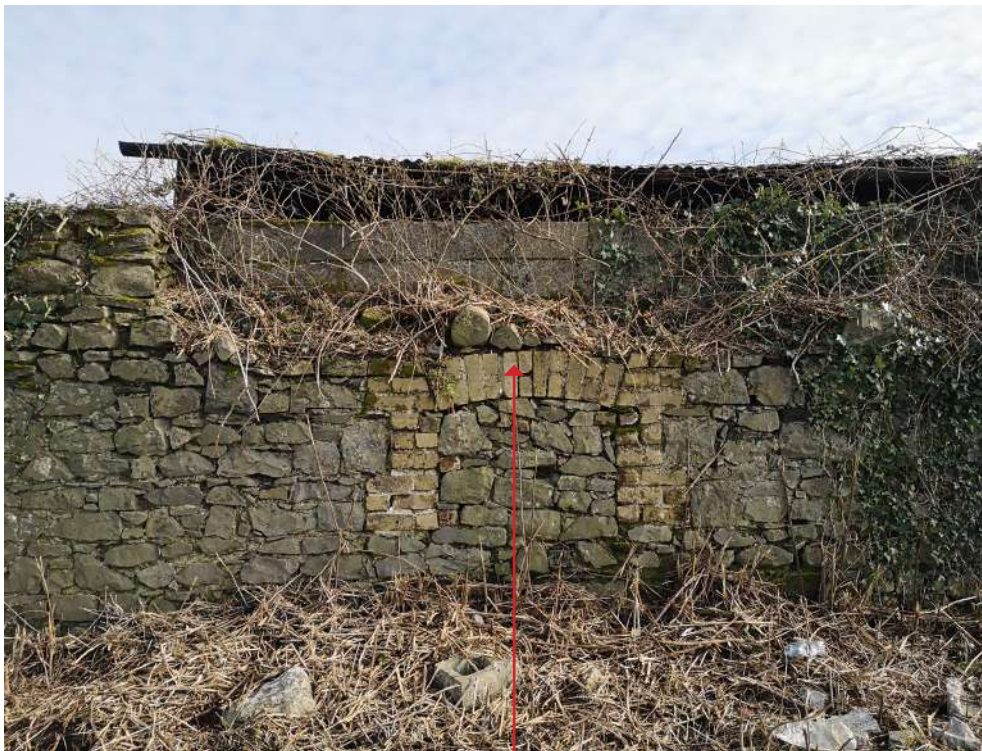
View of shallow brick arches evident along western wall

Damage to upper section of remaining wall where steel agricultural shed introduced

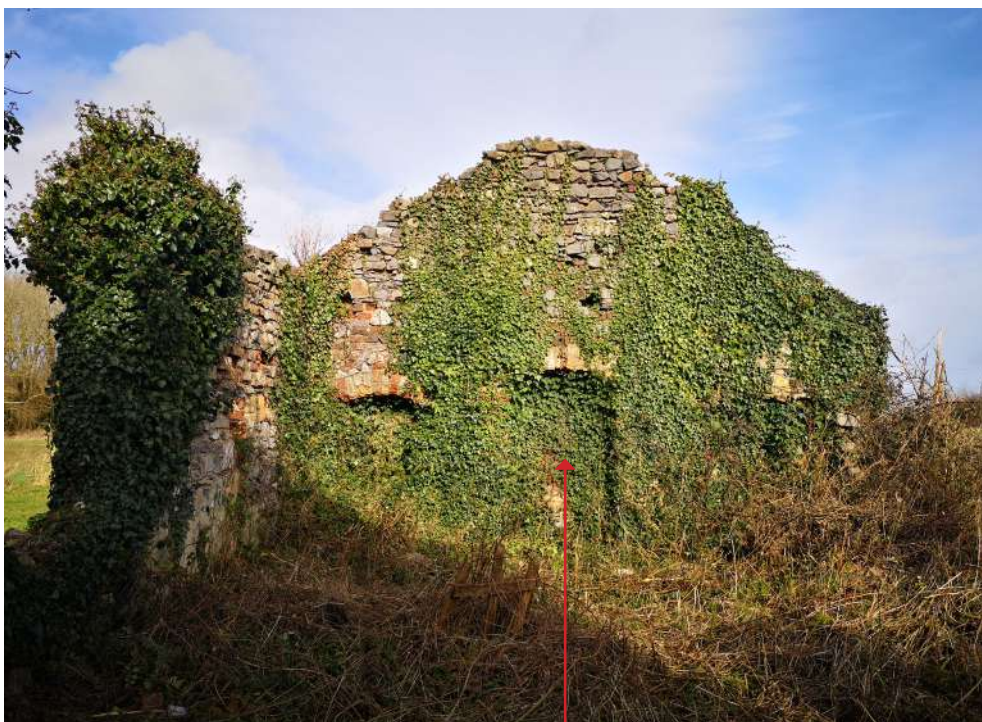
View of Northern gable with 3 no. blocked bricked arched openings

Original centre door with two recessed archway either side

Collapsed arched opening to
centre of ruin - brick reveals still
evident

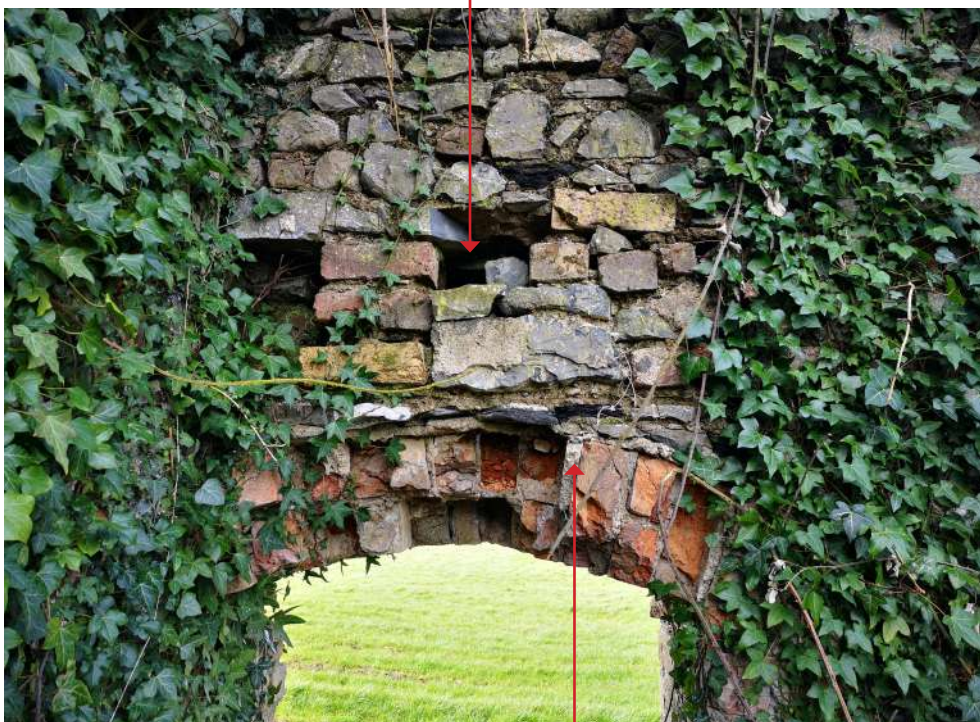
Detail of open brick arch and window

Inner face of brick arch
missing

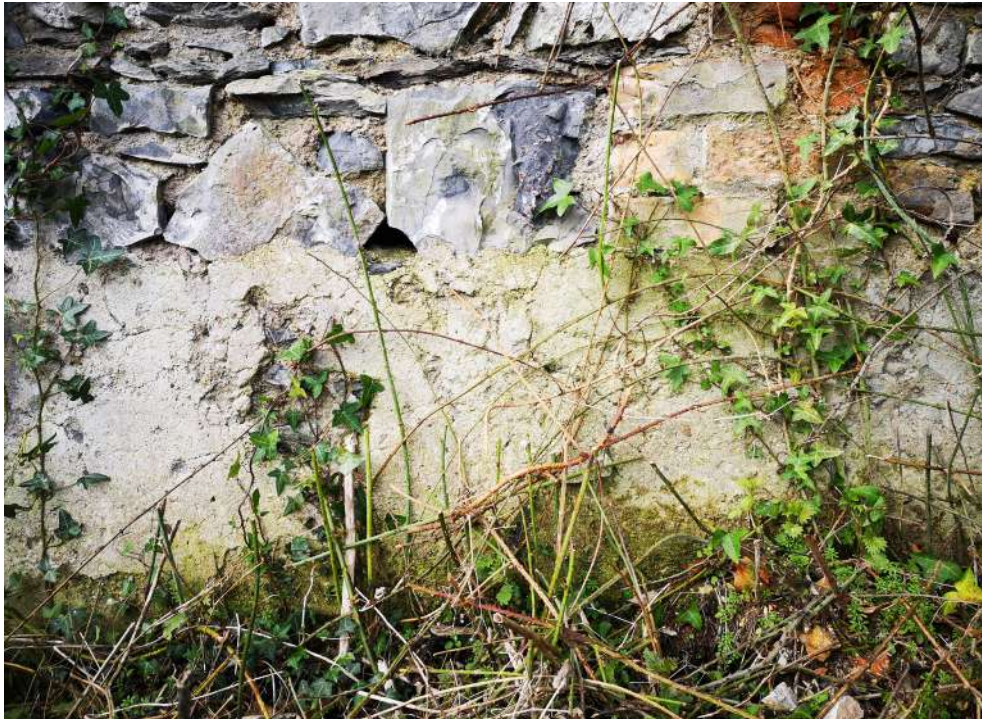
Remnants of lime render to base of wall

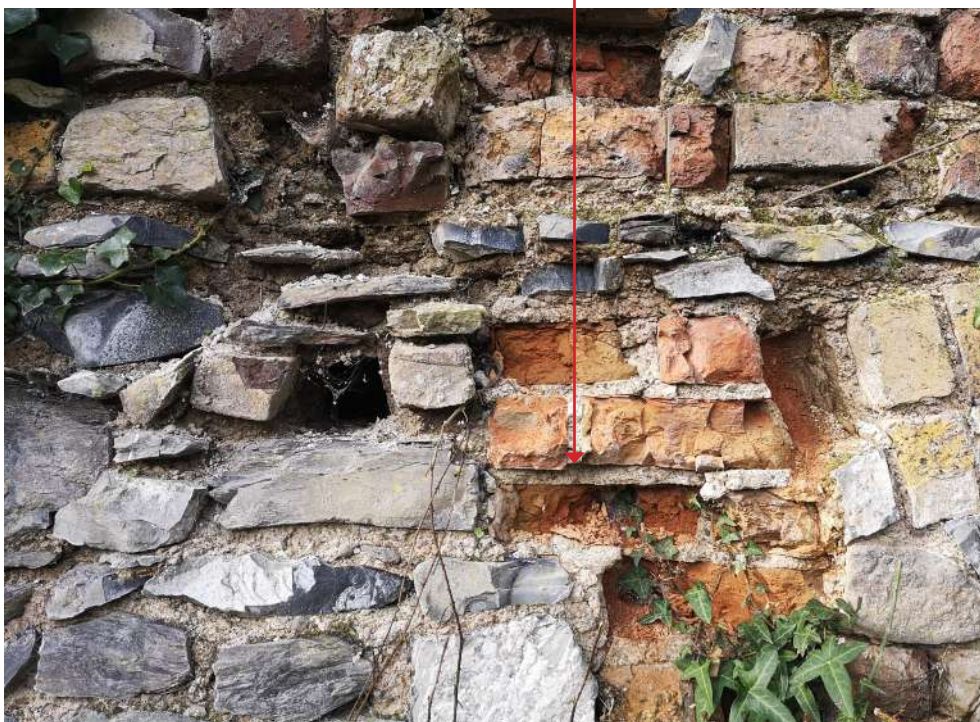
View of mixed fabric of ruin wall

Pockets evident at regular intervals in upper level of stone gable - possibly location of timber structure for loft area above barn

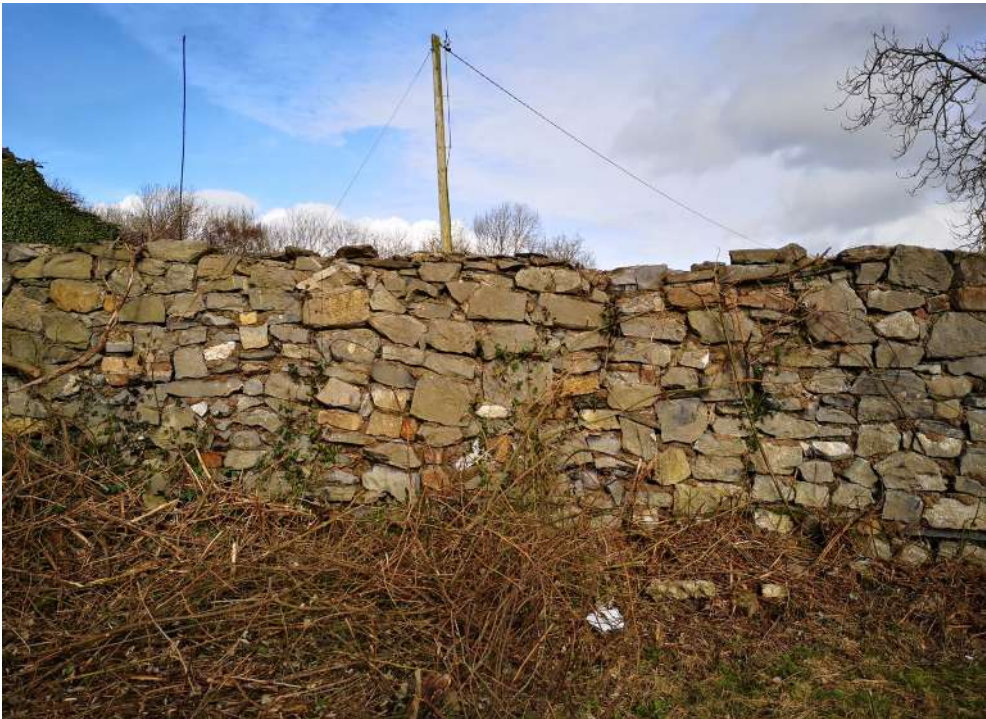
View of dividing courtyard stone wall

Later concrete blockwork repair works completed to reveal

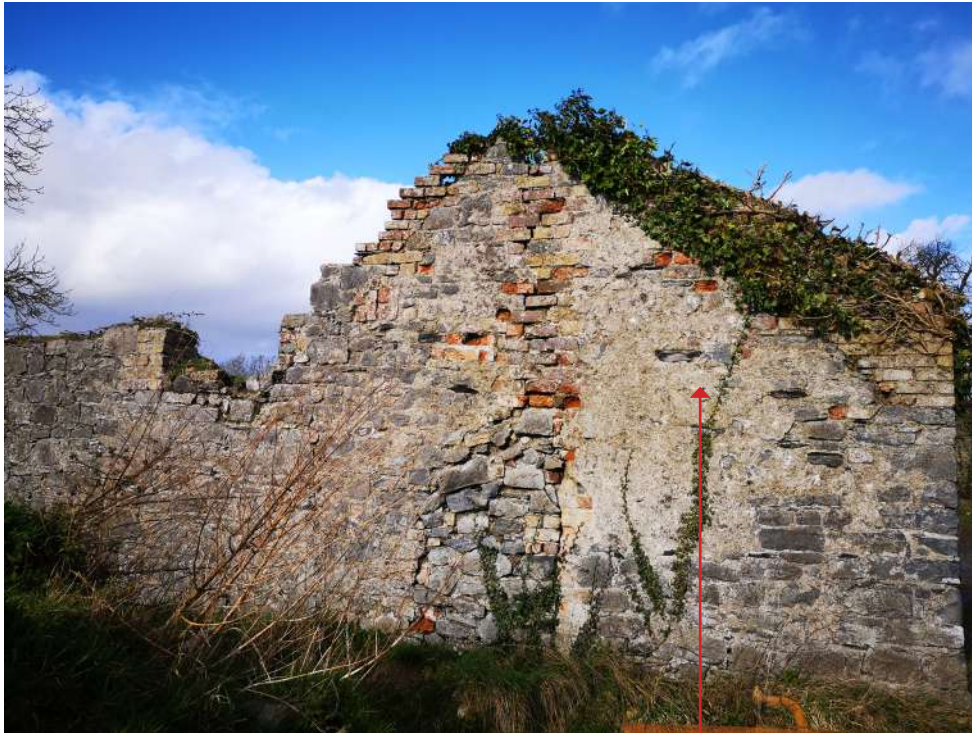
Limestone and brick fabric evident to Southern wall

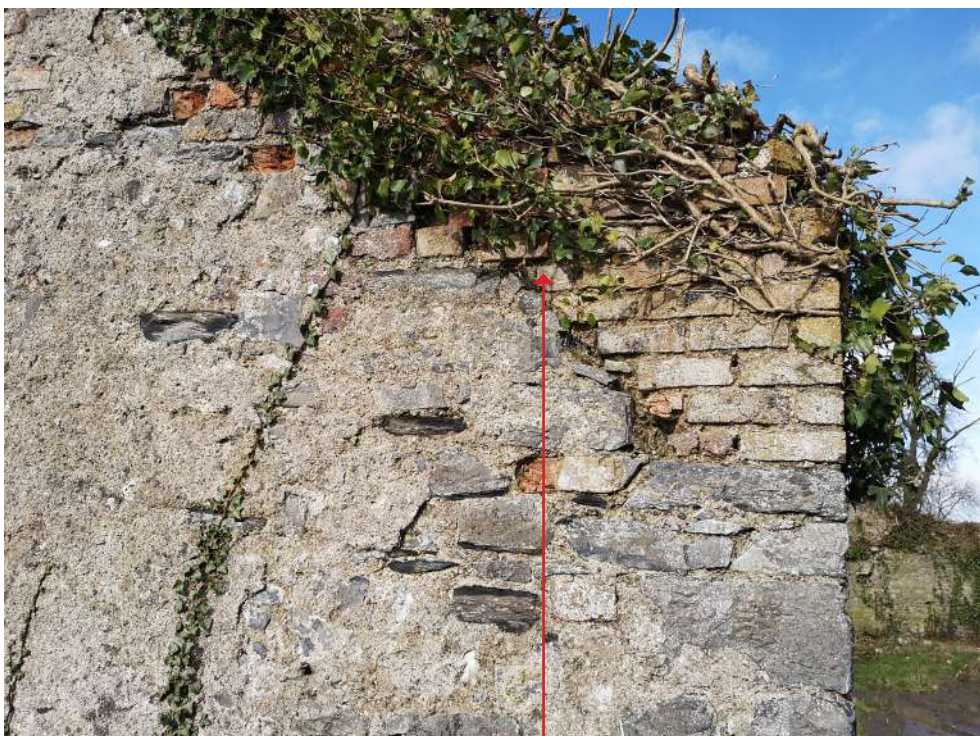
Exposed brickwork to top of gable wall

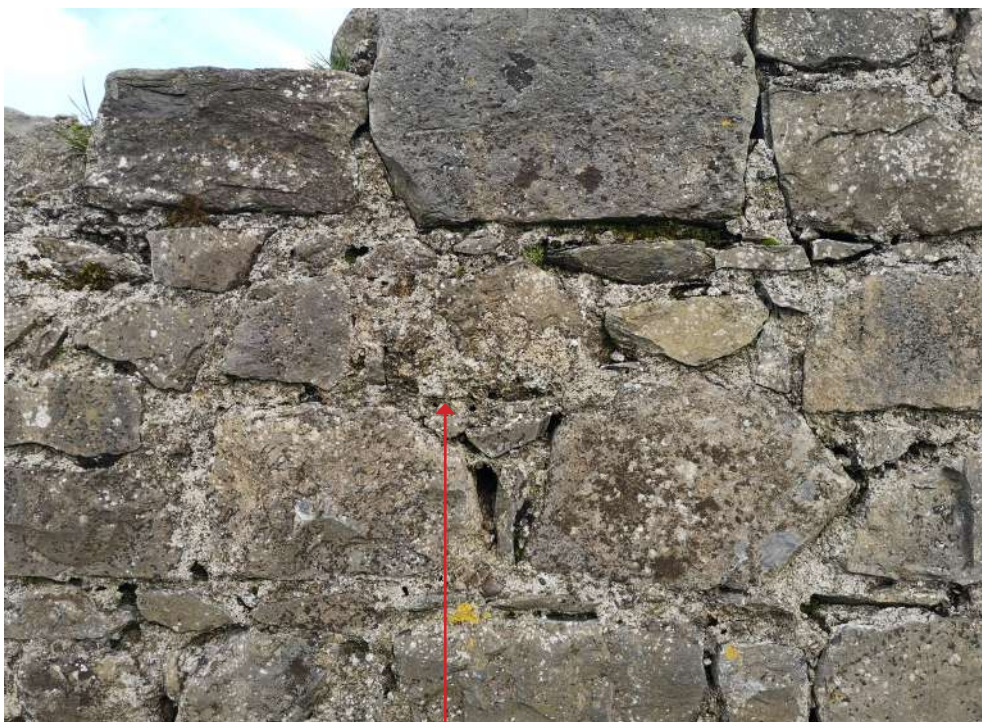
Lime mortar pointing evident to original exposed stonework

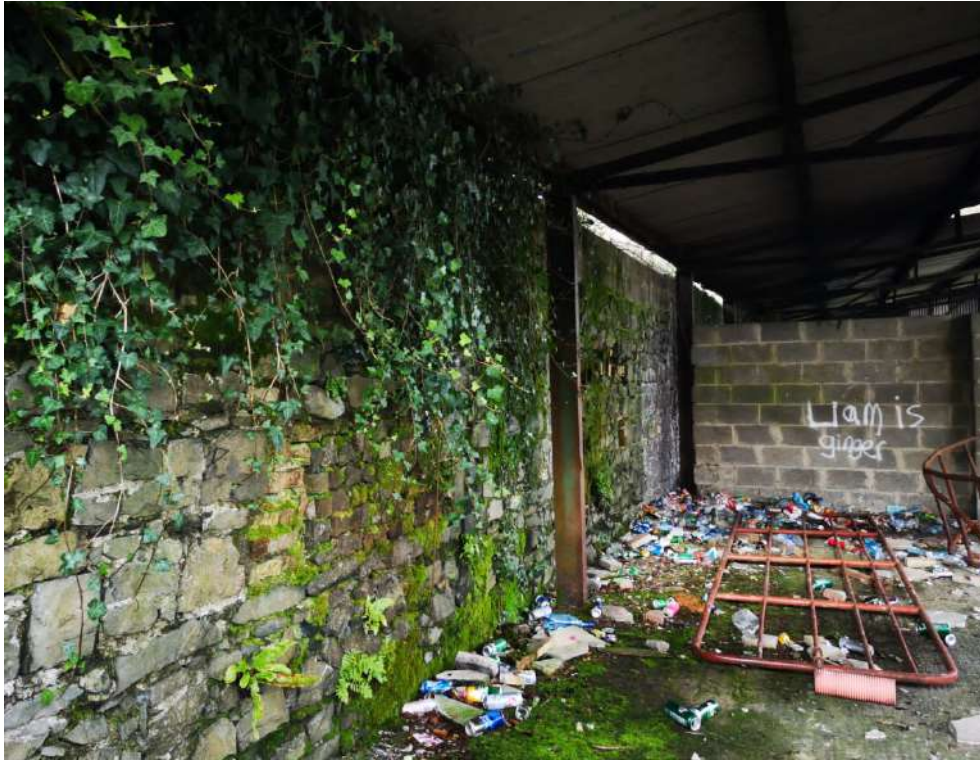
Water penetration damage and overgrowth apparent to Westen stone wall

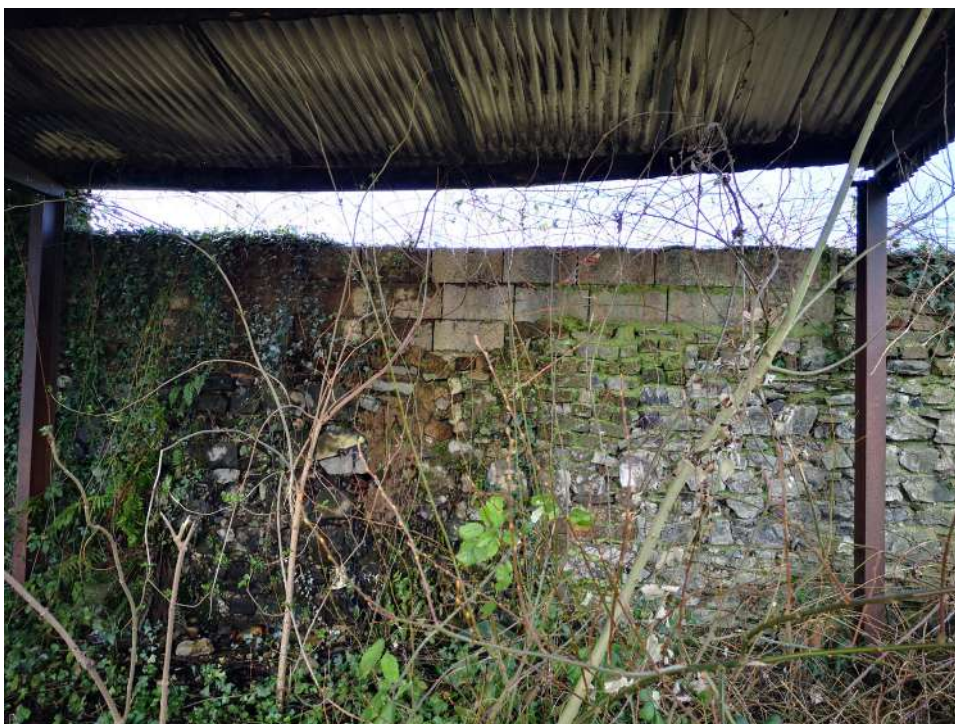
Later concrete blockwork wall intervention to historic stone wall of western ruins

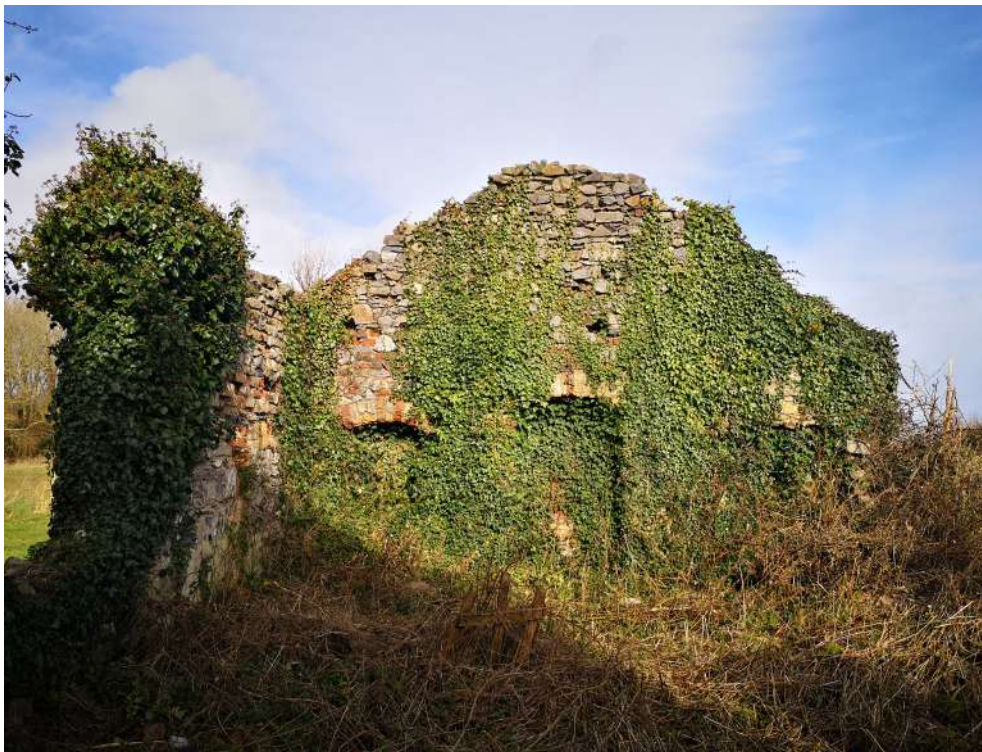
View of remains of northern gable with blocked brick archways
