Kildare Bridges Inventory Gathering and Principal Inspections

Structure Name:
Moone Village Bridge
Structure ID:
KE-L8102-002.00

KE-L8102-002.00 Moone Village Bridge

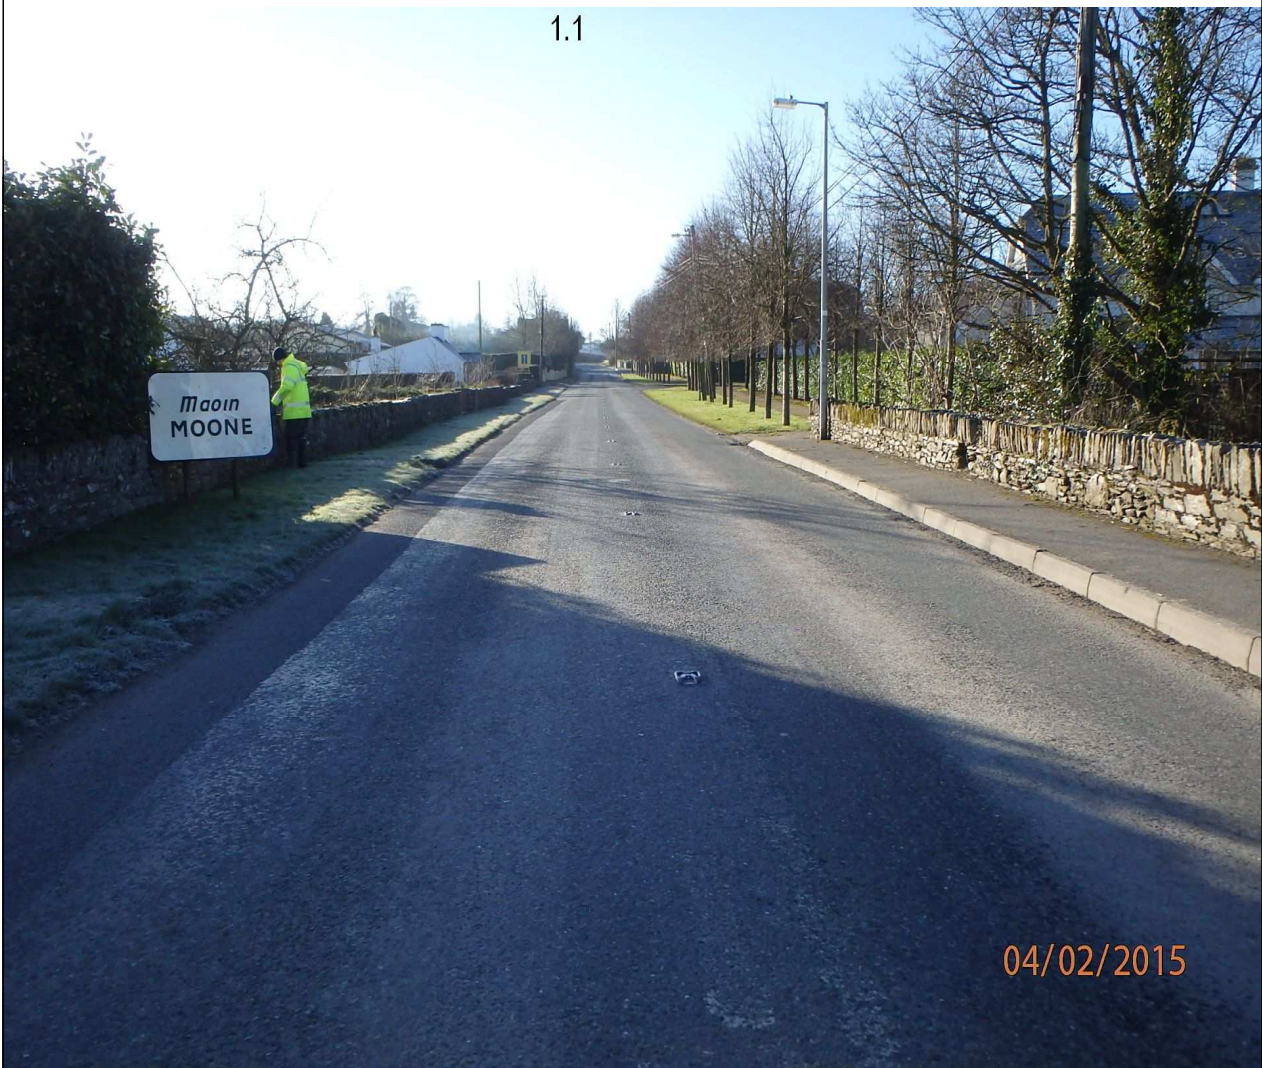
1.1

Soft verge on the East side, rubbing strip to be installed. (Photo 1.1)

Condition/Mainten. 2 / N

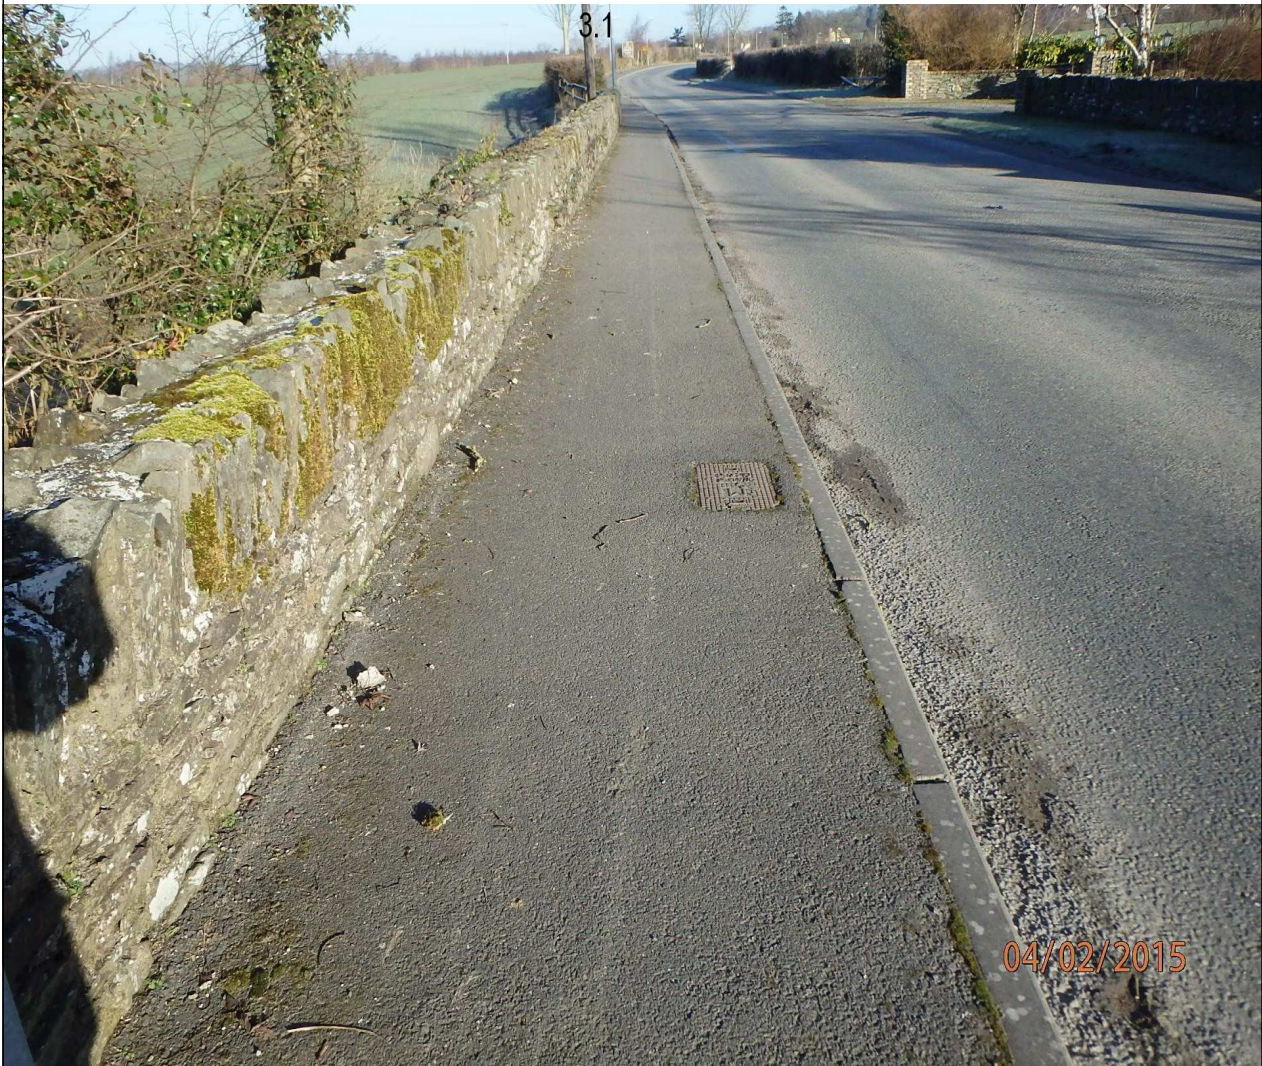
The footway is in good condition. To be swept under routine maintenance.
(Photo 3.1)

Condition/Mainten. 1 / Y

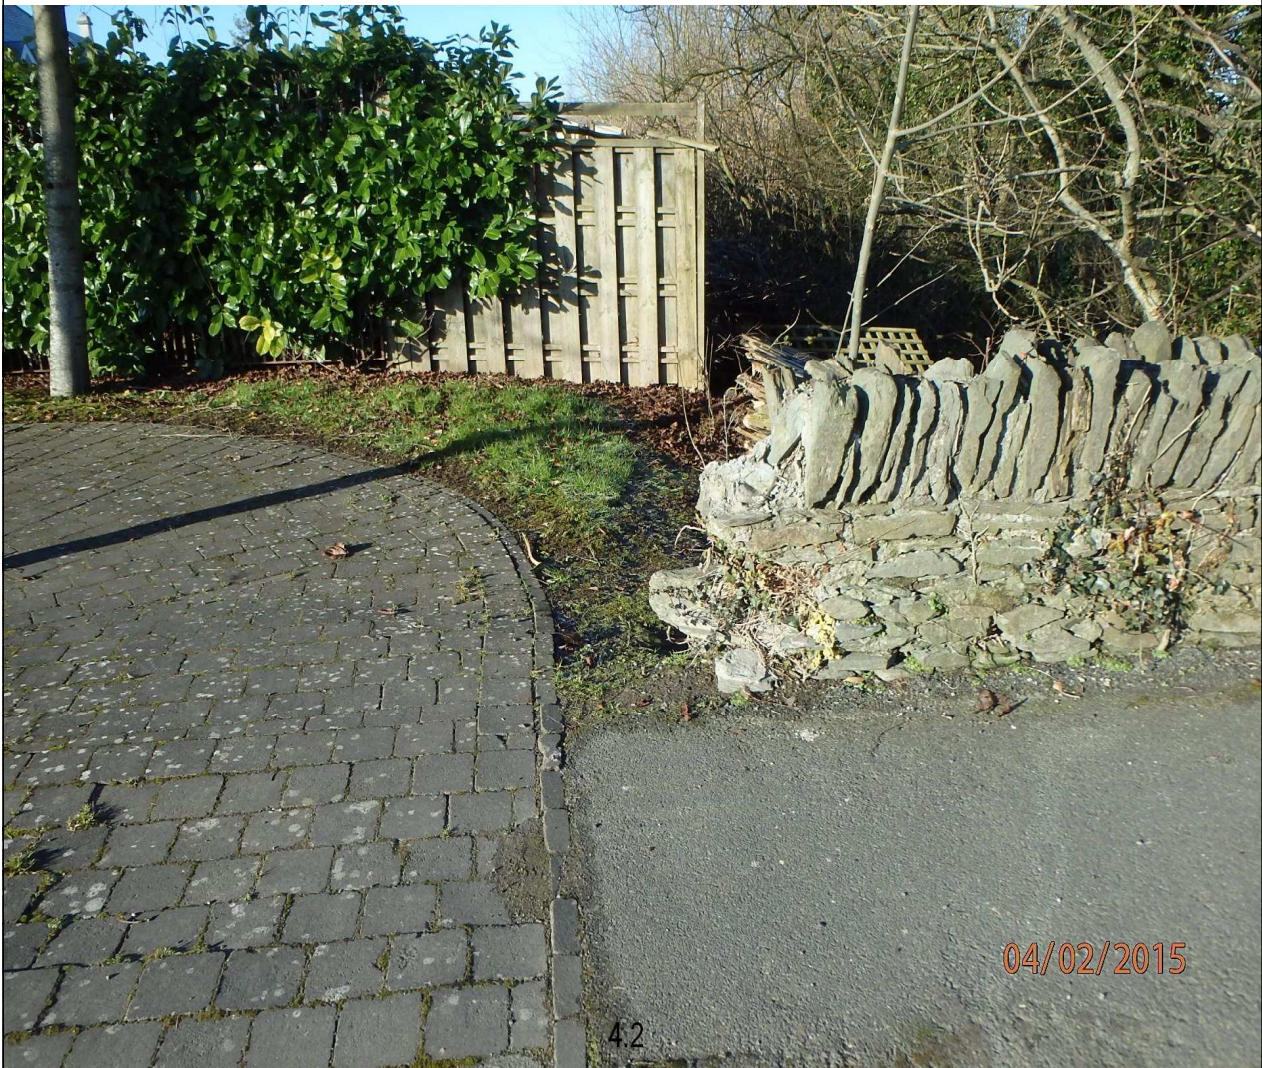
Stones missing from the north end of the west parapet. (Photo 4.1) The south end of the west parapet has collapsed. (Photo 4.2) Minor loss of pointing to the East parapet. (Photo 4.3) Vegetation to be removed under routine maintenance.

Condition/Mainten. 3 / Y

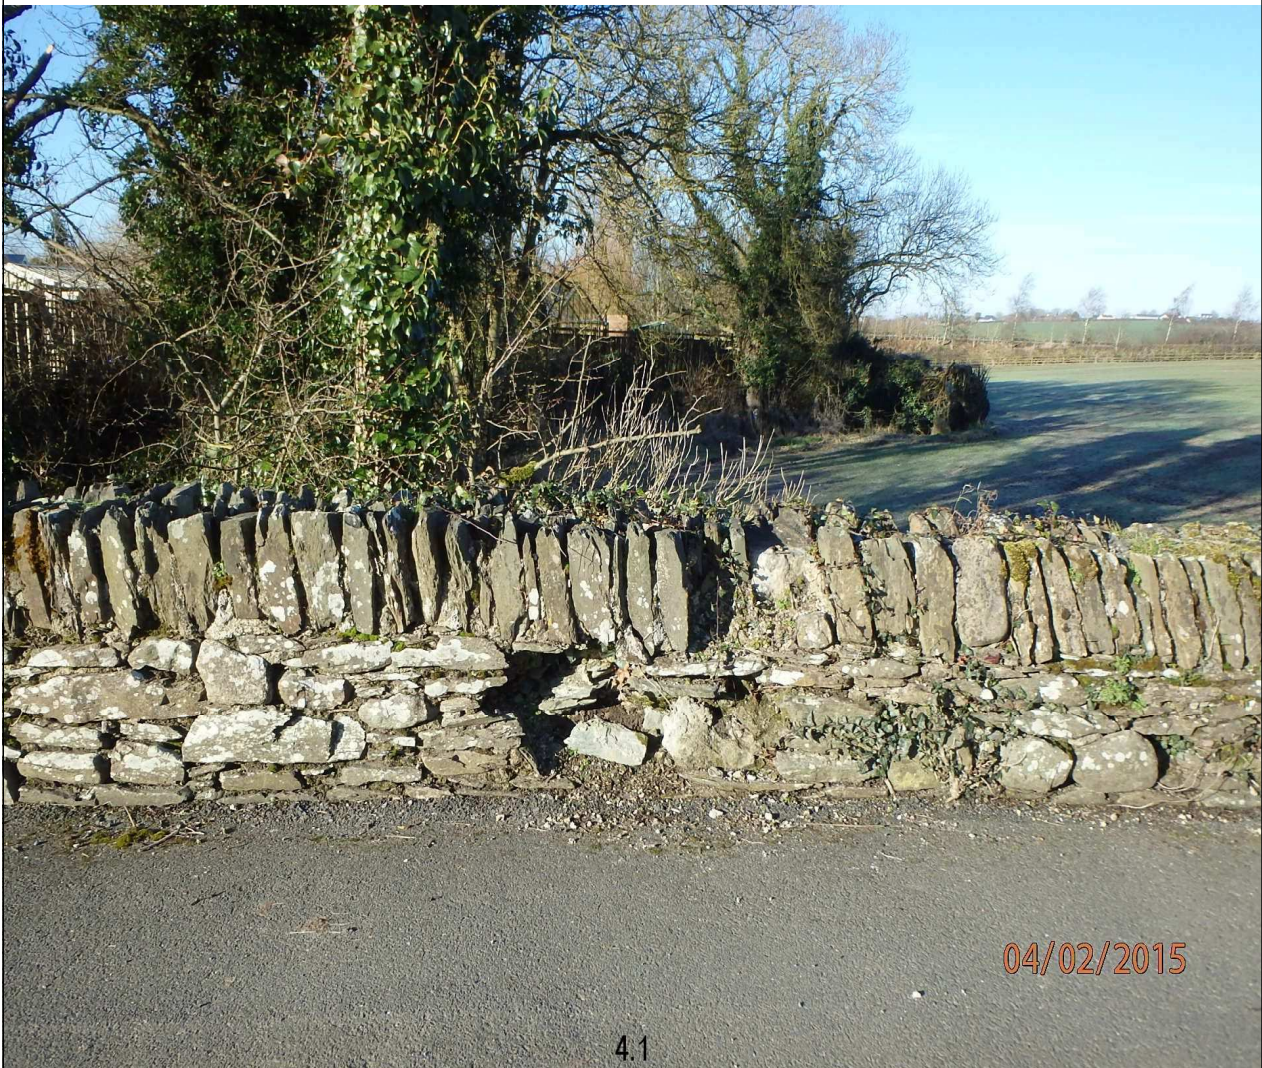
Component No.	4	Parapets/Safety barrier
Stones missing from the north end of the west parapet. (Photo 4.1) The south end of the west parapet has collapsed. (Photo 4.2) Minor loss of pointing to the East parapet. (Photo 4.3) Vegetation to be removed under routine maintenance.		
Condition/Mainten.	3	/ Y

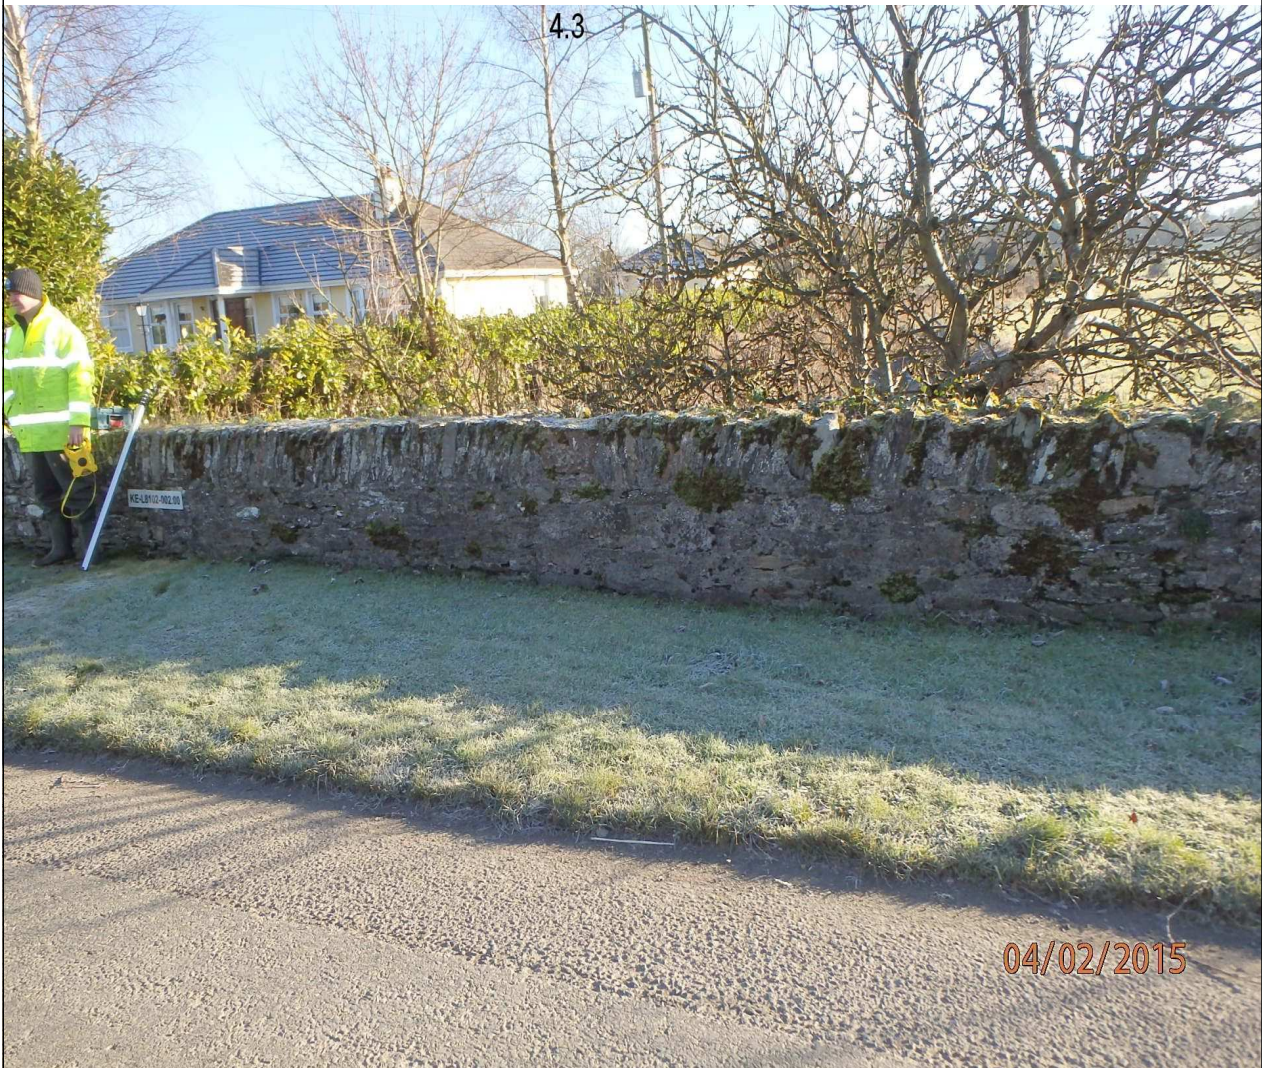
Component No.	4	Parapets/Safety barrier
Stones missing from the north end of the west parapet. (Photo 4.1) The south end of the west parapet has collapsed. (Photo 4.2) Minor loss of pointing to the East parapet. (Photo 4.3) Vegetation to be removed under routine maintenance.		
Condition/Mainten.	3	/ Y

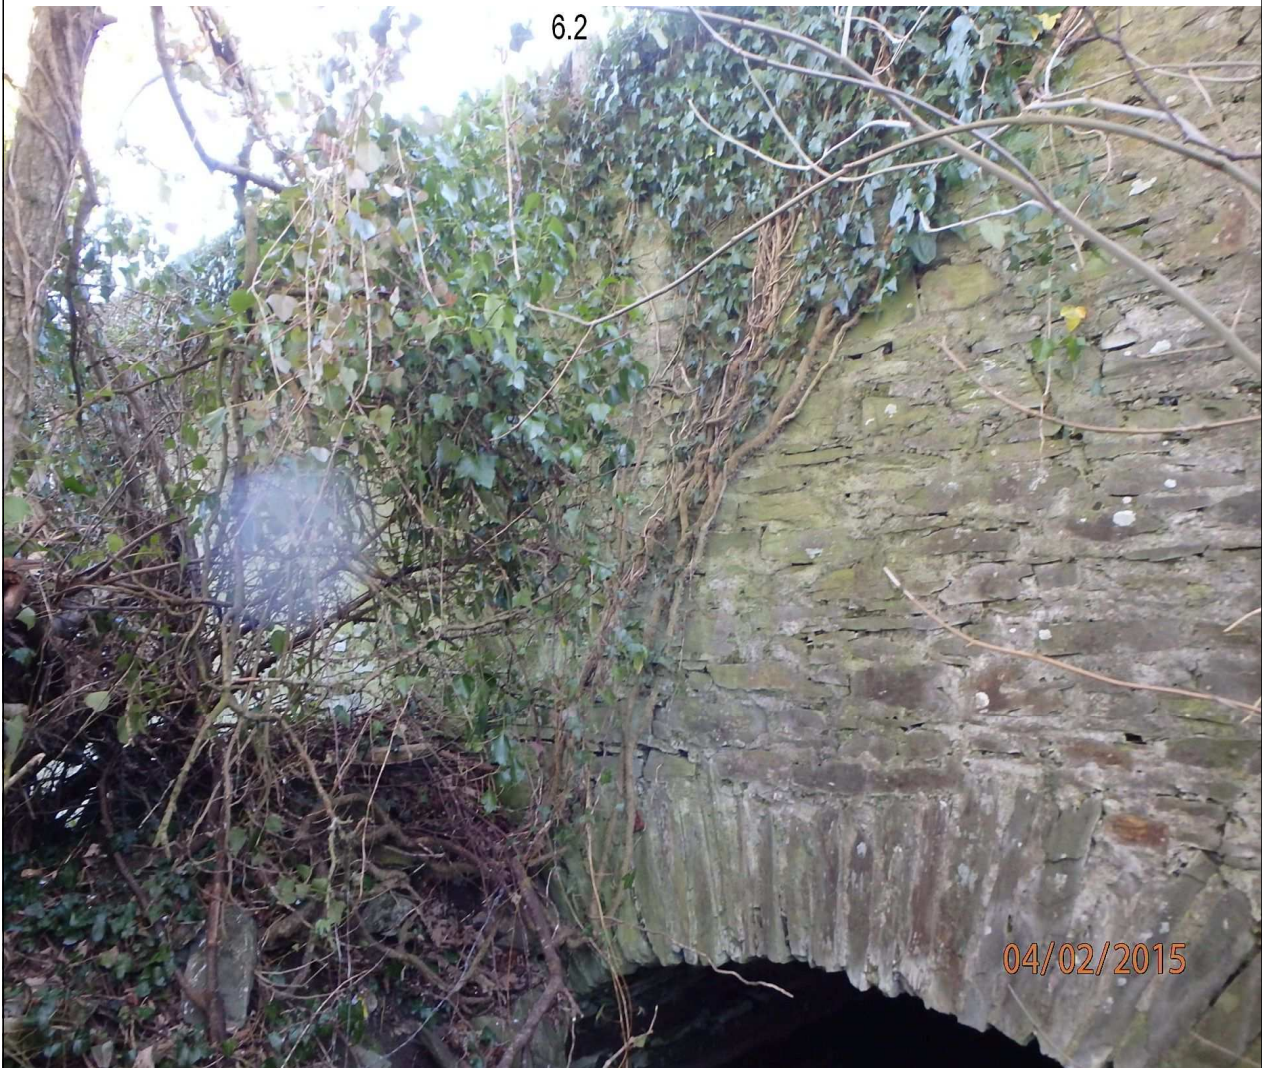
Loss of pointing to the east walls, particularly at the north side. (Photo 6.1) Loss of pointing to the west walls also. (Photo 6.2) Vegetation to be removed under routine maintenance.

Condition/Mainten. 2 / Y

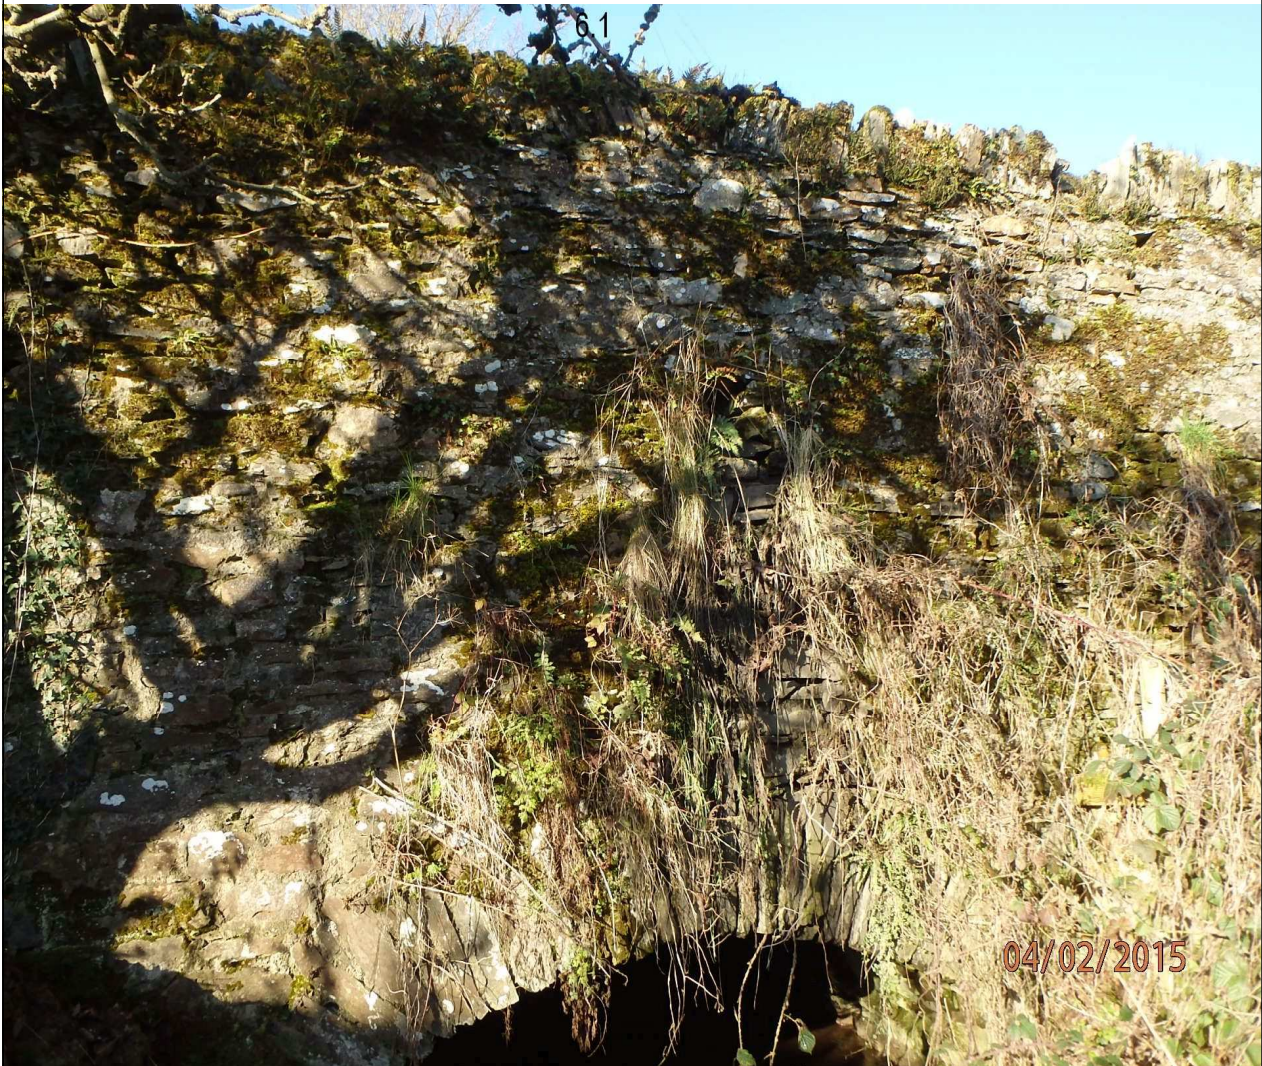
Loss of pointing to the east walls, particularly at the north side. (Photo 6.1) Loss of pointing to the west walls also. (Photo 6.2) Vegetation to be removed under routine maintenance.

Condition/Mainten. 2 / Y

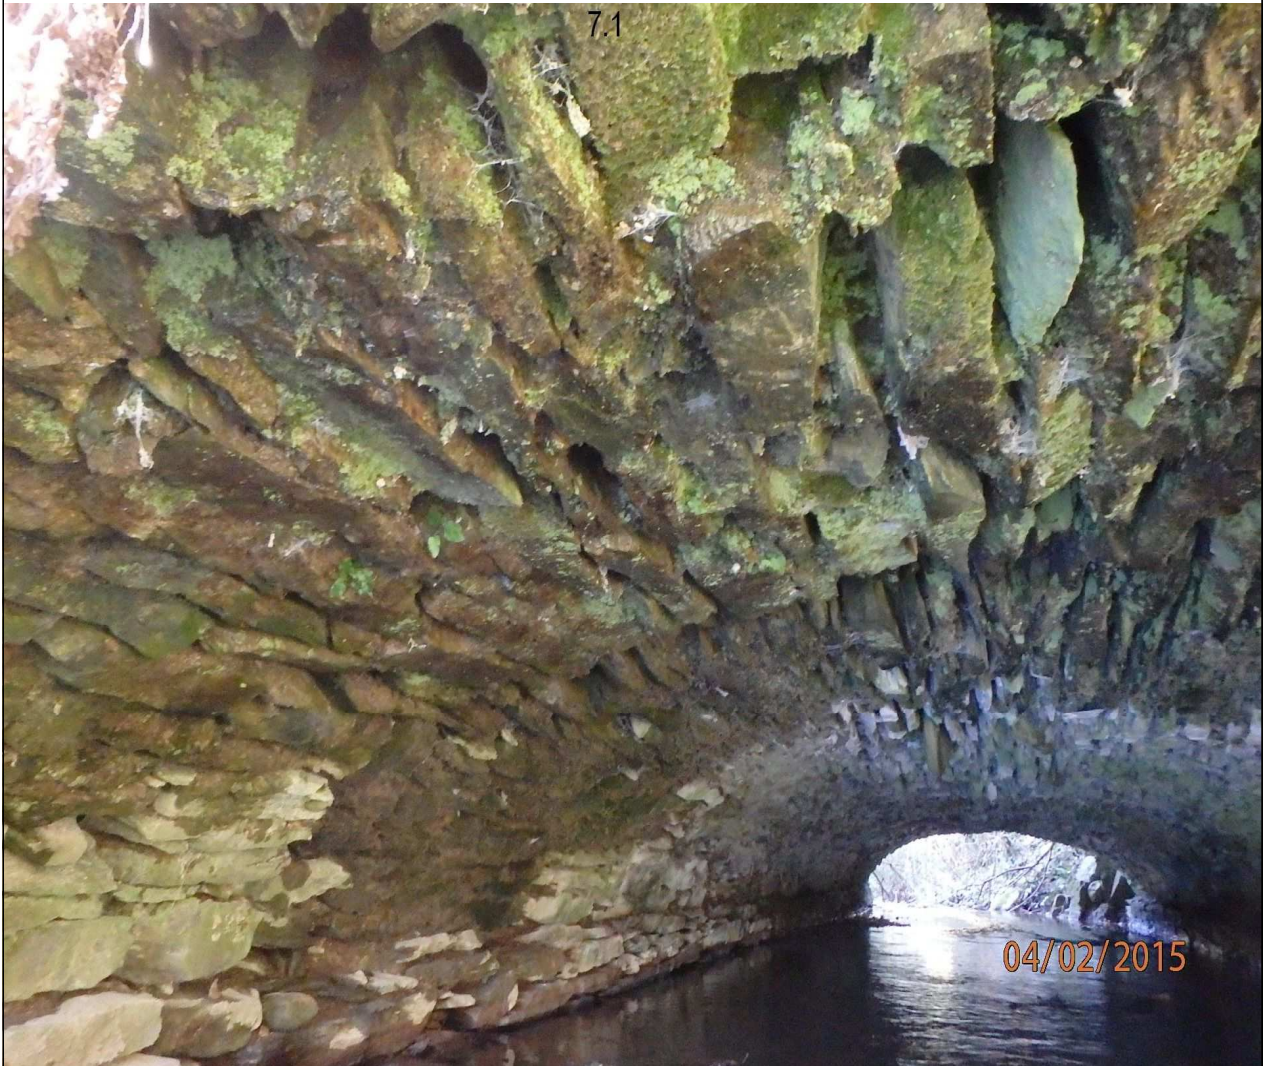
Component No.	7	Abutments s
Complete loss of pointing throughout both abutments. (Photo 7.1 & 7.2)		
Condition/Mainten.	3	/ N

No	Component	Repair Work							
		Con rtg	Mtn req	Spe Ins	T P	Qty	Year	Cost	Pho tos
	Loss of masonry pointing								
7	Abutments	3	N	N					2
	D : Masonry repointing				D	22	2016	2750	
	Complete loss of pointing throughout both abutments. (Photo 7.1 & 7.2)								
	Loss of masonry pointing								
8	Piers			N					0
9	Bearings			N					0
10	Deck/slab/arch barrel	4	N	Y					5
	Z : Other repair work				Z	14	2015	3500	
	Complete loss of pointing throughout the arch. (Photo 10.1) Circumferential crack at the east end of the structure approximately 1m in. (Photo 10.2) The arch has dropped at the east of the crack. Missing stones in the area of the crack. (Photo 10.3) There are several dropped stones in the centre of the arch. (Photo 10.4) The arch shape appears to have flattened at the west end. (Photo 10.5) The shape of the arch should be reformed using a spray applied concrete and mesh reinforcement. Prior to this a special inspection involving a hydraulic capacity check should be undertaken. If the arch will lhave insufficient capacity upon application of the sprayed concrete then the structure will need to be replaced.

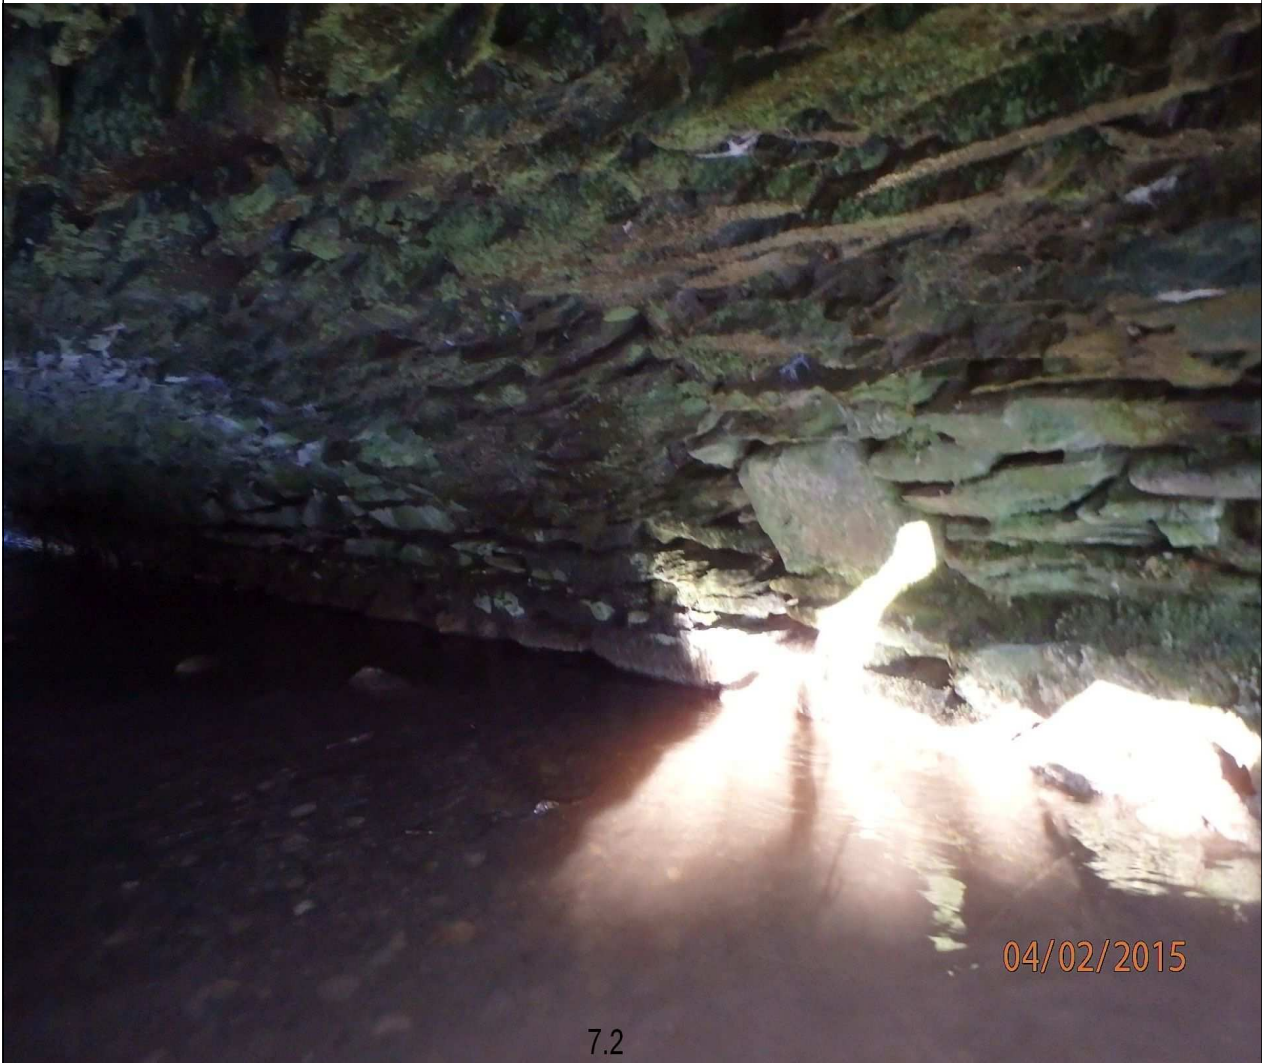
Component No.	7	Abutments s
Complete loss of pointing throughout both abutments. (Photo 7.1 & 7.2)		
Condition/Mainten.	3	/ N

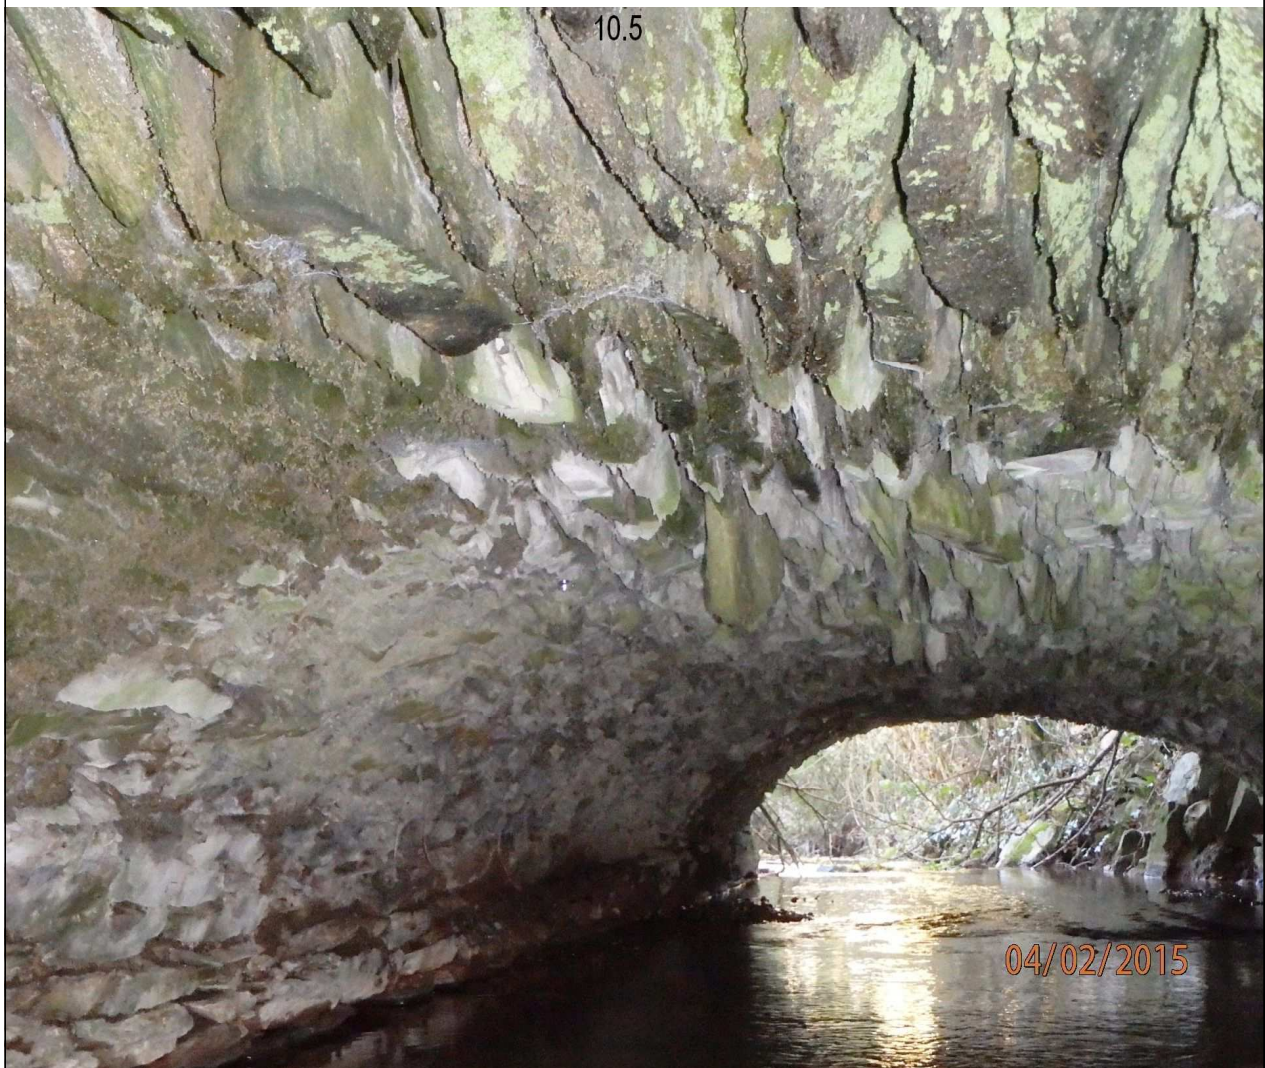
Component No.	10	Deck/slab/arch barrel
<p>Complete loss of pointing throughout the arch. (Photo 10.1) Circumferential crack at the east end of the structure approximately 1m in. (Photo 10.2) The arch has dropped at the east of the crack. Missing stones in the area of the crack. (Photo 10.3) There are several dropped stones in the centre of the arch. (Photo 10.4) The arch shape appears to have flattened at the west end. (Photo 10.5) The shape of the arch should be reformed using a spray applied concrete and mesh reinforcement. Prior to this a special inspection involving a hydraulic capacity check should be undertaken. If the arch will have insufficient capacity upon application of the sprayed concrete then the structure will need to be replaced.</p>		
Condition/Mainten.	4	/ N

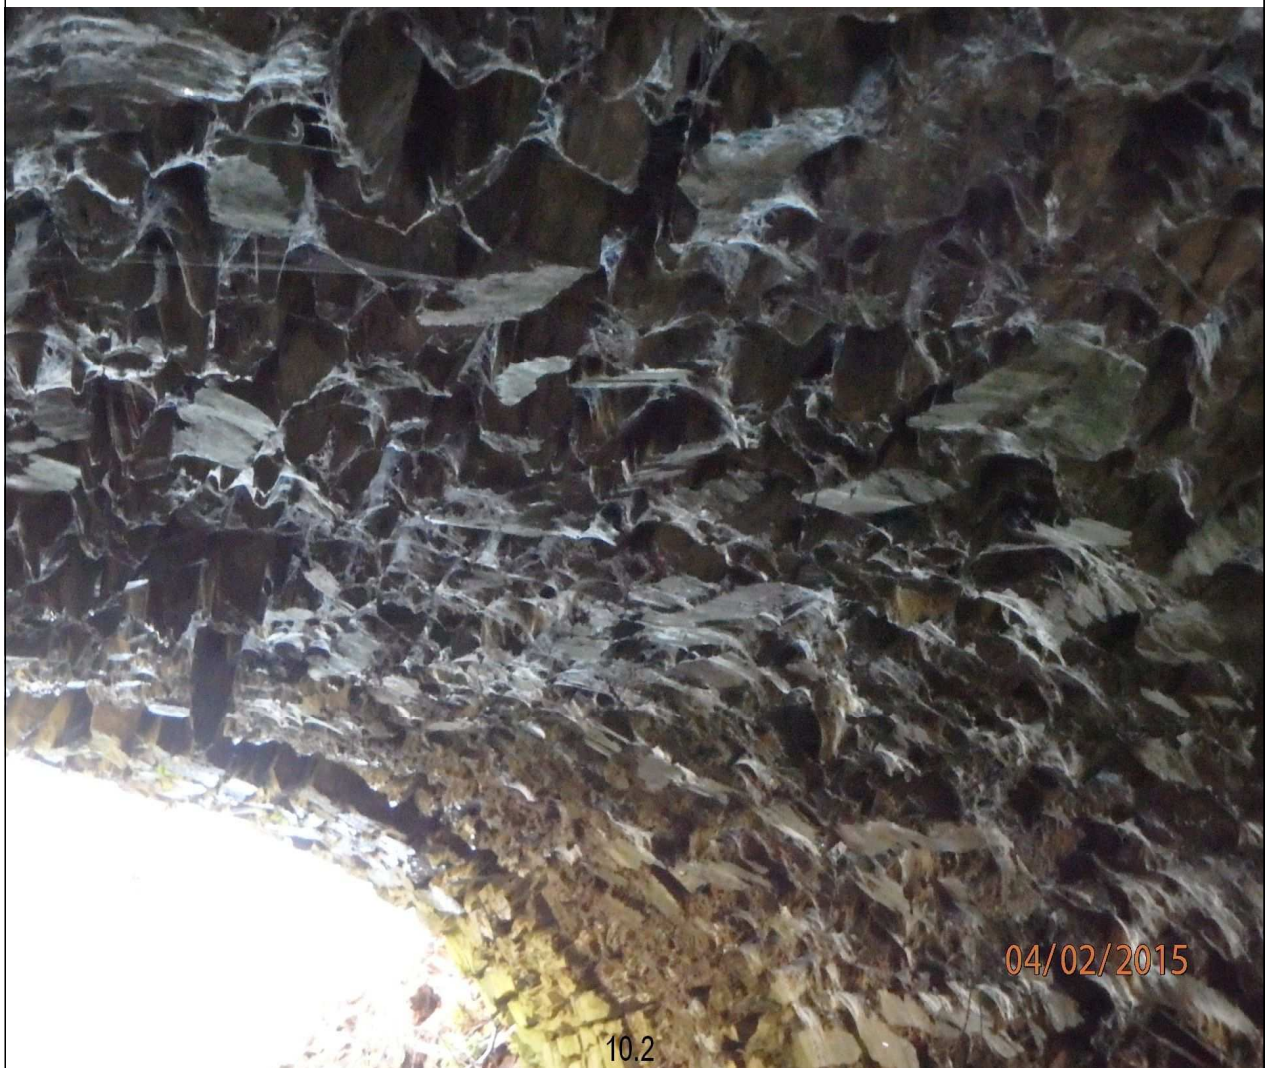
Component No.	10	Deck/slab/arch barrel
<p>Complete loss of pointing throughout the arch. (Photo 10.1) Circumferential crack at the east end of the structure approximately 1m in. (Photo 10.2) The arch has dropped at the east of the crack. Missing stones in the area of the crack. (Photo 10.3) There are several dropped stones in the centre of the arch. (Photo 10.4) The arch shape appears to have flattened at the west end. (Photo 10.5) The shape of the arch should be reformed using a spray applied concrete and mesh reinforcement. Prior to this a special inspection involving a hydraulic capacity check should be undertaken. If the arch will have insufficient capacity upon application of the sprayed concrete then the structure will need to be replaced.</p>		
Condition/Mainten.	4	/ N

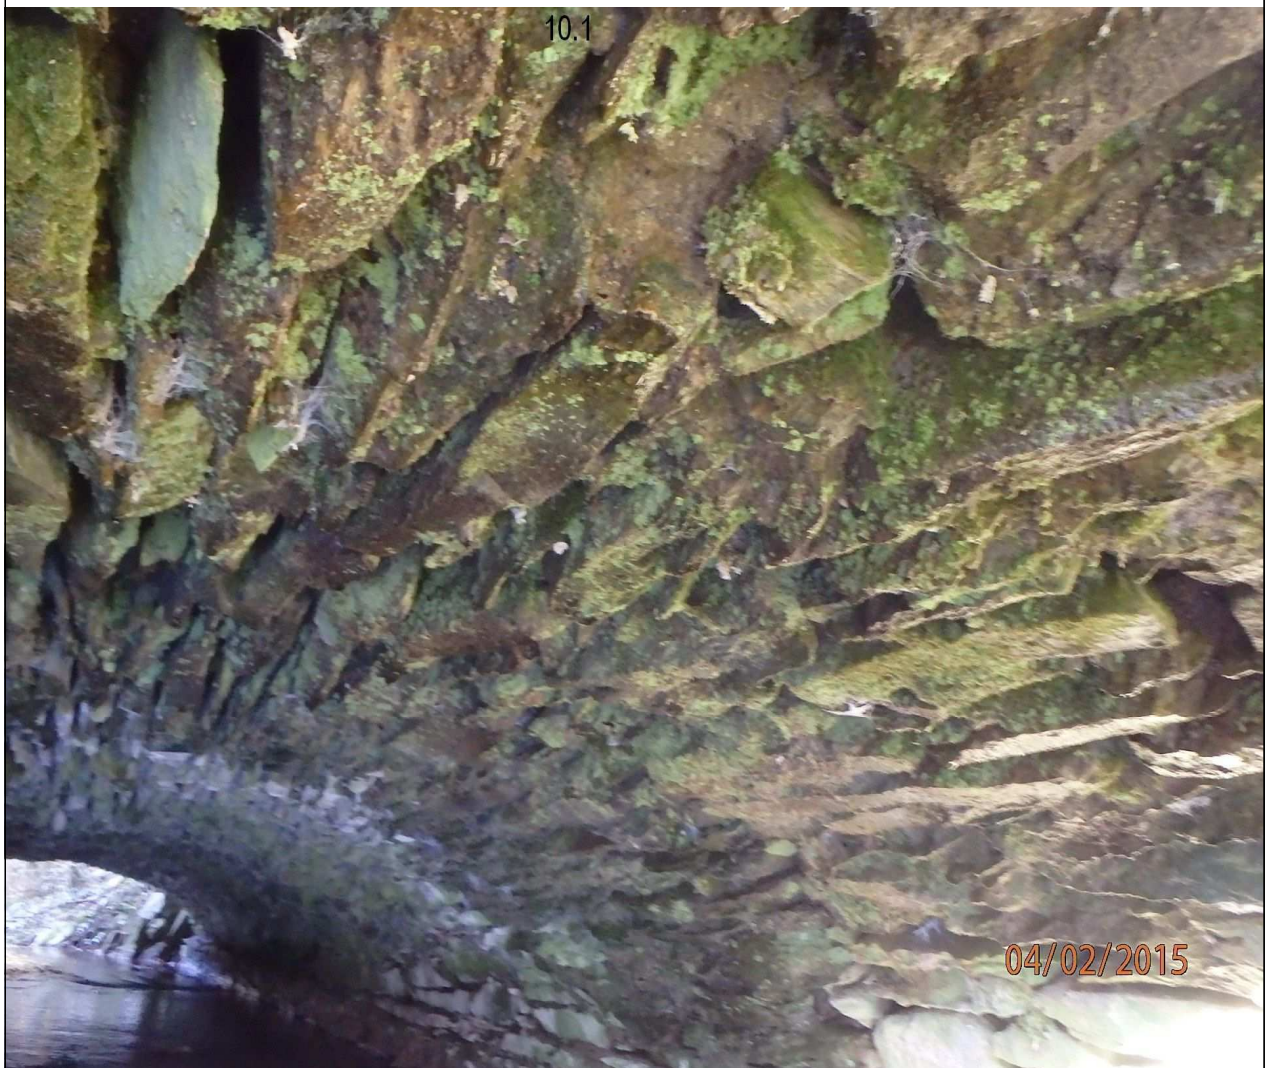
Component No.	10	Deck/slab/arch barrel
<p>Complete loss of pointing throughout the arch. (Photo 10.1) Circumferential crack at the east end of the structure approximately 1m in. (Photo 10.2) The arch has dropped at the east of the crack. Missing stones in the area of the crack. (Photo 10.3) There are several dropped stones in the centre of the arch. (Photo 10.4) The arch shape appears to have flattened at the west end. (Photo 10.5) The shape of the arch should be reformed using a spray applied concrete and mesh reinforcement. Prior to this a special inspection involving a hydraulic capacity check should be undertaken. If the arch will have insufficient capacity upon application of the sprayed concrete then the structure will need to be replaced.</p>		
Condition/Mainten.	4	/ N

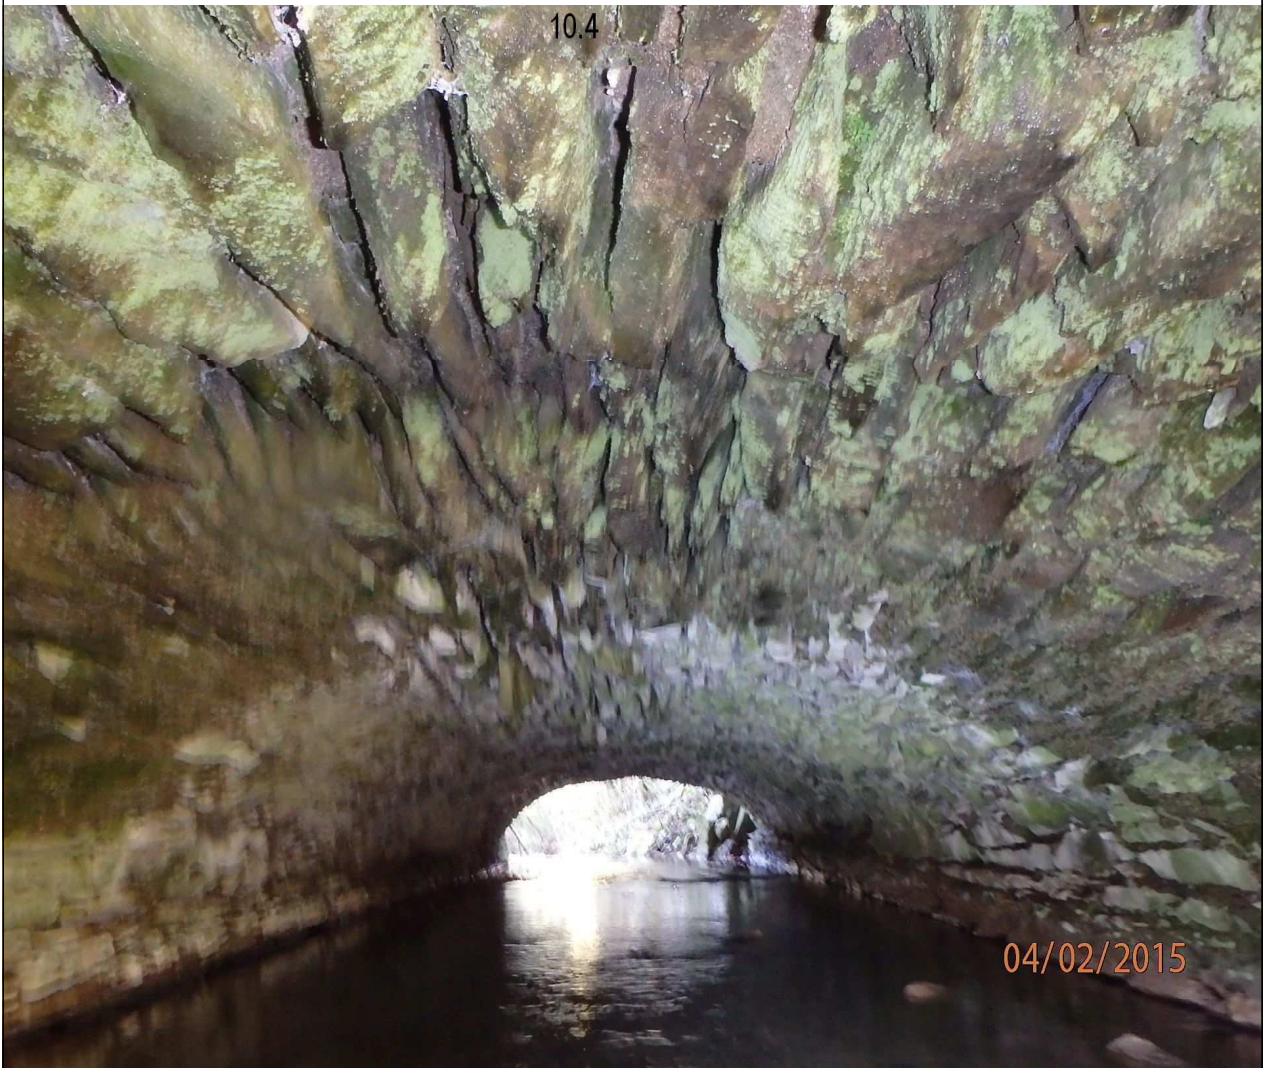
Component No.	10	Deck/slab/arch barrel
<p>Complete loss of pointing throughout the arch. (Photo 10.1) Circumferential crack at the east end of the structure approximately 1m in. (Photo 10.2) The arch has dropped at the east of the crack. Missing stones in the area of the crack. (Photo 10.3) There are several dropped stones in the centre of the arch. (Photo 10.4) The arch shape appears to have flattened at the west end. (Photo 10.5) The shape of the arch should be reformed using a spray applied concrete and mesh reinforcement. Prior to this a special inspection involving a hydraulic capacity check should be undertaken. If the arch will have insufficient capacity upon application of the sprayed concrete then the structure will need to be replaced.</p>		
Condition/Mainten.	4	/ N

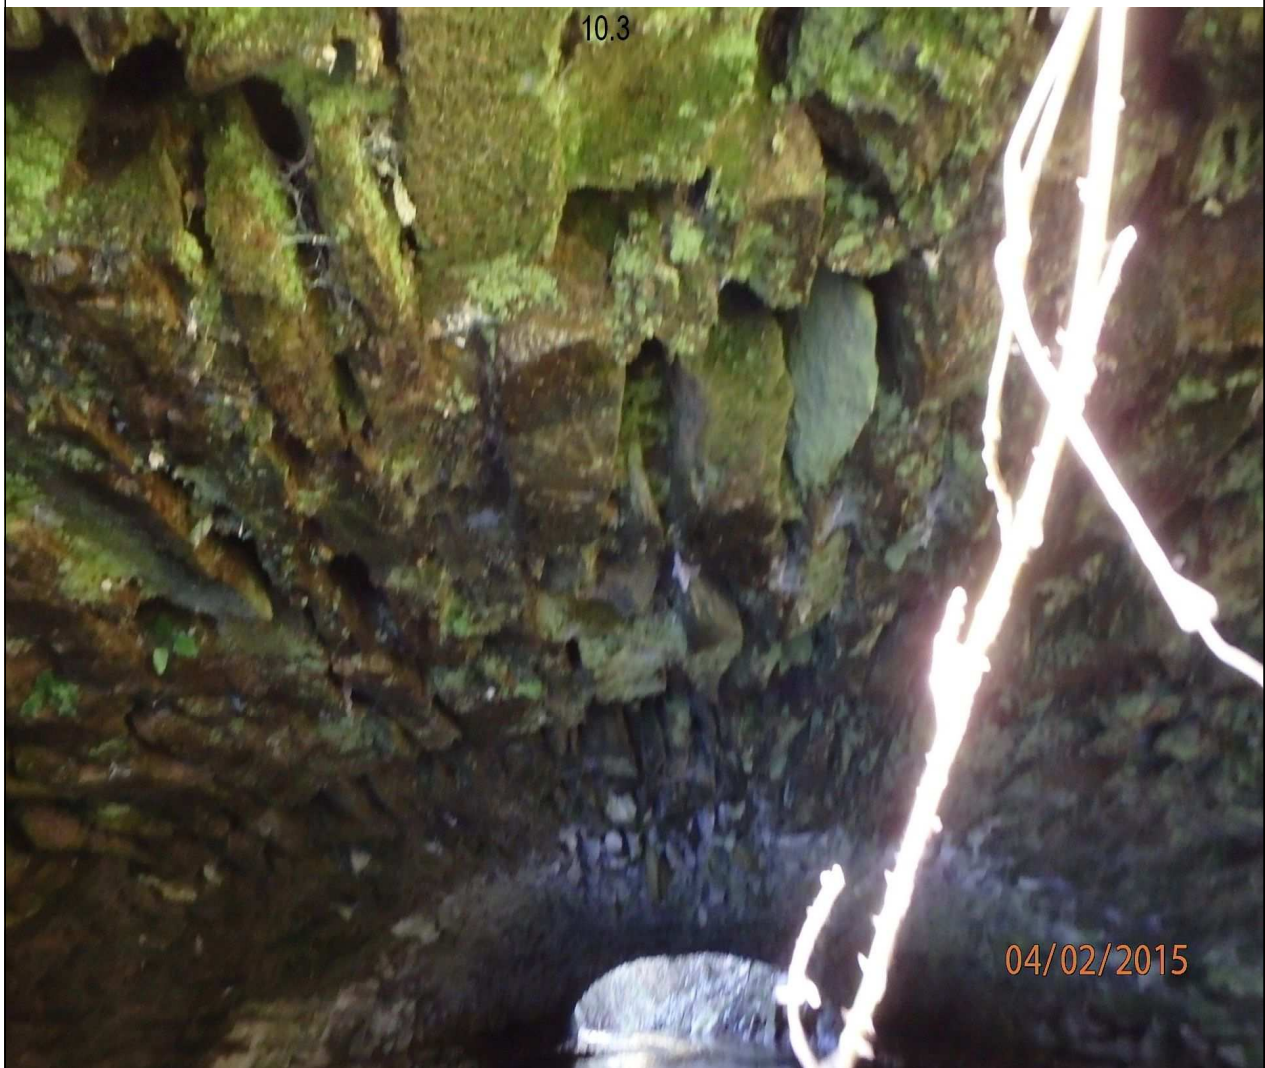
Component No.	10	Deck/slab/arch barrel
<p>Complete loss of pointing throughout the arch. (Photo 10.1) Circumferential crack at the east end of the structure approximately 1m in. (Photo 10.2) The arch has dropped at the east of the crack. Missing stones in the area of the crack. (Photo 10.3) There are several dropped stones in the centre of the arch. (Photo 10.4) The arch shape appears to have flattened at the west end. (Photo 10.5) The shape of the arch should be reformed using a spray applied concrete and mesh reinforcement. Prior to this a special inspection involving a hydraulic capacity check should be undertaken. If the arch will have insufficient capacity upon application of the sprayed concrete then the structure will need to be replaced.</p>		
Condition/Mainten.	4	/ N

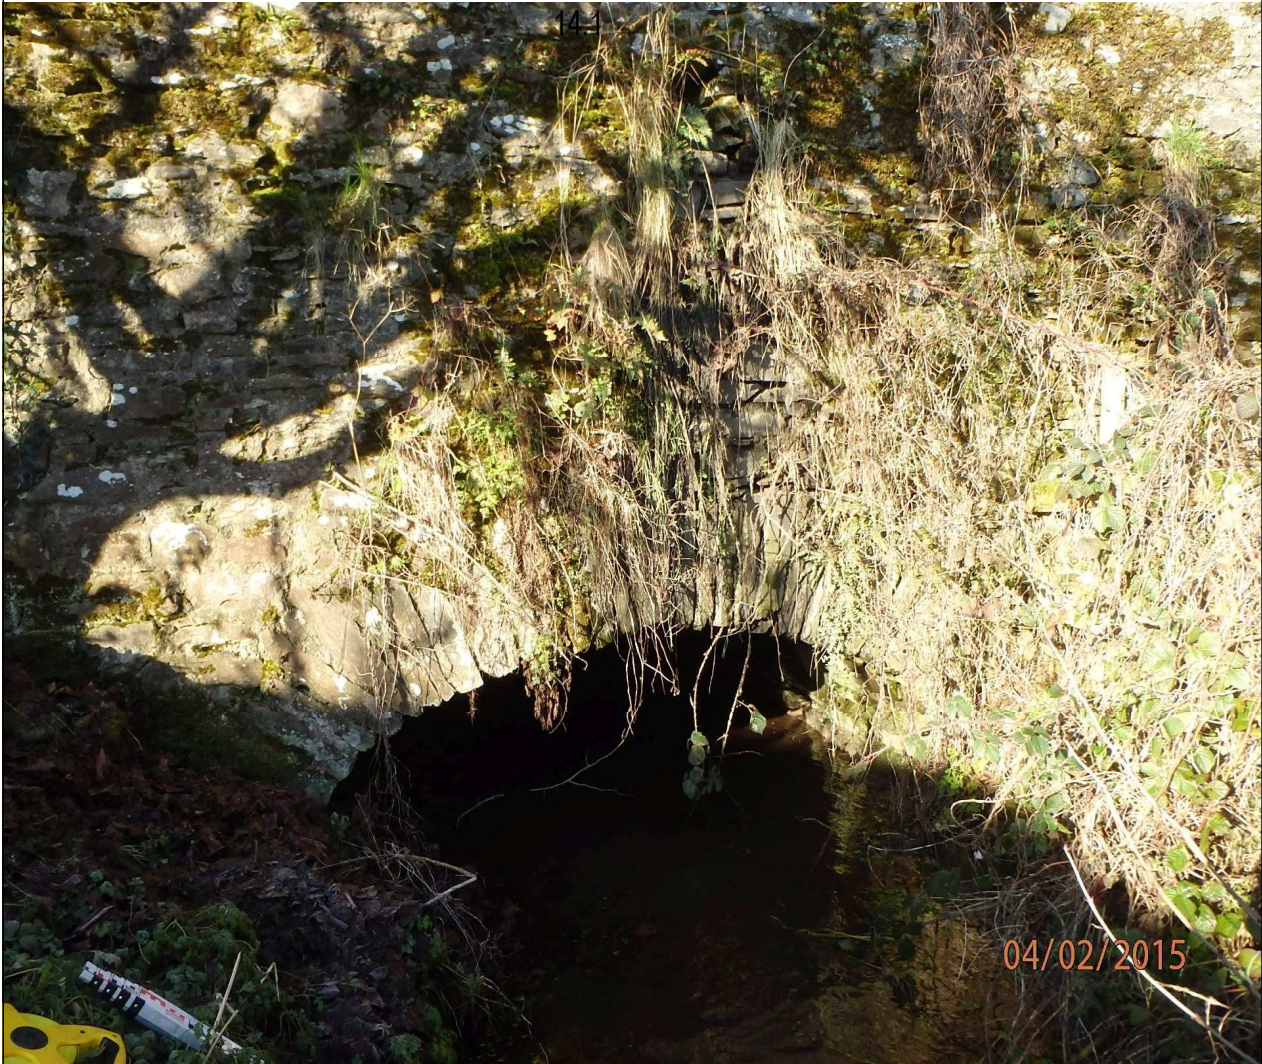
Photo 14.1 - East Elevation
Photo 14.2 - West Elevation

Condition/Mainten. 4 / Y
