Kildare Bridges Inventory Gathering and Principal Inspections

Structure Name:
Moone Village Bridge
Structure ID:
KE-L8102-002.00

KE-L8102-002.00 Moone Village Bridge

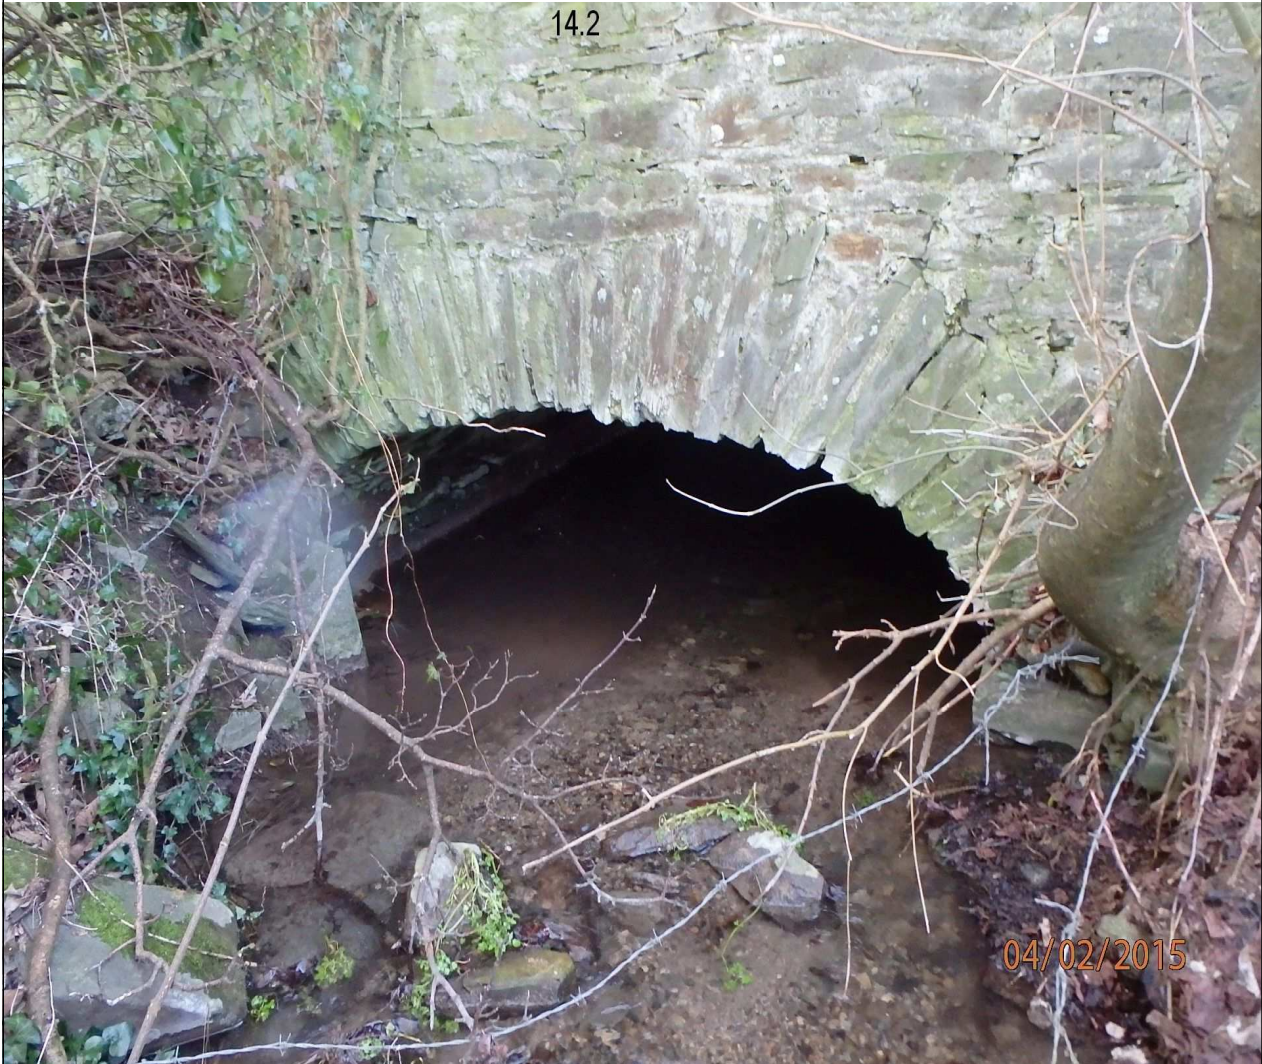
Photo 14.1 - East Elevation
Photo 14.2 - West Elevation

Condition/Mainten. 4 / Y
