REMEDIATION METHODOLOGY

Monasterevin Bridge Remediation

Project: K424

January 2021

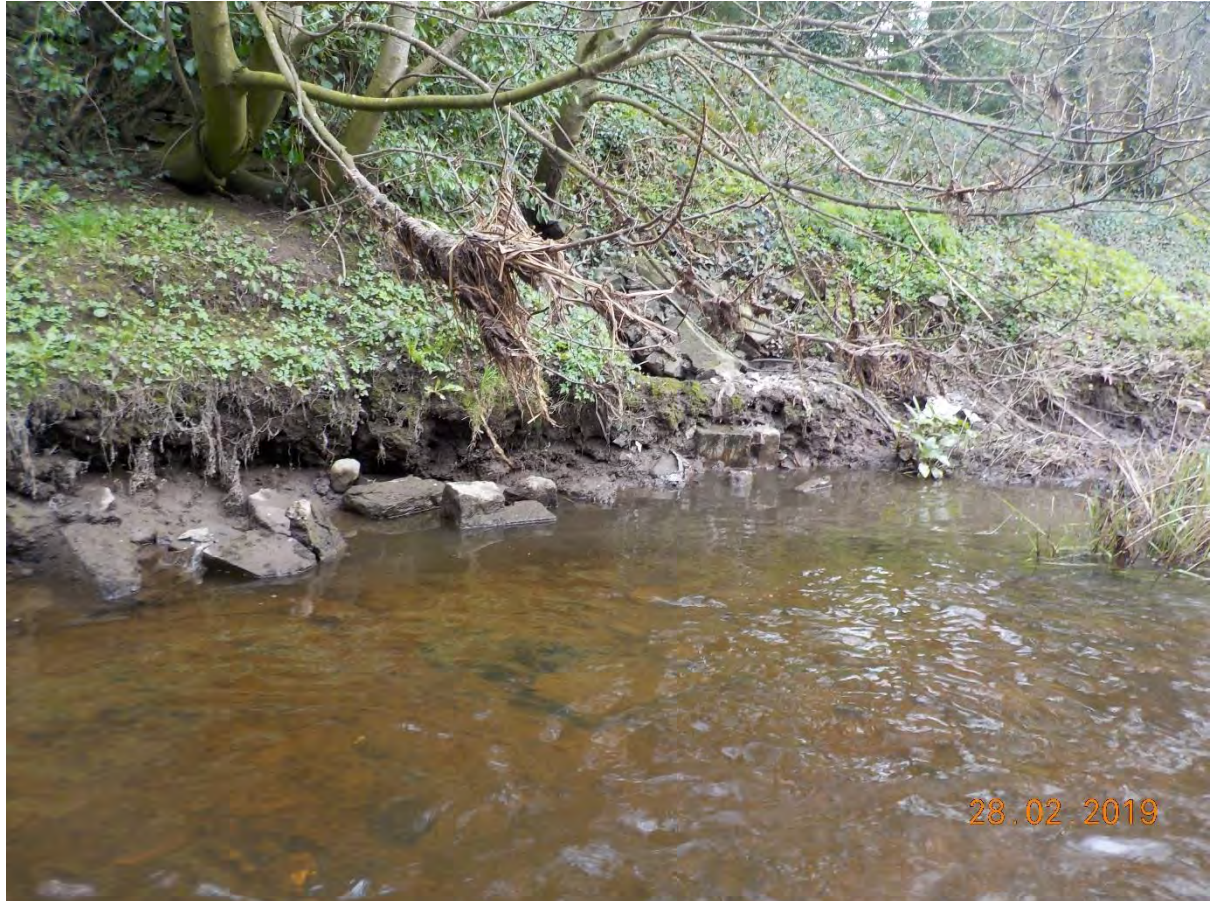
It was noted during OCSCs survey of Monasterevin Bridge that on the downstream east embankment scouring was occurring along a 15m section. OCSC are proposing the installation of rock armour along the 15m section. See Figure 4 below for image of extent of scouring and Detail 8 overleaf for scour protection – rock armour installation.

Figure 4: Scouring along downstream east embankment

The following is the methodology for the installation of rock armour:

- v. The existing embankment will be regraded to achieve a slope ratio 1vertical:1.5horizontal. Any excess material will be taken away and disposed of offsite. Measures will be implemented to minimise waste and ensure correct handling, storage and disposal of waste;

- vi. A toe trench will be dug along the bottom of the embankment, minimum 0.9m wide;
- vii. At the top of the embankment a plateau will be formed tying into the existing bank, minimum 0.9m wide;

- viii. A geotextile, Terram 1000 or similarly approved material will be laid on the newly profiled bank;
- ix. A 130mm thick underlayer consisting of 45/180mm grade material to be laid on the terram;

- x. A 300mm thick rock armour layer to be laid over the underlayer. Stone size in the range 90-250mm;
- xi. Upon completion of the above sequence of works the sandbag protection will be removed the river flow returned to its normal course.

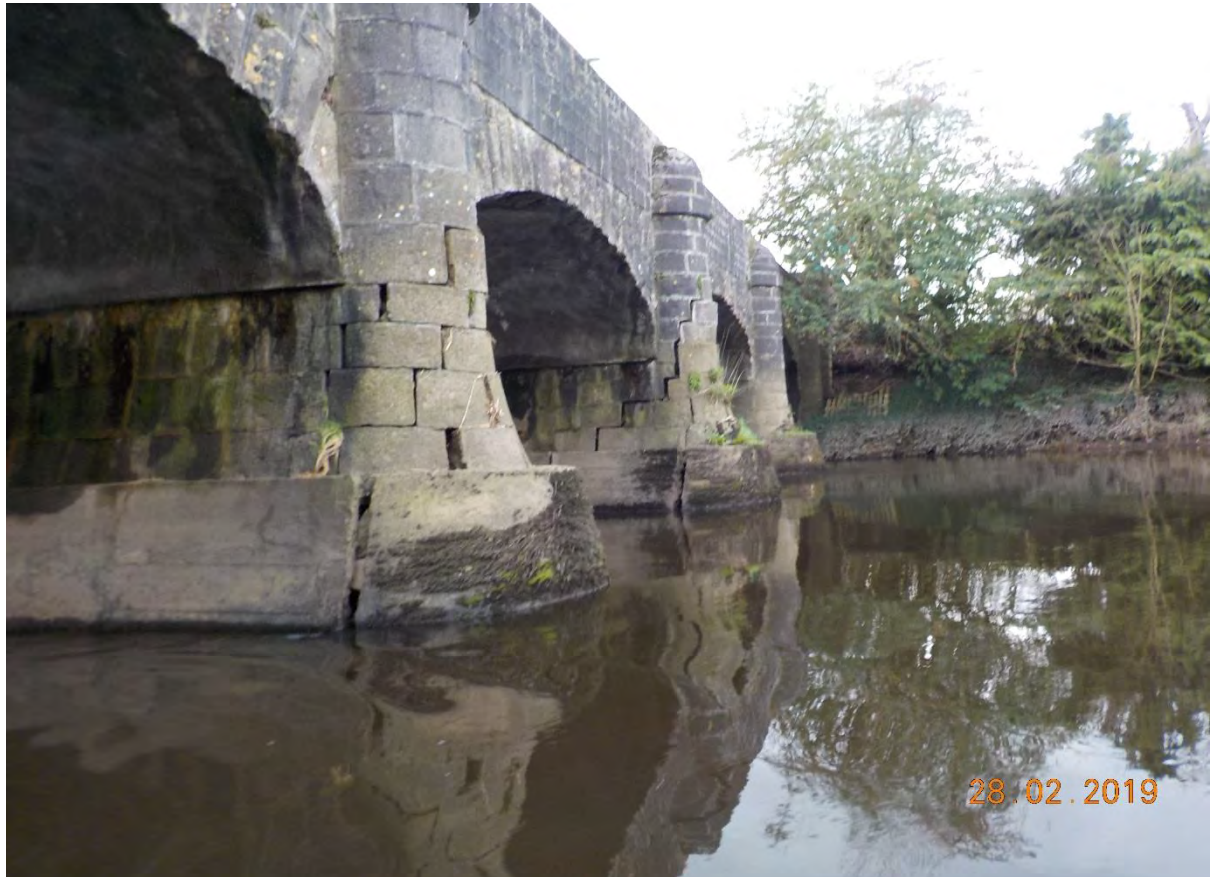
It was noted during OCSCs survey of Monasterevin Bridge that on the upstream face scouring was undermining the leading edge of the concrete skirts that protect the piers. As a result, large cracks have formed in the skirts and the masonry cutwaters are beginning to fail. See figure 5 below for image of damage to concrete skirt and cutwater and Detail 9 overleaf for the proposed scour protection and underpinning detail.

Figure 5: Cracking in concrete skirt and failure of masonry cutwater

- iv. The Contractor will work on one pier at a time so as to not alter the flows dramatically in the other channels;
- v. The damaged concrete skirt shall be removed and taken back to sound material from which the new skirt can be tied into. Material shall be removed and disposed offsite;

- x. It is expected to find a loss of material below the piers at the upstream end and in the fill between the two masonry leaves after removing the cutwater. These voids will be grouted and this will create a solid surface from which the new cutwater will be built;

- xiii. Dowel bars and sleeves shall be drilled through one side of the existing masonry pier and out the other side;
- xiv. With the dowel bars set in place the reinforcement for the concrete skirt can be fixed tying into the existing concrete skirt;

- xvi. Once the concrete has cured the cutwater will be re-erected and tied into the existing masonry pier;

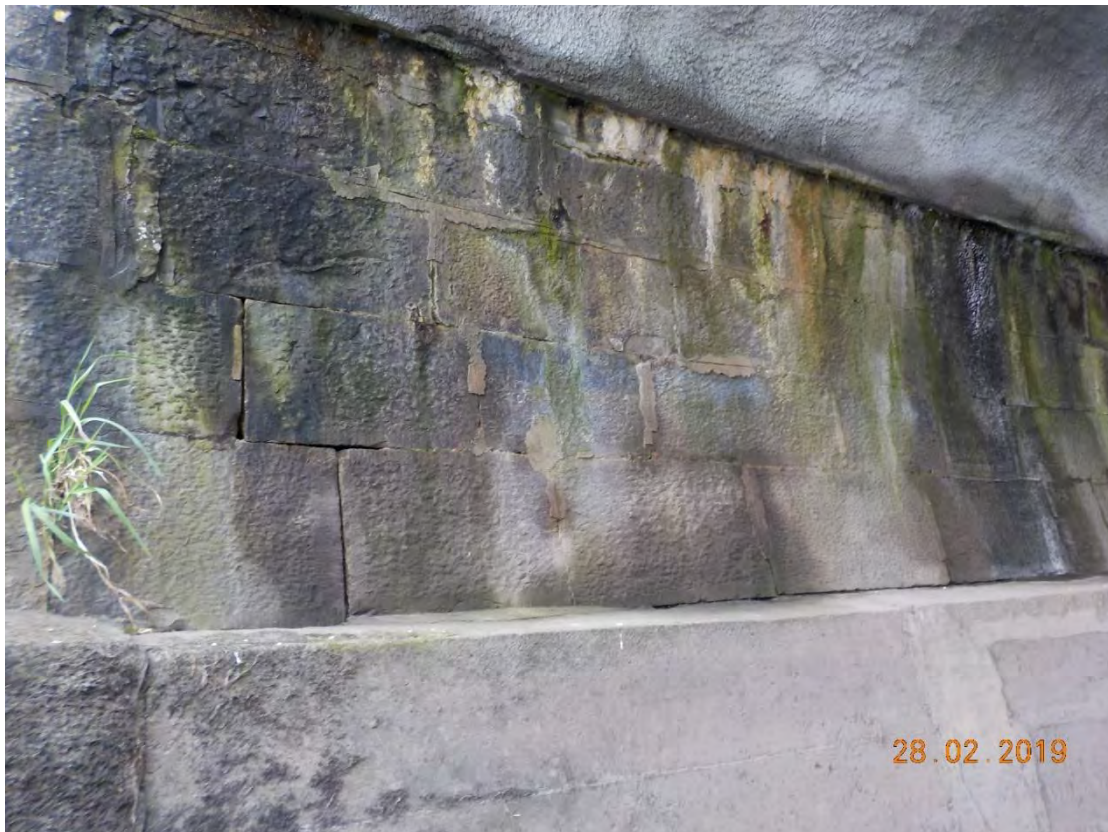
It was noted during OCSCs survey of Monasterevin Bridge that on some of the masonry units there was a loss of mortar in the joints and vegetation growing between the units. See figure 6 below for image of masonry loss and vegetation growth and Detail 1 + 3 below for vegetation removal and masonry repointing.

Figure 6: loss of mortar in joints and vegetation growth

The extent of masonry repointing and vegetation removal is minor in nature with the specific repairs detailed in the notes for Details 1 and 3.

The repointing and vegetation removal will be carried out on each pier at the same time as the underpinning works to make use of the existing protection measures that will be in place.

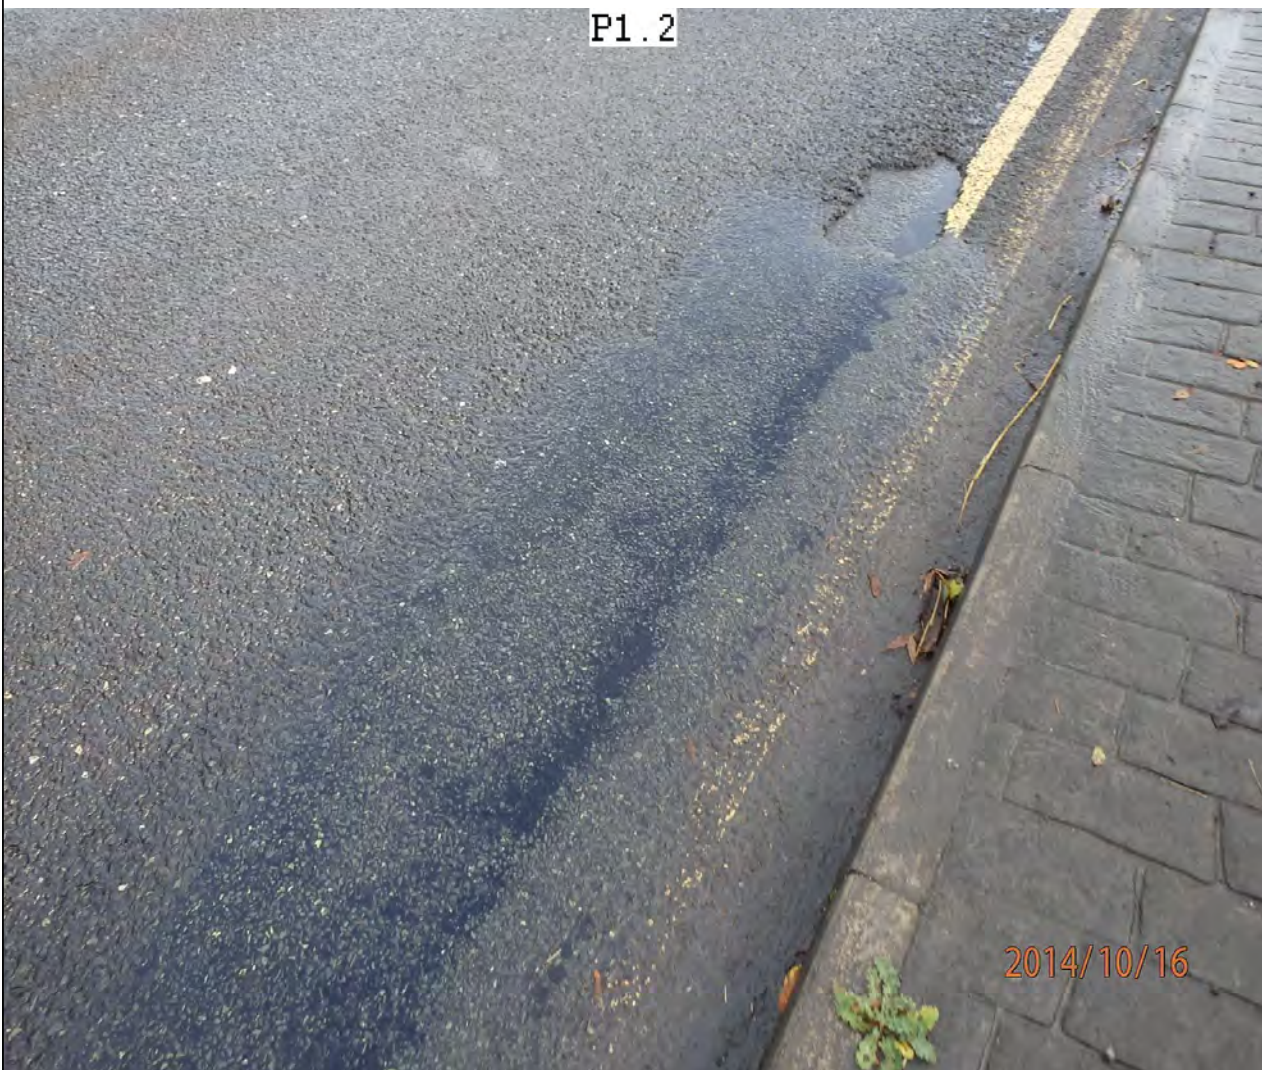
P1.1

Bridge surface is in ok condition. Pothole at west end on south side, trench reinstatement for full length of structure in north lane.

Condition/Mainten. 2 / N

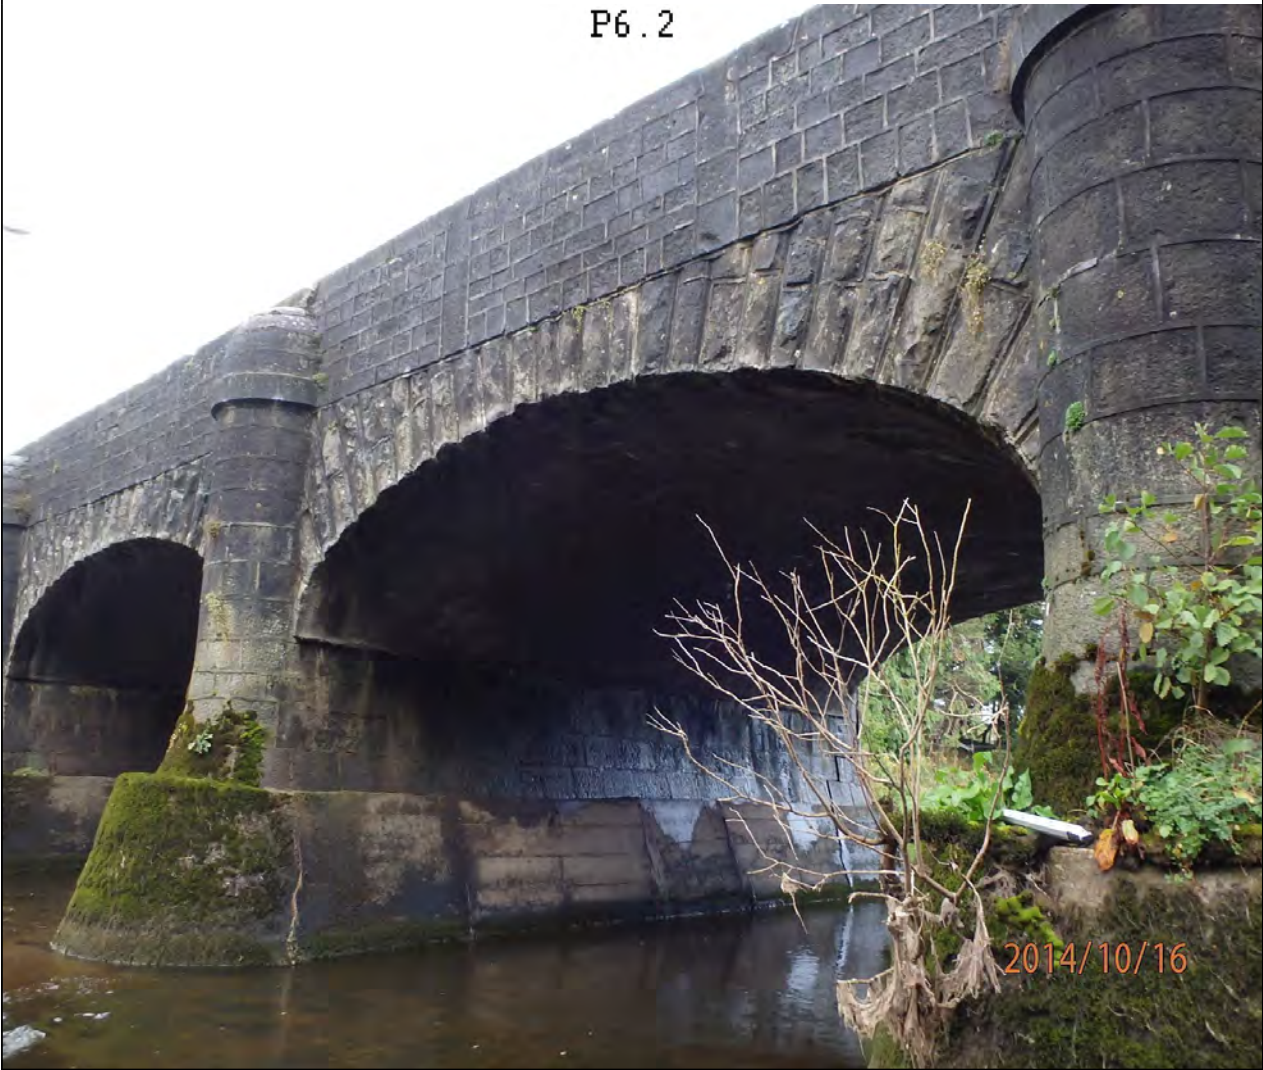
P6.1

Spandrel and wing walls in good condition.
Photo 6.1 - Upstream walls
Photo 6.2 - Downstream walls

Condition/Mainten. 1 / N

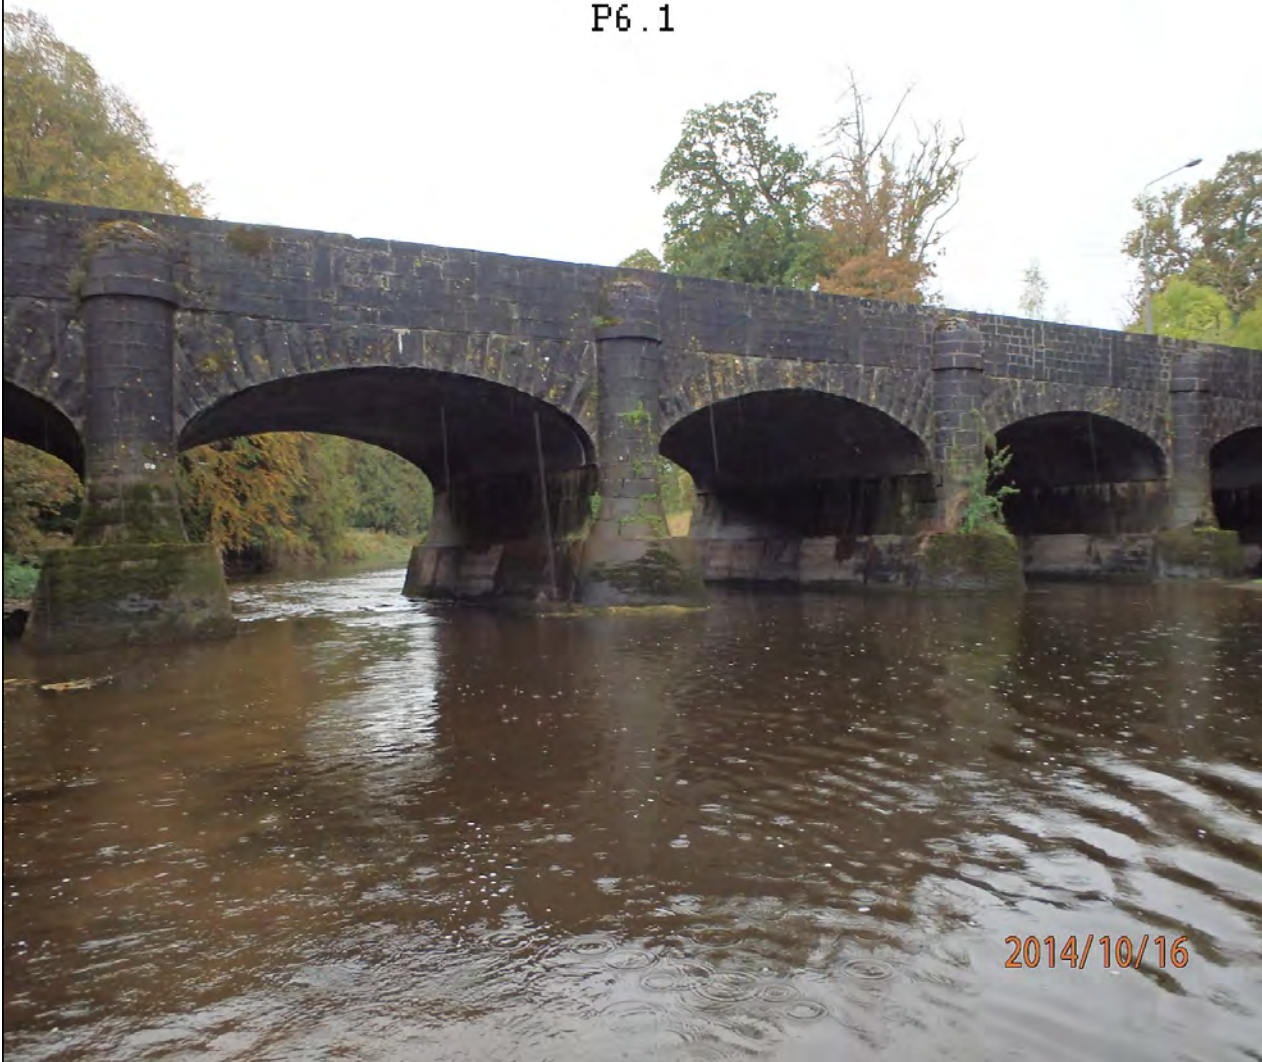
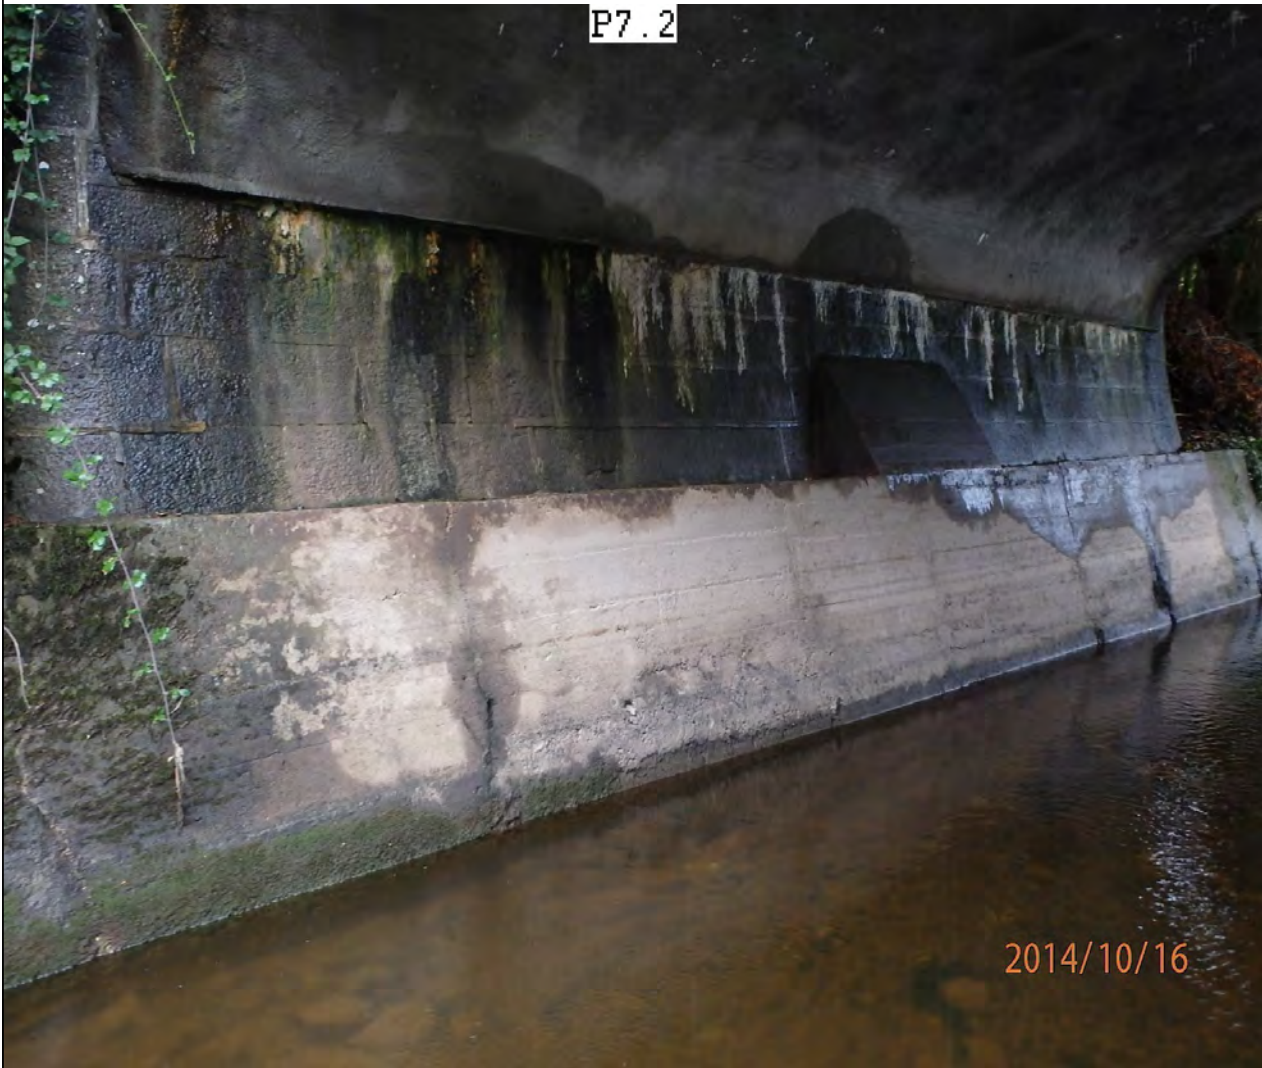
Component No.	7	Abutments s
Abutment surfaces are sloping with scour protection installed. Both sides in good condition. Photo 7.1 - Left side Photo 7.2 - Right side Condition/Mainten. 1 / N

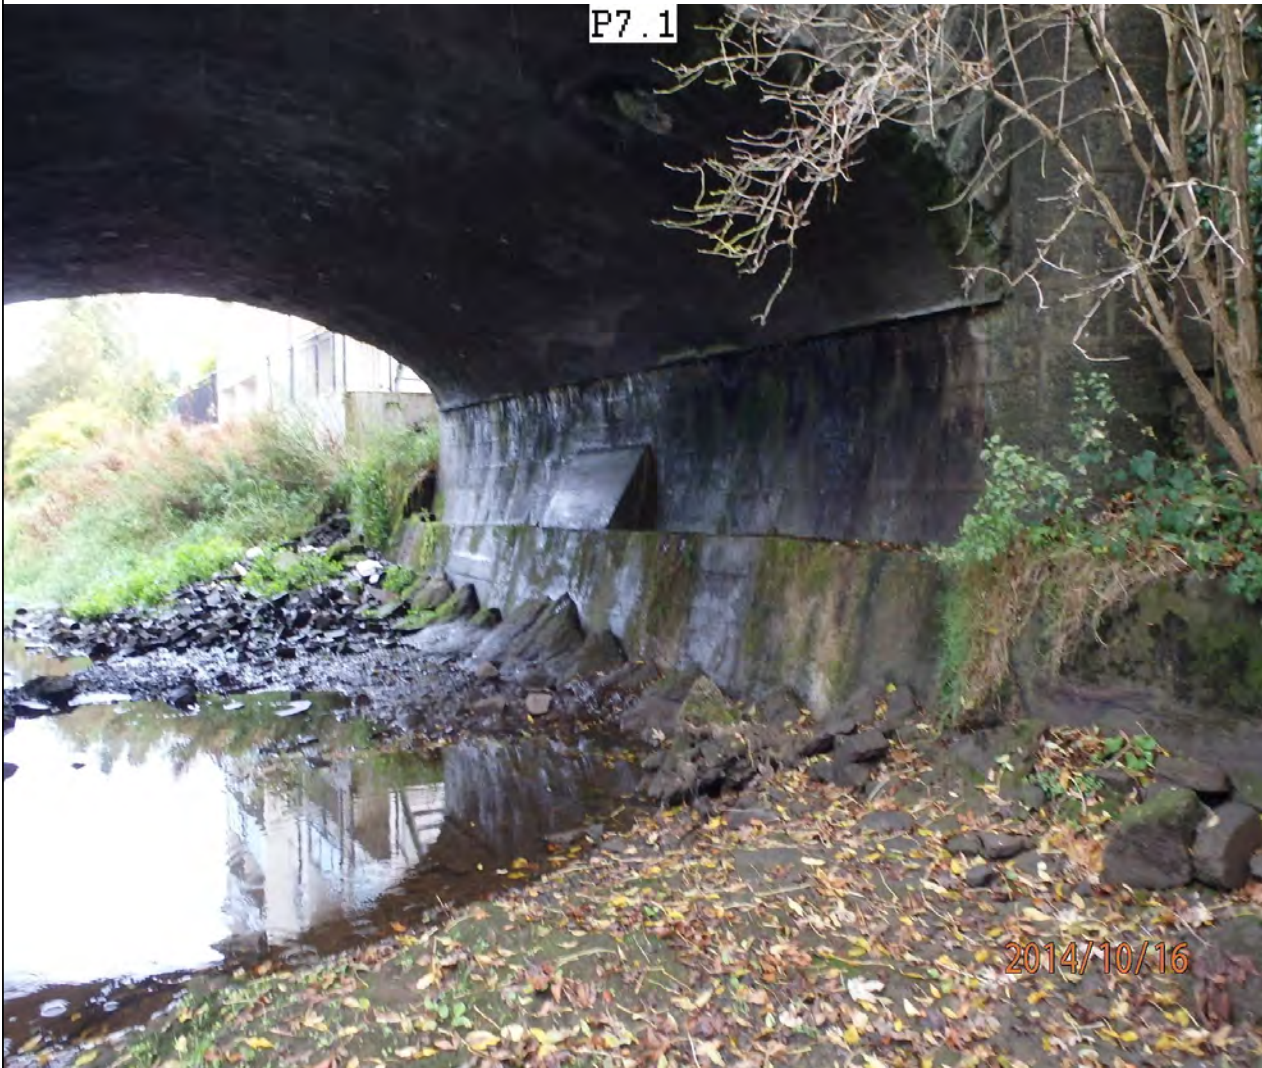
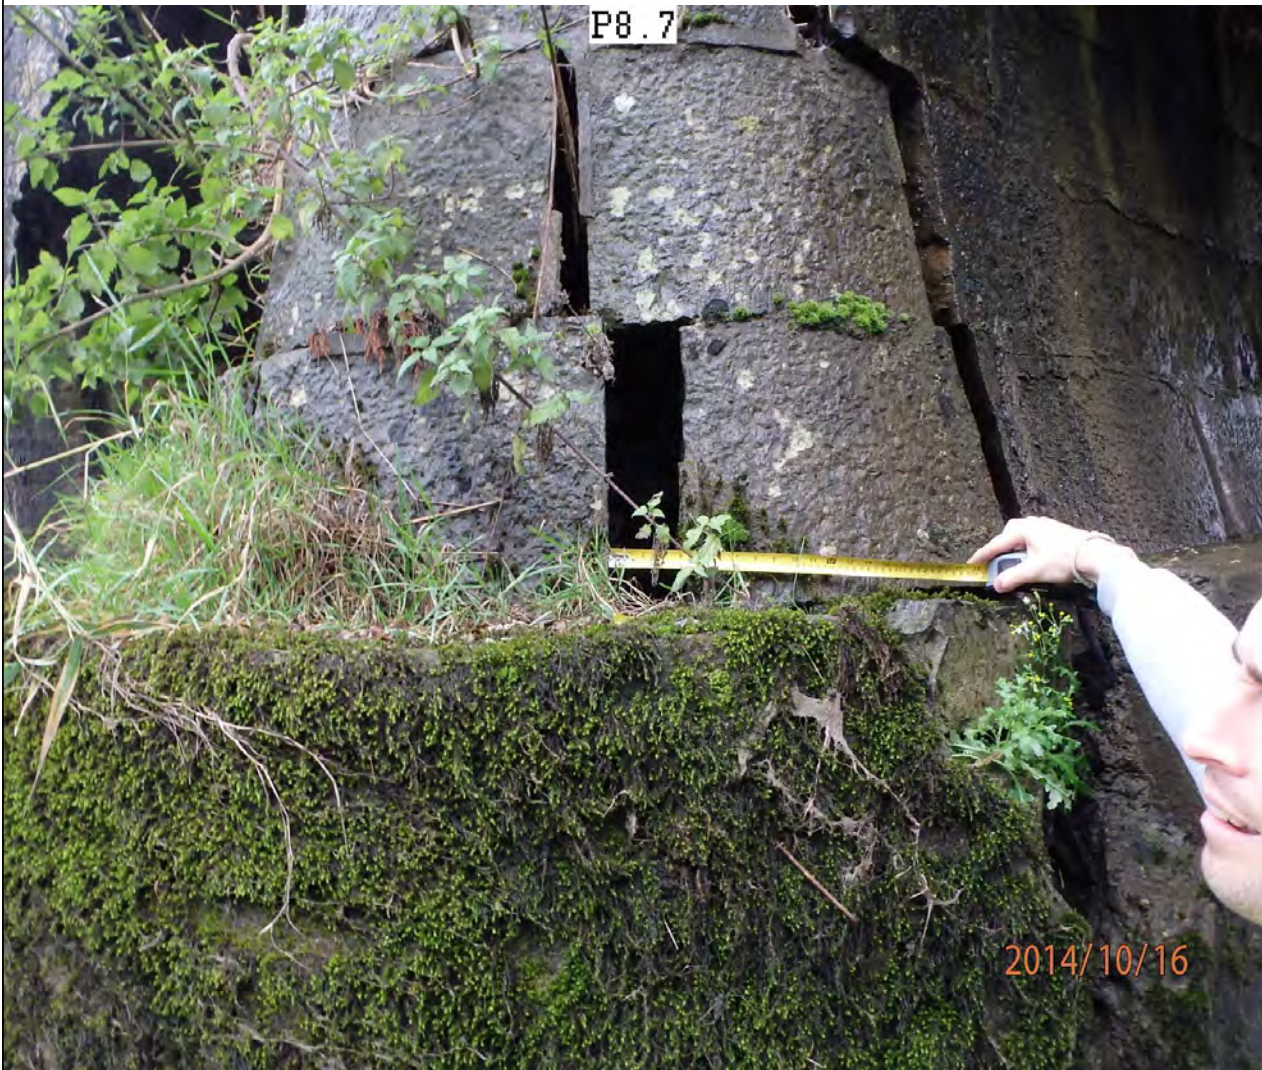
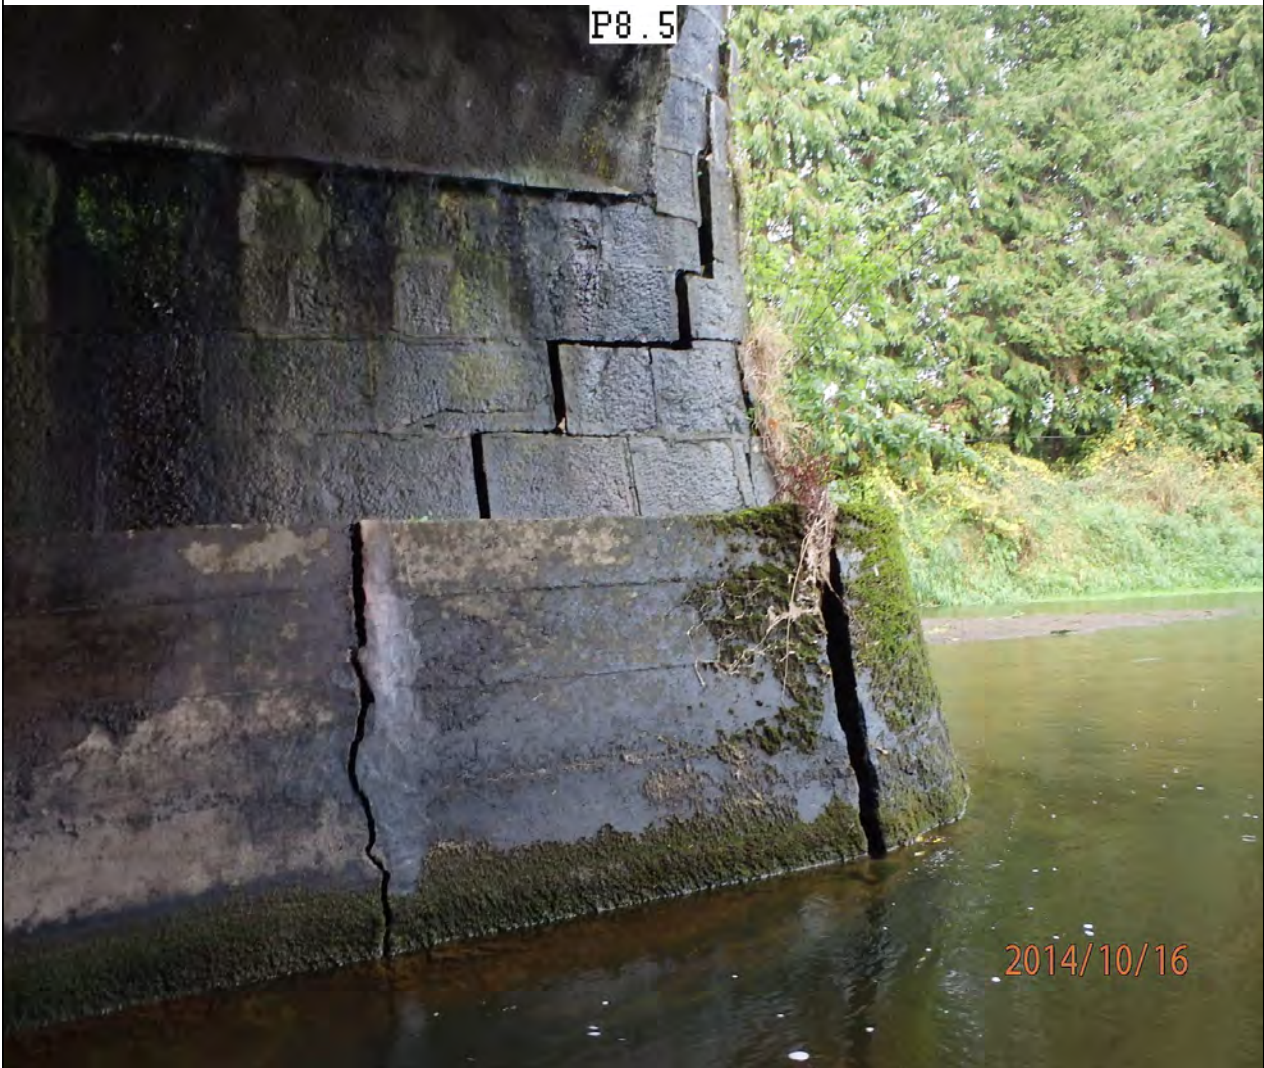
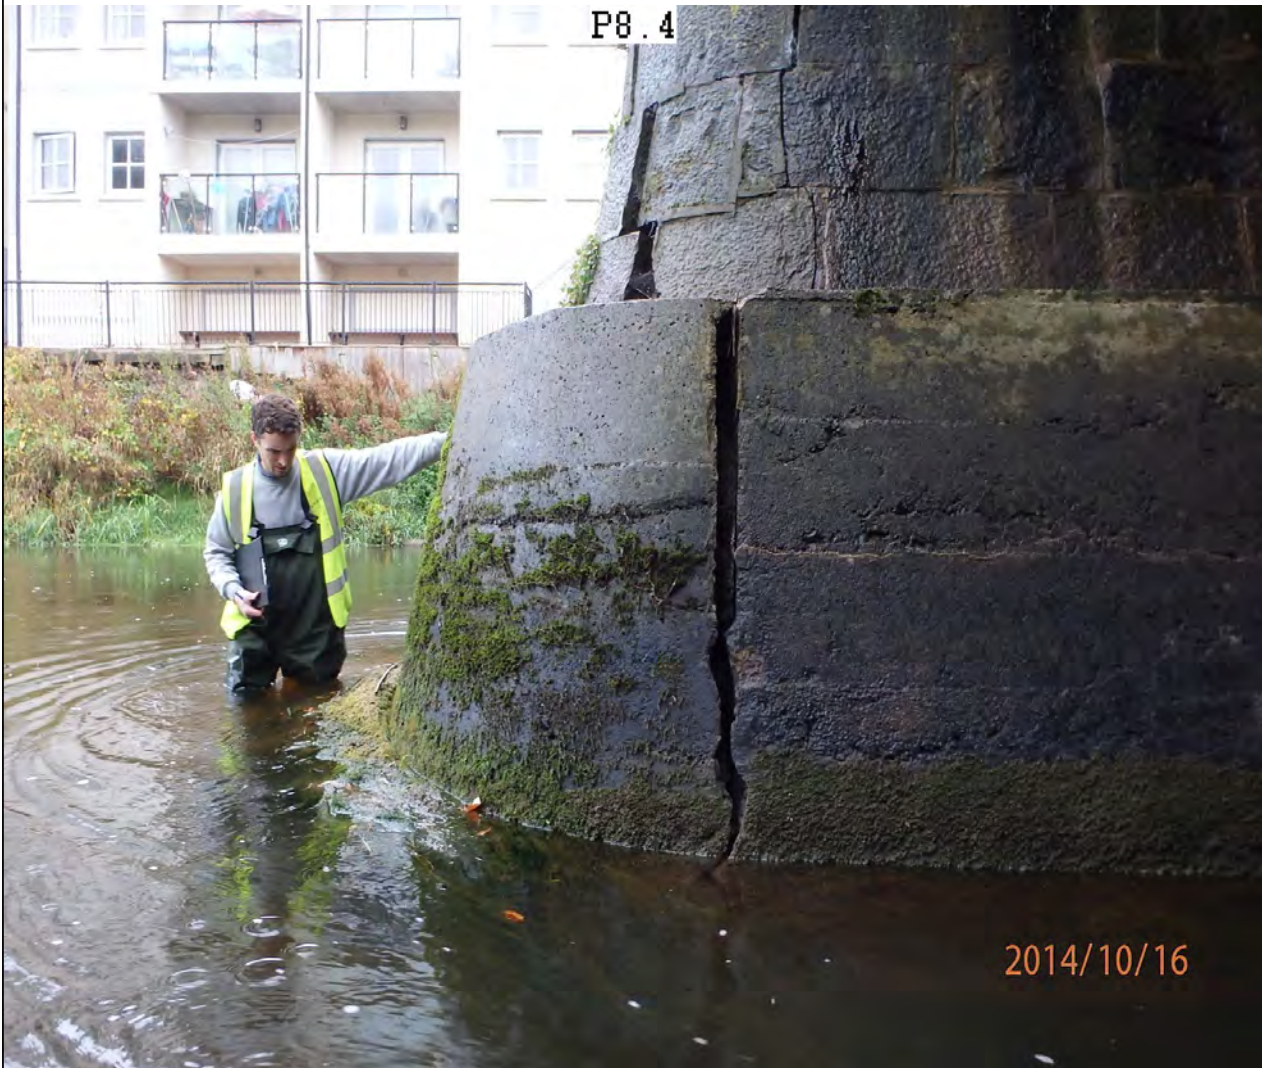
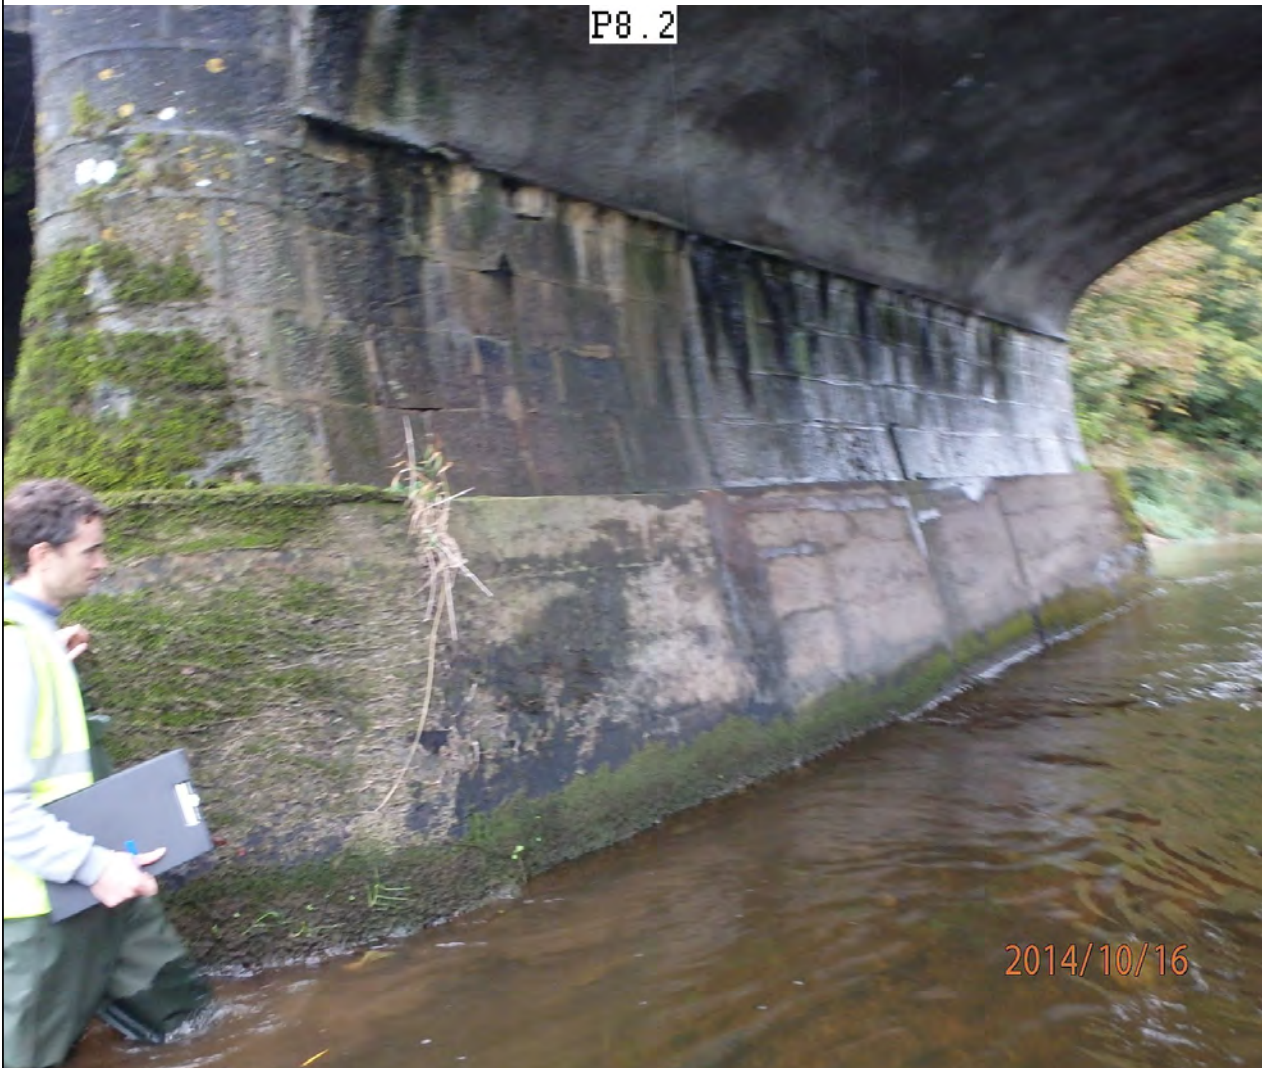
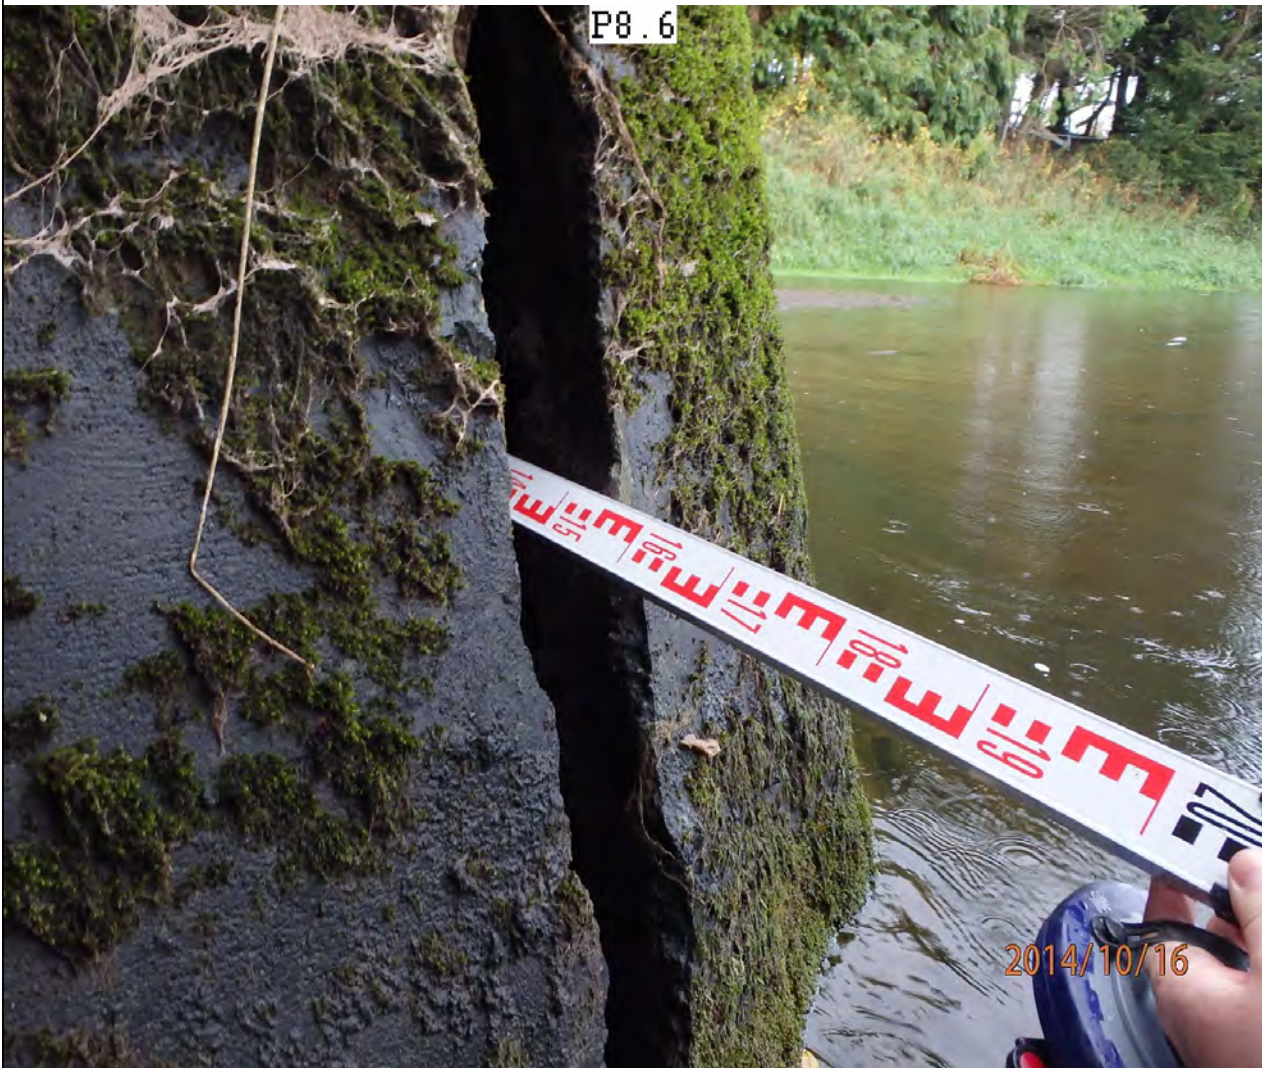
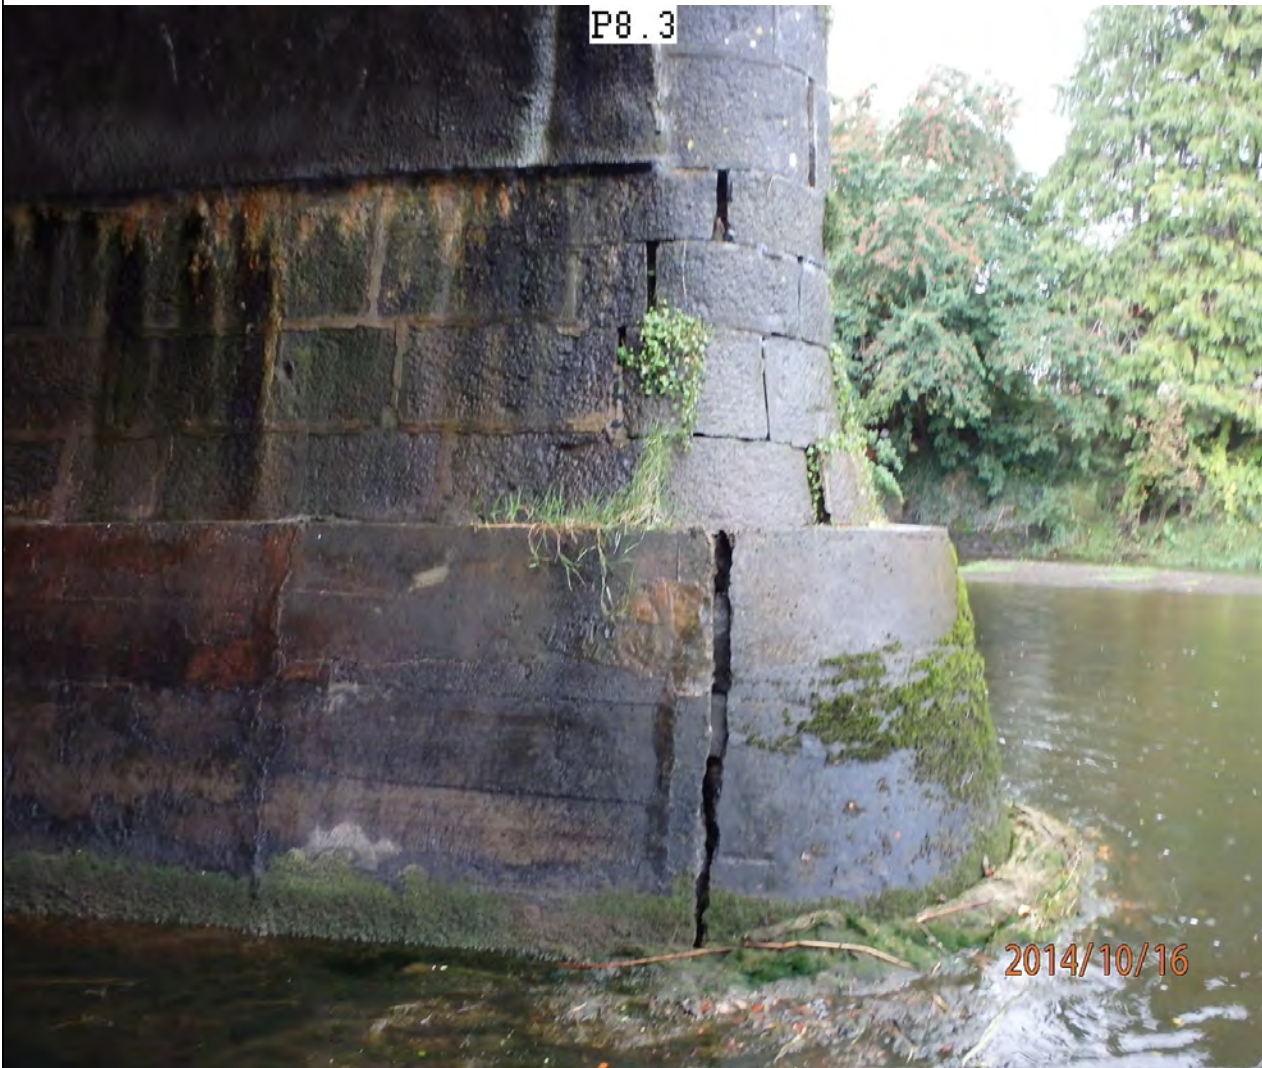
All vegetation to be removed from cutwaters under routine maintenance. Scour protection installed with sloping surfaces to all piers. Pier one right hand side is wet (Photo 8.1). Pier 2 left hand side is wet (Photo 8.2). Upstream cutwater of piers 2 & 3 are undermined and subsiding. 110mm gap in masonry of pier 3, extending 1.5m to 2m into pier. Remove weed growth from piers.

Condition/Mainten. 4 / Y

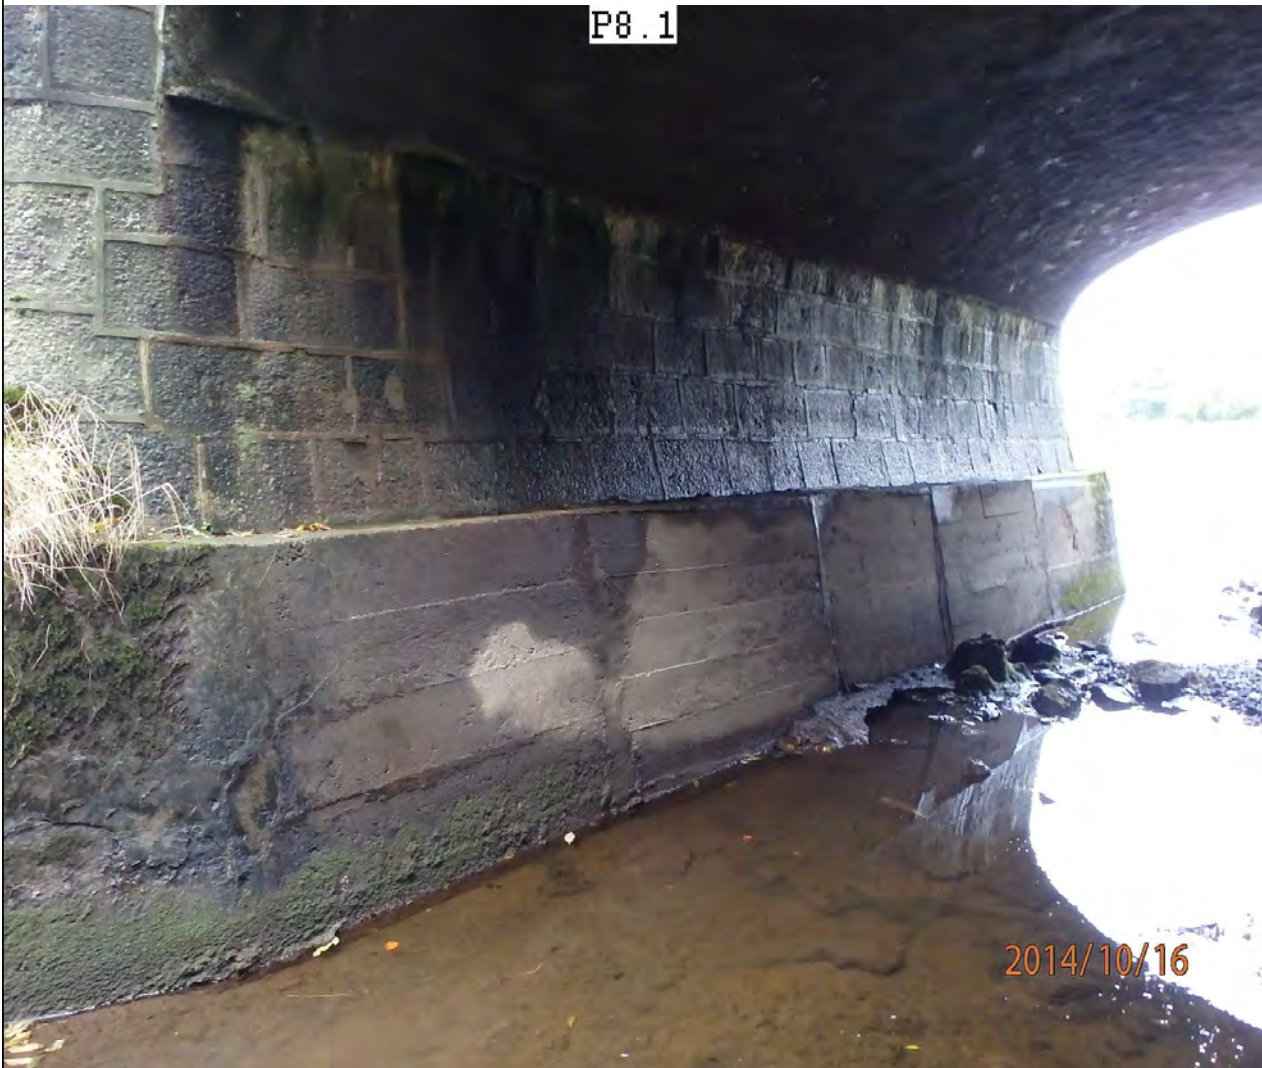
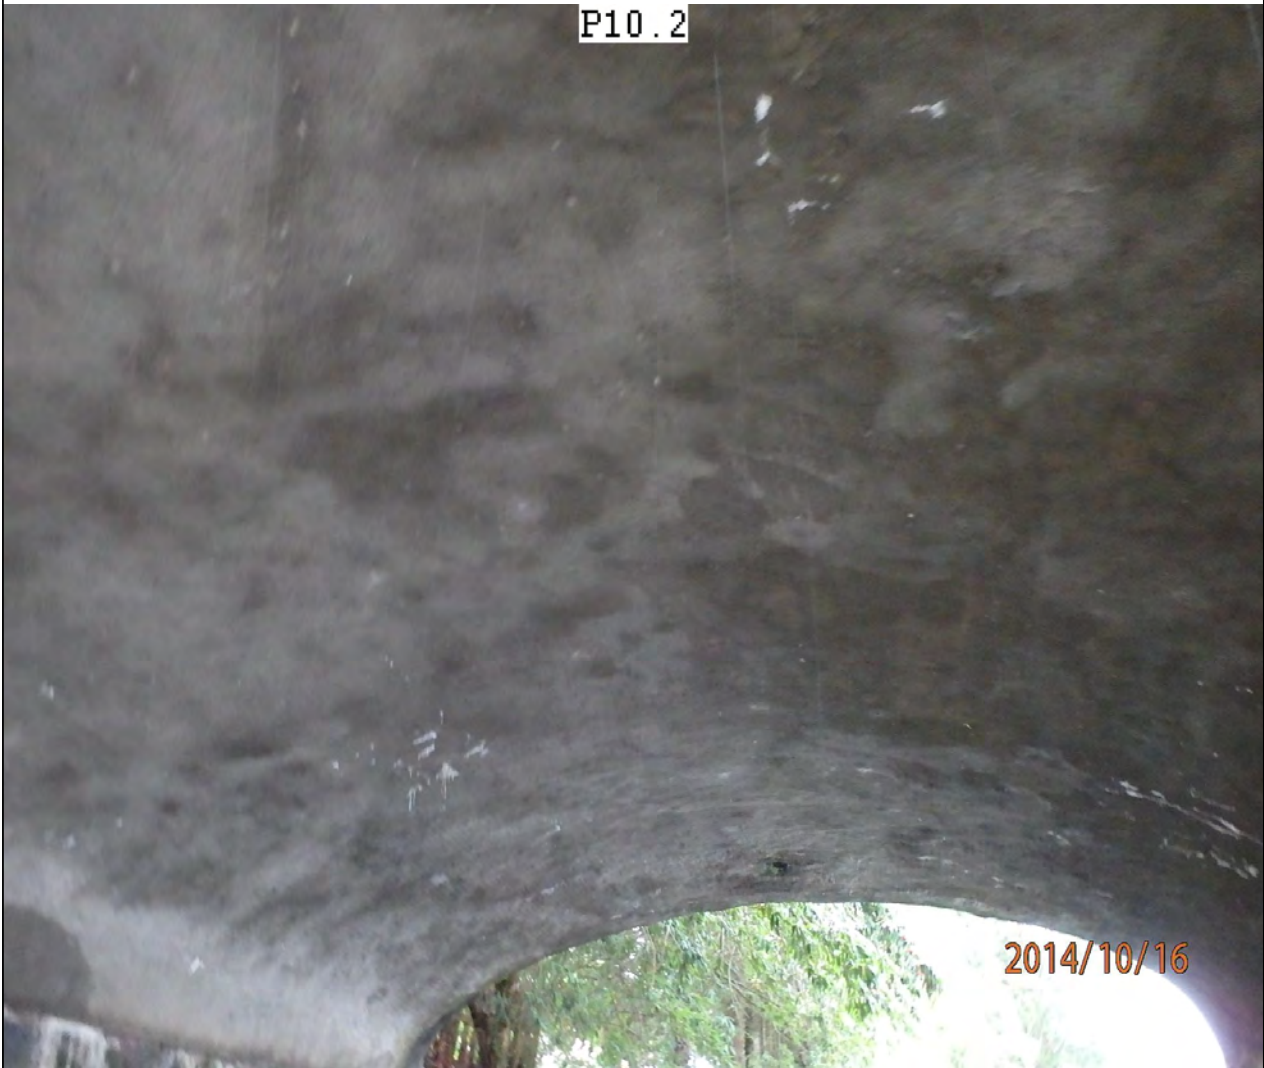
Decks are gunited in all spans and look to be in good condition. Drainage opes present in all spans also.

Condition/Mainten. 1 / N

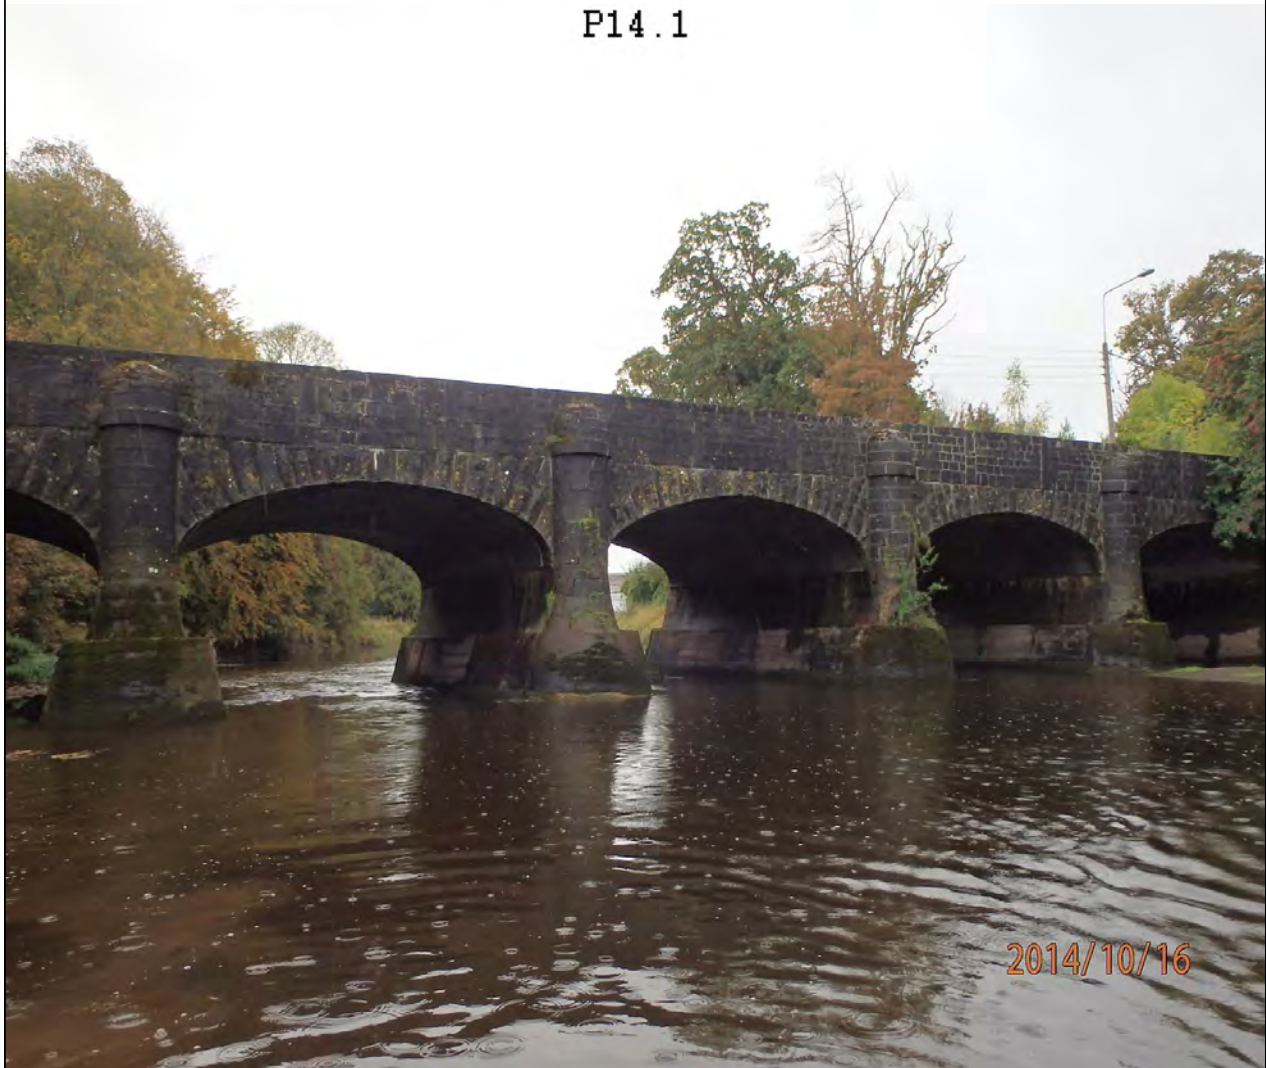
P14.2

Photo 14.1 - Upstream elevation
Photo 14.2 - Downstream elevation
Condition/Mainten. 4 / Y
