# ASBESTOS REFURBISHMENT SURVEY REPORT

Unit 8 and 9, The Village Centre,  
Main Street,  
Clane,  
Co. Kildare

Kildare County Council

Project Number  
**34099**

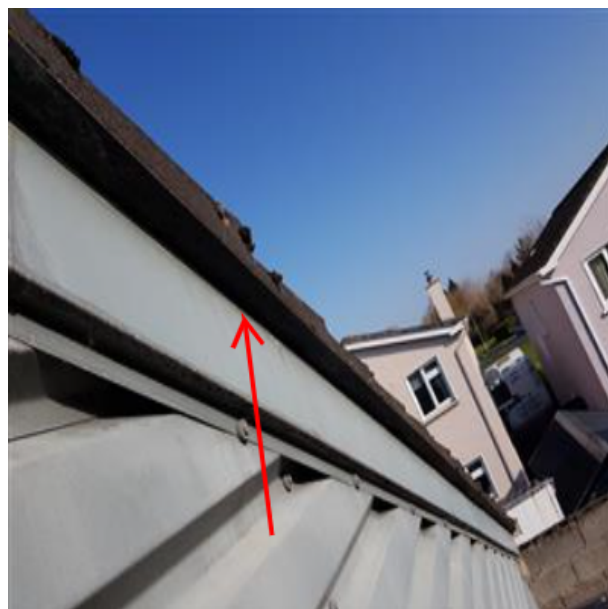
Risk Assessment		449032		Location		RA:449032 Unit 8&9 Village Centre Unit 8 Cavity closer at roof		
Type of Product	Quantity	Condition	Surface Treatment	Asbestos Type	Sample No.	Confirmation	MA	Recommendations
Cement based products	--N\A--	Good condition	Asbestos Cement	Chrysotile	DBB20220328002	Sampled	3	Priority 1:Risk assessment required where work will disturb ACM's

Score	Risk Rating
Asbestos Type : Chrysotile	1	High Risk
Type Of Product : Cement based products	1	Medium Risk
Condition : Good condition	0	Low Risk
Surface Treatment : Asbestos Cement	1	Very Low Risk
Quantity : --N\A--		
Material Assessment Score :	3	Very Low Risk

Priority 1: Risk assessment required where work will disturb ACM's

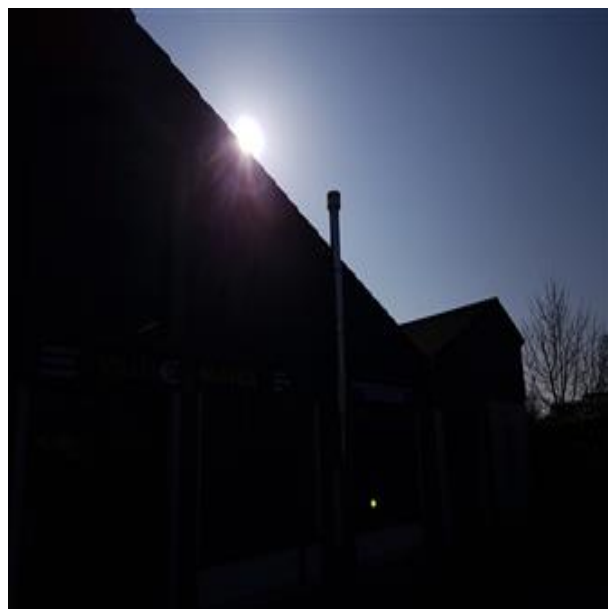
Risk Assessment		449042		Location		RA:449042 Unit 8&9 Village Centre Unit 8&9 Front facade and roof		
Type of Product	Quantity	Condition	Surface Treatment	Asbestos Type	Sample No.	Confirmation	MA	Recommendations
Asbestos Bitumen Products	>50m2 --N\A--	Good condition	Asbestos Cement	Chrysotile	DBB20220328006	Sampled	3	Priority 1 : Remove ACM's Prior to Refurbishment or Demolition.

Score	Risk Rating
Asbestos Type : Chrysotile	1	High Risk
Type Of Product : Asbestos Bitumen Products	1	Medium Risk
Condition : Good condition	0	Low Risk
Surface Treatment : Asbestos Cement	1	Very Low Risk
Quantity : >50m2 --N\A--		
Material Assessment Score :	3	Very Low Risk

Priority 1 : Remove ACM's Prior to Refurbishment or Demolition.

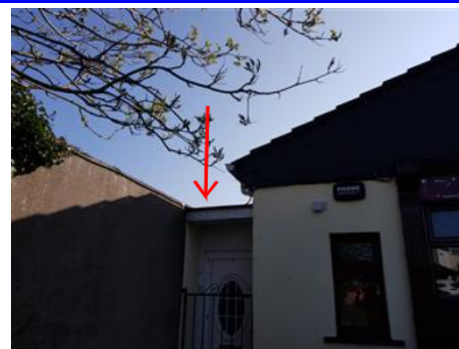
## Location Details 449043 No Asbestos Found

Building/Area : Unit 8&9 Village Centre  
 Room/Section : Unit 8&9  
 Location : flat roof  
 Description : Felt  
 Sample No. : DBB20220328007  
 Confirmation : Sampled  
 Access : Full Access  
 Normal Use : Warehouse  
 Recommendations :  
 ;

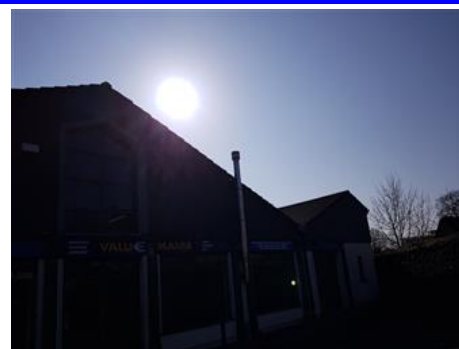
## Location Details 449044 No Asbestos Found

Building/Area : Unit 8&9 Village Centre  
 Room/Section : Unit 8&9  
 Location : Roof, soffits, drainage  
 Description : Concrete, plastic, timber  
 Sample No. :  
 Confirmation : --N\A--  
 Access : Full Access  
 Normal Use : Warehouse  
 Recommendations :  
 ;

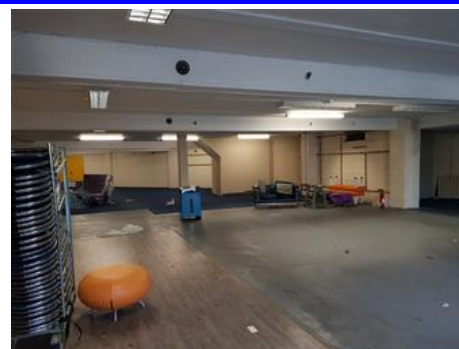
## Location Details 449033 No Asbestos Found

Building/Area : Unit 8&9 Village Centre  
 Room/Section : Unit 9  
 Location : Walls, floor and ceiling  
 Description : Block work, plaster, concrete  
 Sample No. :  
 Confirmation : --N\A--  
 Access : Full Access  
 Normal Use : Warehouse  
 Recommendations :  
 Laminate and carpet flooring;

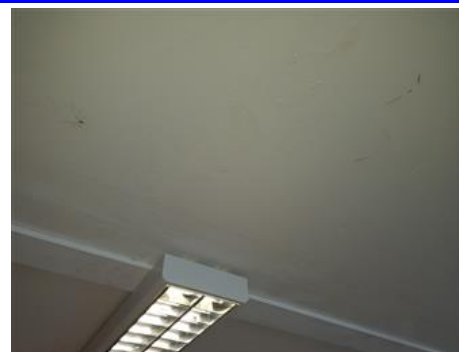
## Location Details 449034 No Asbestos Found

Building/Area : Unit 8&9 Village Centre  
Room/Section : Unit 9  
Location : Ceiling  
Description : Decorative coating  
Sample No. : DBB20220328003  
Confirmation : Sampled  
Access : Full Access  
Normal Use : Warehouse  
Recommendations :

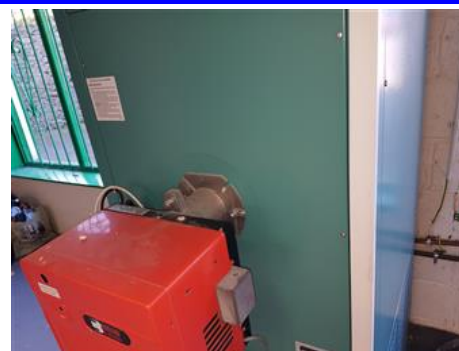
## Location Details 449035 No Asbestos Found

Building/Area : Unit 8&9 Village Centre  
Room/Section : Unit 9  
Location : Heating system  
Description : Gasket  
Sample No. : DBB20220328004  
Confirmation : Sampled  
Access : Full Access  
Normal Use : Warehouse  
Recommendations :  
Manufactured 2003;

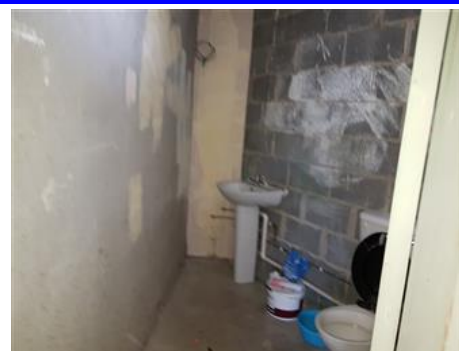
## Location Details 449036 No Asbestos Found

Building/Area : Unit 8&9 Village Centre  
Room/Section : Unit 9 toilet  
Location : Walls, floor and ceiling  
Description : Block work, plaster, concrete  
Sample No. :  
Confirmation : --N/A--  
Access : Full Access  
Normal Use : Warehouse  
Recommendations :

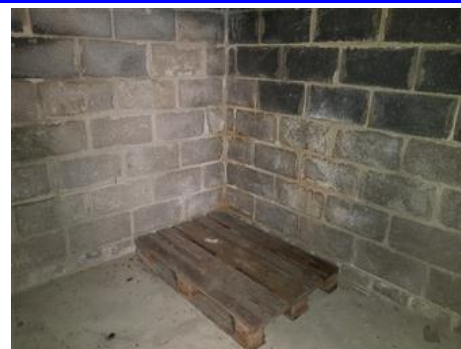
## Location Details 449037 No Asbestos Found

Building/Area : Unit 8&9 Village Centre  
Room/Section : Unit 9 store  
Location : Walls, floor  
Description : Block work, concrete  
Sample No. :  
Confirmation : --N\A--  
Access : Full Access  
Normal Use : Warehouse  
Recommendations :

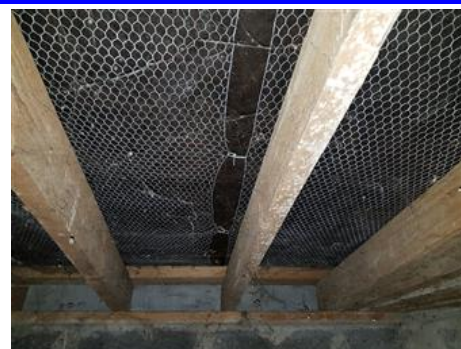
## Location Details 449038 No Asbestos Found

Building/Area : Unit 8&9 Village Centre  
Room/Section : Unit 9 store  
Location : Ceiling  
Description : Felt  
Sample No. : DBB20220328005  
Confirmation : Sampled  
Access : Full Access  
Normal Use : Warehouse  
Recommendations :

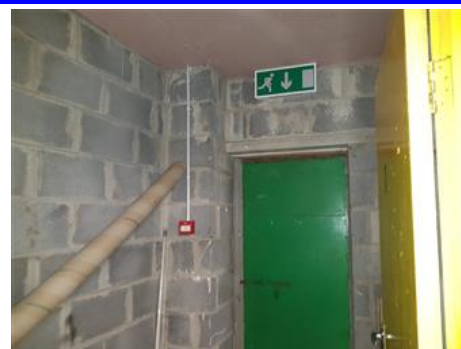
## Location Details 449039 No Asbestos Found

Building/Area : Unit 8&9 Village Centre  
Room/Section : Unit 9 fire escape  
Location : Walls, floor and ceiling  
Description : Block work, plaster, concrete  
Sample No. :  
Confirmation : --N\A--  
Access : Full Access  
Normal Use : Warehouse  
Recommendations :

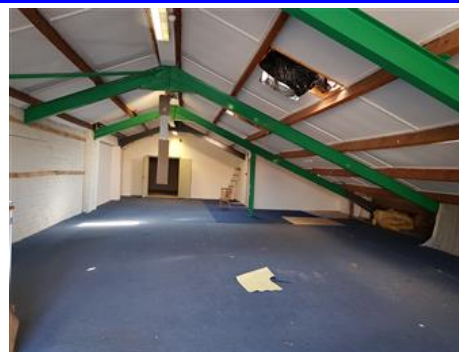
## Location Details 449040 No Asbestos Found

Building/Area : Unit 8&9 Village Centre  
 Room/Section : Unit 9 first floor  
 Location : Walls, floor and ceiling  
 Description : Block work, plaster, timber  
 Sample No. :  
 Confirmation : --N\A--  
 Access : Full Access  
 Normal Use : Warehouse  
 Recommendations :  
 ;

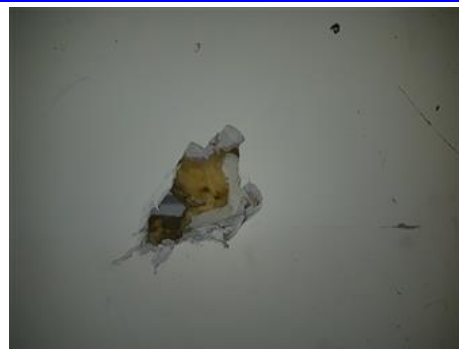
## Location Details 449041 No Asbestos Found

Building/Area : Unit 8&9 Village Centre  
 Room/Section : Unit 9 all rooms  
 Location : Behind stud walls and ceiling  
 Description : Fibreglass, metal panel  
 Sample No. :  
 Confirmation : --N\A--  
 Access : Full Access  
 Normal Use : Warehouse  
 Recommendations :  
 ;

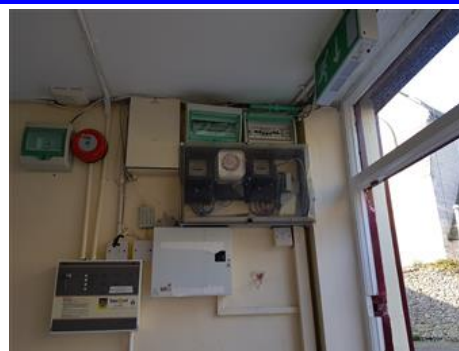
## Location Details 449018 No Asbestos Found

Building/Area : Unit 8&9 Village Centre  
 Room/Section : Unit 8  
 Location : Electrical panels  
 Description : Modern fuse board  
 Sample No. :  
 Confirmation : --N\A--  
 Access : Full Access  
 Normal Use : Warehouse  
 Recommendations :  
 ;

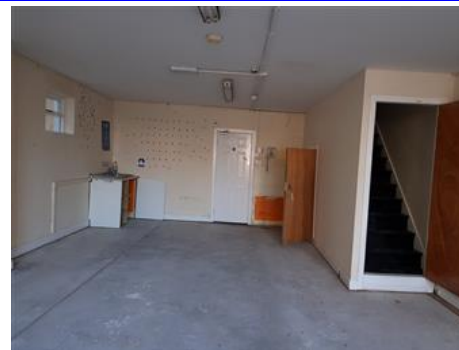
## Location Details 449019 No Asbestos Found

Building/Area : Unit 8&9 Village Centre  
Room/Section : Unit 8 front room  
Location : Walls, floor and ceiling  
Description : Block work, plaster, concrete  
Sample No. :  
Confirmation : --N\A--  
Access : Full Access  
Normal Use : Warehouse  
Recommendations :

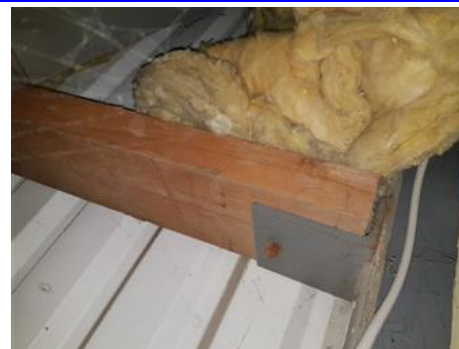
## Location Details 449020 No Asbestos Found

Building/Area : Unit 8&9 Village Centre  
Room/Section : Unit 8 front room  
Location : Above plaster ceiling  
Description : Block work, felt, timber  
Sample No. :  
Confirmation : --N\A--  
Access : Full Access  
Normal Use : Warehouse  
Recommendations :  
Fibre glass insulation;

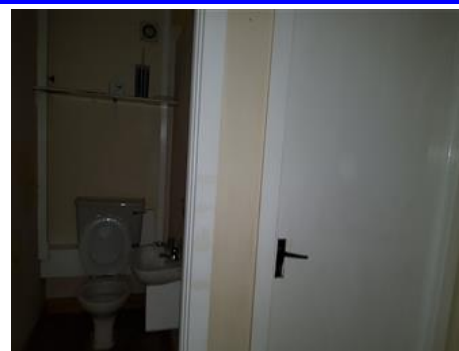
## Location Details 449021 No Asbestos Found

Building/Area : Unit 8&9 Village Centre  
Room/Section : Unit 8 toilets  
Location : Walls, floor and ceiling  
Description : Block work, plaster, concrete  
Sample No. :  
Confirmation : --N\A--  
Access : Full Access  
Normal Use : Warehouse  
Recommendations :  
Lino flooring;

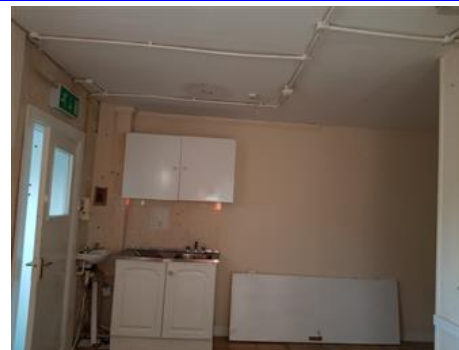
## Location Details 449022 No Asbestos Found

Building/Area : Unit 8&9 Village Centre  
Room/Section : Unit 8 canteen  
Location : Walls, floor and ceiling  
Description : Block work, plaster, concrete  
Sample No. :  
Confirmation : --N\A--  
Access : Full Access  
Normal Use : Warehouse  
Recommendations :  
Laminate flooring;

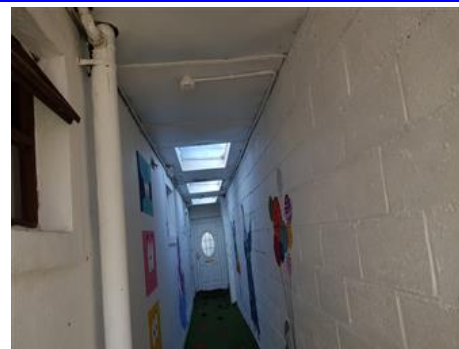
## Location Details 449023 No Asbestos Found

Building/Area : Unit 8&9 Village Centre  
Room/Section : Unit 8 side alley  
Location : Walls, floor and ceiling  
Description : Block work, concrete, timber  
Sample No. :  
Confirmation : --N\A--  
Access : Full Access  
Normal Use : Warehouse  
Recommendations :  
Laminate flooring;

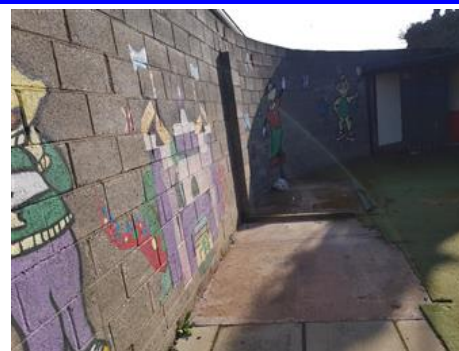
## Location Details 449024 No Asbestos Found

Building/Area : Unit 8&9 Village Centre  
Room/Section : Unit 8 rear of unit  
Location : All areas  
Description : Block work, concrete,  
Sample No. :  
Confirmation : --N\A--  
Access : Full Access  
Normal Use : Warehouse  
Recommendations :  
Laminate flooring;

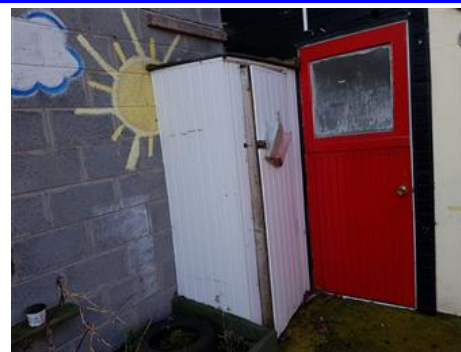
## Location Details 449025 No Asbestos Found

Building/Area : Unit 8&9 Village Centre  
Room/Section : Unit 8 external store  
Location : Walls, floor and ceiling  
Description : Modern  
Sample No. :  
Confirmation : --N\A--  
Access : Full Access  
Normal Use : Warehouse  
Recommendations :  
Laminate flooring;

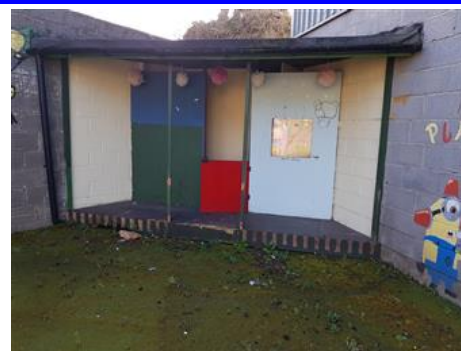
## Location Details 449026 No Asbestos Found

Building/Area : Unit 8&9 Village Centre  
Room/Section : Unit 8 external play house  
Location : Walls, floor and ceiling  
Description : Block work, timber  
Sample No. :  
Confirmation : --N\A--  
Access : Full Access  
Normal Use : Warehouse  
Recommendations :  
Laminate flooring;

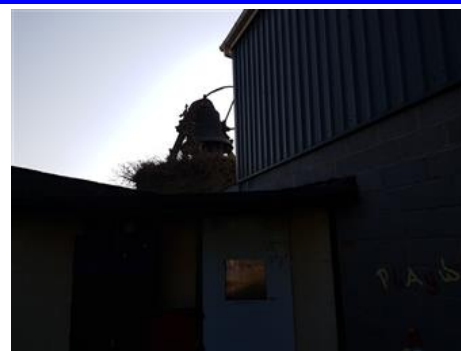
## Location Details 449027 No Asbestos Found

Building/Area : Unit 8&9 Village Centre  
Room/Section : Unit 8 external play house  
Location : Roof  
Description : Felt  
Sample No. : DBB20220328001  
Confirmation : Sampled  
Access : Full Access  
Normal Use : Warehouse  
Recommendations :  
Laminate flooring;

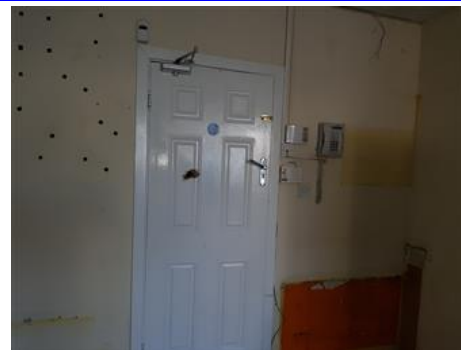
## Location Details 449028 No Asbestos Found

Building/Area : Unit 8&9 Village Centre  
Room/Section : Unit 8  
Location : Fire doors  
Description : Timber  
Sample No. :  
Confirmation : --N\A--  
Access : Full Access  
Normal Use : Warehouse  
Recommendations :  
;

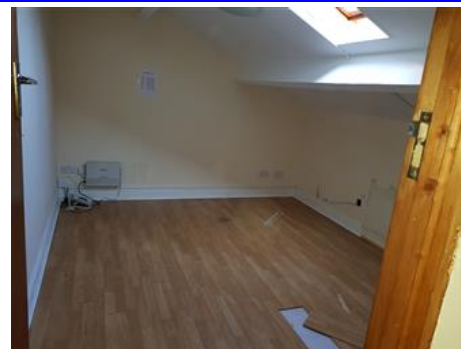
## Location Details 449029 No Asbestos Found

Building/Area : Unit 8&9 Village Centre  
Room/Section : Unit 8 offices x2  
Location : Walls, floor and ceiling  
Description : Block work, plaster, timber  
Sample No. :  
Confirmation : --N\A--  
Access : Full Access  
Normal Use : Warehouse  
Recommendations :  
;

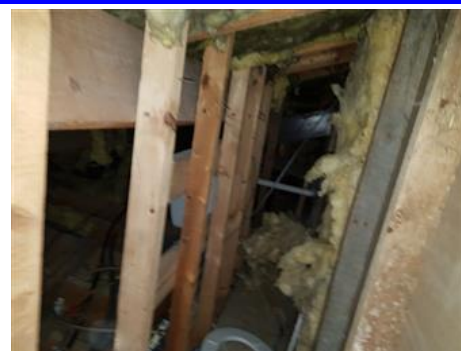
## Location Details 449030 No Asbestos Found

Building/Area : Unit 8&9 Village Centre  
Room/Section : Unit 8 loft  
Location : Walls, floor and ceiling  
Description : Block work, plaster, timber  
Sample No. :  
Confirmation : --N\A--  
Access : Full Access  
Normal Use : Warehouse  
Recommendations :  
Fibre glass insulation, plastic tank;

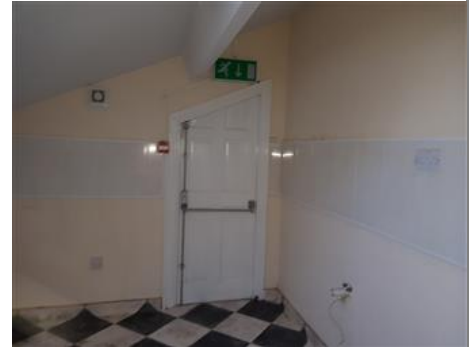
## Location Details 449031 No Asbestos Found

Building/Area : Unit 8&9 Village Centre  
Room/Section : Unit 8 canteen  
Location : Walls, floor and ceiling  
Description : Block work, plaster, timber  
Sample No. :  
Confirmation : --N\A--  
Access : Full Access  
Normal Use : Warehouse  
Recommendations :
