Proposed Playground Leixlip, County
Kildare

Kildare County Council

Ground Investigation Report

November 2022

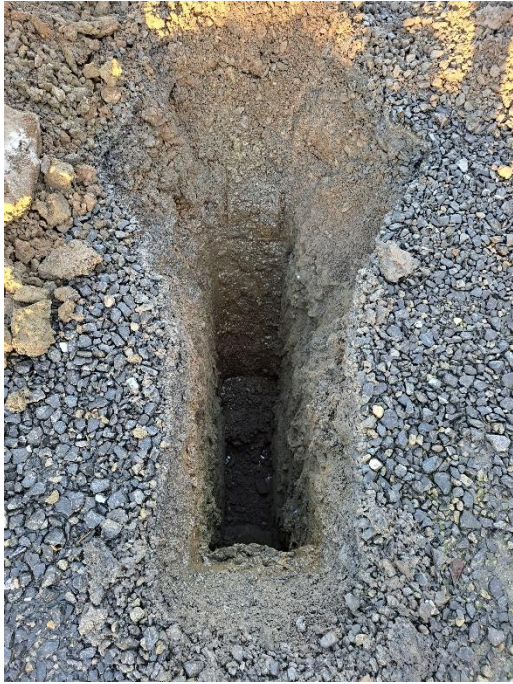
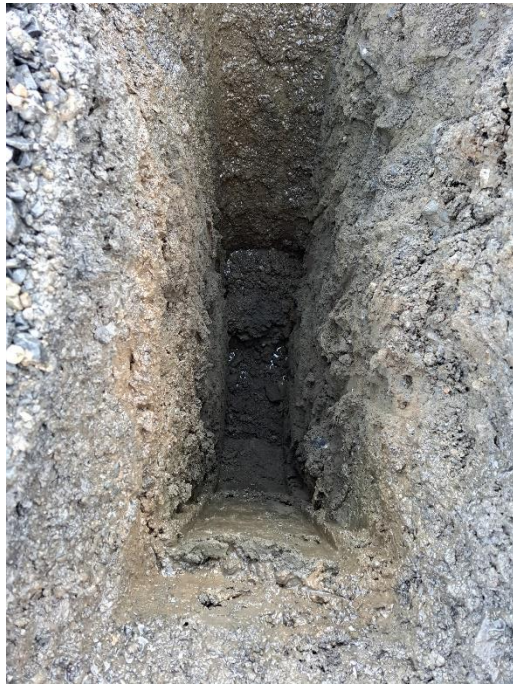
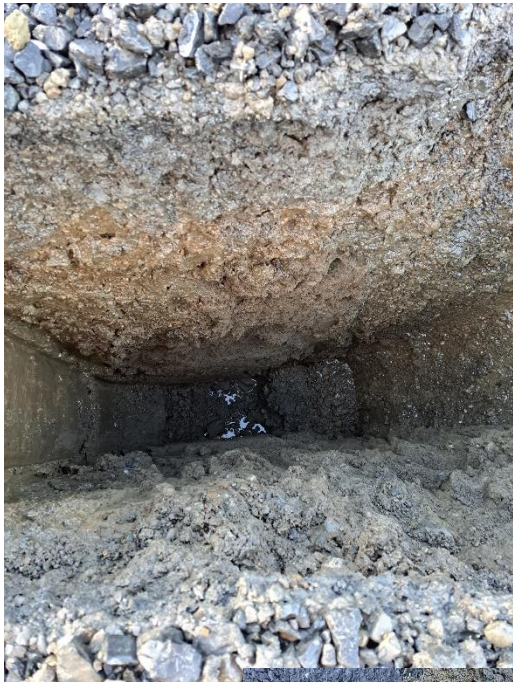
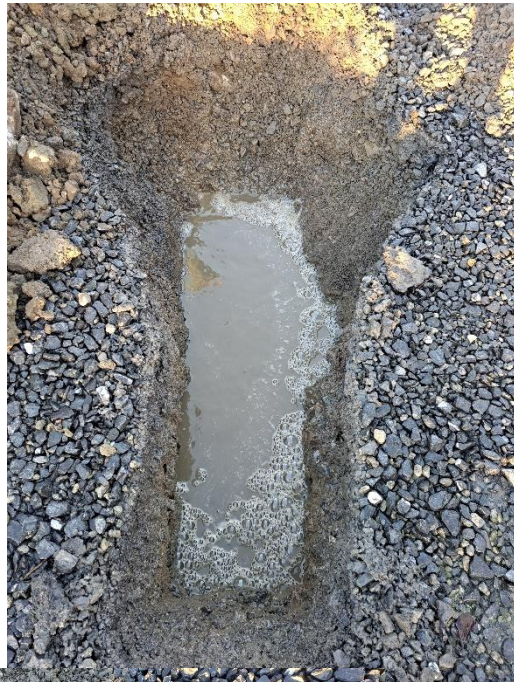
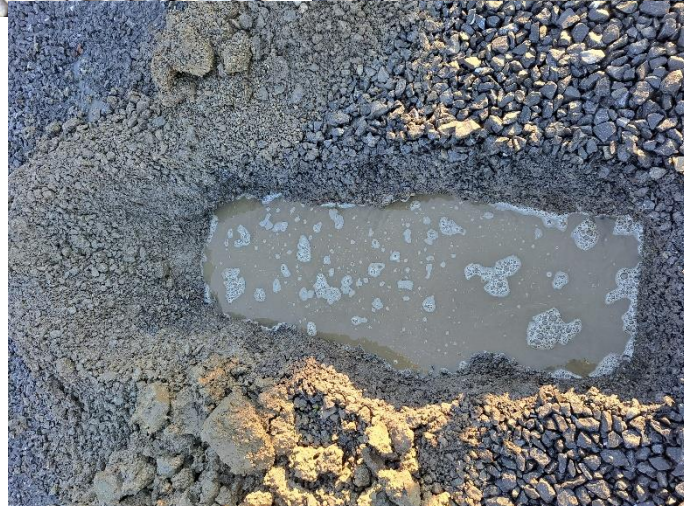
SA01

Plan .	Remarks Trial pit complete at 2.00m Trial pit stable Groundwater ingress once trial pit was opened Trial pit backfilled upon completion		
	Scale (approx) 1:25	Logged By MK	Figure No. 12237-09-22.SA01

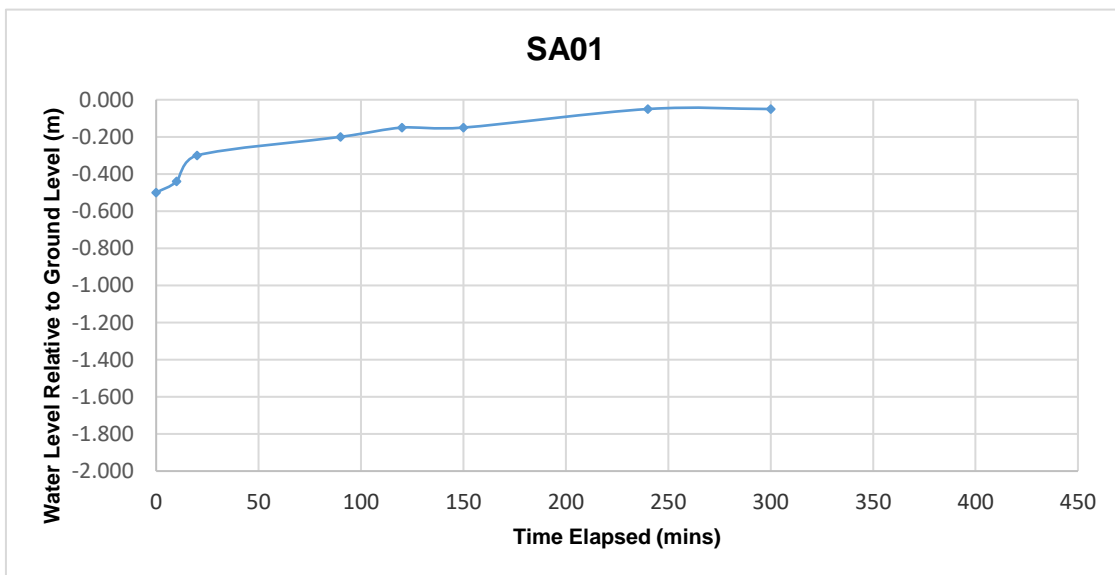
SA01

At the locations of SA-01 and SA-02 the water level dropped too slowly to allow calculation of 'f' the soil infiltration rate. These locations are therefore not recommended as suitable for soakaway design and construction.

***Soakaway failed - Pit backfilled**

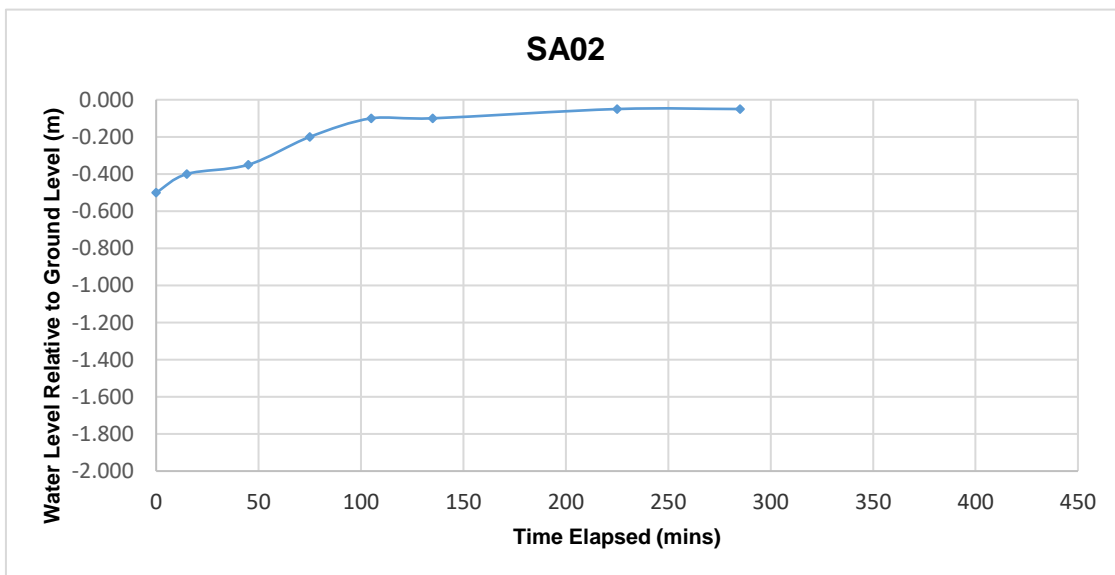
SA02

***Soakaway failed - Pit backfilled**

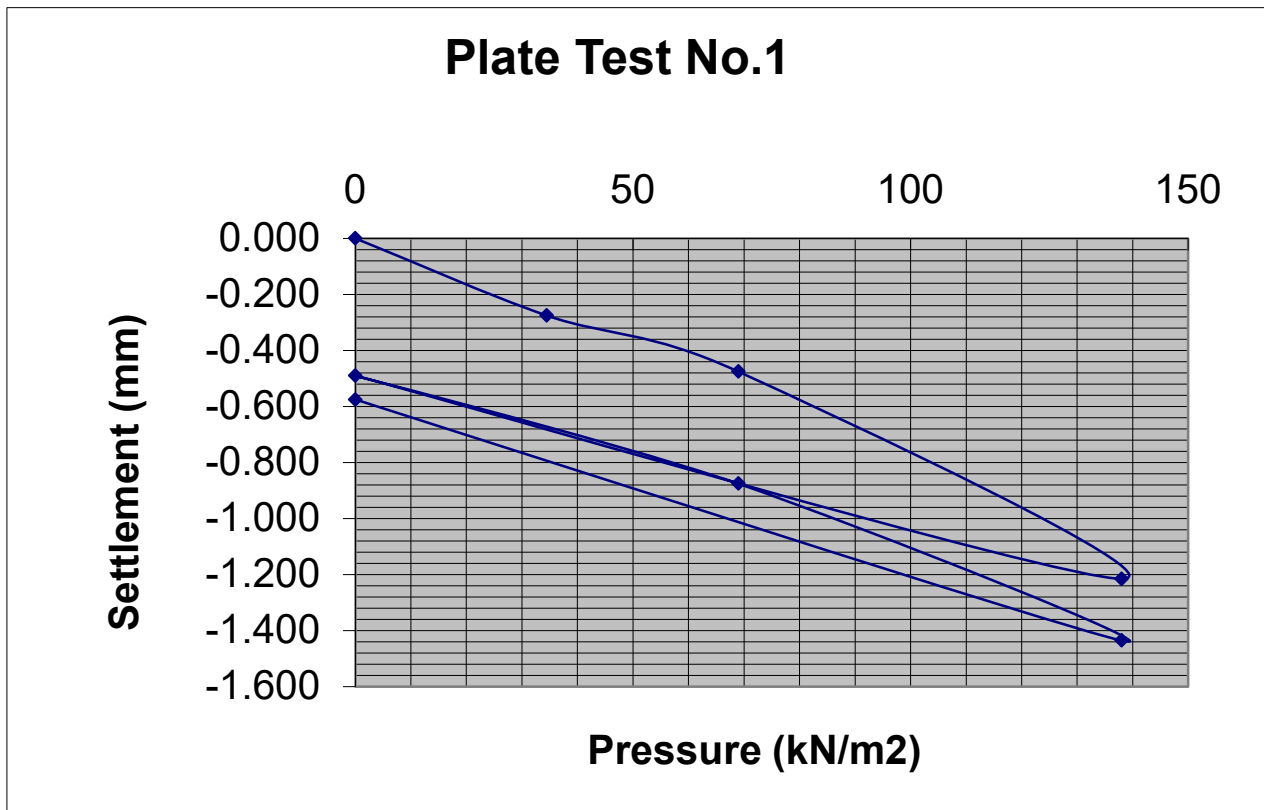
Modulus of subgrade reaction, K (Initial) = **66.02 MN/m²/m**

Modulus of subgrade reaction, K (Reload) = **81.46 MN/m²/m**

Equivalent CBR(initial)in accordance with HD25/94 volume7 section2 = **13.74 %**

Equivalent CBR(reload)in accordance with HD25/94 volume7 section2 = **19.77 %**

The proposed pavements are recommended to be designed in accordance with the CBR test results included in the Appendices of this Report. The CBR test results indicate that a capping layer or a sufficient depth of crushed stone fill may be required. Plate bearing tests are recommended at the time of construction to verify the design assumptions for the proposed pavement make up and to verify adequate compaction has been achieved. The use of a geogrid and separation membrane may improve the performance of the proposed pavement and enable a more economical pavement design to be achieved, a specialist supplier is recommended to advise of the required strength, depth and type of geotextile for the proposed design.

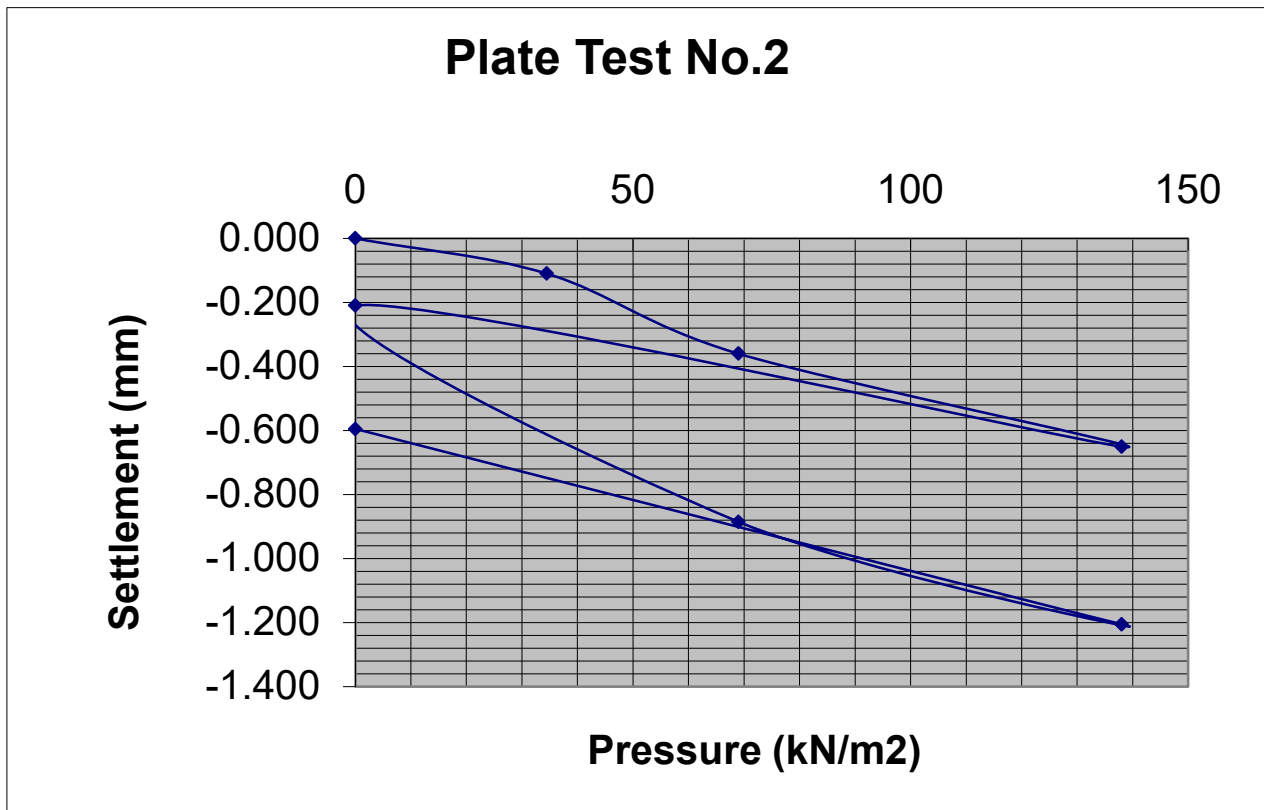
Modulus of subgrade reaction, K (Initial) = **87.11 MN/m²/m**

Modulus of subgrade reaction, K (Reload) = **46.46 MN/m²/m**

Equivalent CBR(initial)in accordance with HD25/94 volume7 section2 = **22.21 %**

Equivalent CBR(reload)in accordance with HD25/94 volume7 section2 = **7.47 %**
