**ARBORICULTURAL ASSESSMENT  
&  
IMPACT REPORT**

**KILDARE MARKET SQUARE  
CO. KILDARE**

<b>Project No.</b>	<b>Project name</b>	<b>Date</b>	<b>Revision</b>
TKIL004	Kildare Market Square	19/12/23	A

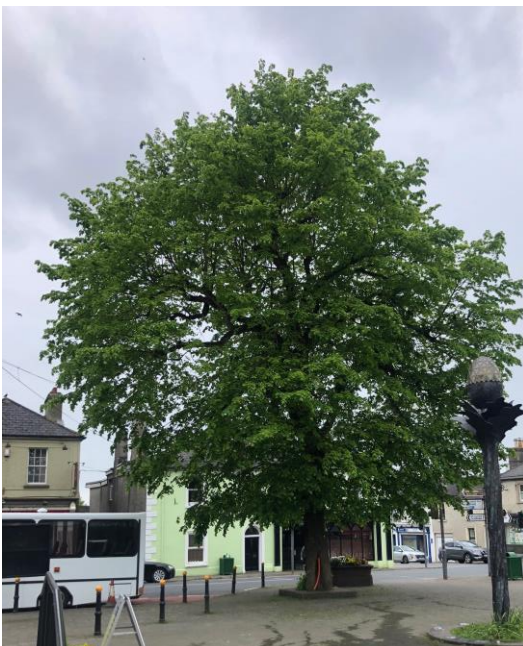
Image 2. Mature common lime (Market Sq. west)

incorporated into the public domain with the provision of seating at the base of a number of trees on the eastern section of the square (image 2) and as sites for lighting during festivals such as Christmas. Unfortunately, the seating has included a build-up of soil against tree trunks. This will negatively impact on the bark of the trees and could lead to bark death and decay establishment. Lighting although innocuous in itself can lead to cables becoming embedded in canopies if retained too long.

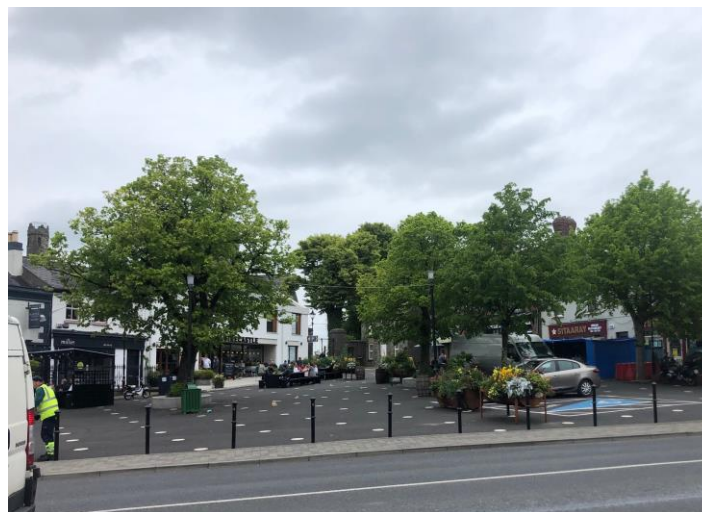
Image 3. Early-mature small leaved lime Market Sq. east)

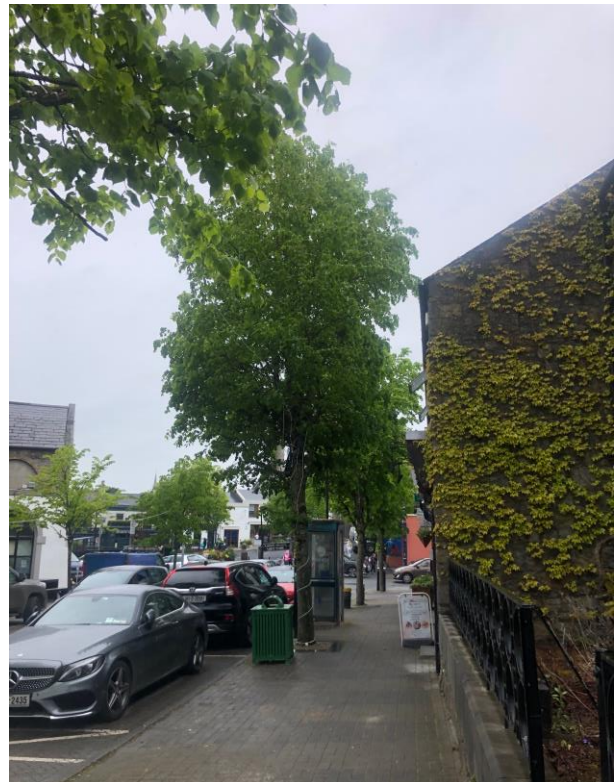
Management of the trees in the square has been largely confined to reducing crown spreads in the vicinity of the shops (image 4). This is an appropriate approach for lime and will continue to be necessary as the trees develop and it is recommended that this approach is adopted for the whole tree canopy to provide a uniformly managed crown shape.

**Image 4.** Small leaved lime on eastern section of Market Square
