Fire Hydrant Flow & Pressure Testing Report

Location: 55 The Paddock, Celbridge, County Kildare, W23 P654, Ireland

Date: 12-Jul-2023

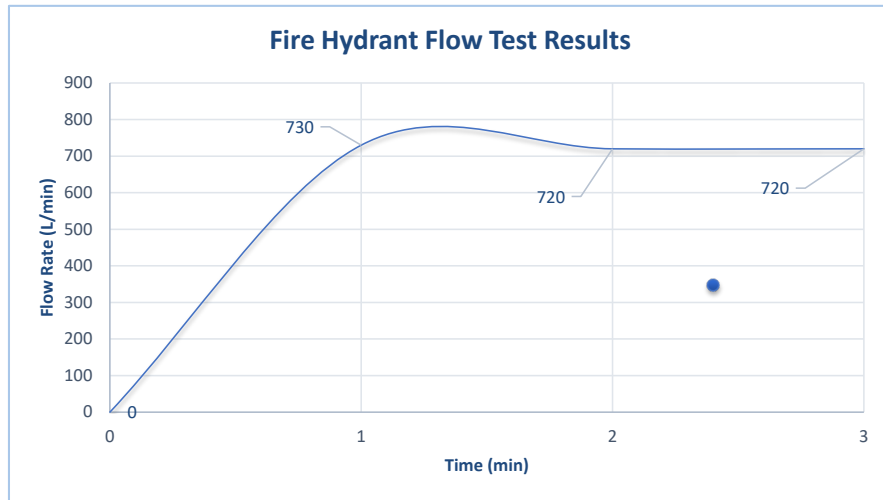
| Max Sustainable Flow | |
| 723 | L/min |

| Static Pressure | |
| 2 | Bar |

| Residual Pressure | |
| 0.6 | Bar |

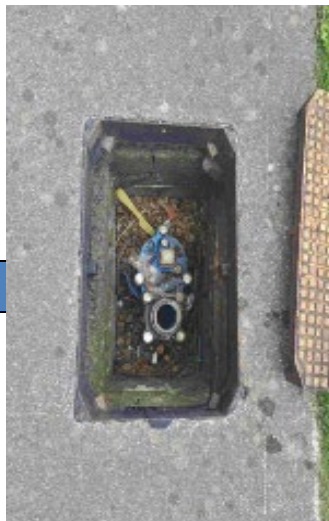
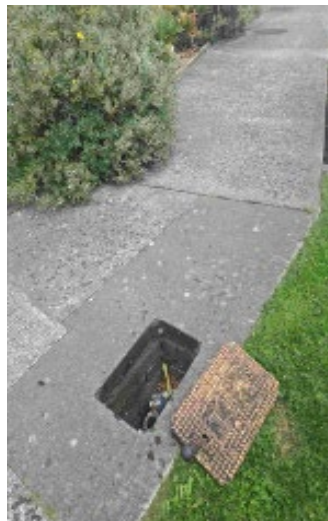
Condition Images:

| FH No. | Surface | Cover / Frame | Pit | Type | Depth (mm) | Marker / Plate | Spindle | Canary Yellow | Hydrant Leaking | Hydrant Cap | Comment |
|---|---|---|---|---|---|---|---|---|---|---|---|
| FH1 | Concrete Footpath | Good | Good | LUG | 280mm | No | Good | Yes | No | Yes | |
