ARBORICULTURAL ASSESSMENT  
&  
IMPACT REPORT

PROPOSED PART 8 RESIDENTIAL DEVELOPMENT  
OLDTOWN MILL  
CELBRIDE  
CO. KILDARE

<b>Project No.</b>	<b>Project name</b>	<b>Date</b>	<b>Revision</b>
TCEL002	Oldtown Celbridge	12/03/23	A

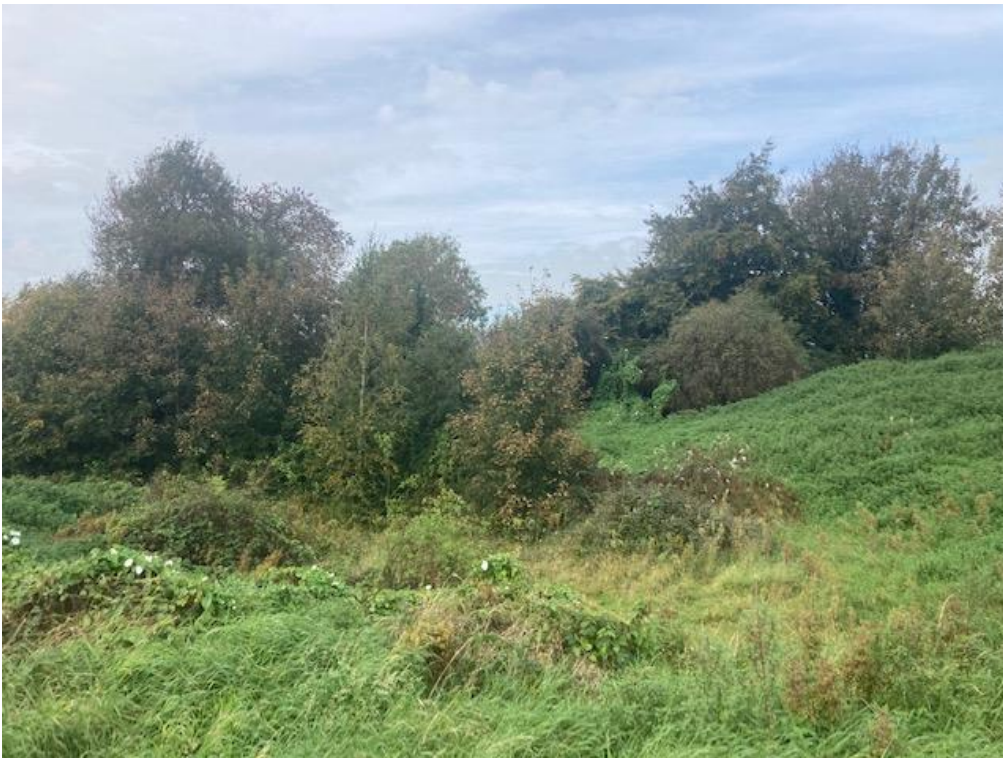
**Image 2.** Typical view of site illustrating undulating ground, bindweed smothering ground vegetation with northwestern boundary hedgerow in background

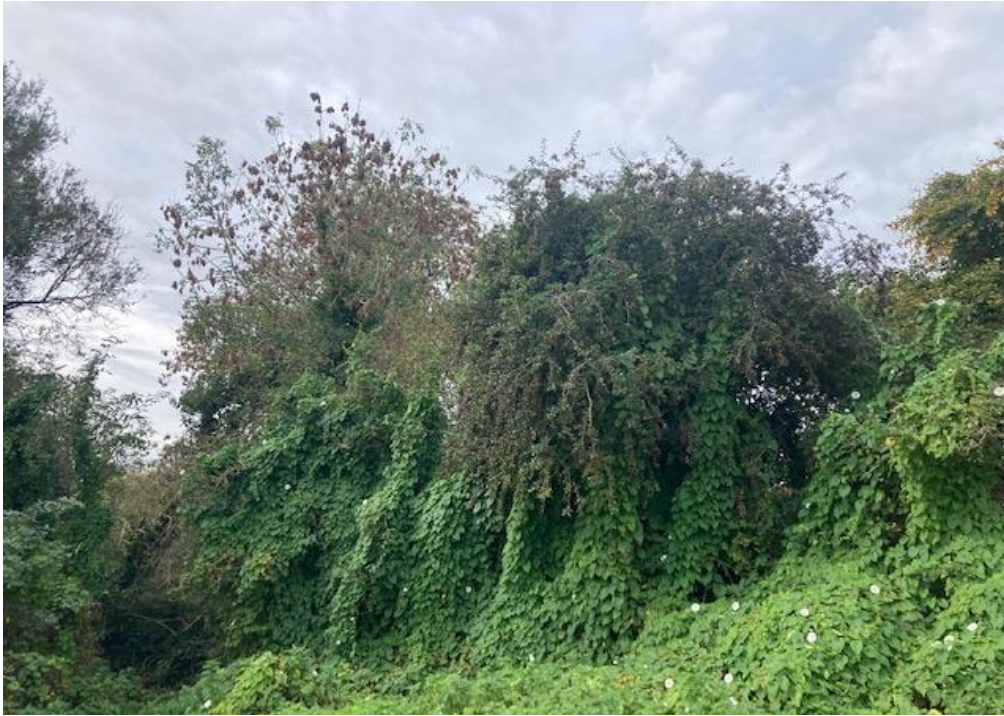
The younger self-seeded trees include birch (*Betula pendula*) and grey alder (*Alnus incana*) with scrub willow (*Salix caprea*), buddleia (*Buddleia davidii*) and bramble (*Rubus fruticosus*) prevalent over much of this area. Although the alder and birch have developed well overall none are particularly high value trees due to their age. Bindweed (*Convolvulus major*) is smothering most of the ground vegetation and is also smothering the canopies of sections of the hedgerows (image 3).

**Image 3.** Bindweed smothering ground vegetation and extending into northwestern boundary hedgerow.

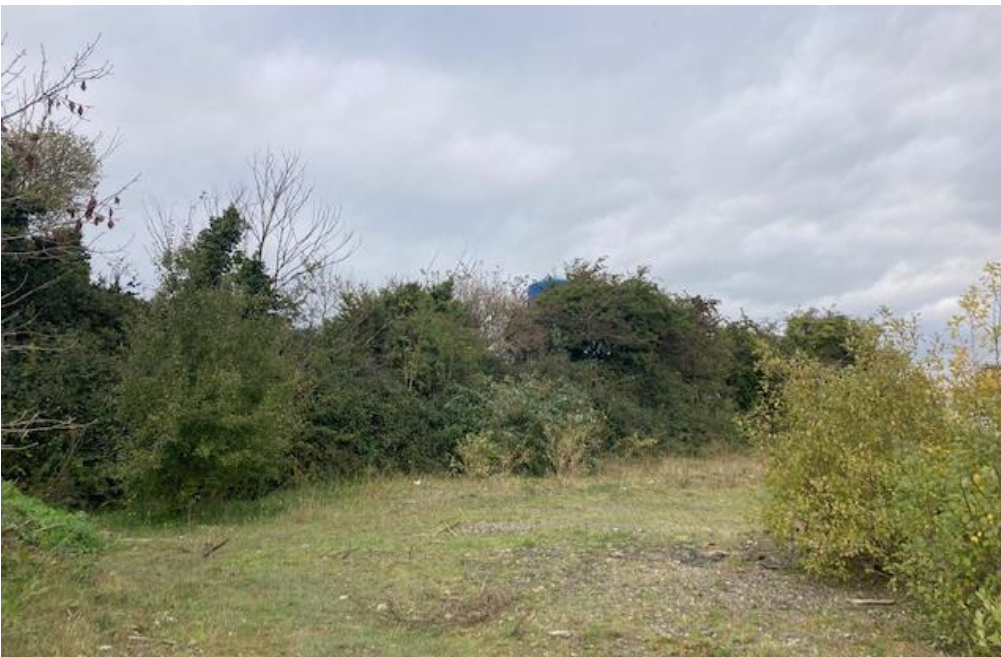
**Image 4.** Typical view of northwestern boundary hedgerow

The hedgerows which are primarily composed of unmanaged hawthorn (*Crataegus monogyna*) are becoming swamped in ivy (image 4). A number of mature sycamore

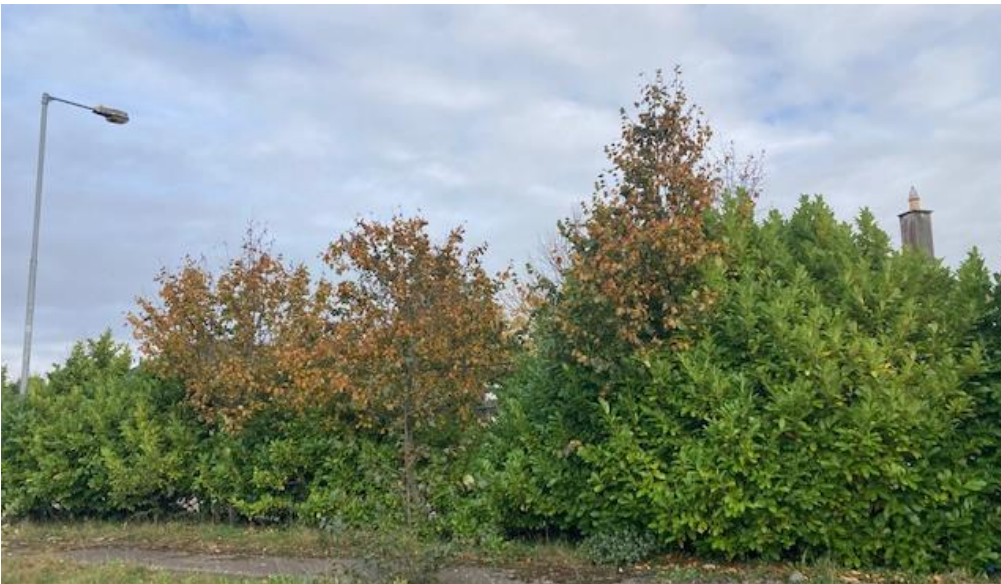
A number of small-leaved lime cultivars located on the eastern boundary with Oldtown Road (image 5) are in good condition overall though could benefit from formative pruning and removal of the wire boundary fence which is becoming enmeshed in the trees' canopies.

**Image 5.** Small-leaved lime on northern boundary with Oldtown Road
