Tree Survey Report

Rathangan

CLIENT: Sophia Housing

July 2023

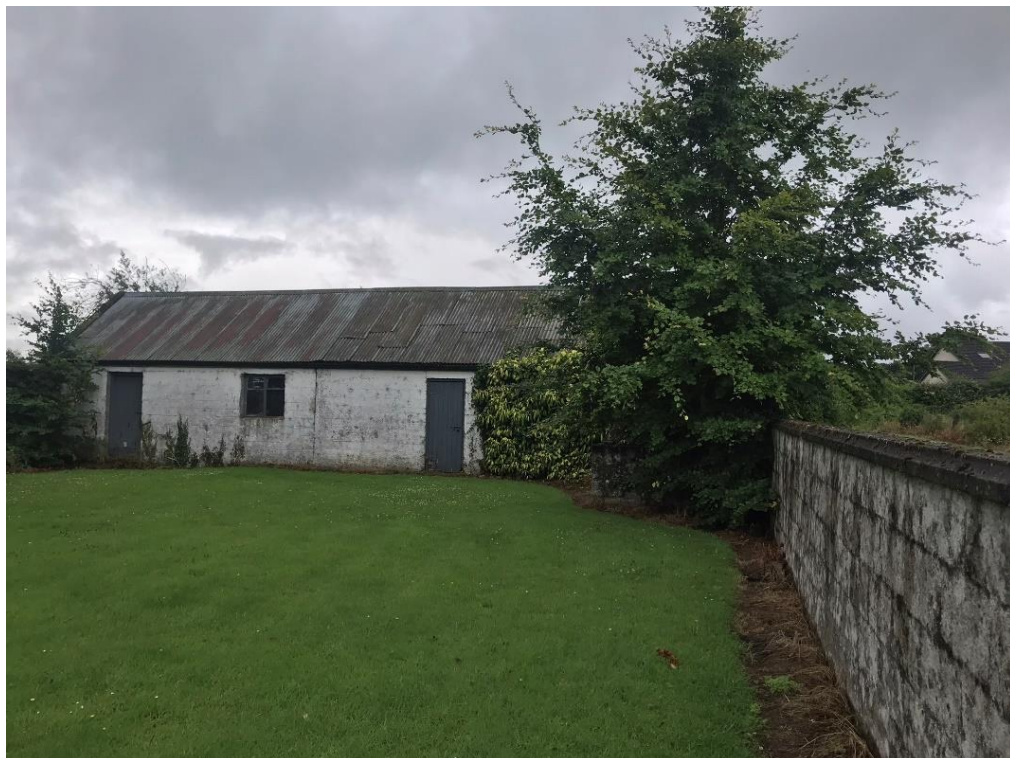
The northern boundary is made up of a barbed wire fence interwoven with unkept vegetation of low quality, the western most part of the northern boundary is made up of a Cherry Laurel hedge which is in good condition, as well as a semi mature Lawson cypress, located outside of the red line boundary. In the corner of the interior wall on the north side of the site within an area of lawn there is a self-seeded *Fagus sylvatica* Beech tree in good condition.

Figure 1: Fagus sylvatica located near the north boundary.

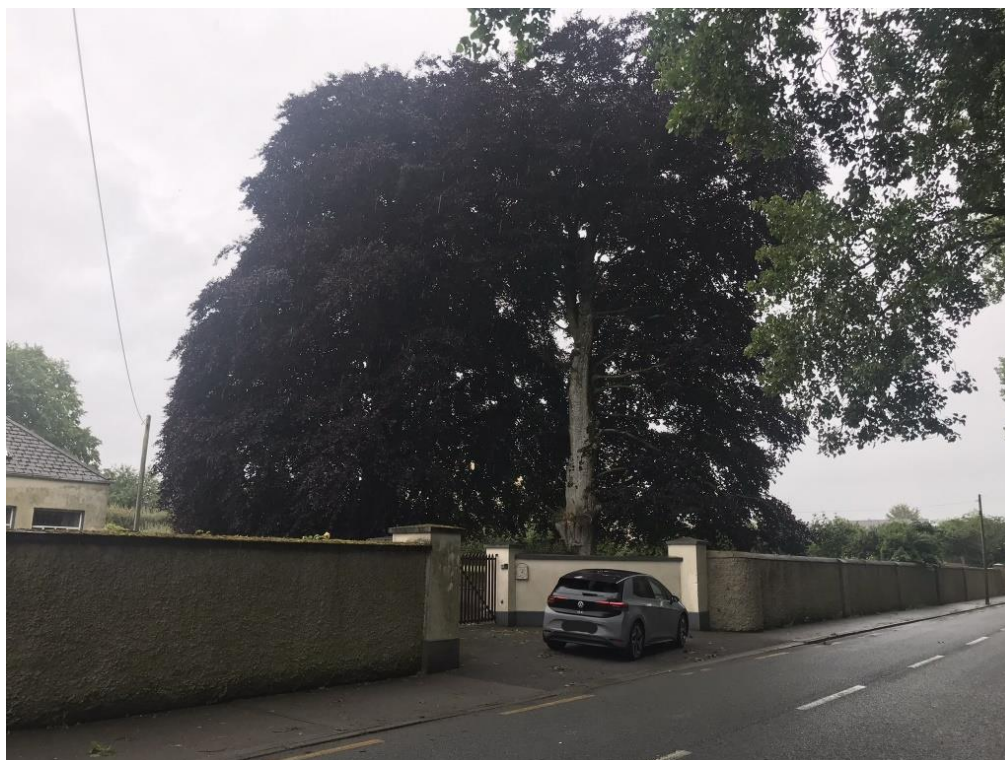
The southern boundary of the site contains a large open space next to the main existing building and its entrance. The open area is divided away from the tarmacadam of the entrance by a small retaining wall about 1 metre in height as the open space is at a higher elevation. The open area contains three trees: a *Prunus cerasifera* 'Nigra' Purple plum, and two *Fagus sylvatica* 'Atropurpurea Group' Copper Beech. The plum tree is in poor condition due to heavy lichen and moss on the bark and will need to be removed for the new design. The two beech trees, although having a few limbs which have been removed and a large amount of decay in them, they are still in very good condition and have grown to a height of between 20-22 metres. These two beech trees are to be retained.

Figure 2: Two beeches at the front of the site

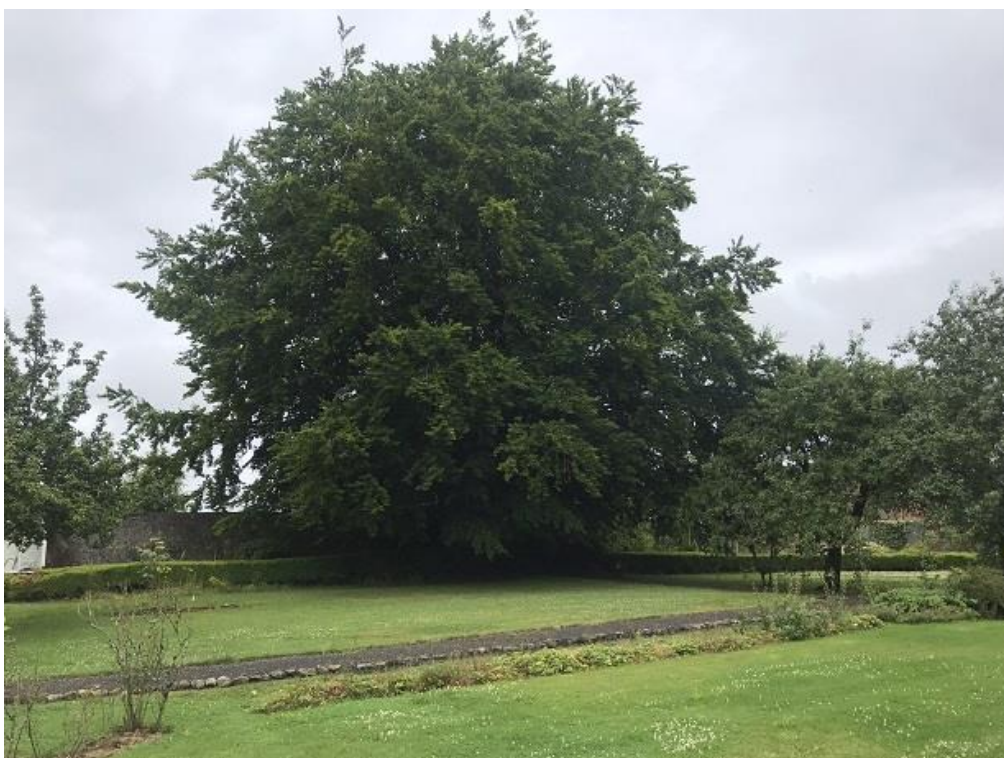
Tree no. 0745 is a large veteran Beech *Fagus sylvatica*. This is an important tree from a cultural and ecological perspective. It has two smaller *Ganoderma lucidum* fungal brackets on the trunk. It is recommended that sonic tomography be used to get a better picture of any internal decay. There is a stone wall existing to the north within the RPA. It is expected that the tree roots do not project beyond this wall, allowing for development to the north

of the wall. A path is proposed in this area and no root protection measures are required in this area.

Figure 3: Beech tree 0745

Impact of development: The site layout has been designed so that there is minimal impact on this tree. Existing pedestrian paths are to be retained in their original alignment. Within the RPA, the surface of these paths may be dressed by hand. There is to be no excavation and no machinery is to encroach within the tree protective fencing alignment/RPA. Follow up surveys every 3 years are recommended.

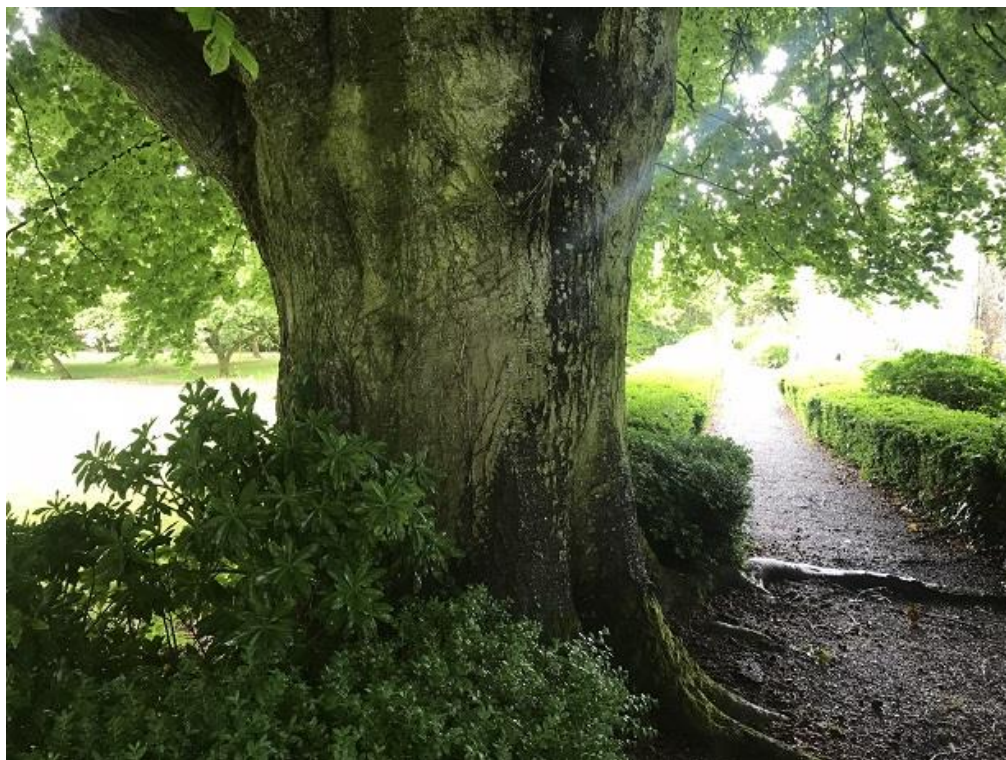
Tree no.'s 0746 – 0758 are orchard trees, species are Apple *Malus* spp. Pear *Pyrus* spp. Plum *Prunus domestica* and Walnut *Juglans nigra*. They create a nice atmosphere in the current use as an enclosed garden. The Walnut *Juglans nigra* has significant basal rot, though would be expected to survive in its current land use. It would be a risk within the proposed development with increased public and residential users passing within falling distance of the tree, making it a potential hazard.

Figure 4: Roots of tree no. 0746 growing in existing path

Impact of the development: The site layout has been designed to retain as many of these trees as possible. Car parking and access road layout will see the removal of tree no.'s 0753 – 0758. Tree numbers 0746 – 0752 will be retained.

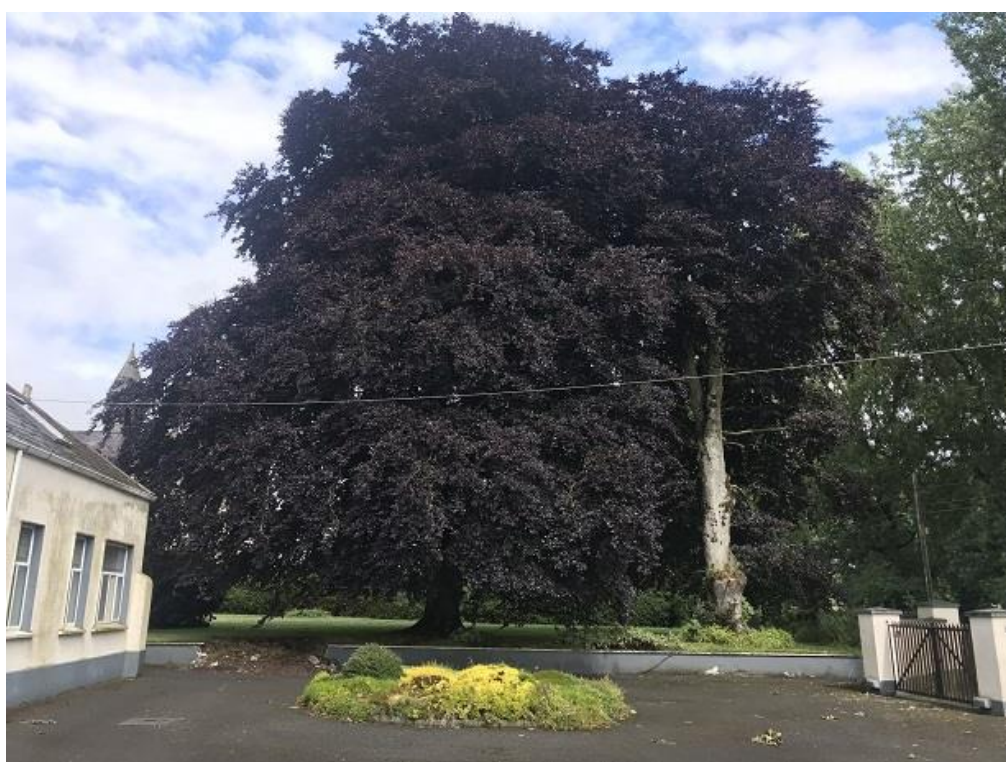
Tree no.'s 0760 & 0761 are champion veteran Copper Beech trees, *Fagus sylvatica* 'Atropurpurea Group'. These trees play an important role in the biodiversity, green infrastructure and cultural heritage of the area. As they are located within the front garden of the existing site, and are visible from the public road and footpath, they contribute greatly to the public realm.

Figure 5: Copper Beech and level change in front garden

Impact of the development: The site layout has been designed to allow the retention of these trees. There is an existing garden wall 3-4 from the trunk of these trees. There is a c.400mm drop to a tarmacadamed driveway area. The theoretical RPA of these trees extends into the driveway area. However, in reality it is unlikely that the roots have grown beneath the wall and its foundations and on underneath the tarmacadamed driveway area. It is recommended that site investigation trenches be excavated to determine the presence of tree roots. This work must be supervised by the project arborist. Excavations are to start at the outer edge of the RPA and work gradually inwards until roots are encountered, or the wall is reached. Lighter machinery may travel across the existing tarmacadamed area within the RPA of the tree, provided that tree protective fencing is in place.
