Title: COMBINED STAGE 1&2 ROAD SAFETY AUDIT

Proposed Residential Development at St. Evin's Park,

Monasterevin, Co. Kildare.

Report reference: 2008R01

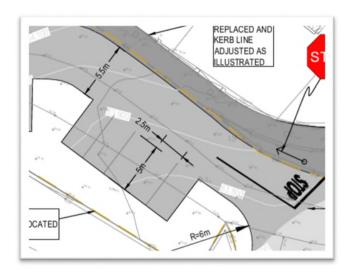
Drawing 2305-DOB-XX-SI-DR-C-0050 S2 P01, Access road

There may not be enough room for those using the perpendicular parking spaces to exit if the adjacent spaces are occupied given the relatively narrow (5.5m) carriageway access road. This could lead to material damage of parked vehicles.

It is recommended that that sufficient space be provided. This may require wider or longer parking spaces.

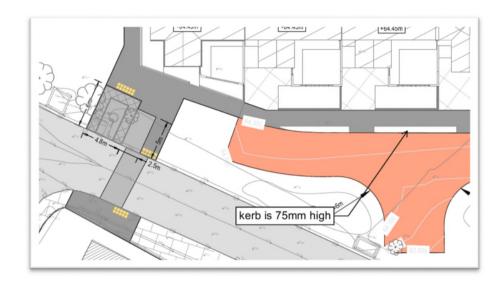
Drawing 2305-DOB-XX-SI-DR-C-0050 S2 P01

There is no on-curtilage parking proposed for the most westerly unit. This could lead to parking in the turning head which in turn could lead to refuse vehicles and the like reversing along the road which would increase the likelihood collisions with pedestrians. It is assumed that the disabled parking bay will be for general use and not exclusive for one dwelling.

It is recommended that parking be provided for the last unit.

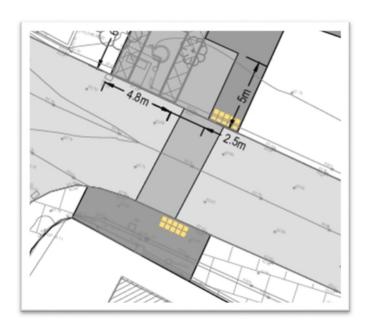
Drawing 2305-DOB-XX-SI-DR-C-0050 S2 P01, road crossing.

The existing carriageway is to be repaired at the new uncontrolled pedestrian crossing at the western end of the development after the water supply connection is complete. New joints in the pavement may deteriorate over time and lead to trip hazards.

It is recommended that new surfacing be provided over the entire crossing area.

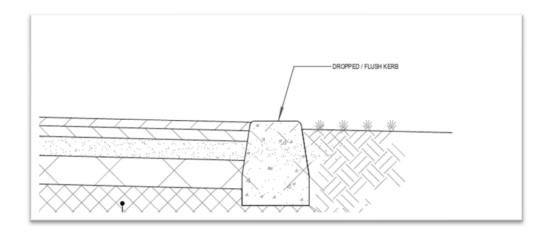
Drawing 2305-DOB-XX-SI-DR-C-0120 S2 P01, Kerb Height.

The access road kerb at the green area side is to be flush to allow surface water runoff. The absence of a kerb could lead to drivers parking partially on the carriageway and partially on the verge which could lead to loss of traction and control when exiting. The absence of a kerb could also lead to higher speeds as drivers perceive a wider road ahead.

It is recommended that a higher kerbs be provided with regular dips to be flush and allow surface water runoff.
