# BRIDGE REHABILITATION WORKS IN CO. KILDARE

## Pass Bridge Remediation Methodology

KCCBFW-CCC-ST-S06-RP-S-0001

Client: Kildare County Council  
Date: 22.11.2024

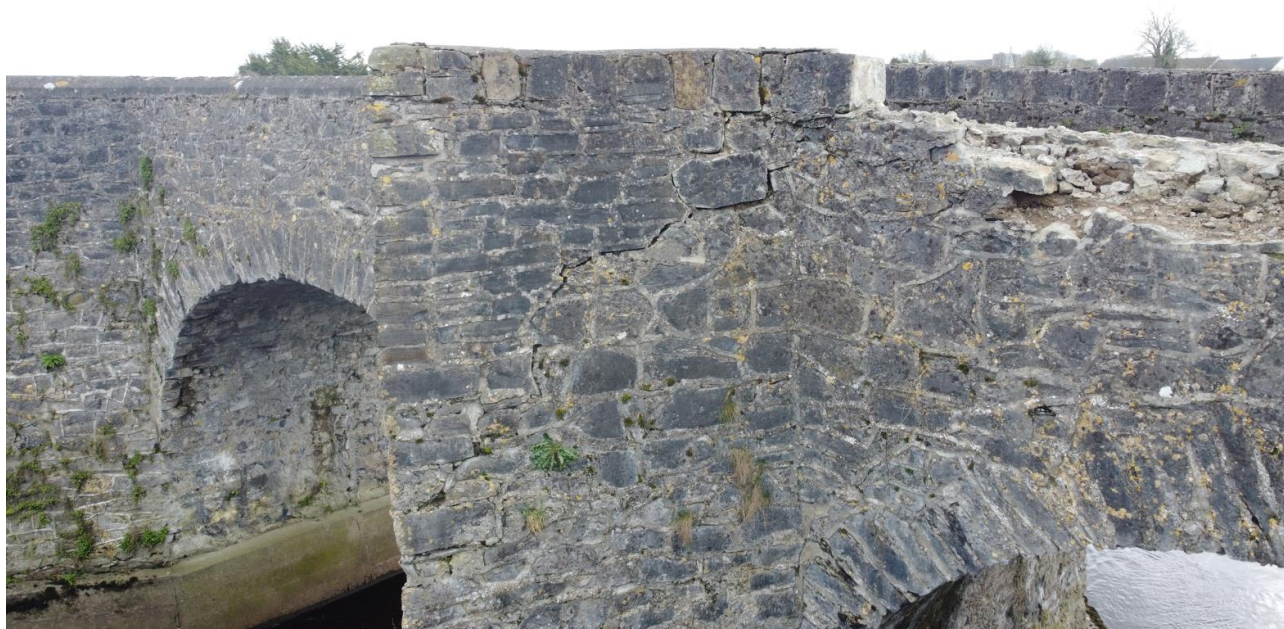
Figure 5 Cutwater/ Parapet Damage, Span 1, upstream view

Damage to the 1<sup>st</sup> pier cutwater and parapet was recorded during the inspection on 7/03/2024. The damage to both elements is likely to be associated with vehicle impact **Figure 5**. Part of the parapet coping approx. 6m long is missing and loose stones are visible in the stream. CCC are proposing to recover the collapsed stone from the stream as much as possible and reconstruct the parapet coping and the cracked cutwater section to its original geometry **Figure 6**. Strap pointing should be used to match the original with NHL 3.5 mortar.

The following is the methodology for the reconstruction of the cutwater and parapet:

- i) Refer to section 6 of this report for plant & equipment before the commencement of works;
- ii) Access to the stream for stone recovery and falsework installation will be by the shortest route - from the north-west bank;

- iv) An appropriate-size excavator will be used to recover the loose stone from the stream;
- v) Remove sandbags and silt trenches and reinstate the stream flow in the affected area;

- vi) Install an approved scaffolding system and netting to access the damaged section and protect the stream pollution from falling debris and rebound materials;

- vii) Marked the cutwater stones and reduced the cracked cutwater to the sound masonry. Stone will be removed from the falsework and cleaned away from the stream and stored safely on site;

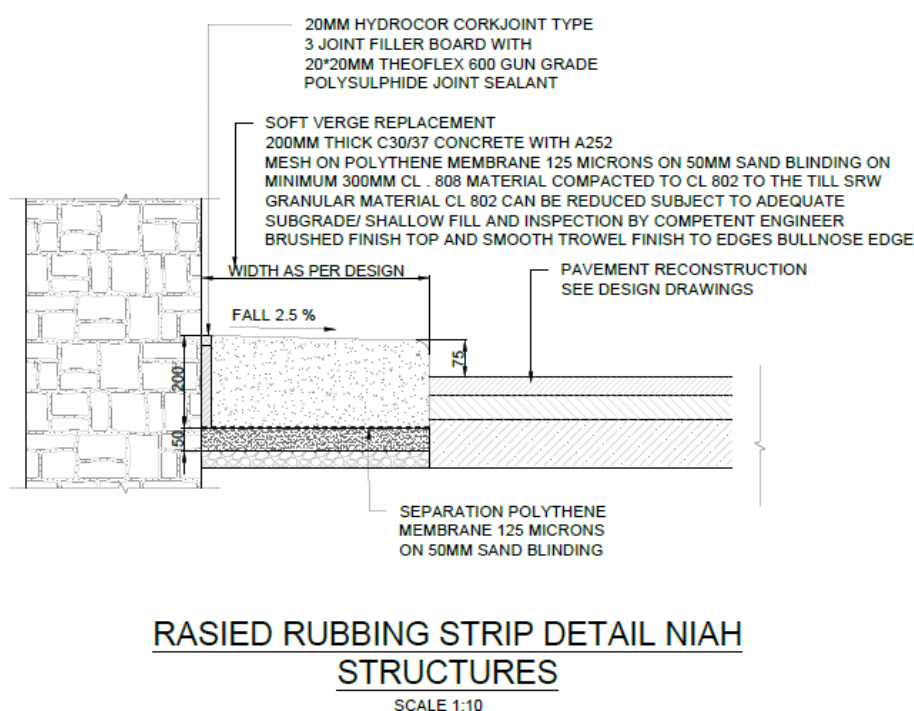
Figure 7 Raised Rubbing Strip Detail, KCCBFW-CCC-ST-XX-DR-S-0002

Soft verges were recorded on both sides of the structure. As a result of water ingress through the permeable verges defects are evident on the soffit of all arches such as water staining and calcite accumulations and, could lead to further masonry deterioration. CCC are proposing to replace the soft verges with an impermeable raised rubbing strip **Figure 7**.

- i) Implement temporary traffic control measures during the works;
- ii) Remove soft verges to the design depth using suitable machinery;
- iii) Construct soft verges as per the design detail KCCBFW-CCC-ST-XX-DR-S-0002;
- iv) Reinststate road surfacing to the new rubbing strip;
- v) Remove temporary traffic control measures;

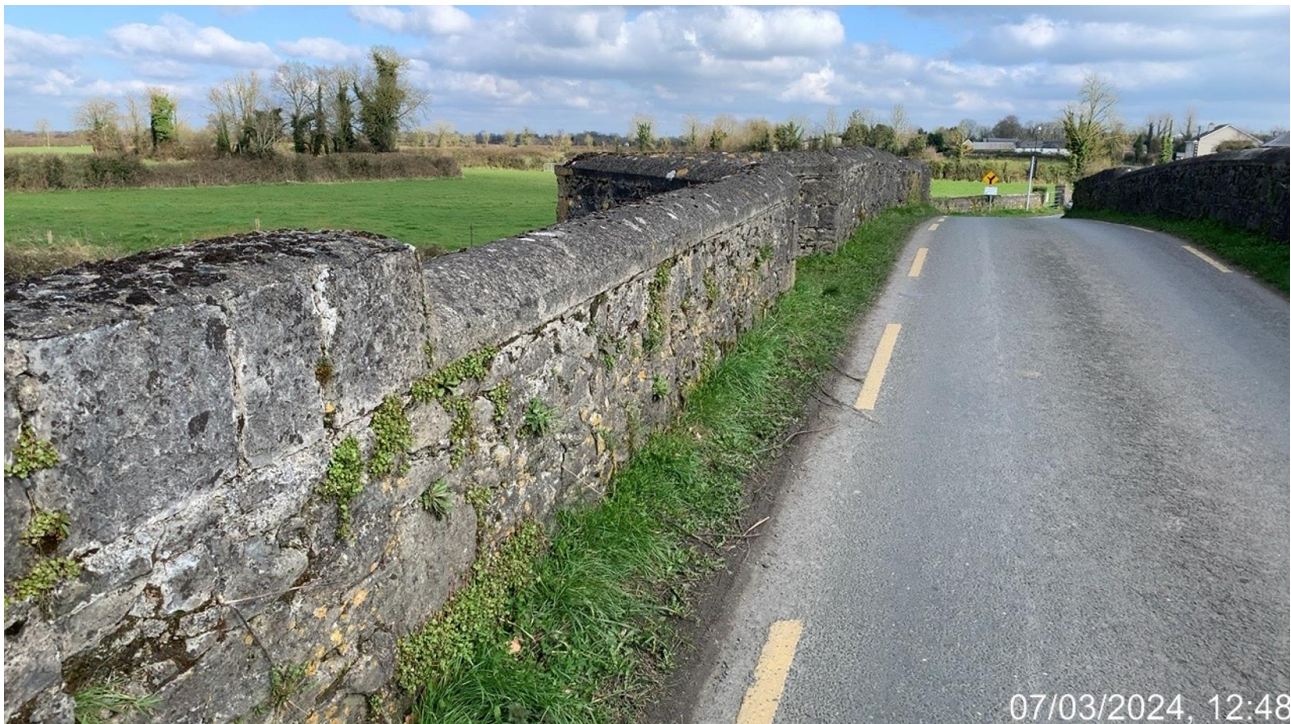
*Figure 8 Minor Vegetation Growth and Missing Pointing, Parapets, looking north*

During the Bridge inspection, it was recorded that areas of masonry have loose, friable or missing masonry pointing as well as being covered in vegetation which causes further masonry degradation if not removed **Figure 8**. CCC are proposing to remove the vegetation in the affected areas, remove loose pointing and reinstate any missing pointing with NHL 3.5 or NHL 5 mortar in the areas subject to water saturation as outlined in the design drawings. Strap pointing should be used in the areas where this pointing is currently present such as spandrel walls and cutwaters. Normal joint pointing should be used on the inner faces of the parapets **Figure 9**. Repointing type should be agreed upon with the Employer's Representative in advance of the works.

The following is the methodology for the vegetation removal and repointing of the masonry:

- i) For repointing/ vegetation removal in the spandrel walls and cutwaters over water, a bridge unit is proposed with adequate debris protection measures;
- ii) For other areas with difficult access, temporary scaffolding could be used. Appropriate debris protection measures should be employed such as debris netting, and temporary lining to avoid material entering the stream/ ground.
- iii) Repointing should be carried out as outlined in Standard Details drawings and Notes illustrated in **Figure 9** and **Appendix B**.

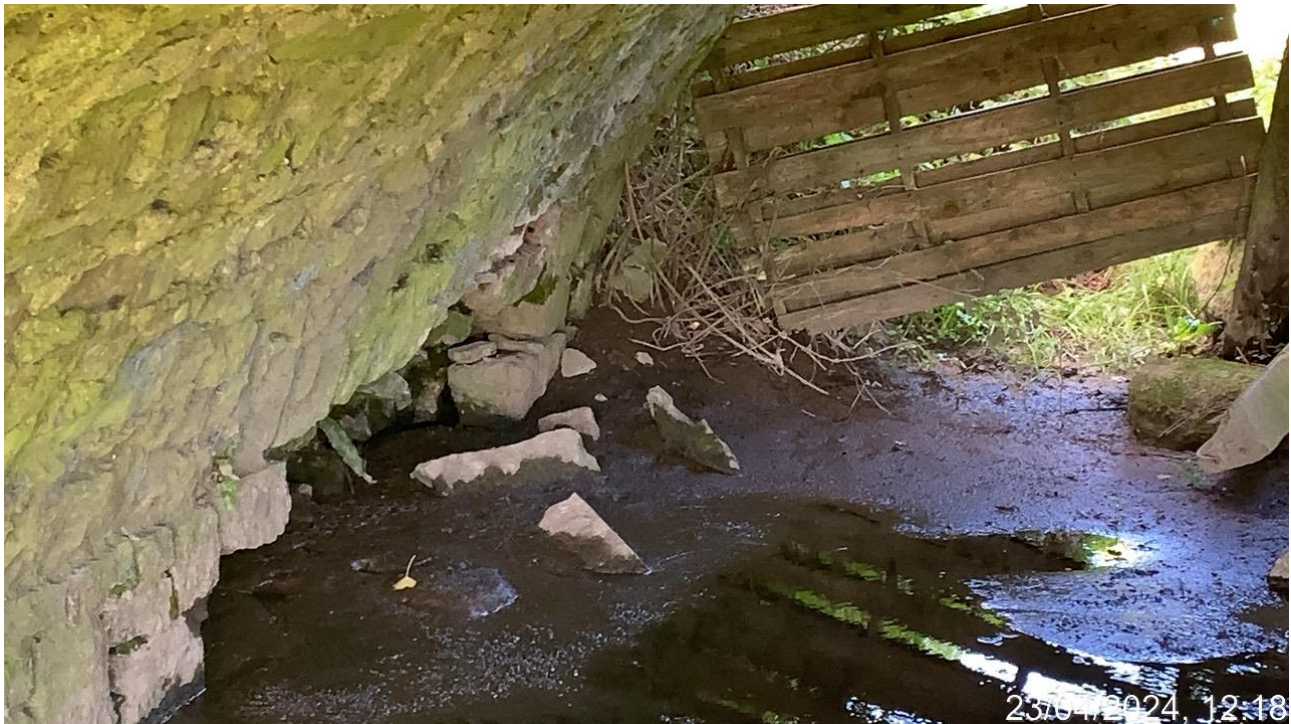
Figure 10 South Abutment Masonry Collapse, Flood Relief Span, looking upstream

During the Engineering Inspection on 23/04/24, additional defects were recorded in the flood relief span on the northern approach to the bridge. Vegetation, missing pointing and soft verges were noted as well as the localised collapse of the south abutment **Figure 10**.

- i) No water or flow was present during the inspection. The flood relief span repairs should be carried out on dry;
- ii) Collapsed stones should be recovered, cleaned and stored safely;
- iii) Appropriate machinery should be used to expose the abutment foundation stone and remove any soft sediments in the span;
- iv) Appropriate debris protection measures should be installed to avoid the contamination of the stream bed;
- v) The abutment should be reconstructed with the original stone and NHL 5 mortar;
- vi) Repointing of the arch barrel will be carried out during the abutment repair stage to avoid
- vii) Remove stream protection measures and reinstate the stream bed level;

- viii) Any obstruction restricting the flow in the relief span should be removed such as pallets, gates etc.

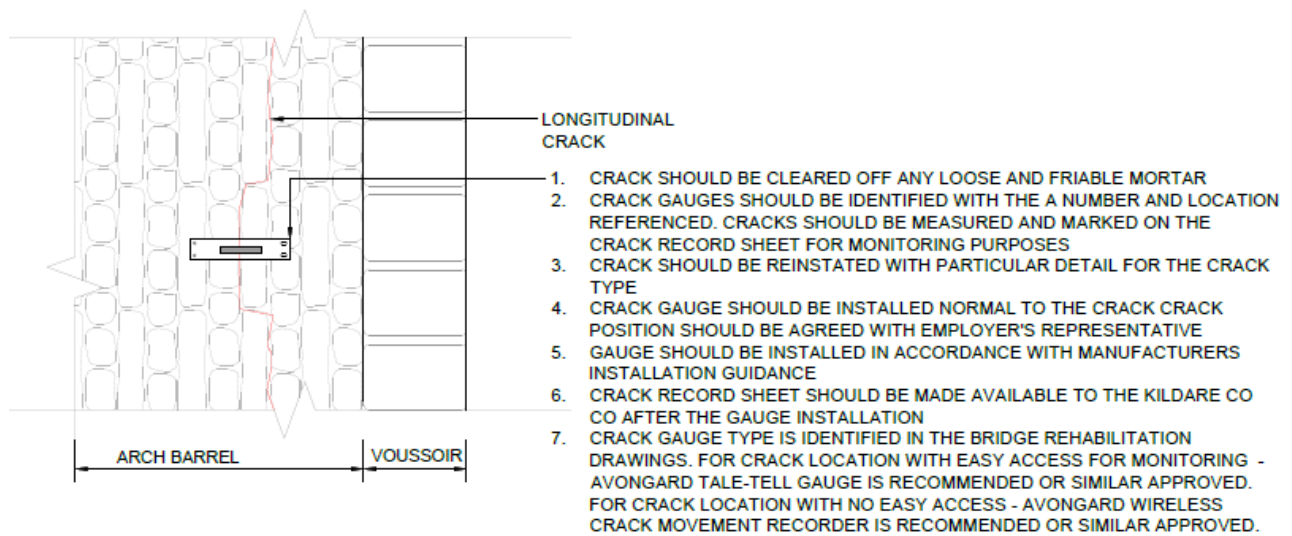
Figure 12 Arch Crack Monitoring Detail

Arch longitudinal cracking was recorded during the inspection of the Bridge arches. Similar cracking was recorded during the previous inspection undertaken in 2015. No immediate intervention is proposed to remediate the cracks and monitoring should be undertaken **Figure 12**.

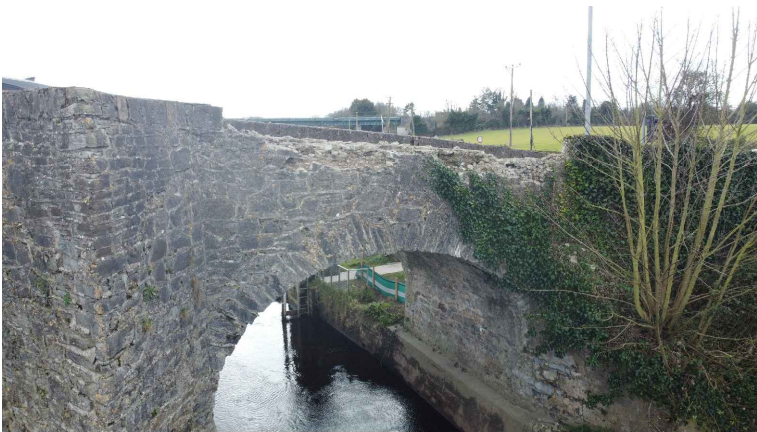
PHOTO 01  
UPSTREAM SPAN 1 MISSING COPING

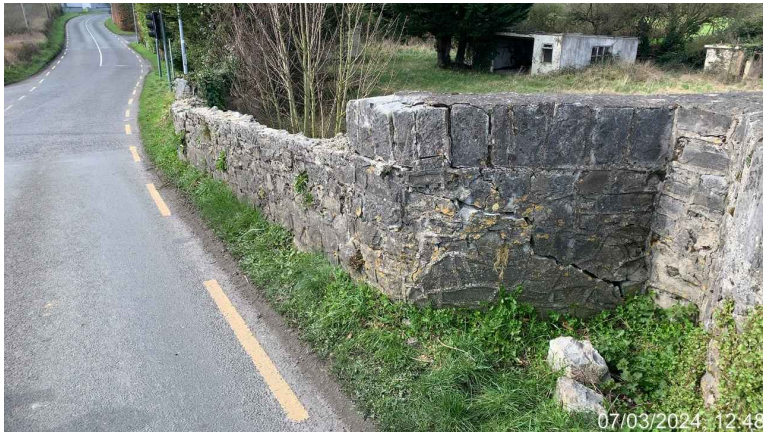
PHOTO 02  
UPSTREAM SPAN 1 DAMAGED PARAPET

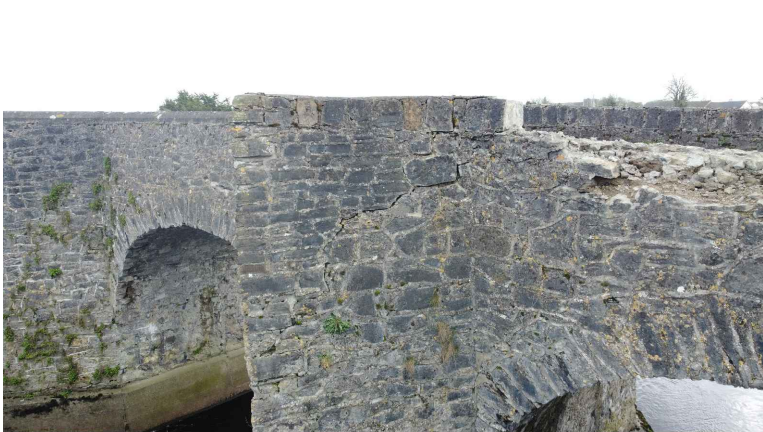
PHOTO 03  
UPSTREAM SPAN 1 DAMAGED CUTWATER/CRACKING

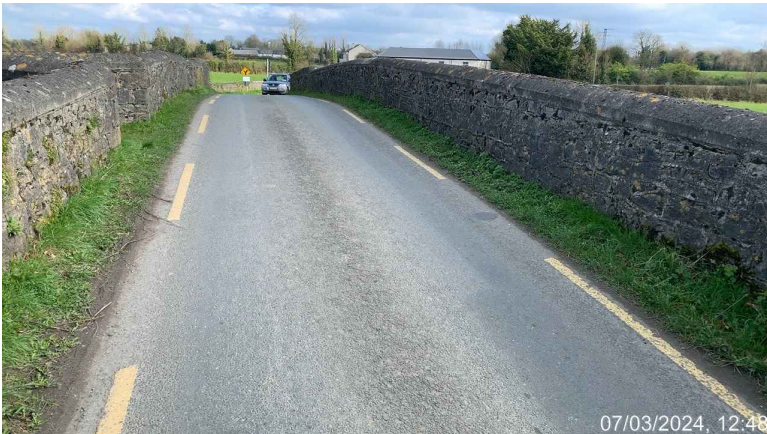
PHOTO 04  
SOFT VERGES

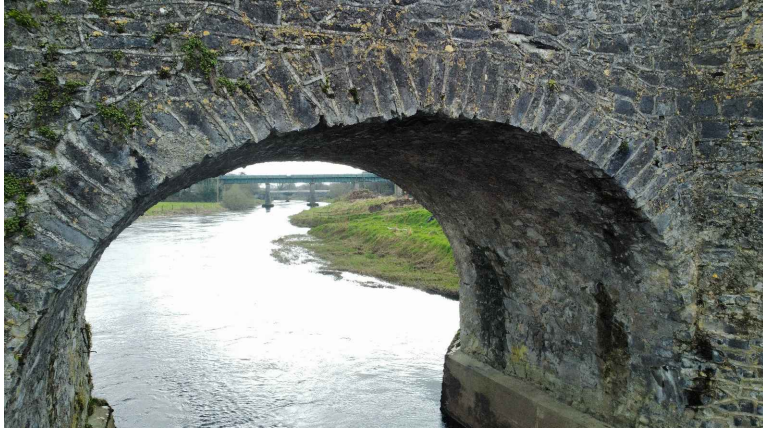
PHOTO 05  
ARCH WATER STAINS

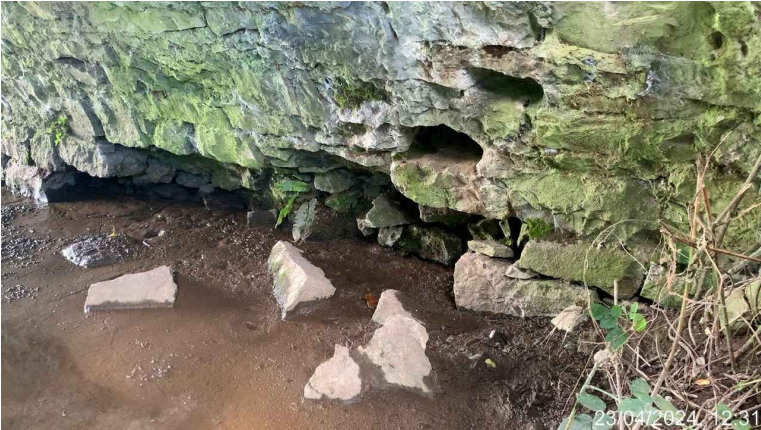
PHOTO 04  
RELIEF ARCH UNDERMINING /  
COLLAPSED ABUTMENT
