Title: **STAGE 1&2 ROAD SAFETY AUDIT**

Proposed Residential Development at Mill Lane, Leixlip.

Client: **Pinnacle Consulting Engineers on behalf of Clúid Housing**

Report reference: **2058R01- Rev 1**

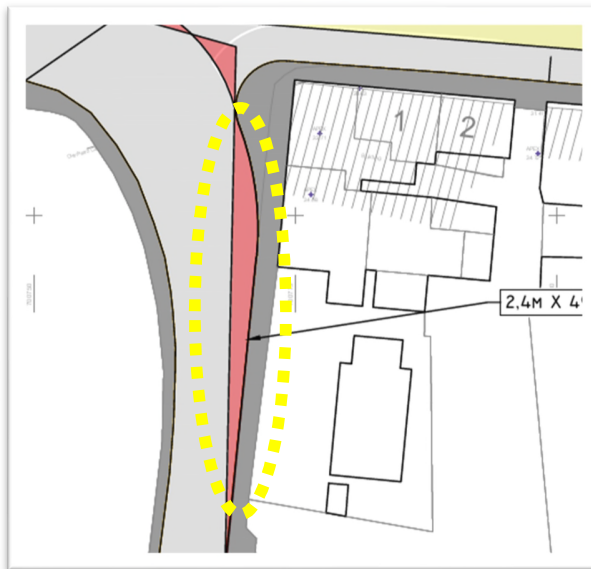
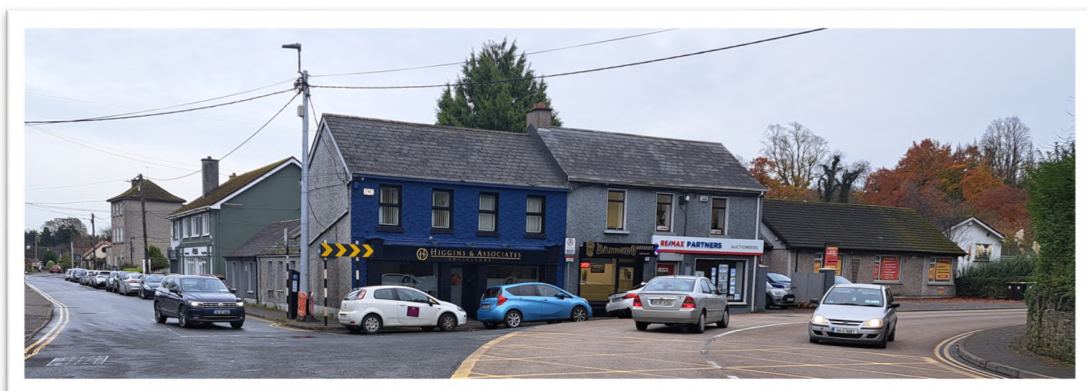
Drawing P230400419-PIN-XX-XX-DR-D-101-SI Rev P04, Mill Lane junction visibility.

The drawing shows the visibility to the left for drivers exiting Mill Lane onto Main Street. There is a risk that parked vehicles will obscure the sightline resulting in side-impact or rear-end collisions.

It is recommended that parking be prohibited or that the visibility splay take into account any proposed parking arrangements.

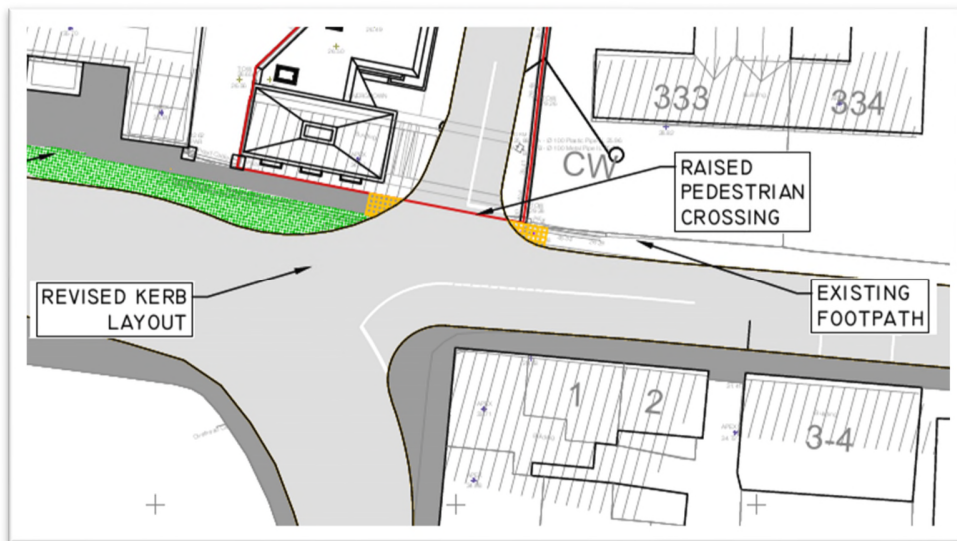
Drawing P230400419-PIN-XX-XX-DR-D-101-SI Rev P04, Mill Lane junction, Pedestrian desire line.

There will be a pedestrian desire line to cross the Mill Lane junction with Main Street. Without adequate crossing facilities there could be trips and falls on the high kerbs or slips on the landscaped area.

It is recommended that a crossing be provided along the desire line.

A crossing has been provided in the July 2025 update – This problem is therefore resolved.

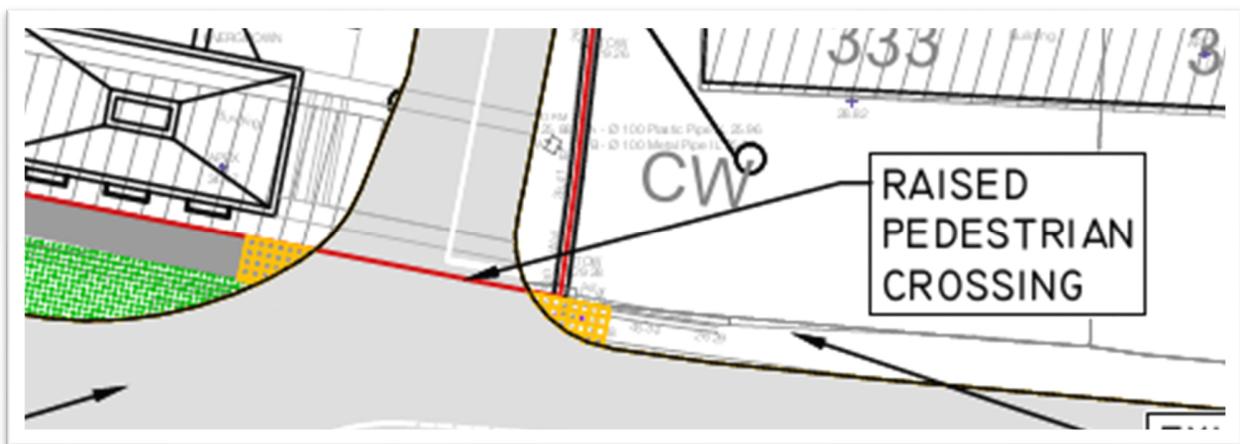
Drawing P230400419-PIN-XX-XX-DR-D-101-SI Rev P04, Mill Lane junction, Access junction.

The drawing indicates a raised pedestrian crossing at the access junction into the development. There is a risk that given the fixed footpath location that to raise the crossing would lead to a steep taper which could result in grounding of vehicles or a narrow crossing point which could lead to inaccessibility for some pedestrians and loss of balance/falls on the steep crossfall of the taper.

It is recommended an at-grade crossing be provided with additional warning for drivers of the need to stop by providing STOP road marking text and a stop sign.

[This issue has been resolved in the 2025 update.](#)

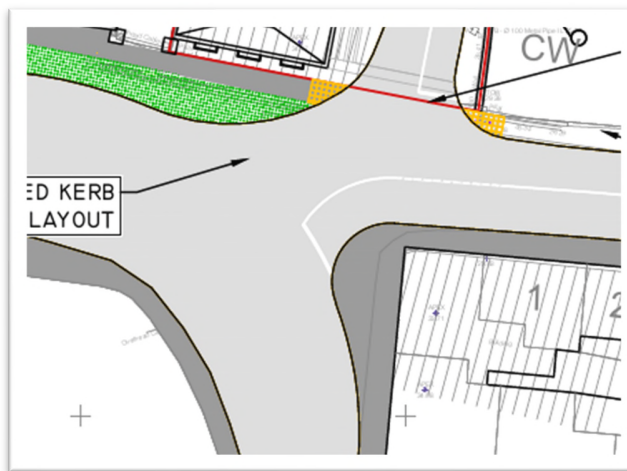
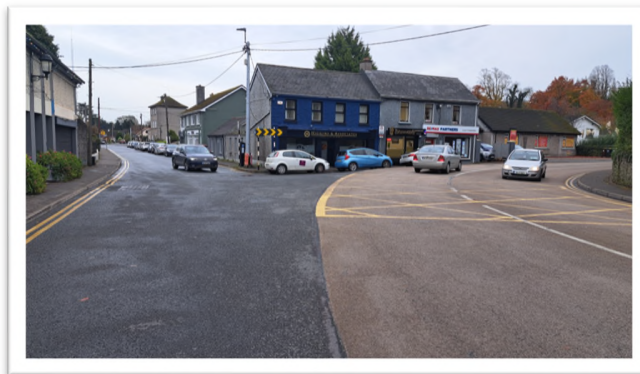
Drawing P230400419-PIN-XX-XX-DR-D-101-SI Rev P04, Main Street, yellow box.

It is unclear if the existing yellow box on Main Street is to be retained. Without this yellow box drivers may not get much opportunity to exit from Mill Lane given how busy Main Street is. This could result in drivers attempting to take small gaps in traffic leading to side-impact or rear-end collisions.

It is recommended that the yellow box (and high friction surfacing) be retained.

The Yellow box is shown to be retained. It is unclear if the high friction surfacing is to be retained.

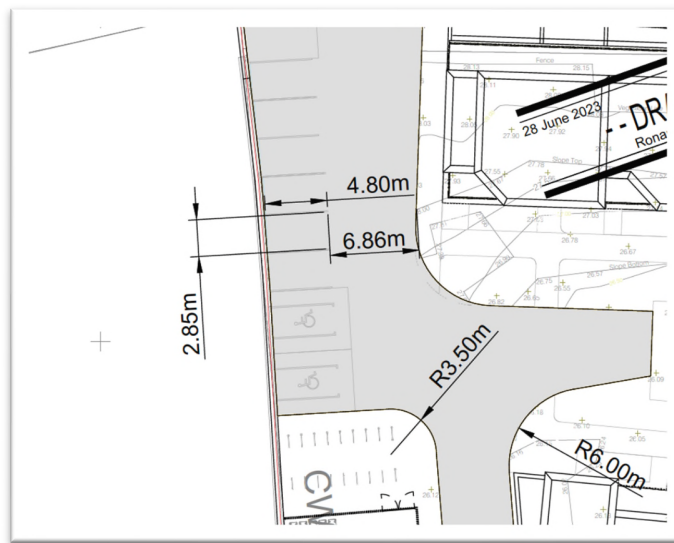
Drawing P230400419-PIN-XX-XX-DR-D-101-SI Rev P14, Internal footpaths.

It is unclear where access points are for pedestrians to the access road and car parking including the disabled spaces. A lack of dropped kerbs could lead to falls at the high kerbs.

It is recommended that dropped kerbs be provided at suitable access points to the access road and parking.
