Asbestos Demolition Survey (including Sampling and Analysis) for *Plus Architecture* at Main St, Leixlip, Co. Kildare, W23R7P1.

Project N° and Revision N°	Report Status	Surveyor	Report Author	Approved by	Issue Date
A-02978 (Revision 1)	Issued	Daragh Gogarty	Jordan Costello

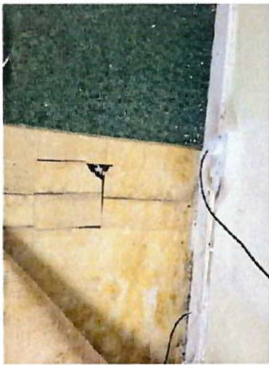
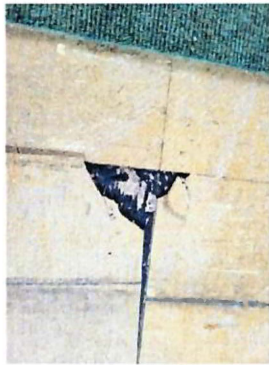
FLOOR:	Ground Floor			SURVEY DATES:	19/05/2023		
ROOM NAME / NO.:	0-003			SAMPLE REF NO.:	S1

PRODUCT TYPE:	Vinyl Floor Tile and Bitumen			ACCESSIBILITY:	Easy		
FOUND IN:	Floor						
LOCATION:	Office 1			EXTENT / QUANTITY:	15 approx m ²		
ASBESTOS TYPE	NON ASBESTOS	0		EXTENT OF DAMAGE / DETERIORATION	GOOD CONDITION	0	
	CHRYSTOLITE	1	✓		LOW DAMAGE	1	
	AMOSITE	2			MEDIUM DAMAGE	2	✓
	CROCIDOLITE	3			HIGH DAMAGE	3	
	OTHER (ACTINOLITE/TREMOLITE/ANTHOPHYLLITE)	2			LOOSE ASBESTOS	3	
SURFACE TREATMENT	COMPOSITE MATERIAL	0	✓	FIBRE RELEASE POTENTIAL	HIGH RISK	10-12	
	ENCLOSED SPRAY / LAGGING, PAINTED / ENCAPSULATED AIB, ASBESTOS CEMENT SHEETS	1			MEDIUM RISK	7-9	
	UNSEALED AIB OR ENCAPSULATED LAGGING AND SPRAYS	2			LOW RISK	5-6	
	UNSEALED LAGGING / SPRAY COATING	3			VERY LOW RISK	1-4	✓
PRODUCT TYPE	ASBESTOS REINFORCED COMPOSITES	1	✓	RECOMMENDED ACTION	REMOVE		✓
	ASBESTOS INSULATING BOARD, TEXTILES, GASKETS, ROPE, PAPER, FELT	2			REPAIR / SEAL ENCAPSULATE

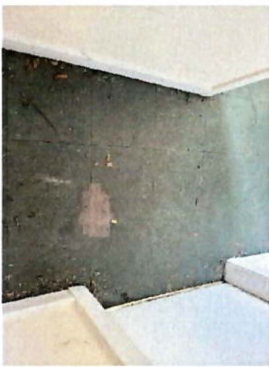
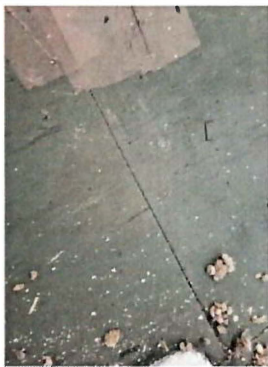
FLOOR:	Ground Floor			SURVEY DATES:	19/05/2023			
ROOM NAME / NO.:	0-004			SAMPLE REF NO.:	S2

PRODUCT TYPE:	Vinyl Floor Tile and Bitumen						ACCESSIBILITY:	Easy
FOUND IN:	Floor							
LOCATION:	Corridor			EXTENT / QUANTITY:	10 approx m ²			
ASBESTOS TYPE	NON ASBESTOS	0		EXTENT OF DAMAGE / DETERIORATION	GOOD CONDITION	0		
	CHRYSTOTILE	1	✓		LOW DAMAGE	1		
	AMOSITE	2			MEDIUM DAMAGE	2	✓	
	CROCIDOLITE	3			HIGH DAMAGE	3		
	OTHER (ACTINOLITE/TREMOLITE/ANTHOPHYLLITE)	2			LOOSE ASBESTOS	3		
SURFACE TREATMENT	COMPOSITE MATERIAL	0	✓	FIBRE RELEASE POTENTIAL	HIGH RISK	10-12		
	ENCLOSED SPRAY / LAGGING, PAINTED / ENCAPSULATED AIB, ASBESTOS CEMENT SHEETS	1			MEDIUM RISK	7-9		
	UNSEALED AIB OR ENCAPSULATED LAGGING AND SPRAYS	2			LOW RISK	5-6		
	UNSEALED LAGGING / SPRAY COATING	3			VERY LOW RISK	1-4	✓	
PRODUCT TYPE	ASBESTOS REINFORCED COMPOSITES	1	✓	RECOMMENDED ACTION	REMOVE		✓	
	ASBESTOS INSULATING BOARD, TEXTILES, GASKETS, ROPE, PAPER, FELT	2			REPAIR / SEAL ENCAPSULATE

THERMAL INSULATION, SPRAYED ASBESTOS, LOOSE ASBESTOS	3			LABEL AND MANAGE			
OTHER RELEVANT INFORMATION:								
Vft & bitumen adhesive.								
All work with asbestos materials must be carried out in accordance with SI No 386 of the Safety, Health & Welfare at Work (Exposure to Asbestos) Regulations 2006 & amended version 2010 & Guidelines issued by the Health & Safety Authority in Ireland. 14 days notification may be required to the HSA. Ensure valid asbestos insurance & evidence of current training & competency is obtained from your selected approved asbestos removal contractor prior to works commencing.

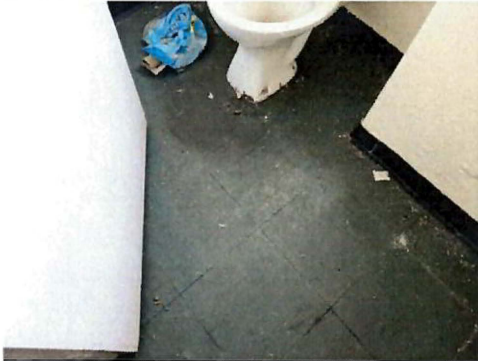
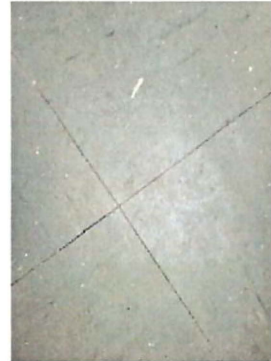
FLOOR:	Ground Floor	SURVEY DATES:	19/05/2023				
ROOM NAME / NO.:	0-005	SAMPLE REF NO.:	Same As 2

PRODUCT TYPE:	Vinyl Floor Tile and Bitumen		ACCESSIBILITY:	Easy			
FOUND IN:	Floor						
LOCATION:	Toilet		EXTENT / QUANTITY:	5 approx m ²			
ASBESTOS TYPE	NON ASBESTOS	0	EXTENT OF DAMAGE / DETERIORATION	GOOD CONDITION	0		
	CHRYSTOTILE	1		✓	LOW DAMAGE	1	
	AMOSITE	2			MEDIUM DAMAGE	2	✓
	CROCIDOLITE	3			HIGH DAMAGE	3	
	OTHER (ACTINOLITE/TREMOLITE/ANTHOPHYLLITE)	2			LOOSE ASBESTOS	3	
SURFACE TREATMENT	COMPOSITE MATERIAL	0	✓	FIBRE RELEASE POTENTIAL	HIGH RISK	10-12	
	ENCLOSED SPRAY / LAGGING, PAINTED / ENCAPSULATED AIB, ASBESTOS CEMENT SHEETS	1			MEDIUM RISK	7-9	
	UNSEALED AIB OR ENCAPSULATED LAGGING AND SPRAYS	2			LOW RISK	5-6	
	UNSEALED LAGGING / SPRAY COATING	3			VERY LOW RISK	1-4	✓
PRODUCT TYPE	ASBESTOS REINFORCED COMPOSITES	1	✓	RECOMMENDED ACTION	REMOVE		✓
	ASBESTOS INSULATING BOARD, TEXTILES, GASKETS, ROPE, PAPER, FELT	2			REPAIR / SEAL ENCAPSULATE

THERMAL INSULATION, SPRAYED ASBESTOS, LOOSE ASBESTOS	3			LABEL AND MANAGE		
OTHER RELEVANT INFORMATION:							
Vft & bitumen adhesive.							
All work with asbestos materials must be carried out in accordance with SI No 386 of the Safety, Health & Welfare at Work (Exposure to Asbestos) Regulations 2006 & amended version 2010 & Guidelines issued by the Health & Safety Authority in Ireland. 14 days notification may be required to the HSA. Ensure valid asbestos insurance & evidence of current training & competency is obtained from your selected approved asbestos removal contractor prior to works commencing.

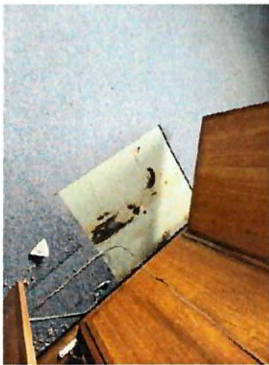
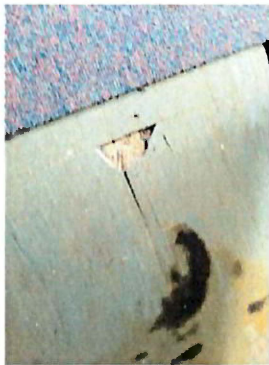
FLOOR:	Ground Floor			SURVEY DATES:	19/05/2023		
ROOM NAME / NO.:	0-006			SAMPLE REF NO.:	S3

PRODUCT TYPE:	Vinyl Floor Tile and Bitumen					ACCESSIBILITY:	Easy
FOUND IN:	Floor						
LOCATION:	Office/Reception			EXTENT / QUANTITY:	15 approx m ²		
ASBESTOS TYPE	NON ASBESTOS	0		EXTENT OF DAMAGE / DETERIORATION	GOOD CONDITION	0	
	CHRYSTOTILE	1	✓		LOW DAMAGE	1	
	AMOSITE	2			MEDIUM DAMAGE	2	✓
	CROCIDOLITE	3			HIGH DAMAGE	3	
	OTHER (ACTINOLITE/TREMOLITE/ANTHOPHYLLITE)	2			LOOSE ASBESTOS	3	
SURFACE TREATMENT	COMPOSITE MATERIAL	0	✓	FIBRE RELEASE POTENTIAL	HIGH RISK	10-12	
	ENCLOSED SPRAY / LAGGING, PAINTED / ENCAPSULATED AIB, ASBESTOS CEMENT SHEETS	1			MEDIUM RISK	7-9	
	UNSEALED AIB OR ENCAPSULATED LAGGING AND SPRAYS	2			LOW RISK	5-6	
	UNSEALED LAGGING / SPRAY COATING	3			VERY LOW RISK	1-4	✓
PRODUCT TYPE	ASBESTOS REINFORCED COMPOSITES	1	✓	RECOMMENDED ACTION	REMOVE		✓
	ASBESTOS INSULATING BOARD, TEXTILES, GASKETS, ROPE, PAPER, FELT	2			REPAIR / SEAL ENCAPSULATE

THERMAL INSULATION, SPRAYED ASBESTOS, LOOSE ASBESTOS	3			LABEL AND MANAGE		
OTHER RELEVANT INFORMATION:							
Vft & bitumen adhesive.							
All work with asbestos materials must be carried out in accordance with SI No 386 of the Safety, Health & Welfare at Work (Exposure to Asbestos) Regulations 2006 & amended version 2010 & Guidelines issued by the Health & Safety Authority in Ireland. 14 days notification may be required to the HSA. Ensure valid asbestos insurance & evidence of current training & competency is obtained from your selected approved asbestos removal contractor prior to works commencing.

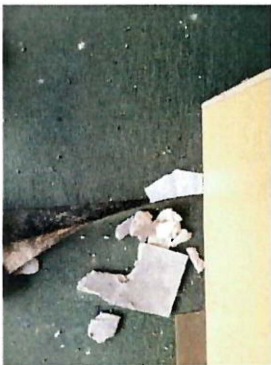
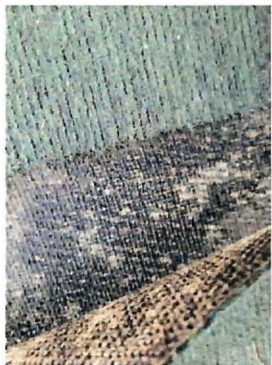
FLOOR:	Ground Floor			SURVEY DATES:	19/05/2023		
ROOM NAME / NO.:	0-007			SAMPLE REF NO.:	S4

PRODUCT TYPE:	Board			ACCESSIBILITY:	Difficult		
FOUND IN:	Safe						
LOCATION:	Public Reception			EXTENT / QUANTITY:	30 approx m²		
ASBESTOS TYPE	NON ASBESTOS	0		EXTENT OF DAMAGE / DETERIORATION	GOOD CONDITION	0	
	CHRYSTOLITE	1	✓		LOW DAMAGE	1	
	AMOSITE	2			MEDIUM DAMAGE	2	✓
	CROCIDOLITE	3			HIGH DAMAGE	3	
	OTHER (ACTINOLITE/TREMOLITE/ANTHOPHYLLITE)	2			LOOSE ASBESTOS	3	
SURFACE TREATMENT	COMPOSITE MATERIAL	0	✓	FIBRE RELEASE POTENTIAL	HIGH RISK	10-12	
	ENCLOSED SPRAY / LAGGING, PAINTED / ENCAPSULATED AIB, ASBESTOS CEMENT SHEETS	1			MEDIUM RISK	7-9	
	UNSEALED AIB OR ENCAPSULATED LAGGING AND SPRAYS	2			LOW RISK	5-6	
	UNSEALED LAGGING / SPRAY COATING	3			VERY LOW RISK	1-4	✓
PRODUCT TYPE	ASBESTOS REINFORCED COMPOSITES	1	✓	RECOMMENDED ACTION	REMOVE		✓
	ASBESTOS INSULATING BOARD, TEXTILES, GASKETS, ROPE, PAPER, FELT	2			REPAIR / SEAL ENCAPSULATE

THERMAL INSULATION, SPRAYED ASBESTOS, LOOSE ASBESTOS	3			LABEL AND MANAGE		
OTHER RELEVANT INFORMATION:							
Bitumen adhesive below carpet.							
All work with asbestos materials must be carried out in accordance with SI No 386 of the Safety, Health & Welfare at Work (Exposure to Asbestos) Regulations 2006 & amended version 2010 & Guidelines issued by the Health & Safety Authority in Ireland. 14 days notification may be required to the HSA. Ensure valid asbestos insurance & evidence of current training & competency is obtained from your selected approved asbestos removal contractor prior to works commencing.

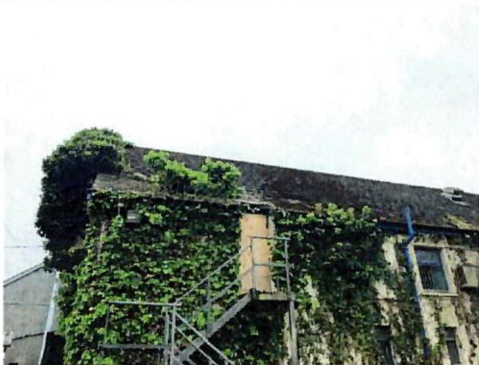
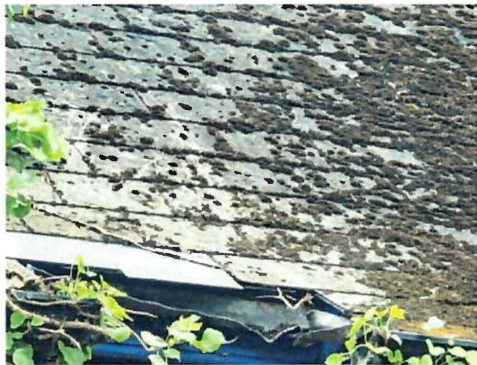
FLOOR:	External			SURVEY DATES:	19/05/2023		
ROOM NAME / NO.:	99-001			SAMPLE REF NO.:	S5

PRODUCT TYPE:	Cement Slate			ACCESSIBILITY:	Medium		
FOUND IN:	Roof						
LOCATION:	Main roof			EXTENT / QUANTITY:	1000 approx m ²		
ASBESTOS TYPE	NON ASBESTOS	0		EXTENT OF DAMAGE / DETERIORATION	GOOD CONDITION	0	
	CHRYSTOTILE	1	✓		LOW DAMAGE	1	
	AMOSITE	2	✓		MEDIUM DAMAGE	2	✓
	CROCIDOLITE	3			HIGH DAMAGE	3	
	OTHER (ACTINOLITE/TREMOLITE/ANTHOPHYLLITE)	2			LOOSE ASBESTOS	3	
SURFACE TREATMENT	COMPOSITE MATERIAL	0	✓	FIBRE RELEASE POTENTIAL	HIGH RISK	10-12	
	ENCLOSED SPRAY / LAGGING, PAINTED / ENCAPSULATED AIB, ASBESTOS CEMENT SHEETS	1			MEDIUM RISK	7-9	
	UNSEALED AIB OR ENCAPSULATED LAGGING AND SPRAYS	2			LOW RISK	5-6	✓
	UNSEALED LAGGING / SPRAY COATING	3			VERY LOW RISK	1-4	
PRODUCT TYPE	ASBESTOS REINFORCED COMPOSITES	1	✓	RECOMMENDED ACTION	REMOVE		✓
	ASBESTOS INSULATING BOARD, TEXTILES, GASKETS, ROPE, PAPER, FELT	2			REPAIR / SEAL ENCAPSULATE

THERMAL INSULATION, SPRAYED ASBESTOS, LOOSE ASBESTOS	3			LABEL AND MANAGE		
OTHER RELEVANT INFORMATION:							
Cement Slate to main roof							
All work with asbestos materials must be carried out in accordance with SI No 386 of the Safety, Health & Welfare at Work (Exposure to Asbestos) Regulations 2006 & amended version 2010 & Guidelines issued by the Health & Safety Authority in Ireland. 14 days notification may be required to the HSA. Ensure valid asbestos insurance & evidence of current training & competency is obtained from your selected approved asbestos removal contractor prior to works commencing.

Main St,								
Area Surveyed	Sample Number	Location and Use of Material	Asbestos Type	Condition	Accessibility	Extent	Material Risk Assessment Score	Recommended Action
Ground Floor	S1	Office 1 0-003 – Floor (Vinyl Floor Tile and Bitumen)	Chrysotile	Medium Damage	Easy	15 approx m ²	4	Remove
Ground Floor	S2	Corridor 0-004 – Floor (Vinyl Floor Tile and Bitumen)	Chrysotile	Medium Damage	Easy	10 approx m ²	4	Remove
Ground Floor	Same As S2	Toilet 0-005 – Floor (Vinyl Floor Tile and Bitumen)	Chrysotile	Medium Damage	Easy	5 approx m ²	4	Remove
Ground Floor	Presumed	Office/Reception 0-006 – Safe (Board)	Amosite	Low Damage	Difficult	3 no	6	Remove
Ground Floor	S3	Office/Reception 0-006 – Floor (Vinyl Floor Tile and Bitumen)	Chrysotile	Medium Damage	Easy	15 approx m ²	4	Remove
Ground Floor	S4	Public Reception 0-007 – Safe (Board)	Chrysotile	Medium Damage	Difficult	30 approx m ²	4	Remove
External	S5	Main roof 99-001 – Roof (Cement Slate)	Amosite, Chrysotile	Medium Damage	Medium	1000 approx m ²	5	Remove

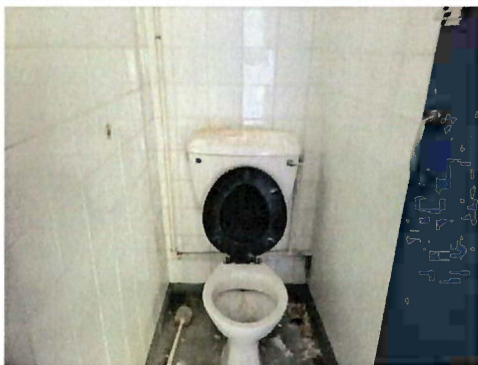
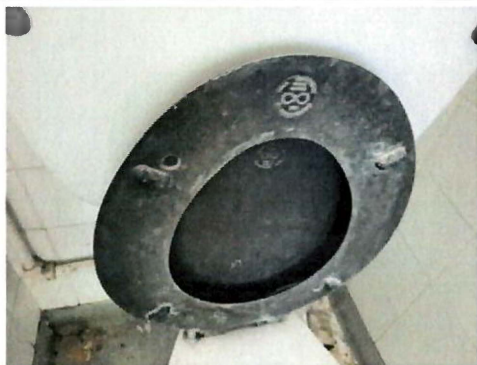
FLOOR:	External	SURVEY DATES:	19/05/2023			
ROOM NAME / NO.:	99-003	SAMPLE REF NO.:	Strongly Presumed

PRODUCT TYPE:	Bakelite		ACCESSIBILITY:	Easy		
FOUND IN:	Toilet Seat					
LOCATION:	Rear Toilet Block		EXTENT / QUANTITY:	2 no		
ASBESTOS TYPE	NON ASBESTOS	0	EXTENT OF DAMAGE / DETERIORATION	GOOD CONDITION	0	
	CHRYSLITILE	1		LOW DAMAGE	1	
	AMOSITE	2		MEDIUM DAMAGE	2	✓
	CROCIDOLITE	3		HIGH DAMAGE	3	
	OTHER (ACTINOLITE/TREMOLITE/ANTHOPHYLLITE)	2		LOOSE ASBESTOS	3	
SURFACE TREATMENT	COMPOSITE MATERIAL	0	FIBRE RELEASE POTENTIAL	HIGH RISK	10-12	
	ENCLOSED SPRAY / LAGGING, PAINTED / ENCAPSULATED AIB, ASBESTOS CEMENT SHEETS	1		MEDIUM RISK	7-9	
	UNSEALED AIB OR ENCAPSULATED LAGGING AND SPRAYS	2		LOW RISK	5-6	✓
	UNSEALED LAGGING / SPRAY COATING	3		VERY LOW RISK	1-4	
PRODUCT TYPE	ASBESTOS REINFORCED COMPOSITES	1	RECOMMENDED ACTION	REMOVE		✓
	ASBESTOS INSULATING BOARD, TEXTILES, GASKETS, ROPE, PAPER, FELT	2		REPAIR / SEAL ENCAPSULATE

THERMAL INSULATION, SPRAYED ASBESTOS, LOOSE ASBESTOS	3		LABEL AND MANAGE		
OTHER RELEVANT INFORMATION:						
Toiler seat x 2						
All work with asbestos materials must be carried out in accordance with SI No 386 of the Safety, Health & Welfare at Work (Exposure to Asbestos) Regulations 2006 & amended version 2010 & Guidelines issued by the Health & Safety Authority in Ireland. 14 days notification may be required to the HSA. Ensure valid asbestos insurance & evidence of current training & competency is obtained from your selected approved asbestos removal contractor prior to works commencing.

Area Surveyed	Sample Number	Location and Use of Material	Asbestos Type	Condition	Accessibility	Extent	Material Risk Assessment Score	Recommended Action
External	Strongly Presumed	Rear Toilet Block 99-003 – Toilet Seat (Bakelite)	Amosite	Medium Damage	Easy	2 no	5	Remove

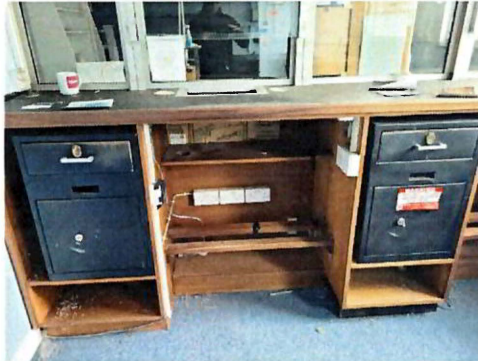
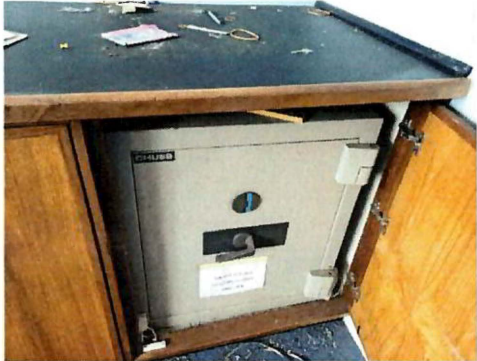
FLOOR:	Ground Floor			SURVEY DATES:	19/05/2023		
ROOM NAME / NO.:	0-006			SAMPLE REF NO.:	Presumed

PRODUCT TYPE:	Board			ACCESSIBILITY:	Difficult		
FOUND IN:	Safe						
LOCATION:	Office/Reception			EXTENT / QUANTITY:	3 no		
ASBESTOS TYPE	NON ASBESTOS	0		EXTENT OF DAMAGE / DETERIORATION	GOOD CONDITION	0	
	CHRYSTOLITE	1			LOW DAMAGE	1	✓
	AMOSITE	2	✓		MEDIUM DAMAGE	2	
	CROCIDOLITE	3			HIGH DAMAGE	3	
	OTHER (ACTINOLITE/TREMOLITE/ANTHOPHYLLITE)	2			LOOSE ASBESTOS	3	
SURFACE TREATMENT	COMPOSITE MATERIAL	0		FIBRE RELEASE POTENTIAL	HIGH RISK	10-12	
	ENCLOSED SPRAY / LAGGING, PAINTED / ENCAPSULATED AIB, ASBESTOS CEMENT SHEETS	1	✓		MEDIUM RISK	7-9	
	UNSEALED AIB OR ENCAPSULATED LAGGING AND SPRAYS	2			LOW RISK	5-6	✓
	UNSEALED LAGGING / SPRAY COATING	3			VERY LOW RISK	1-4	
PRODUCT TYPE	ASBESTOS REINFORCED COMPOSITES	1		RECOMMENDED ACTION	REMOVE		✓
	ASBESTOS INSULATING BOARD, TEXTILES, GASKETS, ROPE, PAPER, FELT	2	✓		REPAIR / SEAL ENCAPSULATE

THERMAL INSULATION, SPRAYED ASBESTOS, LOOSE ASBESTOS	3			LABEL AND MANAGE		
OTHER RELEVANT INFORMATION:							
Presumed board to internal safe. No access							
All work with asbestos materials must be carried out in accordance with SI No 386 of the Safety, Health & Welfare at Work (Exposure to Asbestos) Regulations 2006 & amended version 2010 & Guidelines issued by the Health & Safety Authority in Ireland. 14 days notification may be required to the HSA. Ensure valid asbestos insurance & evidence of current training & competency is obtained from your selected approved asbestos removal contractor prior to works commencing.

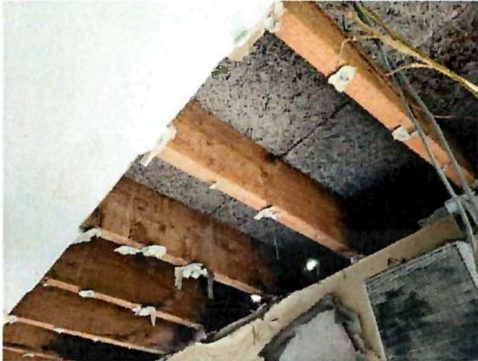
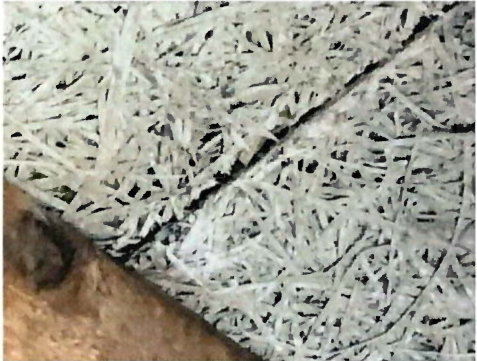
FLOOR:	External			SURVEY DATES:	19/05/2023		
ROOM NAME / NO.:	99-003			SAMPLE REF NO.:	Presumed

PRODUCT TYPE:	Bituminous Product			ACCESSIBILITY:	Easy		
FOUND IN:	Roof						
LOCATION:	Rear Toilet Block			EXTENT / QUANTITY:	30 approx no		
ASBESTOS TYPE	NON ASBESTOS	0		EXTENT OF DAMAGE / DETERIORATION	GOOD CONDITION	0	
	CHRYSTOTILE	1	✓		LOW DAMAGE	1	
	AMOSITE	2			MEDIUM DAMAGE	2	✓
	CROCIDOLITE	3			HIGH DAMAGE	3	
	OTHER (ACTINOLITE/TREMOLITE/ANTHOPHYLLITE)	2			LOOSE ASBESTOS	3	
SURFACE TREATMENT	COMPOSITE MATERIAL	0	✓	FIBRE RELEASE POTENTIAL	HIGH RISK	10-12	
	ENCLOSED SPRAY / LAGGING, PAINTED / ENCAPSULATED AIB, ASBESTOS CEMENT SHEETS	1			MEDIUM RISK	7-9	
	UNSEALED AIB OR ENCAPSULATED LAGGING AND SPRAYS	2			LOW RISK	5-6	
	UNSEALED LAGGING / SPRAY COATING	3			VERY LOW RISK	1-4	✓
PRODUCT TYPE	ASBESTOS REINFORCED COMPOSITES	1	✓	RECOMMENDED ACTION	REMOVE		✓
	ASBESTOS INSULATING BOARD, TEXTILES, GASKETS, ROPE, PAPER, FELT	2			REPAIR / SEAL ENCAPSULATE

THERMAL INSULATION, SPRAYED ASBESTOS, LOOSE ASBESTOS	3			LABEL AND MANAGE		
OTHER RELEVANT INFORMATION:							
Strawboard to roof below felt.							
All work with asbestos materials must be carried out in accordance with SI No 386 of the Safety, Health & Welfare at Work (Exposure to Asbestos) Regulations 2006 & amended version 2010 & Guidelines issued by the Health & Safety Authority in Ireland. 14 days notification may be required to the HSA. Ensure valid asbestos insurance & evidence of current training & competency is obtained from your selected approved asbestos removal contractor prior to works commencing.

External	Presumed	Rear Toilet Block 99-003 – Roof (Bituminous Product)	Chrysotile	Medium Damage	Easy	30 approx no	4	Remove

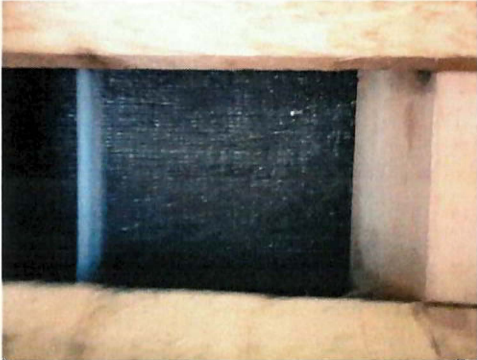
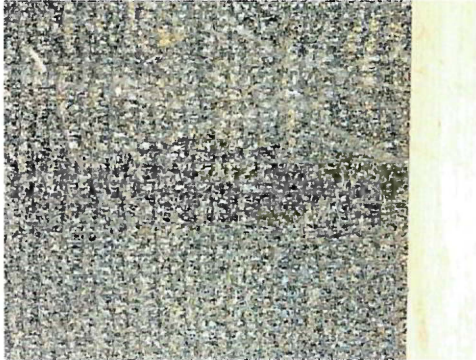
FLOOR:	Void	SURVEY DATES:	23/05/2023
ROOM NAME / NO.:	V-001	SAMPLE REF NO.:	S8

PRODUCT TYPE:	Felt (bituminous product)	ACCESSIBILITY:	Medium
FOUND IN:	Roof		
LOCATION:	Attic Void	EXTENT / QUANTITY:	1000 approx m ²
Comments: NO ASBESTOS DETECTED IN ORIGINAL SAMPLE

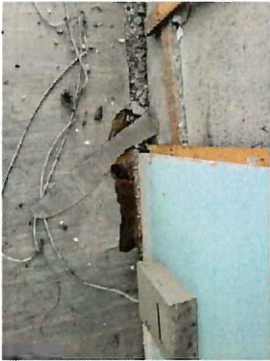
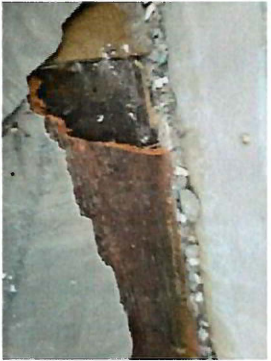
FLOOR:	1st Floor	SURVEY DATES:	23/05/2023
ROOM NAME / NO.:	1-001	SAMPLE REF NO.:	S7

PRODUCT TYPE:	Vinyl Floor Covering	ACCESSIBILITY:	Medium
FOUND IN:	Floor		
LOCATION:	Open Room	EXTENT / QUANTITY:	50 approx m ²
Comments: NO ASBESTOS DETECTED IN ORIGINAL SAMPLE

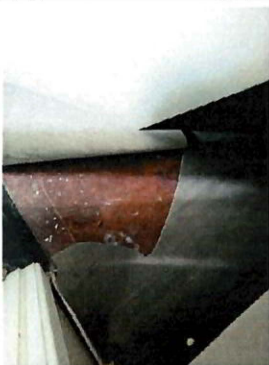
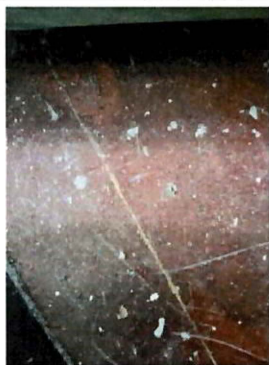
FLOOR:	1st Floor	SURVEY DATES:	23/05/2023
ROOM NAME / NO.:	1-003	SAMPLE REF NO.:	Same As 7

PRODUCT TYPE:	Vinyl Floor Covering	ACCESSIBILITY:	Medium
FOUND IN:	Floor		
LOCATION:	Room	EXTENT / QUANTITY:	12 approx m ²
Comments: NO ASBESTOS DETECTED IN ORIGINAL SAMPLE			
FLOOR:	External	SURVEY DATES:	19/05/2023
ROOM NAME / NO.:	99-003	SAMPLE REF NO.:	S6

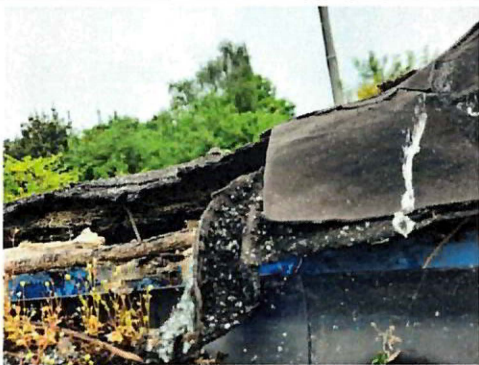
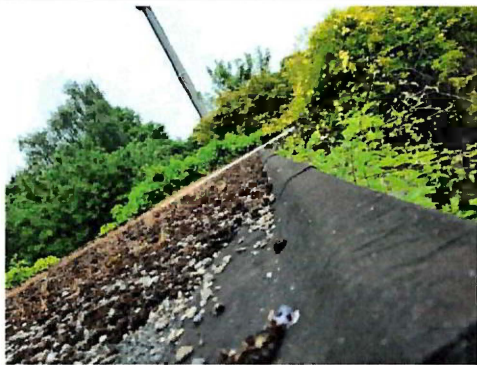
PRODUCT TYPE:	Flat, bitumen felt lined	ACCESSIBILITY:	Medium
FOUND IN:	Roof		
LOCATION:	Rear Toilet Block	EXTENT / QUANTITY:	30 approx m ²
Comments: NO ASBESTOS DETECTED IN ORIGINAL SAMPLE
