## **Former ESB building, Main Street, Leixlip**

### **Architectural heritage assessment**

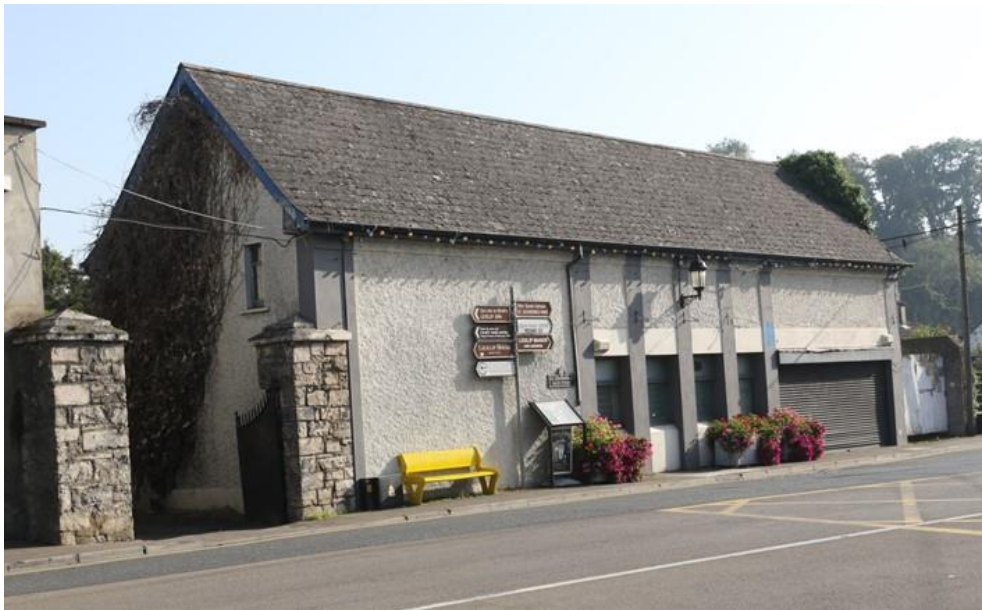
*Plate 1: Former ESB showroom and offices*

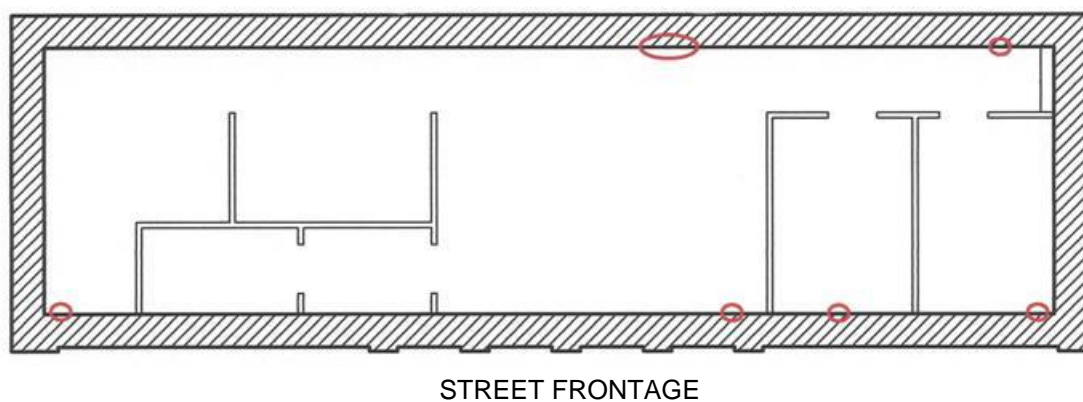
*Figure 2: Sketch plan at first floor showing locations of opening up*

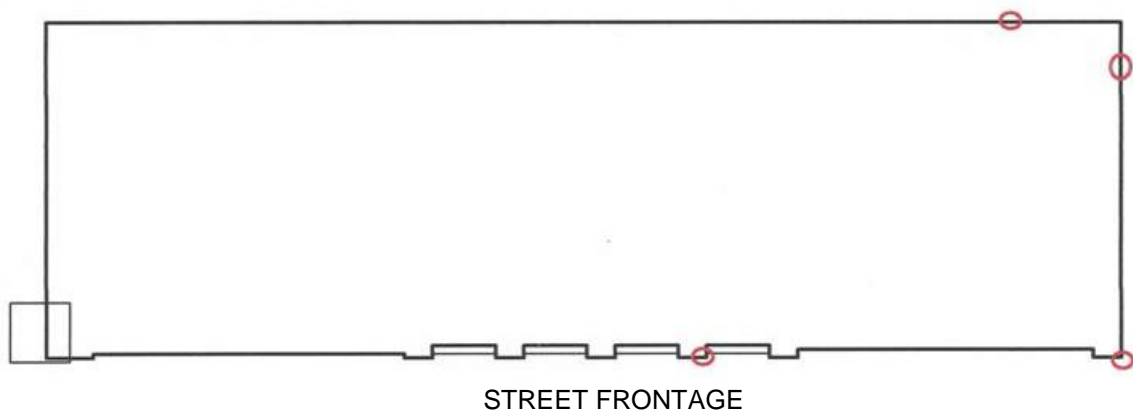
*Figure 3: Sketch plan of external face at ground level showing opening up*

Surprisingly, the one area at the rear of the building that was investigated proved to have concrete blockwork beneath the roughcast render. It is concluded that there is a blocked doorway at this location and the blockwork is merely the infill of the ope.

A small area on the eastern gable end was opened up and revealed limestone rubble beneath.

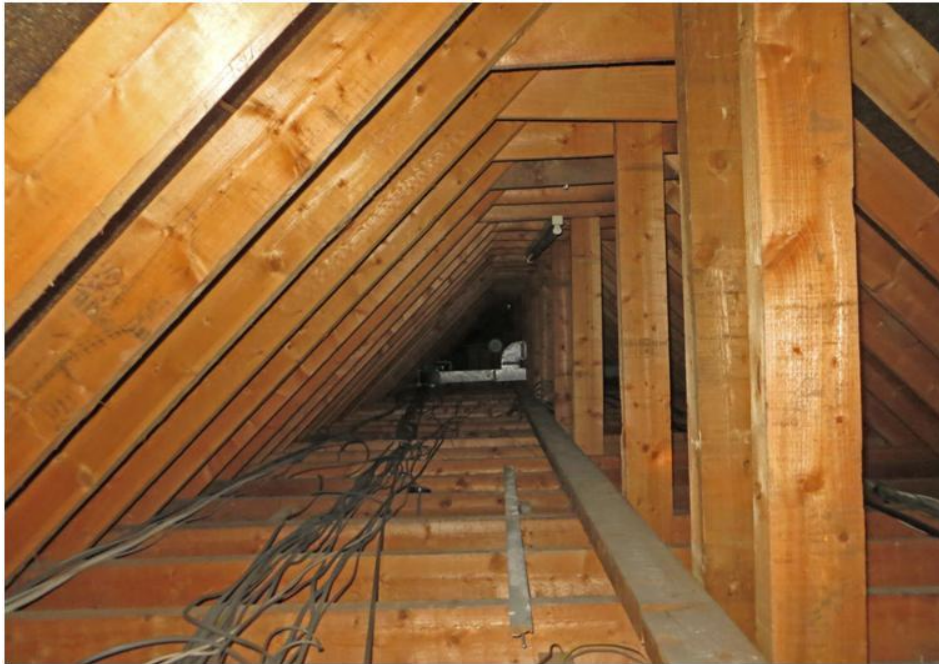
*Plate 3: Timber structure of roof*

The roof has a comparatively steep pitch and is constructed with coupled rafters and collars, which are set high. Hangers are suspended from the collars to support the ceiling joists at mid-point. The ceiling joists are set well above the eaves and would function as a second line of collars to cross-brace the rafters. All of these timbers are of mid-twentieth century date, suggesting that the roof was entirely rebuilt during the conversion to ESB showroom in the mid-1960s. The ceiling attached to the joists is entirely of plasterboard.

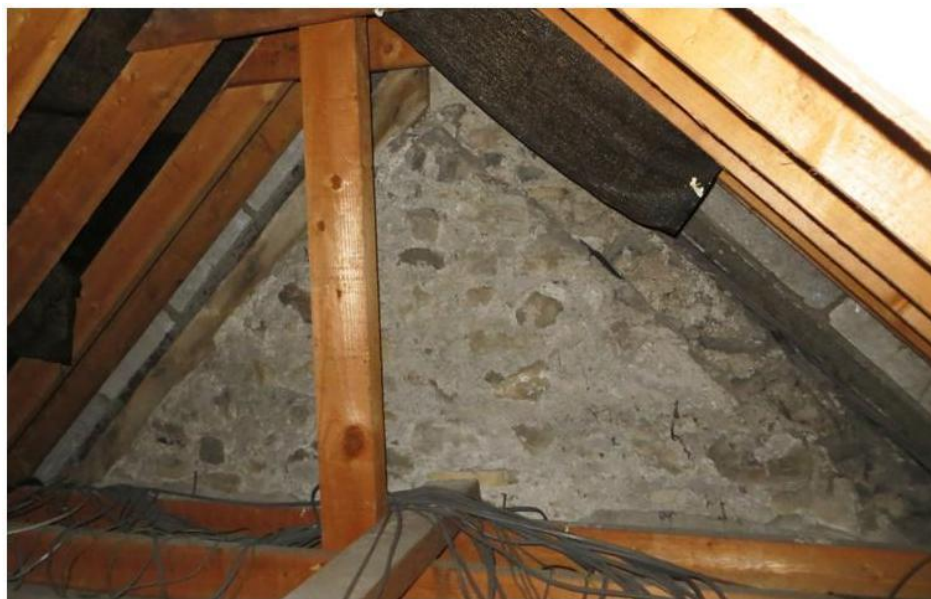
*Plate 4: Inner face of eastern gable*

At either end of the roof the inner face of the gable is visible and is constructed for the most part from rubble limestone set in lime-based mortar. The outer portion of the gable rises higher than the inner portion, leaving a recessed section of masonry which originally held the end rafters. On the northern slope of the eastern gable one of the rafters is still in place, though serving no purpose. This is visible in plate 4 above, to the left of the photograph. The overall height of the gable has been raised with the addition of two courses of concrete, raising the gable by 360mm from the top of the stone gable to the underside of the present roof.

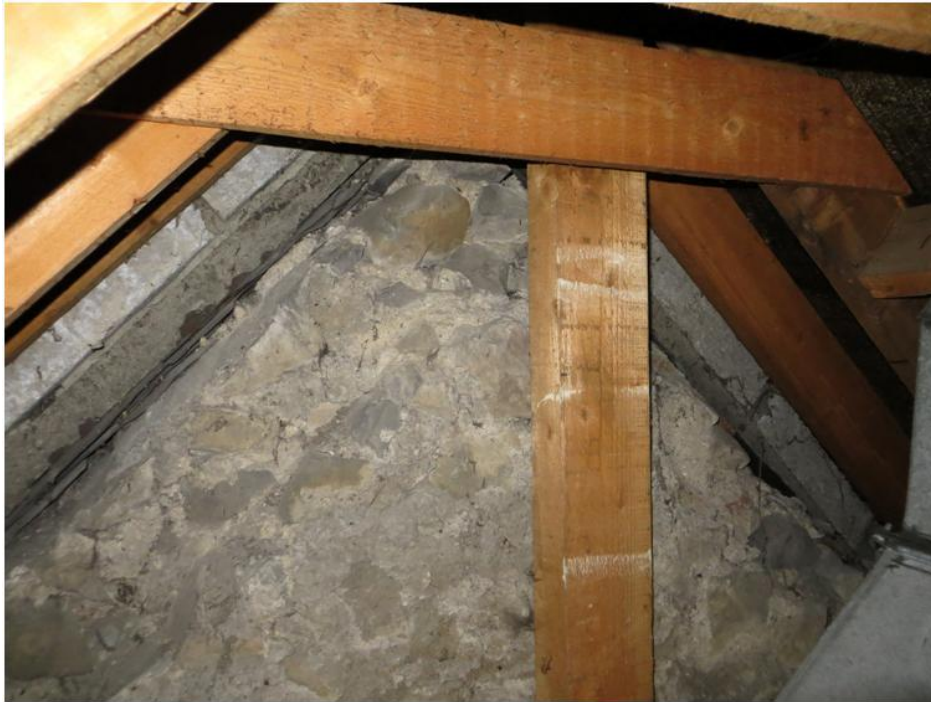
*Plate 5: Detail of inner face of western gable*

In the photograph above the inner face of the western gable is seen, with the two different levels in the stonework. Part of the concrete which raised the gable is seen on either side of the gable, while below this on the left-hand side it may be seen that the slates are still in place, indicating the nature of the roof covering prior to the reconstruction of the building in the 1960s.

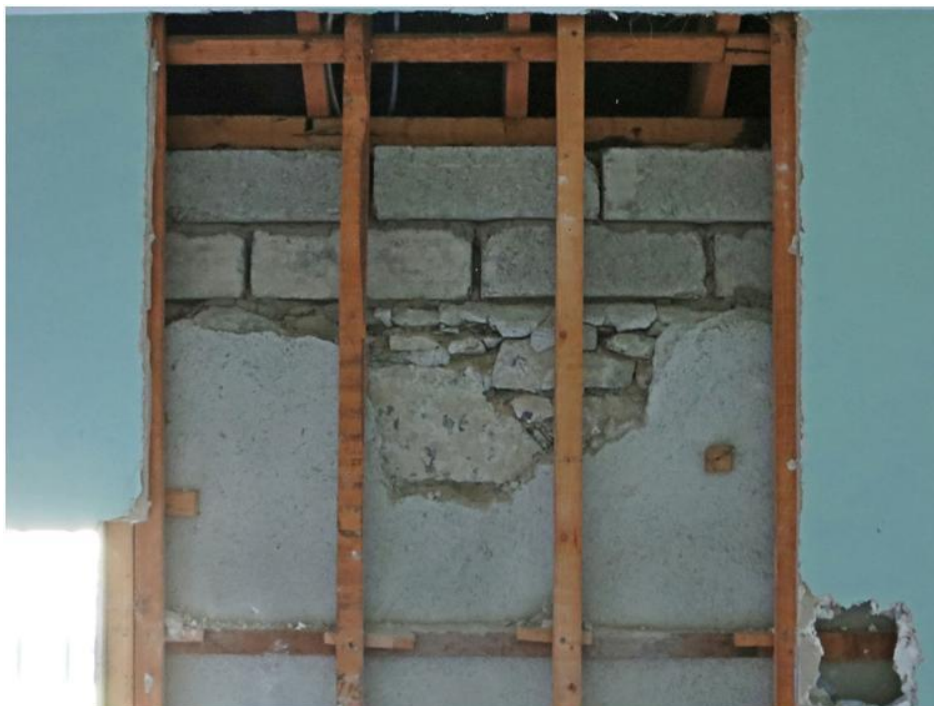
*Plate 6: Opened area of rear wall at first floor level*

The investigation shows that the wall had been raised by the addition of two courses of concrete blocks, thereby raising the eaves by about 450mm. Below this the inner face of the walls had been rendered with sand and cement. Beneath this render the walls are of limestone rubble, with a poor quality of stonework comprised of a mix of stone sizes, including a significant number of relatively small stones, all set in a lime-based mortar that is relatively soft and friable. The coursing did not appear to be particularly regular, though the areas opened up were too limited to be sure of the exact nature of the coursing.

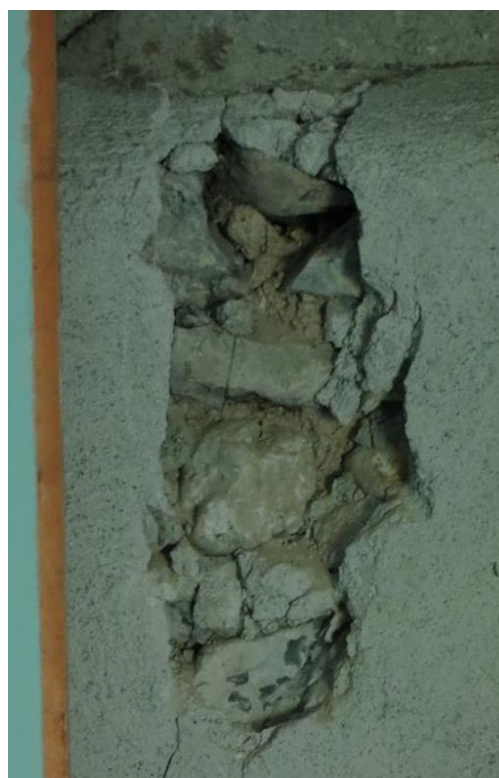
*Plate 7: Detail of stonework on front wall*

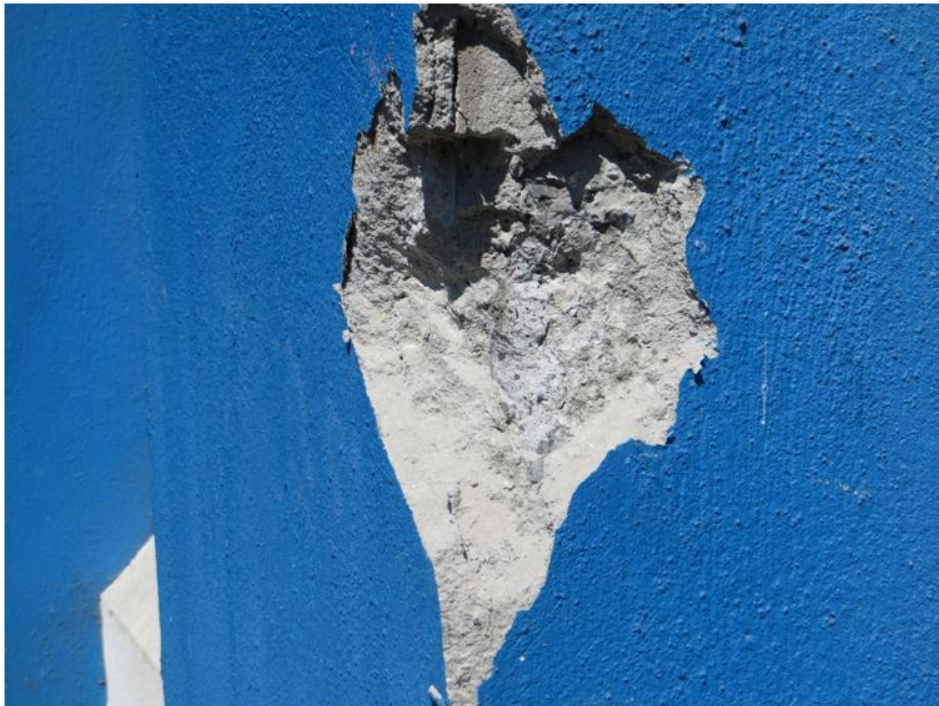
*Plate 8: Detail of pier at front of building*

There were several breaks in the south-eastern corner of the building where it appears that vehicles entering the gates had impacted on the wall. Examination of the revealed masonry showed that this corner of the building consists of a mass concrete pier with a facing of sand and cement render. One of the piers to the west of the shopfront was opened up, as seen in the photograph above, and this also revealed a concrete core with a sand and cement render.

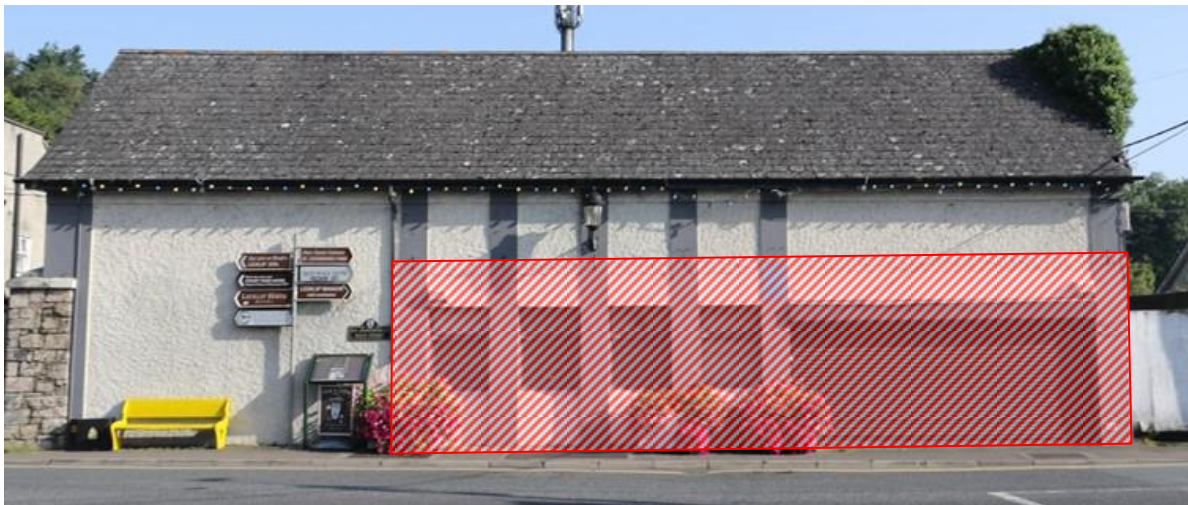
The investigations at ground floor level were intended to establish whether the front elevation was the original building, though pierced with new openings. What the investigation has shown is that two-thirds of the elevation to the street has been replaced with concrete and opes. The full length of the facade is 19.86 metres, while the shopfront and the area of concrete piers and windows to the west of the shopfront occupy a total of 13.25 metres of the street frontage. The smooth rendered area above the shopfront and windows would represent the substantial beam that supports the masonry above. The opening up at first floor level included three locations above this beam, the purpose of which was to establish whether the facade was demolished and rebuilt at first floor level as well as on the ground floor, as this would seem to have been the simplest way to have carried out the construction, particularly as the roof was removed and a new roof structure provided. However, the finding was that the limestone rubble wall extends over the top of the shopfront and the ground floor windows.

*Plate 9: Front facade showing area where original walling has been removed*

The photograph above shows with red hatching the area that was opened up during the construction in the 1960s, and which has been replaced with concrete and openings. As has been noted above, the roof was reconstructed in its entirety, with the total height of the roof raised by about 450mm.
