REMEDIATION METHODOLOGY

Moone Bridge Remediation

Project: K454

December 2021

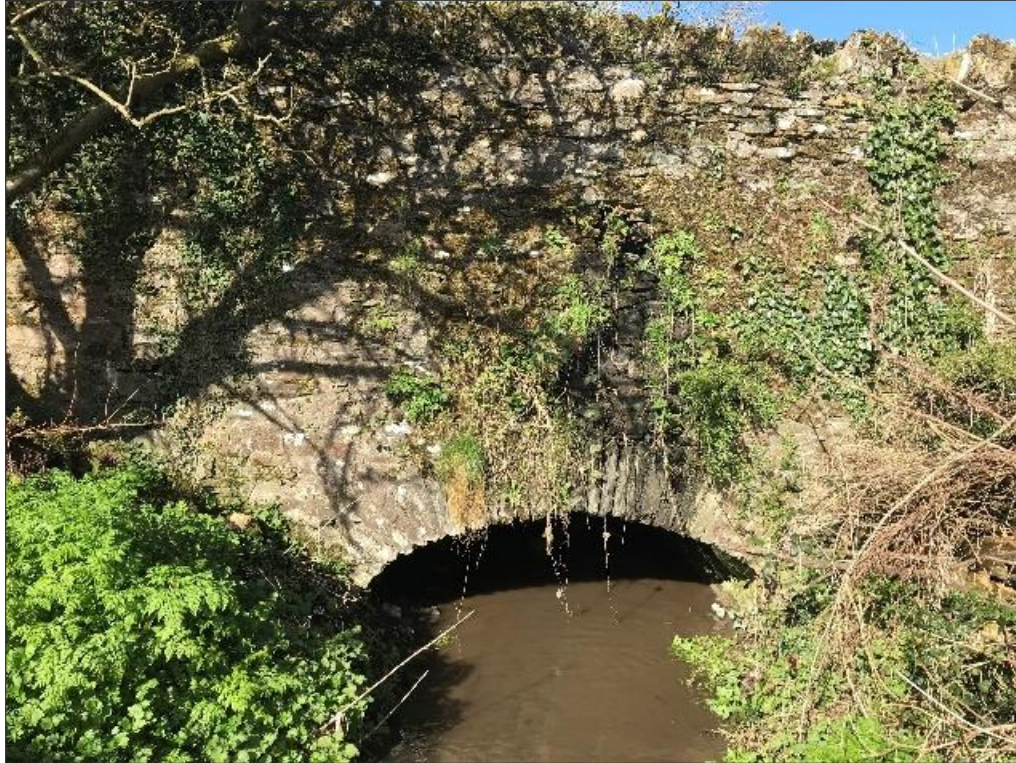
Figure 1: Moone Bridge Upstream Elevation

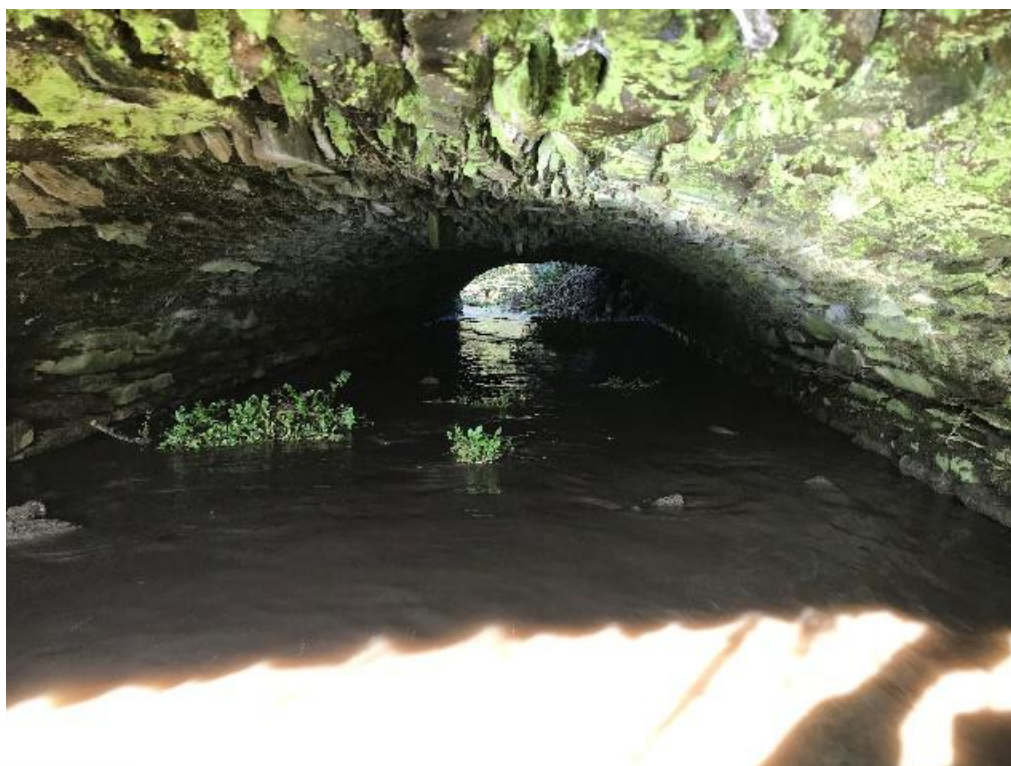
It was noted during OCSC's survey of Moone Bridge that on several masonry units of the arch barrel, there was a loss of mortar in the joints and vegetation growing between the units. The extent of masonry repointing and vegetation removal is minor in nature with the specific repairs detailed in the notes for Details 1 and 3. See figure 3 below for image of masonry loss and vegetation growth and Detail 1 and 3 below for vegetation removal and masonry repointing, respectively. In order to further mitigate debris entering the watercourse, cleaning, and vegetation removal of bridge elements will be undertaken in such way as to prevent any debris falling into the watercourses. A sealed working platform – CRASH DECK - will be provided at the structure to contain the cleaning works. The crash deck will be fully boarded out and effectively screened and sealed on all edges to ensure that no products enter the watercourse. Debris will be removed from the crash deck at the end of each working day to avoid the build-up of material on the crash deck. During the cleaning works the Contractor must use a filtration membrane on the scaffold/ crash deck to capture particles and prevent them from entering the river/ watercourse.

Figure 3: Loss of mortar in joints and vegetation growth

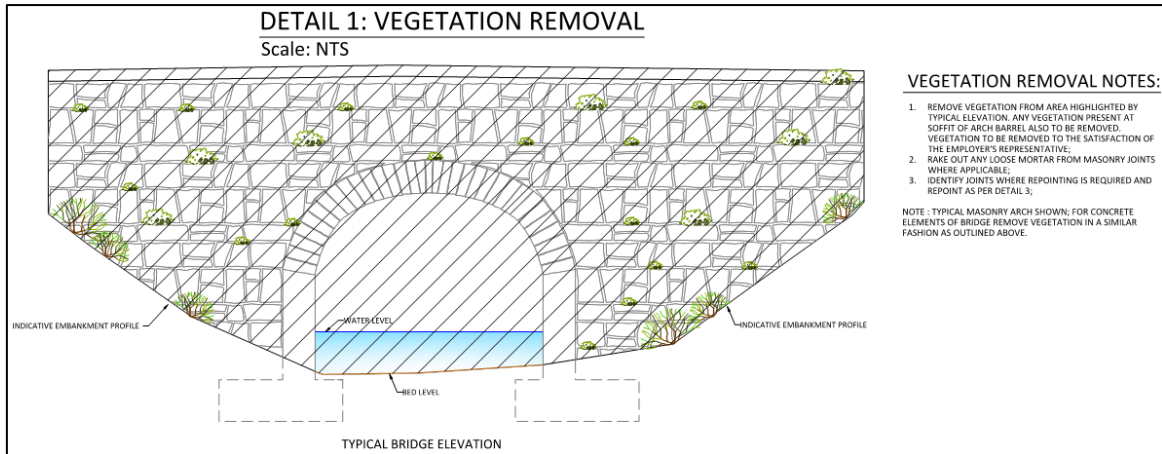
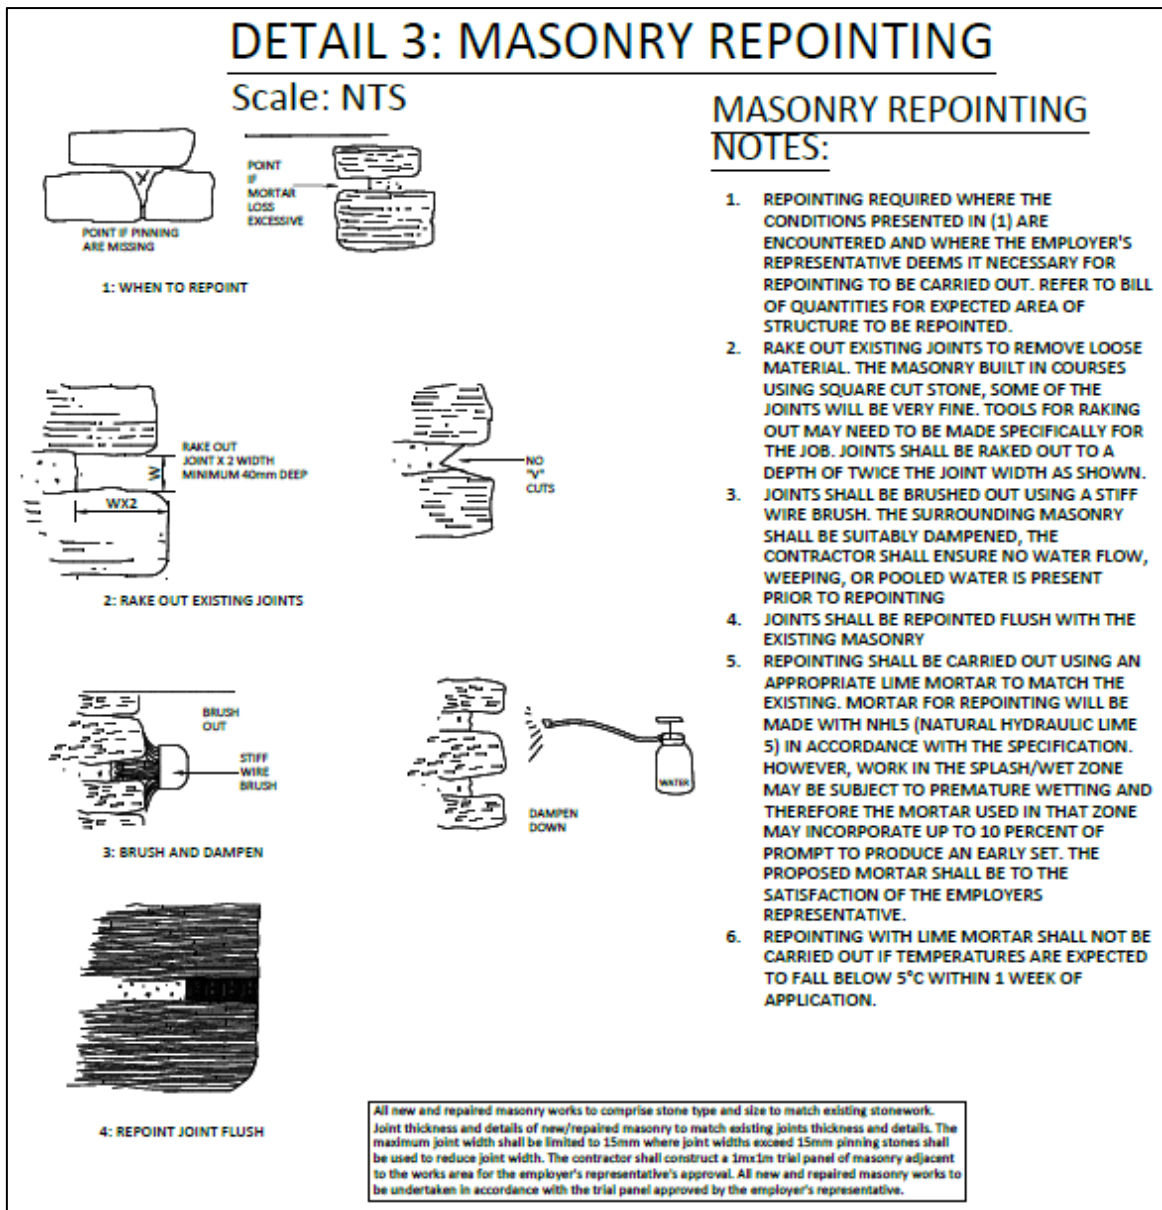
Figure 4: Typical Detail for Vegetation removal and Masonry Repointing.

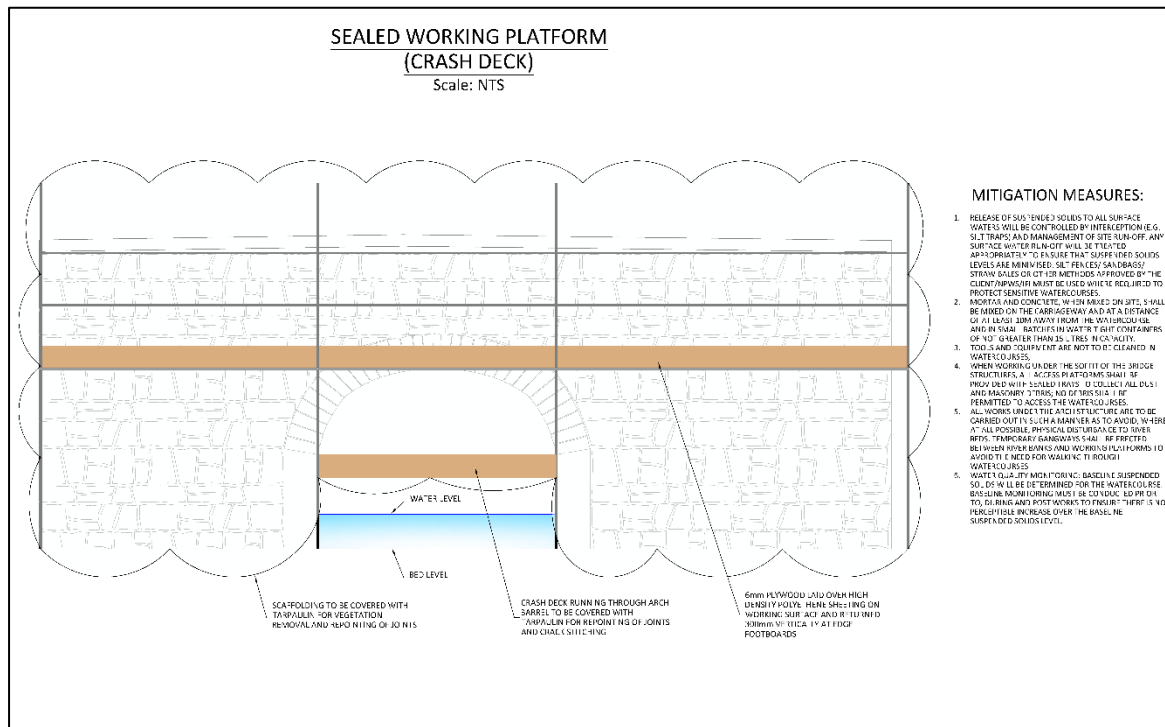
Figure 5: Typical tarpaulin and scaffolding setup

In order to further mitigate debris entering the watercourse, the contractor will install a sealed working platform – CRASH DECK - fully boarded out and effectively screened and sealed on all edges to ensure that no products enter the watercourse. A filtration membrane will be installed on the scaffold/ crash deck to capture particles and prevent them from entering the river/ watercourse. This crash deck system will be installed around the areas to be repointed and masonry replacement. See figure 5 below for image of typical crash deck/ scaffolding setup.
