Monasterevin Bridge Rehabilitation Works

Preliminary Remedial Works Report

Client: Kildare County Council

Project: K424

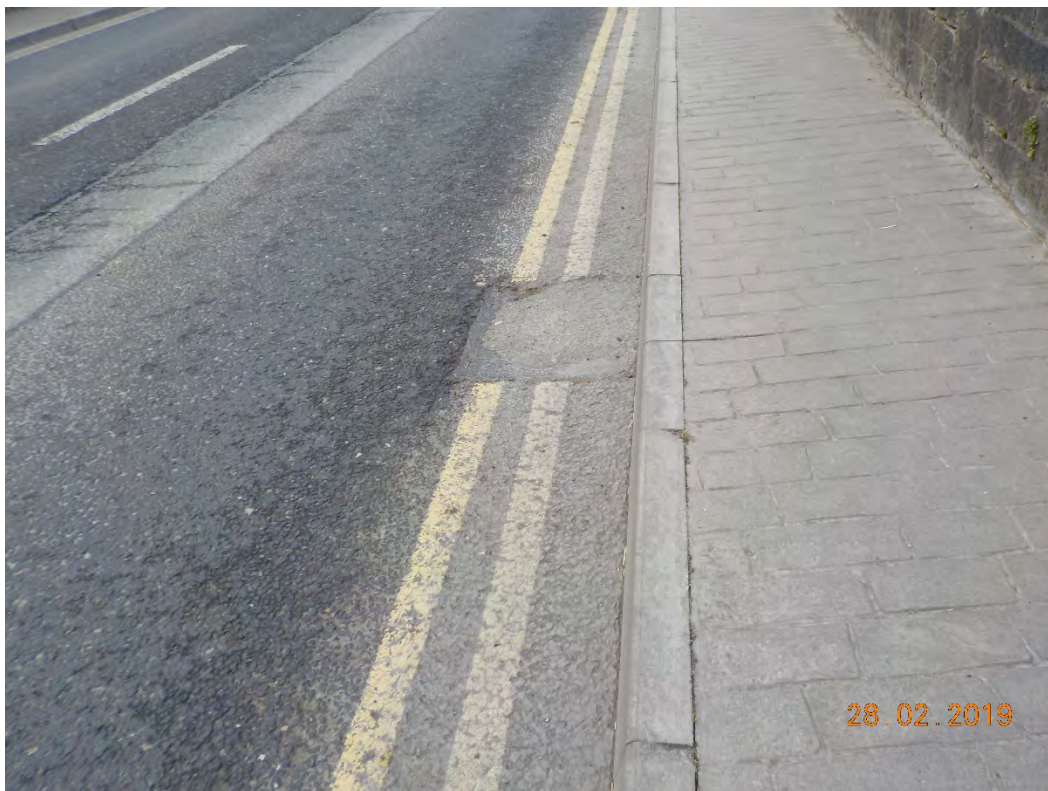
- i. Major patch repair works to Surface, see photograph 3-1, 3.2 and 3.3

Photograph 3-2: Poor Patch Repair on Bridge Surface

- i. Road to be planned and resurfaced, see photograph 3.4

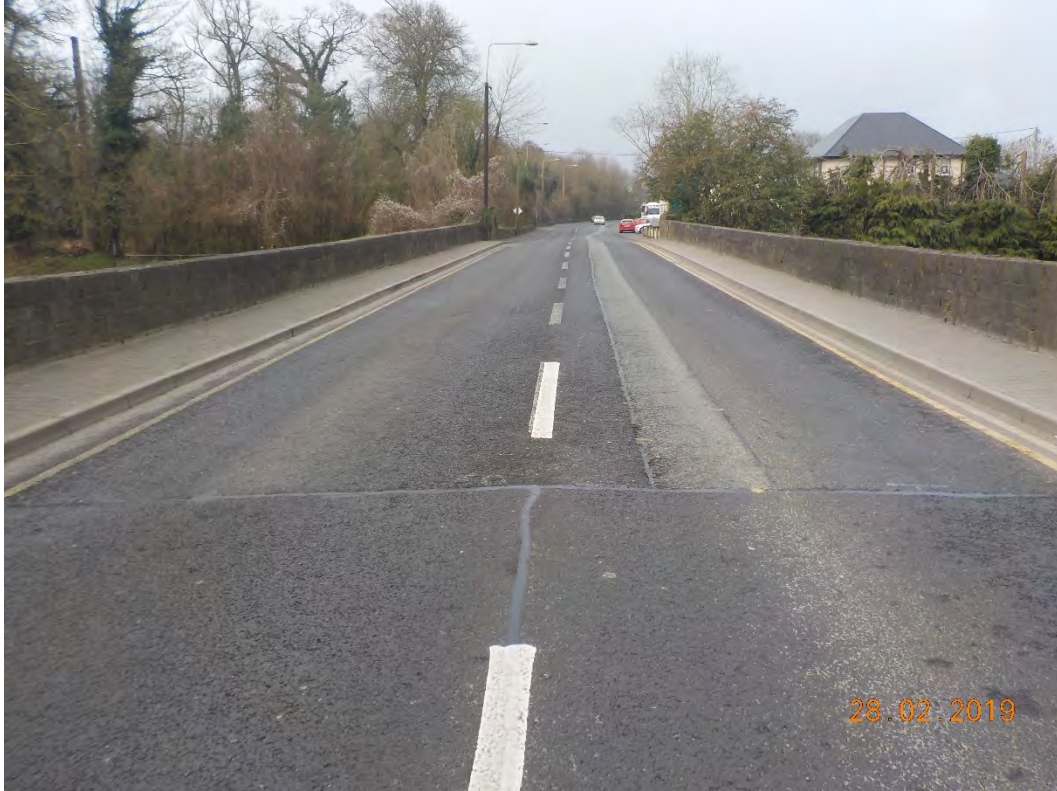
Photograph 3-3: Poor Patch Repair on Bridge Surface

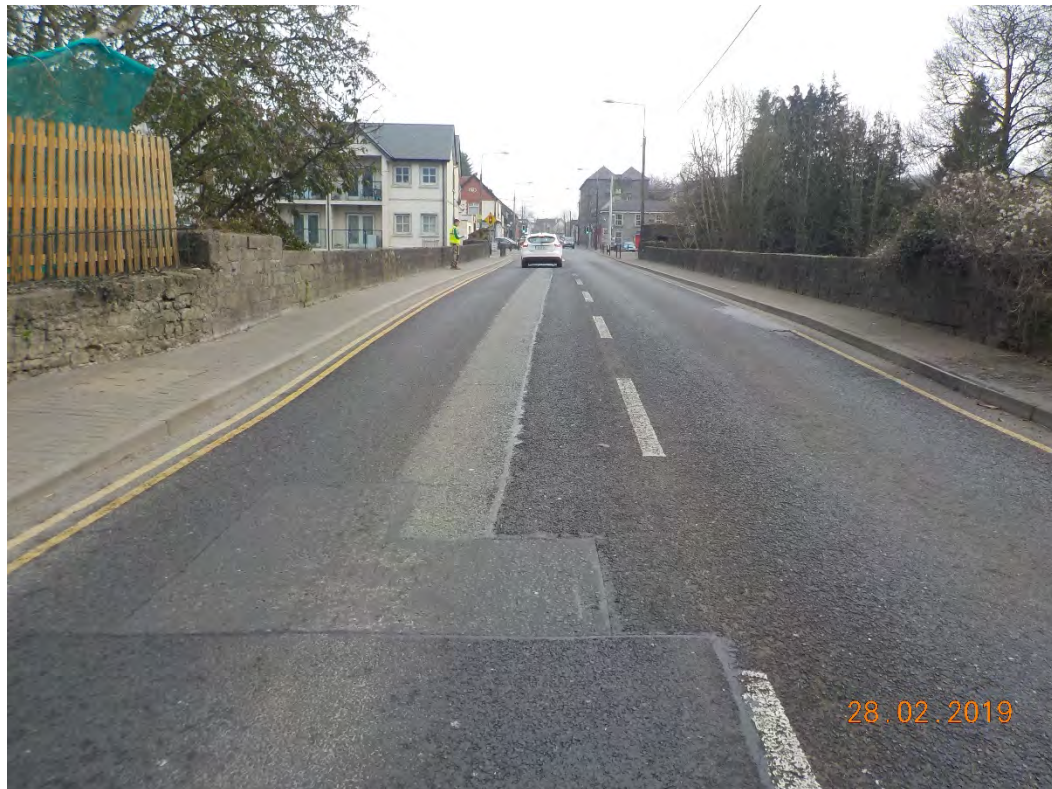
Photograph 3-4: Poor Patch Repair on Bridge Surface

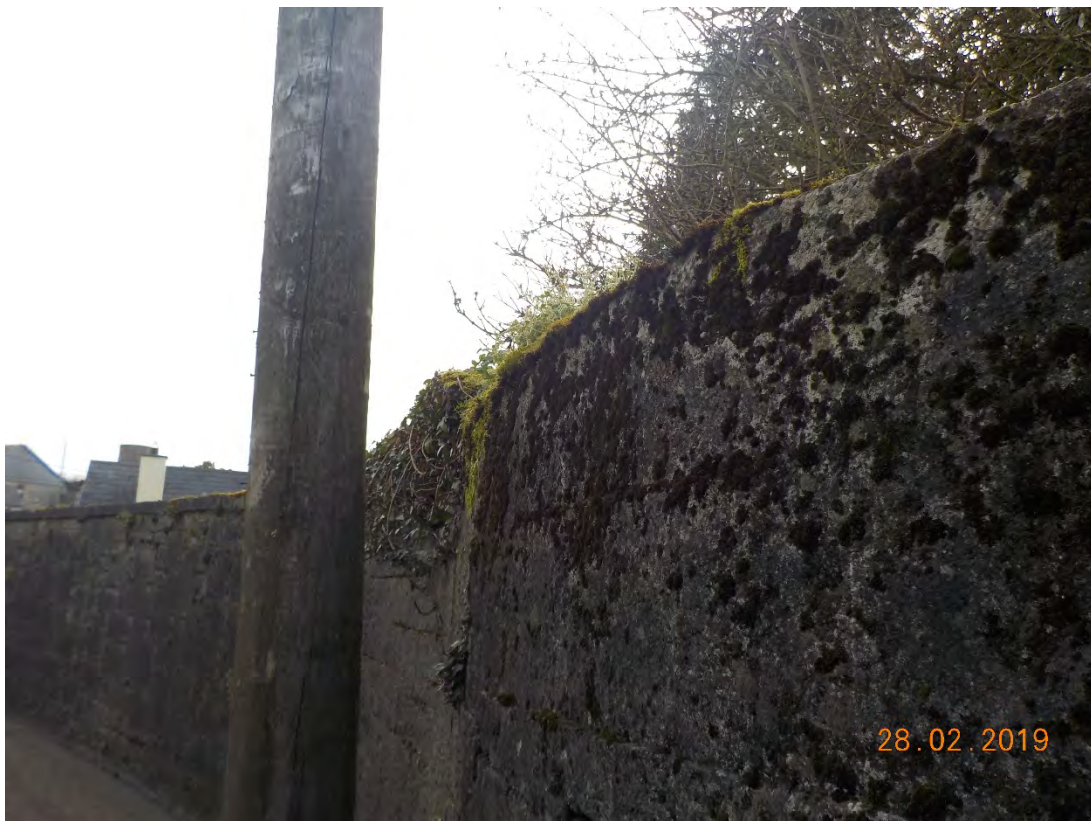
- i. Vegetation on Downstream Roadside West capping, See photographs 3.5, 3.6, 3.7 and 3.8
- ii. Tree roots growing between capping on West roadside parapet, See photographs 3.9 and 3.10
- iii. Missing Masonry on Downstream West Parapet, See photograph 3.11
- iv. Bunker settling on Downstream side West, See photographs 3.12, 3.13, 3.14 and 3.15
- v. Joints in poor condition on downstream roadside parapet, See photographs 3.16, 3.17 and 3.18
- vi. Masonry dislodged at section of downstream East parapet, See photograph 3.19 and 3.20
- vii. Bulging on section of downstream East parapet, See photograph 3.21
- viii. East parapet settling away from capping, See photograph 3.22
- ix. East parapet wall joints in poor condition, See photograph 3.23, 3.24 and 3.25
- x. Downstream East parapet wall collapsing, See photograph 3.26

Photograph 3-8: Downstream Capping on Road Side Parapet

- i. Vegetation to removed, raking and repointing of joints, 2m x 5m
- ii. Capping to be removed to allow for removal of vegetation growth underneath. Original capping to be reinstated after, 10mm dia tree root to be removed.
- iii. Masonry to be reinstated to match existing, 0.15m x 0.2m.
- iv. Due to the heavy overgrowth on the riverside bank of the bunker, the full extent of the remediation works cannot be deemed. From inspection on the roadside, it can be seen that the foundation should be underpinned, Crack 50mm-10mm and 4.2m long
- v. Rake and repoint joints, 10% of joints.
- vi. Section of wall to be demolished and reconstructed, 0.35m x 0.4m
- vii. Section of wall to be demolished and reconstructed, 2.6m x 1.1m x 1.4m

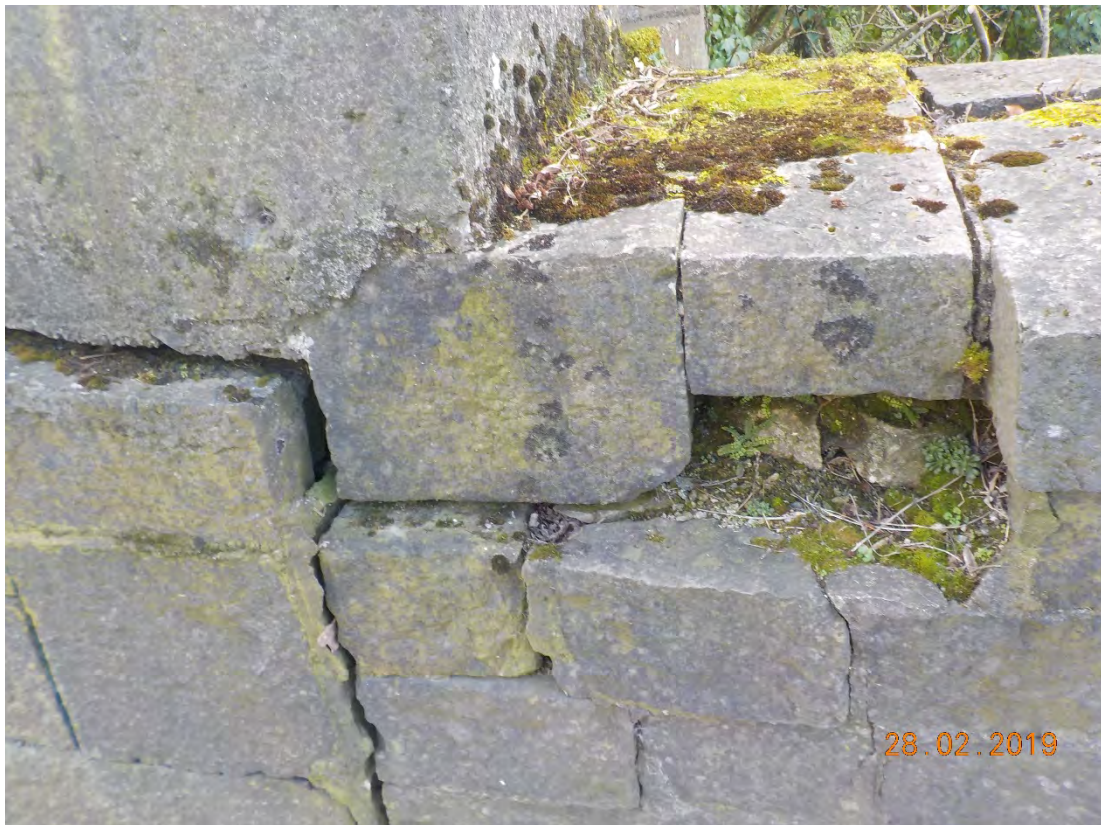
Photograph 3-12: Settlement of Bunker on Downstream side

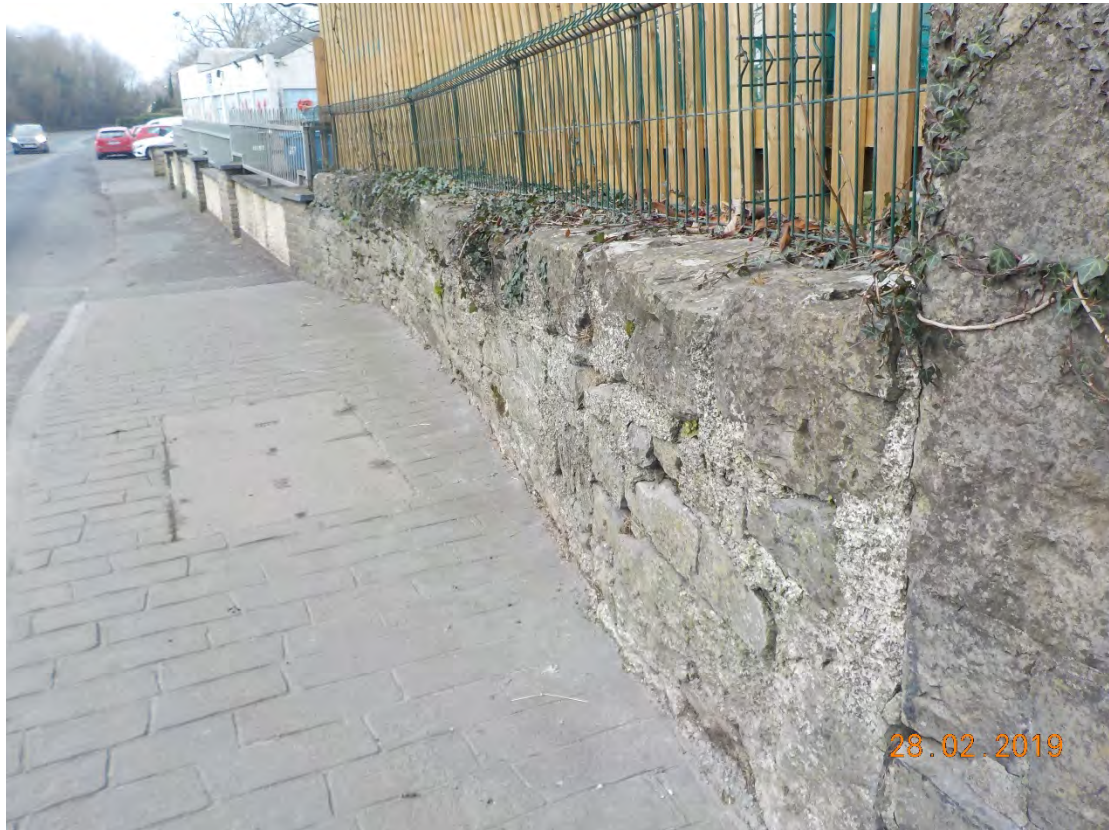
- i. Vegetation on upstream West side parapet capping, See photograph 3.27
- ii. Tree roots growing within capping on upstream West side parapet, See photograph 3.28
- iii. Joints in poor condition on Upstream roadside parapet wall, See photograph 3.29
- iv. Vegetation growing on Upstream capping eastroadside parapet, See photograph 3.30 and 3.31
- v. Edge stones in poor condition on upstream East parapet, See photograph 3.32
- vi. Joints on upstream West roadside parapet in poor condition, See photograph 3.33 and 3.34

Photograph 3-27: Vegetation on Upstream side Parapet Capping.

- i. Vegetation to be removed and joints to be raked and repointed, 6m x 0.8m, fencing on top
- ii. Capping to be removed to allow for removal of vegetation growth underneath. Original capping to be reinstated after, 3.1m x 1.3m
- iii. Joints to be raked and repointed, 10% of joints.
- iv. Remove vegetation from capping and rake and repoint joints, 80% of joints (3.5m x 1.7m)
- v. Remove existing edge stones and replace to match existing, 0.5m x 1.6m
- vi. Joints to be raked and repointed, 60% of joints.

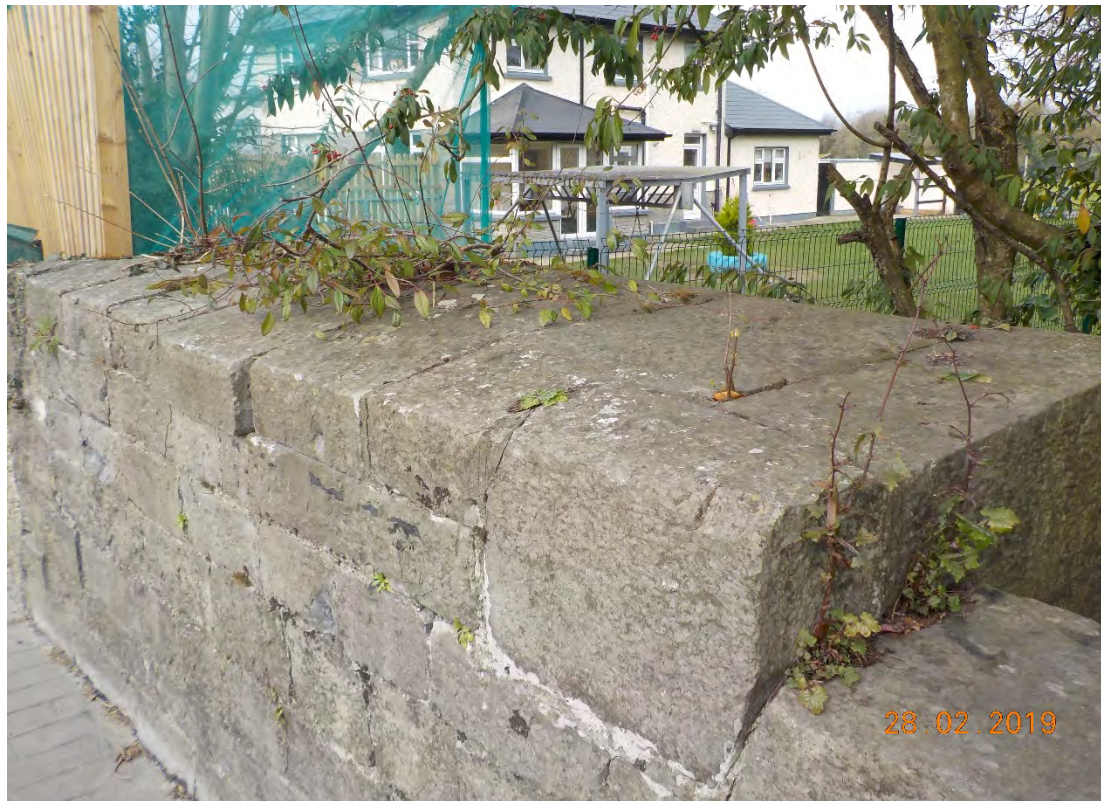
Photograph 3-28: Tree Roots in Capping on Upstream Parapet

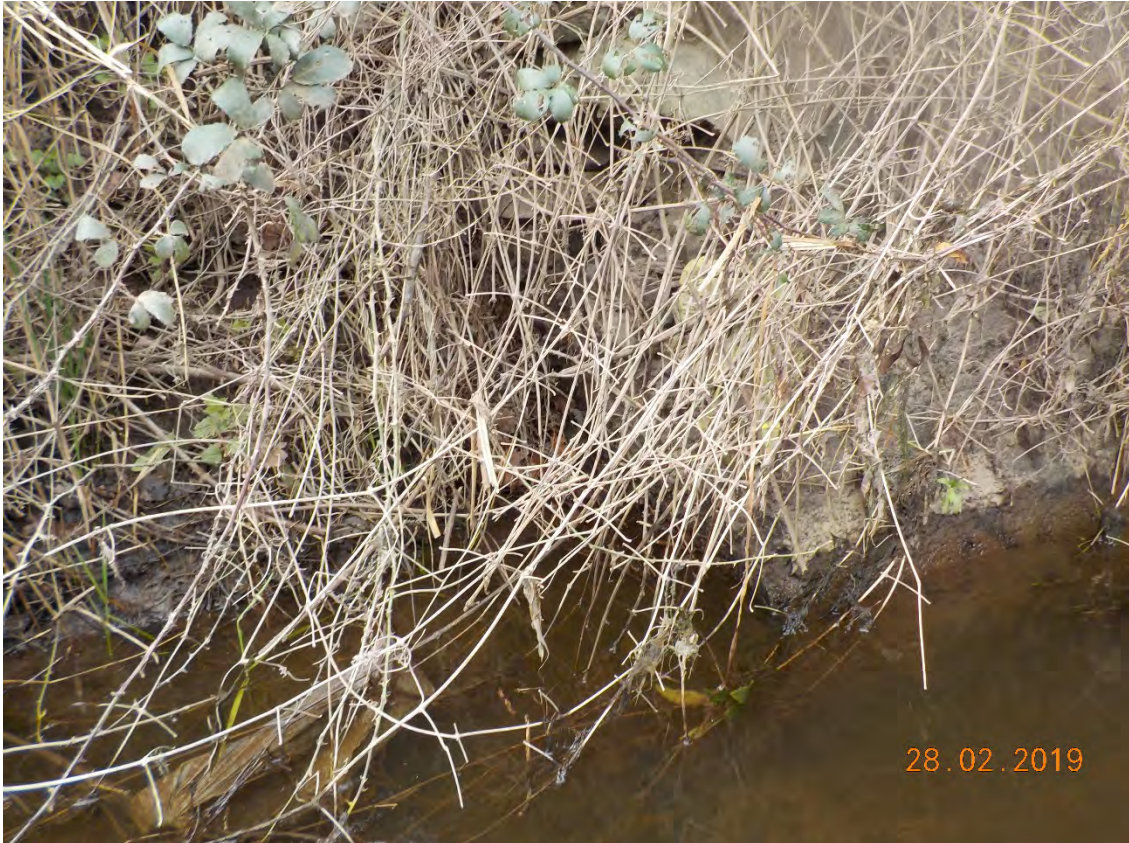
- i. Heavy overgrowth on downstream west left embankment causing a blockage for accessing the embankment, See photograph 3.35, 3.36 and 3.37
- ii. Retaining wall failing on downstream west left embankment, See photograph 3.38 and 3.77
- iii. Tree's overgrowing on downstream west left embankment, See photograph 3.39 and 3.40
- iv. Tree's and overgrowth growing wild on downstream east embankment, See photographs 3.41, 3.42 and 3.43
- v. Outfall pipe has collapsed on downstream left embankment, See photographs 3.78 and 3.79

Photograph 3-38: Downstream Left Embankment Retaining Wall

- i. Remove area of overgrowth on the embankment to allow ease of access
- ii. Retaining wall to be reconstructed, 1m x 1.5m x 2m.
- iii. Remove 2 no overgrown tree's.
- iv. Tree's to be cut back and partially removed
- v. Outfall pipe to be reconstructed in embankment, 225 diameter.

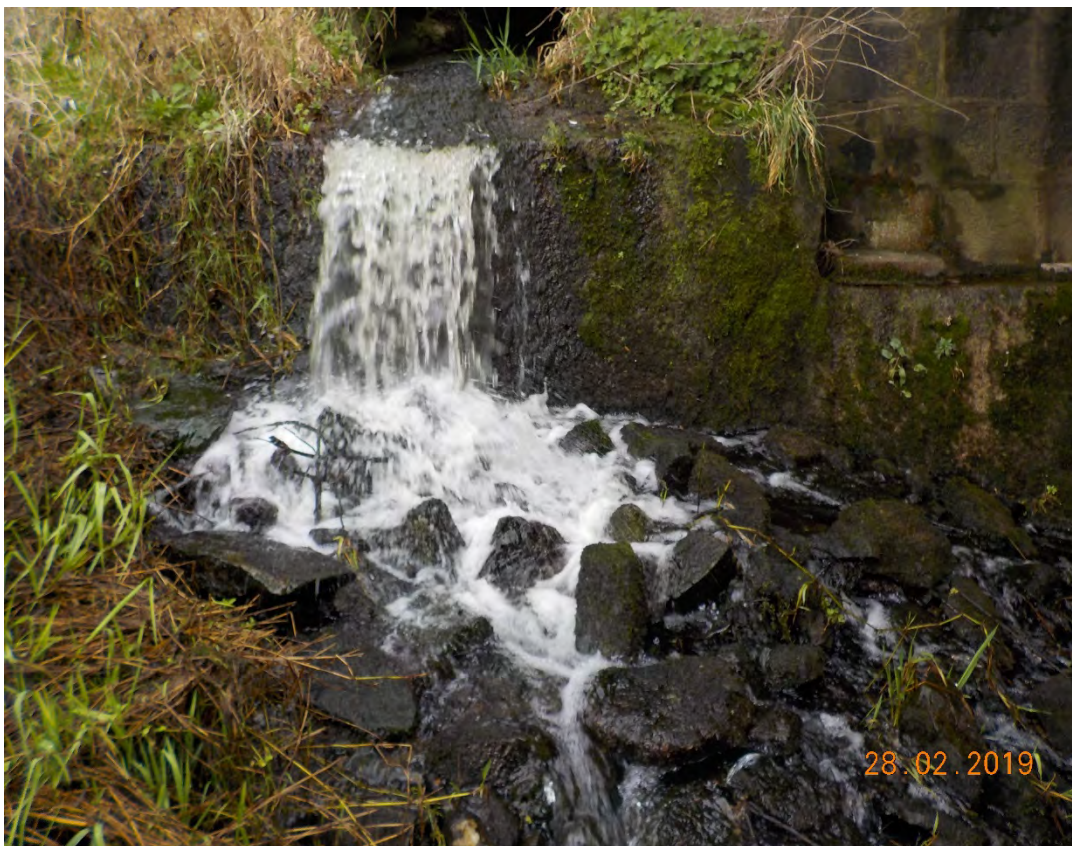
- i. Heavy overgrowth on upstream east embankment, See photograph 3.47
- ii. Culvert on upstream embankment failing, See photograph 3.48 and 4.49
- iii. Wall at outfall of culvert has collapsed, See photograph 3.50
- iv. Tree growing from upstream east parapet, See photograph 3.51

Photograph 3-48: Culvert on Upstream Embankment Failing

- i. Remove vegetation and overgrowth from embankment
- ii. Reconstruct failing section of culvert 3.48 & 3.49
- iii. Wall to be reconstructed at outfall of culvert, 1.2m x 1.4m x 0.6m.
- iv. Tree to be poisoned and killed off, 1m diameter.

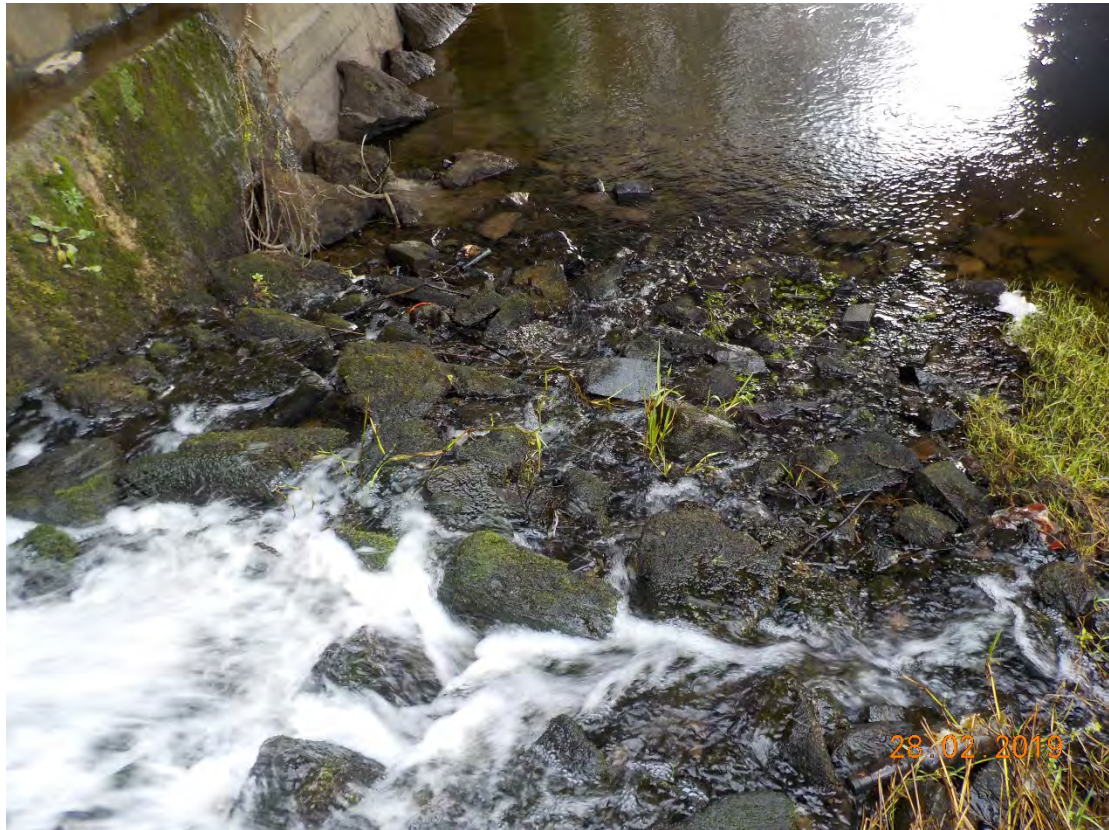
Photograph 3-49: Culvert on Upstream Embankment Failing

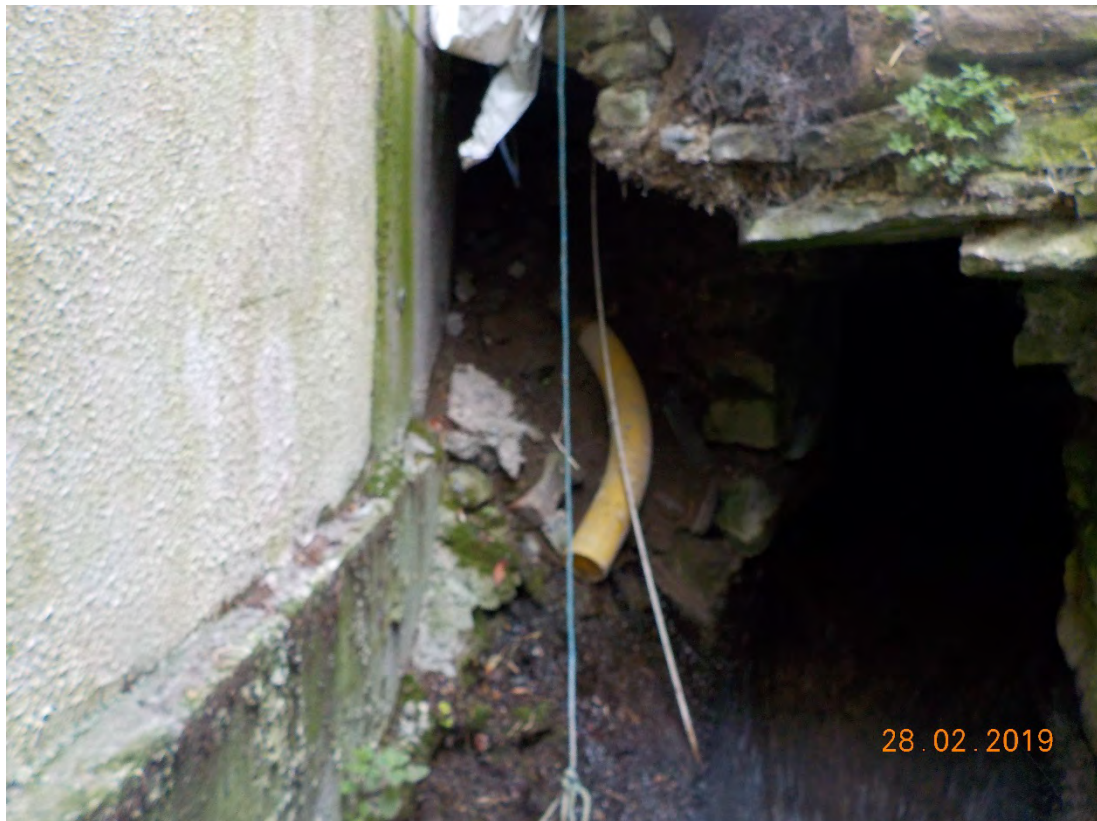
Photograph 3-50: Wall to be reconstructed

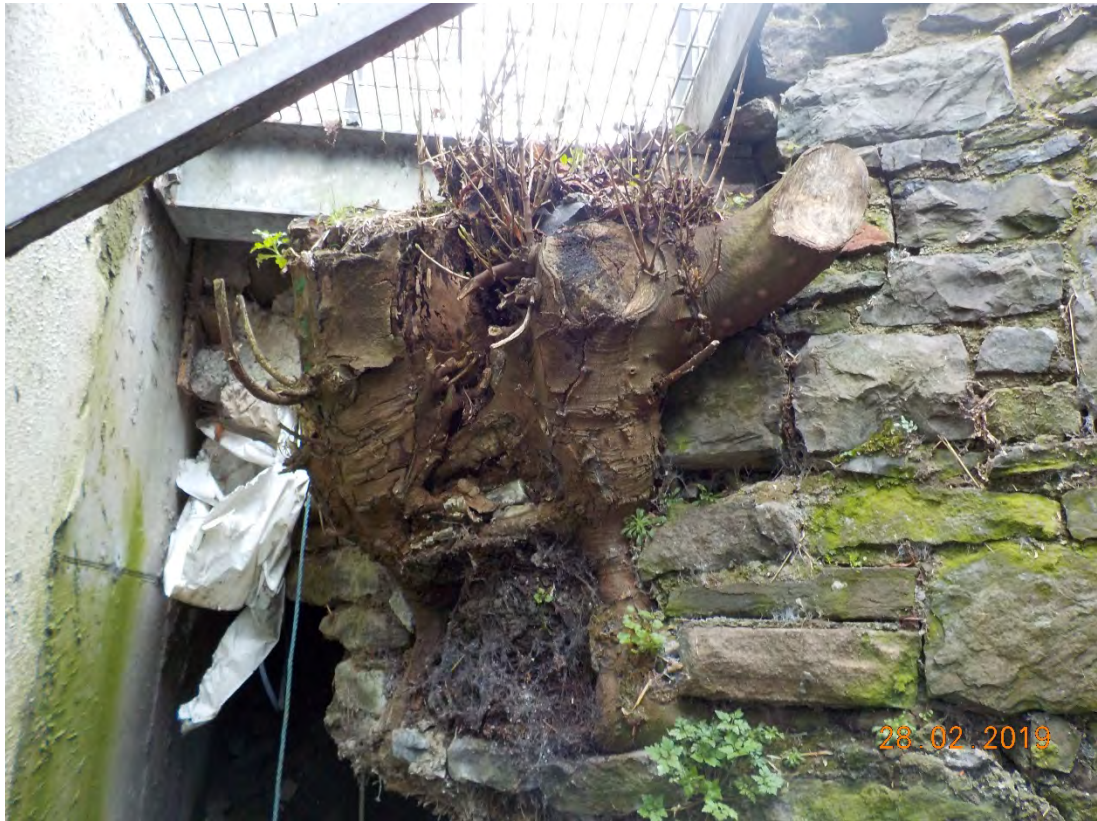
Photograph 3-51: Tree to be Poisoned and Killed

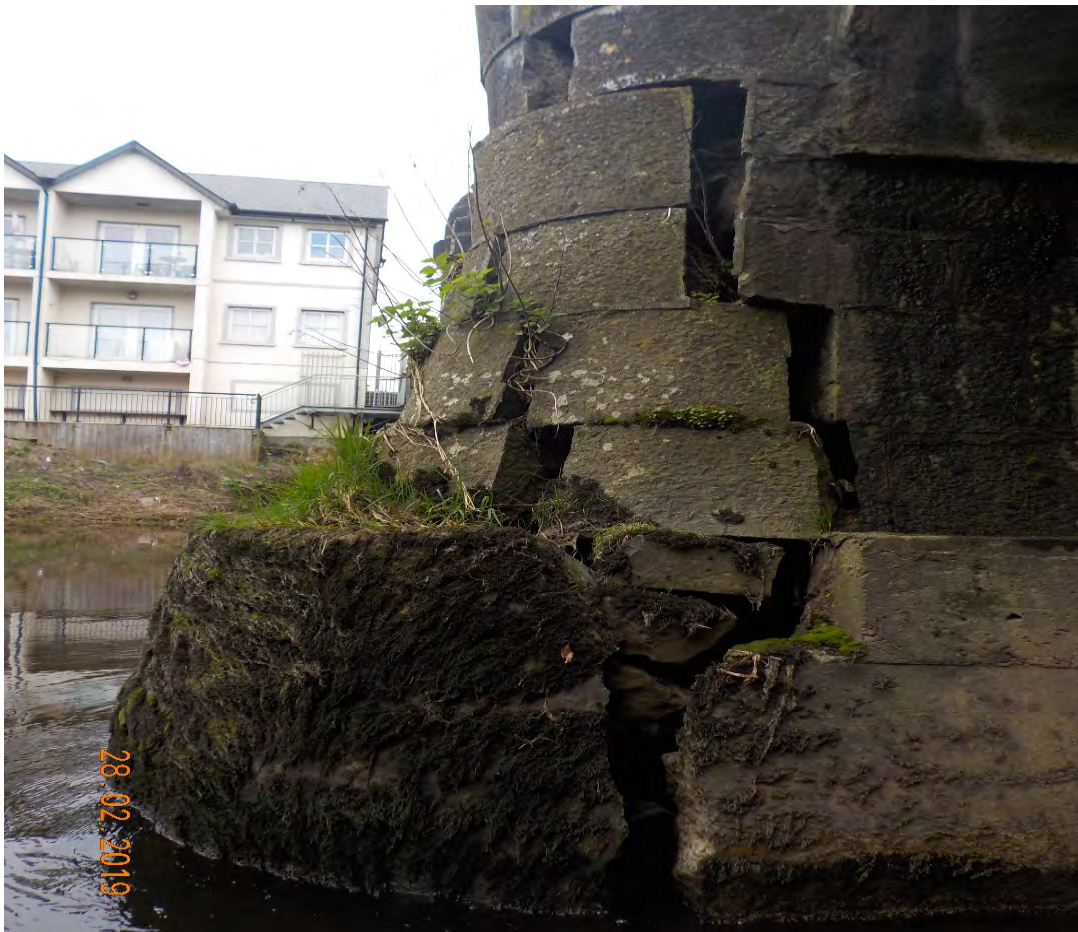
- i. Vegetation growing around Pier 1, See photograph 3.53
- ii. Pier 2 upstream cutwater undermined and separating from bridge pier, See photograph 3.54 and 3.55
- iii. Vegetation growing on downstream Pier 2, See photograph 3.57 and 3.58
- iv. Scouring occurring at upstream cutwater Pier 3, See photograph 3.66, 3.67 and 3.68
- v. Vegetation growing on downstream Pier 4, See photograph 3.62
- vi. Vegetation growing on upstream Pier 4 and a small crack commencing in the upstream cutwater, See photographs 3.69, 3.70 and 3.71

Photograph 3-54: Pier 2 – Settling away from Bridge

- i. Remove vegetation and clean pier.
- ii. Underpin cutwater, provide scour protection and reconstruct Pier 2 upstream cutwater
- iii. Remove vegetation and clean pier, 40% of joints
- iv. Underpin cutwater, provide scour protection and reconstruct Pier 3 upstream cutwater
- v. Remove vegetation and clean pier, 40% of joints
- vi. Remove vegetation and clean pier, 50% of joints. Provide scour protection to upstream cutwater.

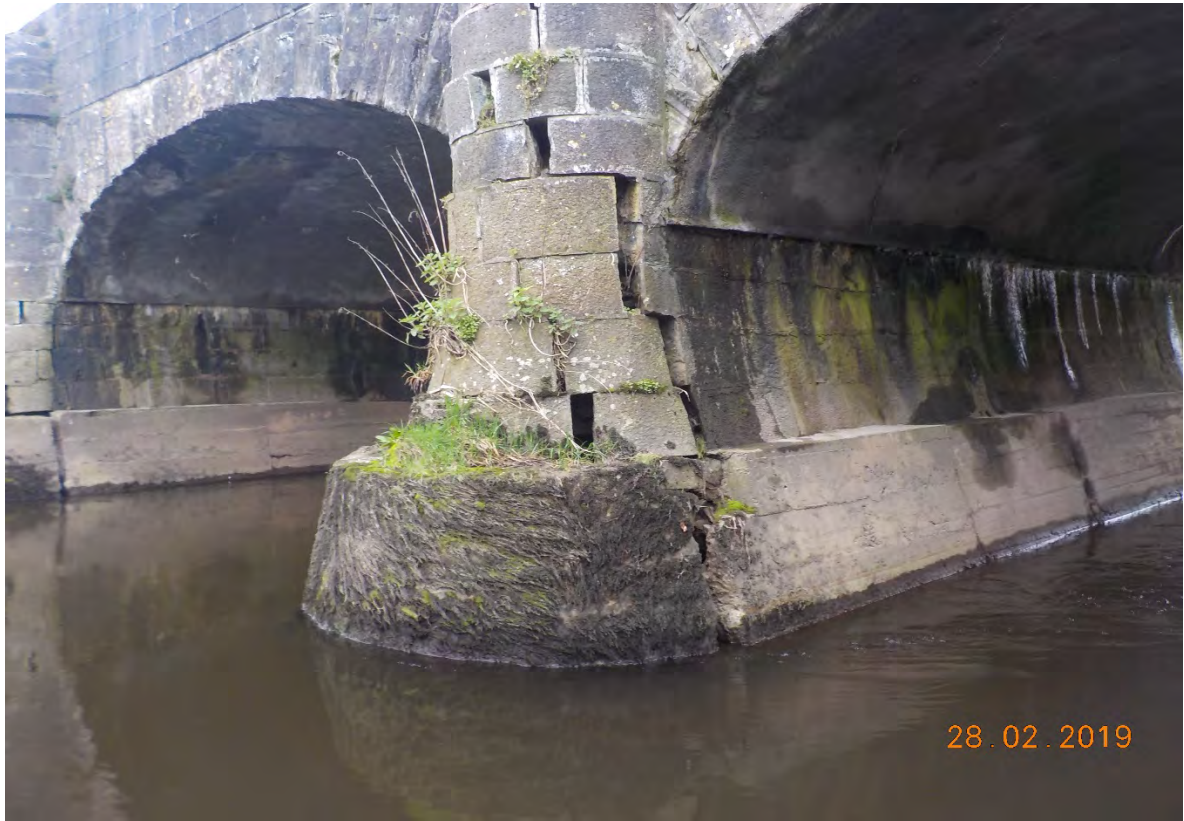
Photograph 3-55: Pier 2 – Settling away from Bridge

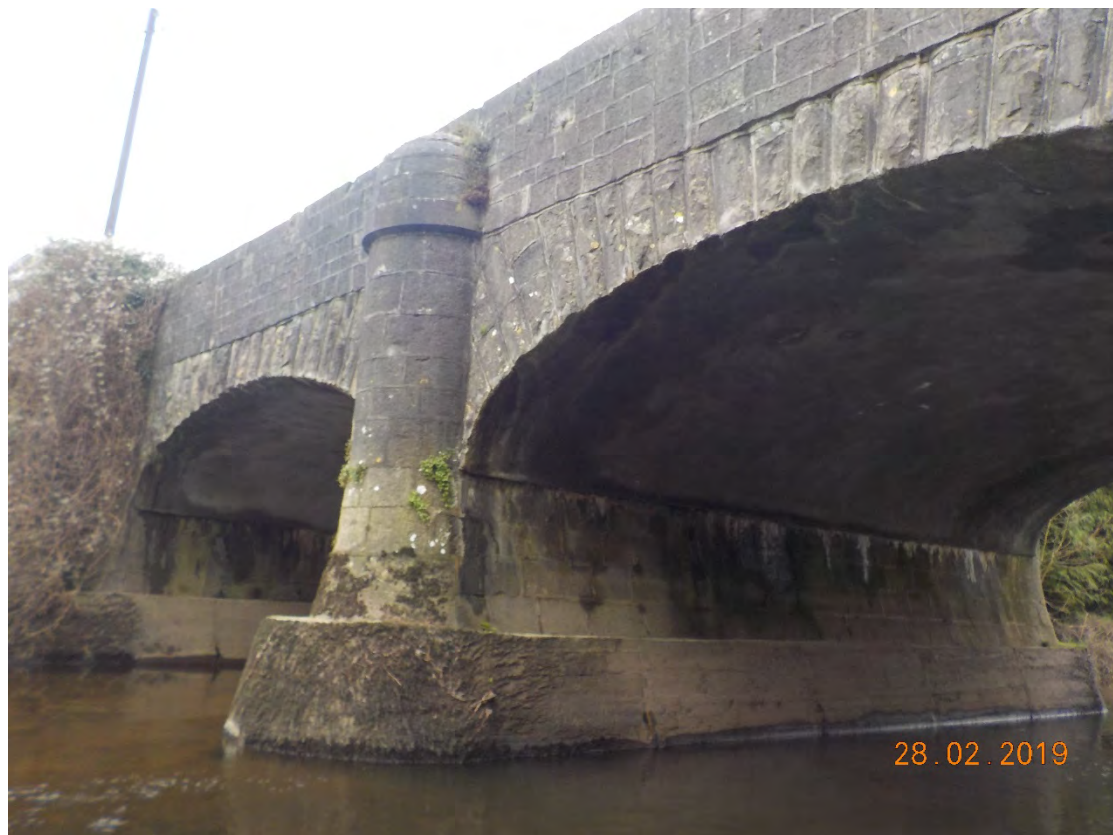
- i. Vegetation growing on the spandrel walls at Pier 2, See photograph 3.59 and 3.60

Photograph 3-60: Pier 2 – Spandrel Walls

- i. Remove vegetation, rake and repoint 5% of joints.

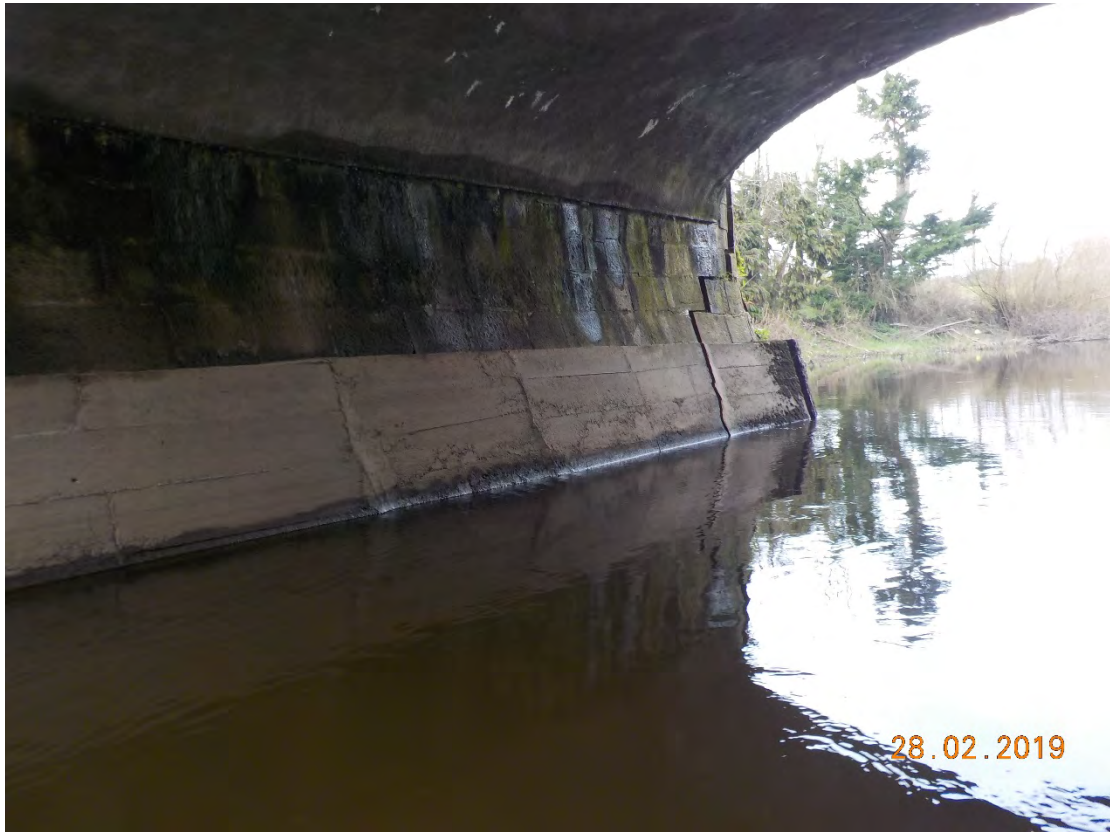
- i. Minor mortar loss to joints, see photograph 3.61

Photograph 3-61: Arch 3 – West Abutment

- i. Rake and repointing needed on 40% of the joints.

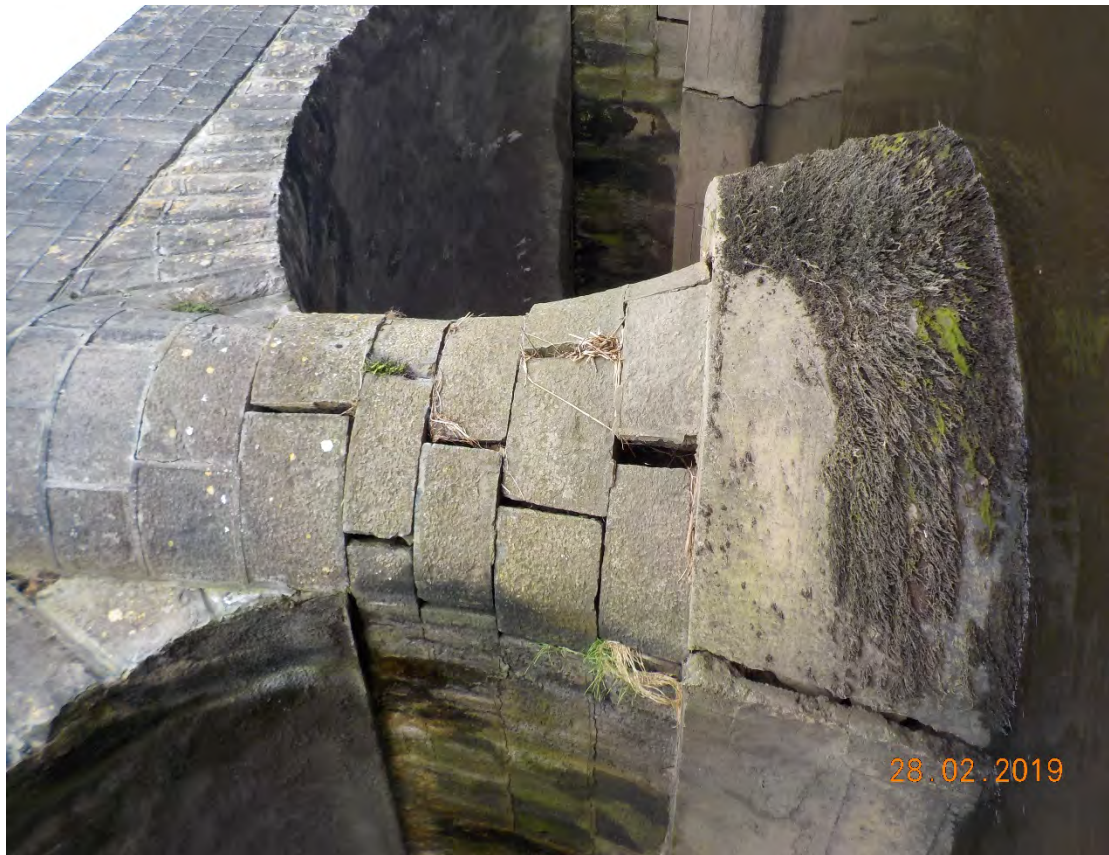
Photograph 3-66: Pier 3 – Natural Scouring

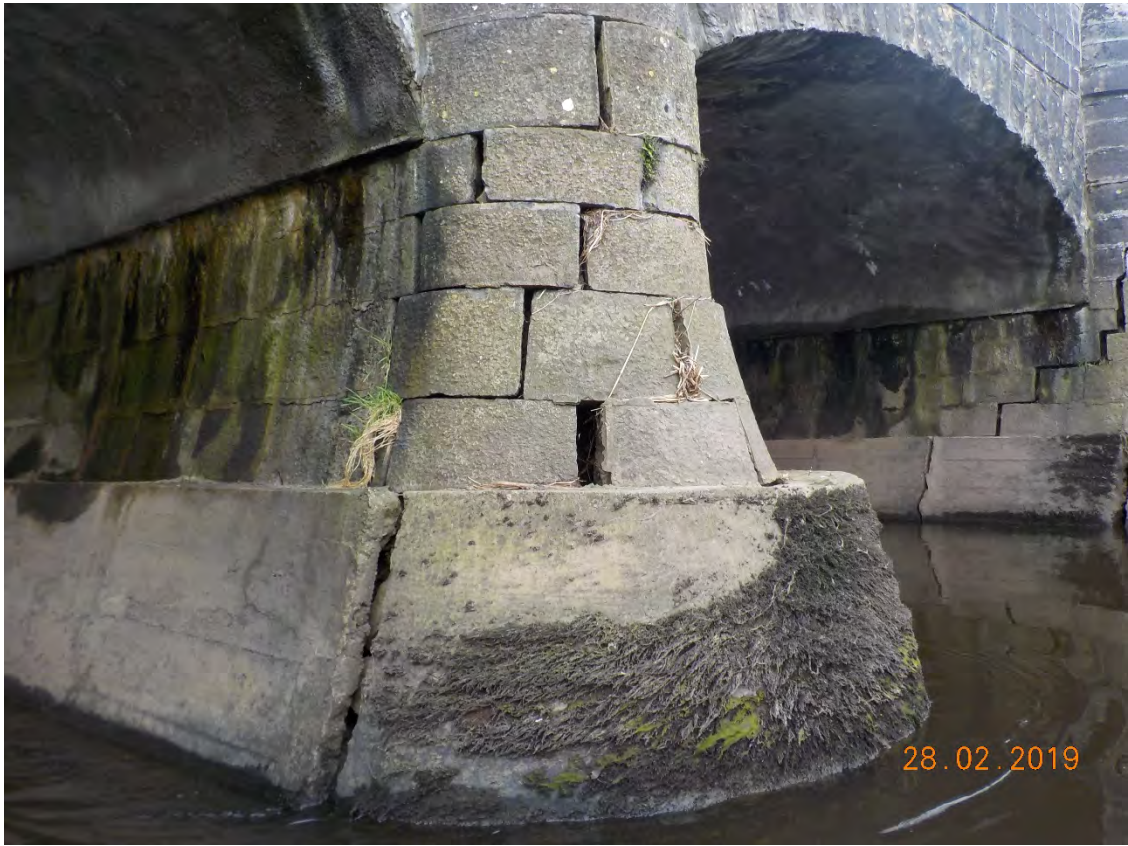
Photograph 3-67: Pier 3 – Natural Scouring

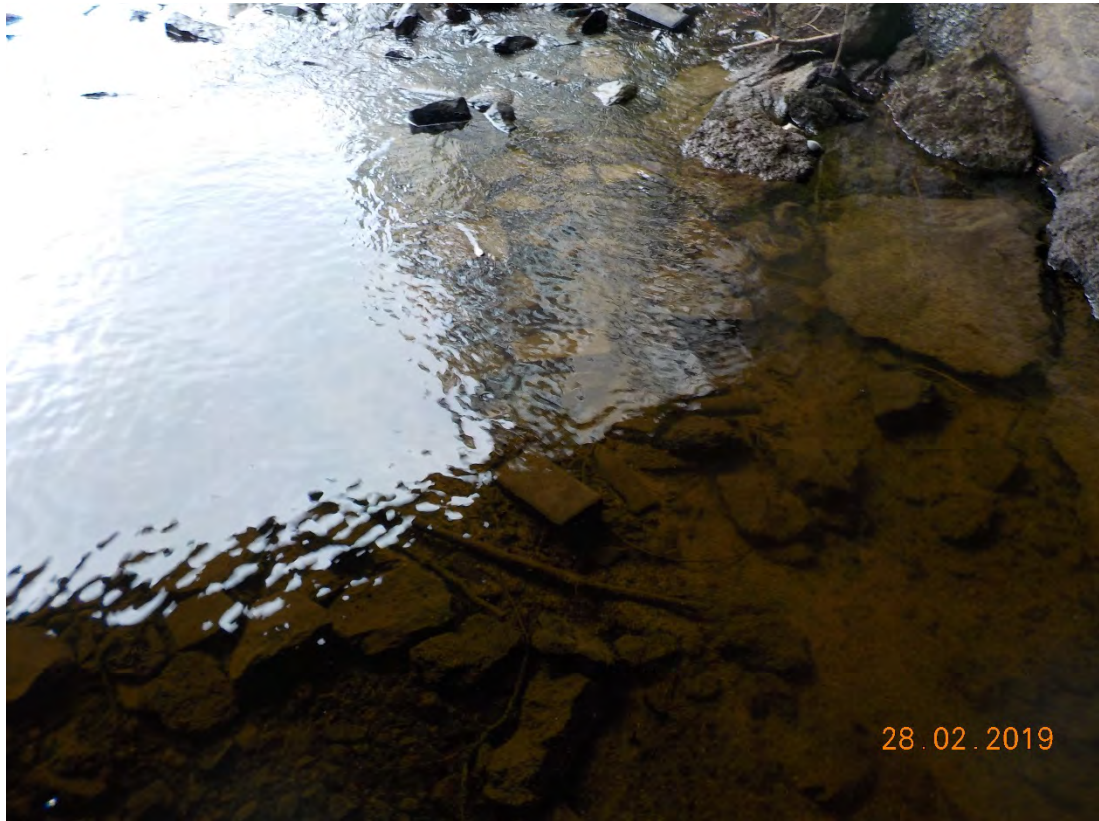
- i. Evidence of stone or concrete eroded away on river bed under Arch 5, see photographs 3-74, 3-75 and 3.76

Photograph 3-74: Riverbed under Arch 5

- i. Remove debris and regrade the riverbed

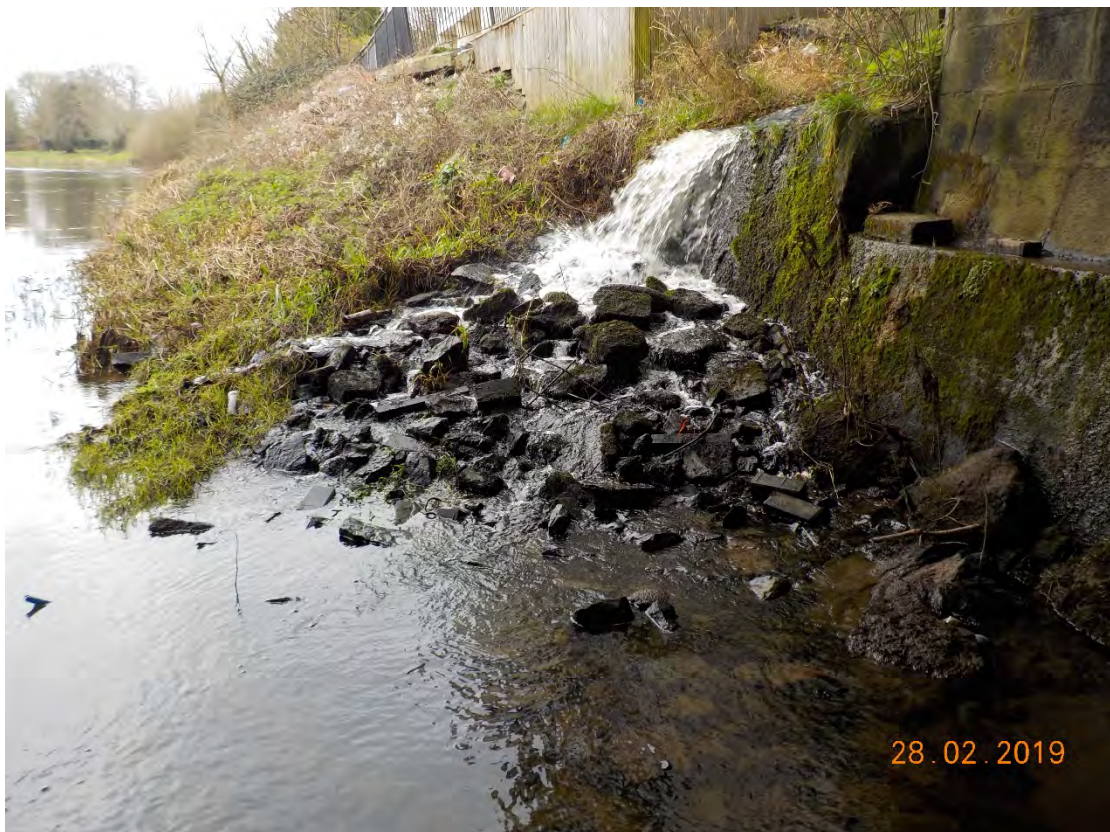
Photograph 3-75: River bed under Arch 5

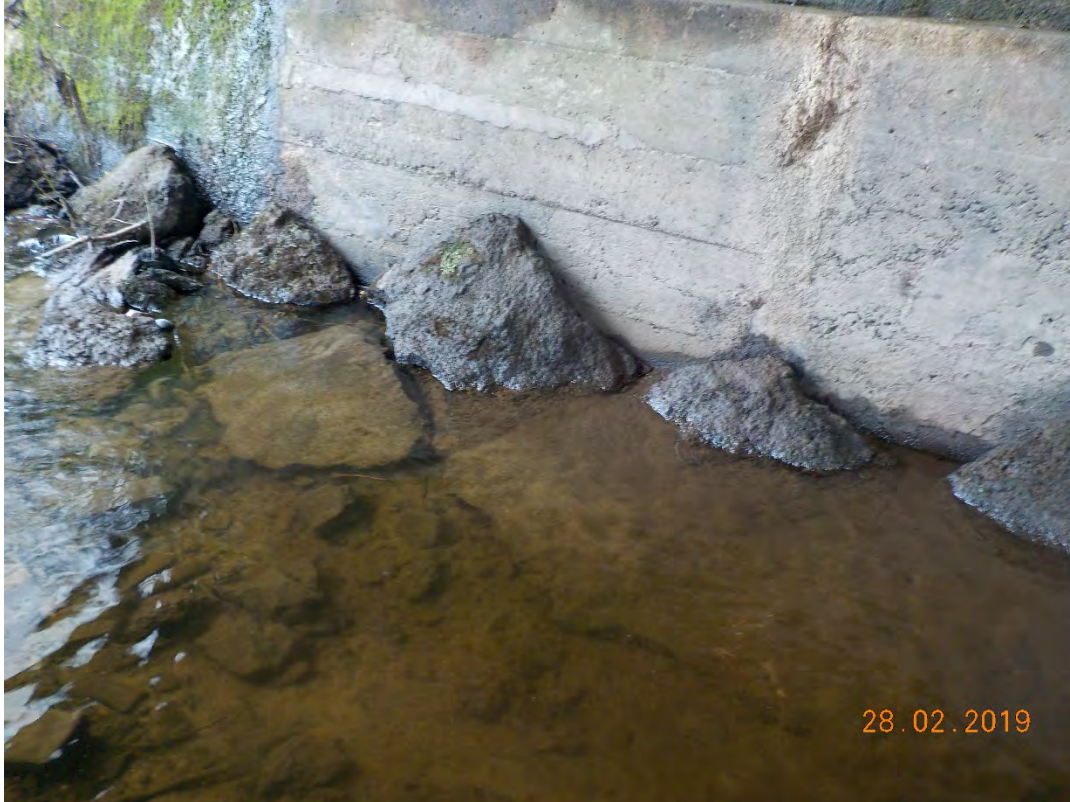
Photograph 3-76: River Bed under Arch 5

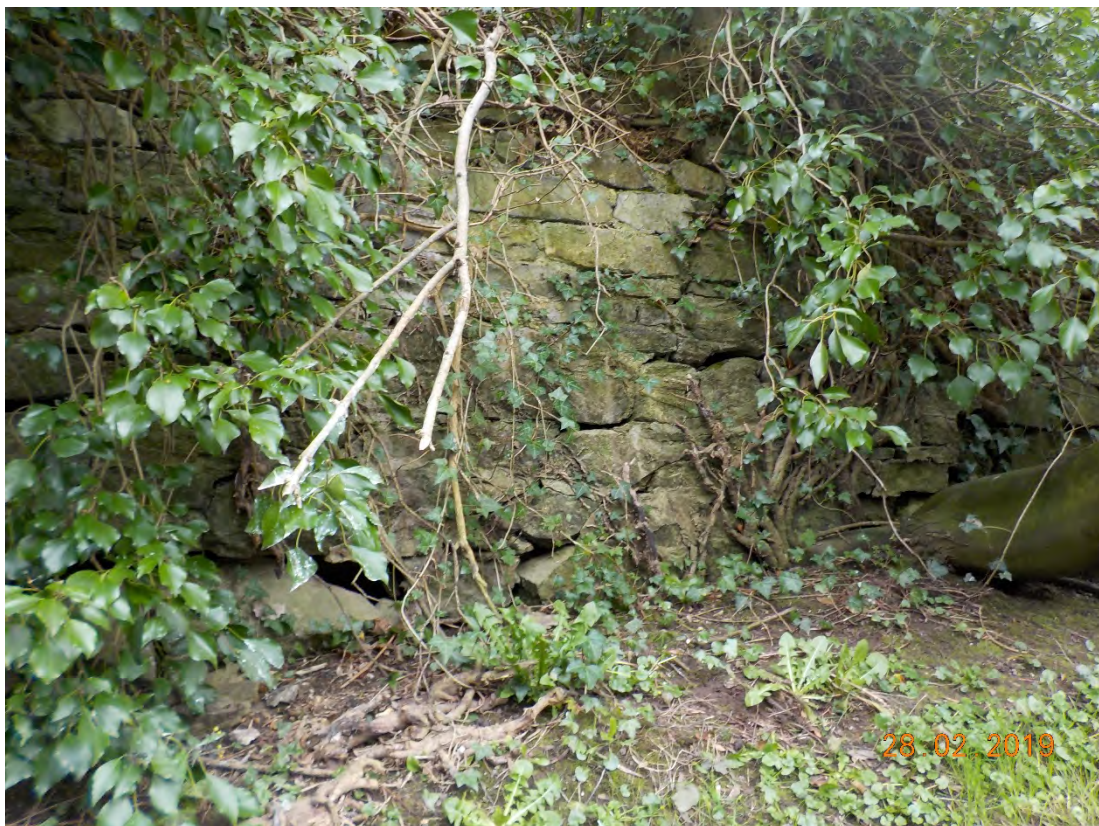
Photograph 3-77: Retaining Wall to be reconstructed

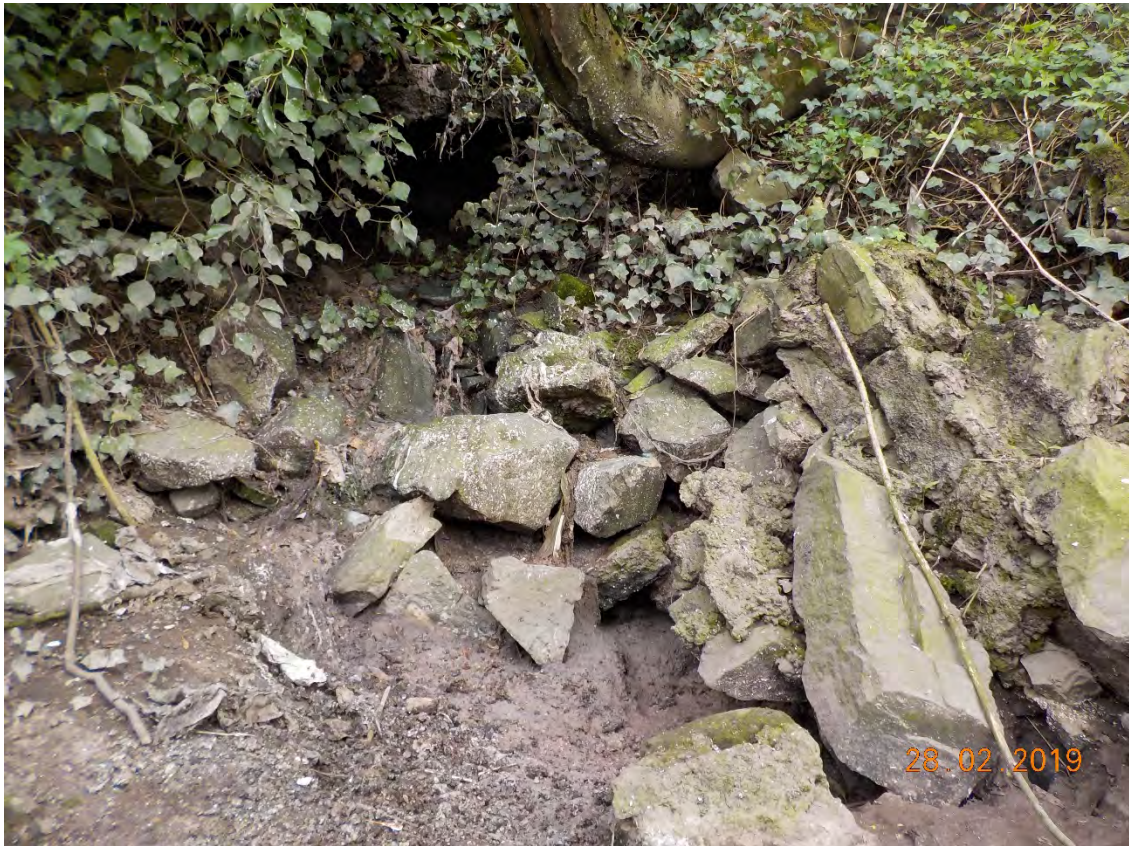
Photograph 3-78: Outfall to be reconstructed
