# **ASBESTOS SURVEY REPORT**

**(Refurbishment / Demolition Survey)**

**Location: Old Greenfields Site,  
Maynooth, Co. Kildare**

**Report No. PE21-279**

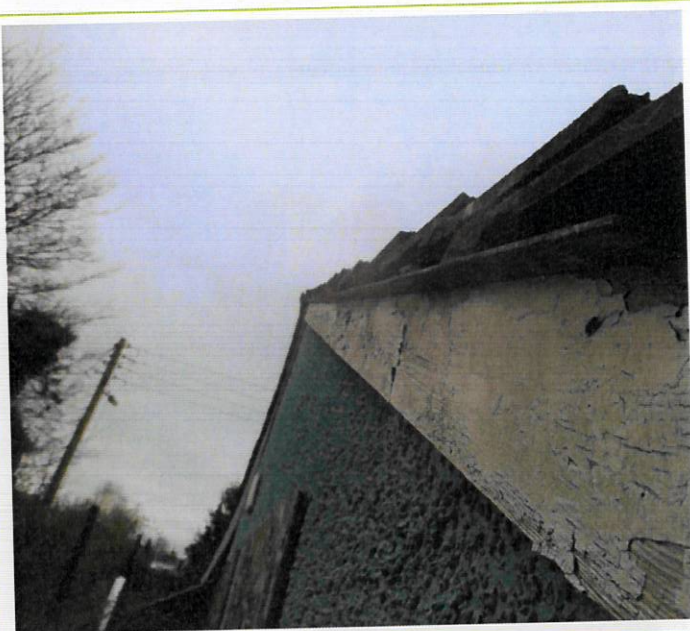
Created By	Andrew Hickey
Date	22 <sup>nd</sup> March 2021
Site Details	Old Greenfields Site, Maynooth, Co. Kildare
Client Name	Kildare County Council
Survey Type	R/D Asbestos Survey
Site Ref	PE21-279
Building Ref.	Rear extension
Location	Roof barge
Extent/ Amount	12 linear meters approx.

MATERIAL ASSESSMENT		PRIORITY ASSESSMENT
Product type	Cement slates	Normal occupant activity	N/A
Extent of damage	Low	Likelihood of disturbance	N/A
Surface treatment	None	Human exposure potential	N/A
Asbestos type	Chrysotile	Maintenance activity	N/A
	Material assessment score: N/A	TOTAL SCORE: N/A	Priority assessment score: N/A

The cement fillet slates identified along the roof barge of the rear extension contains Chrysotile (white) asbestos. Asbestos cement products generally contain 10 to 15% asbestos fibres, bound in Portland cement

The cement fillet slates should be removed by an asbestos removal contractor and disposed of as asbestos waste before the demolition works commence

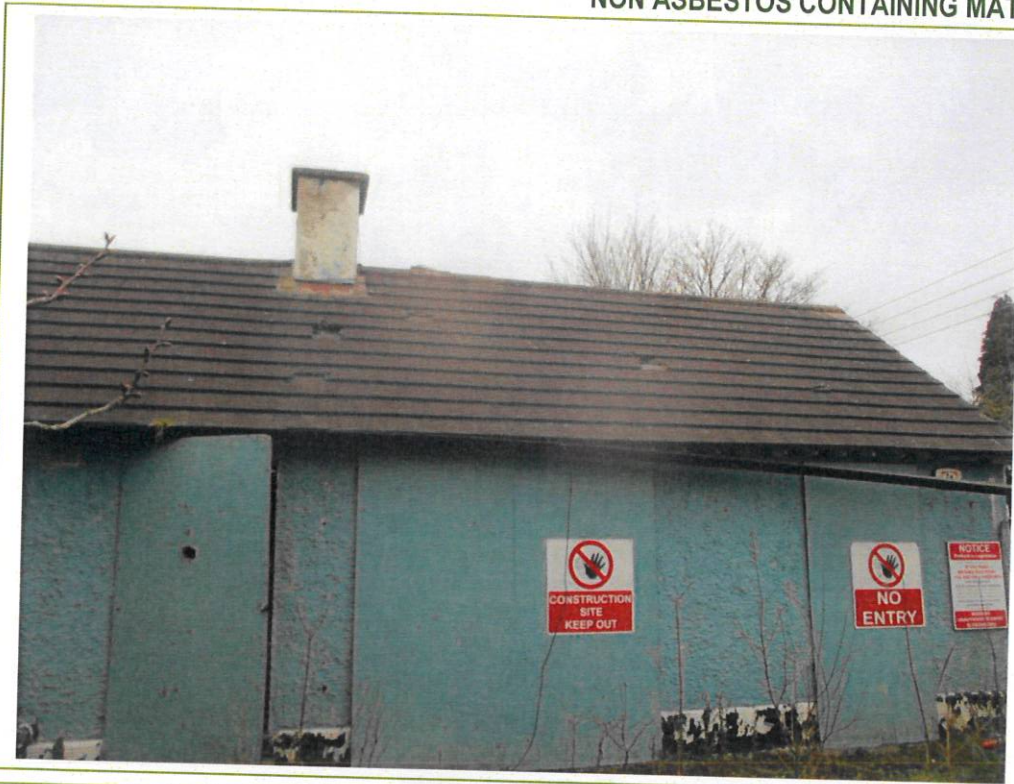
Concrete roof tiles

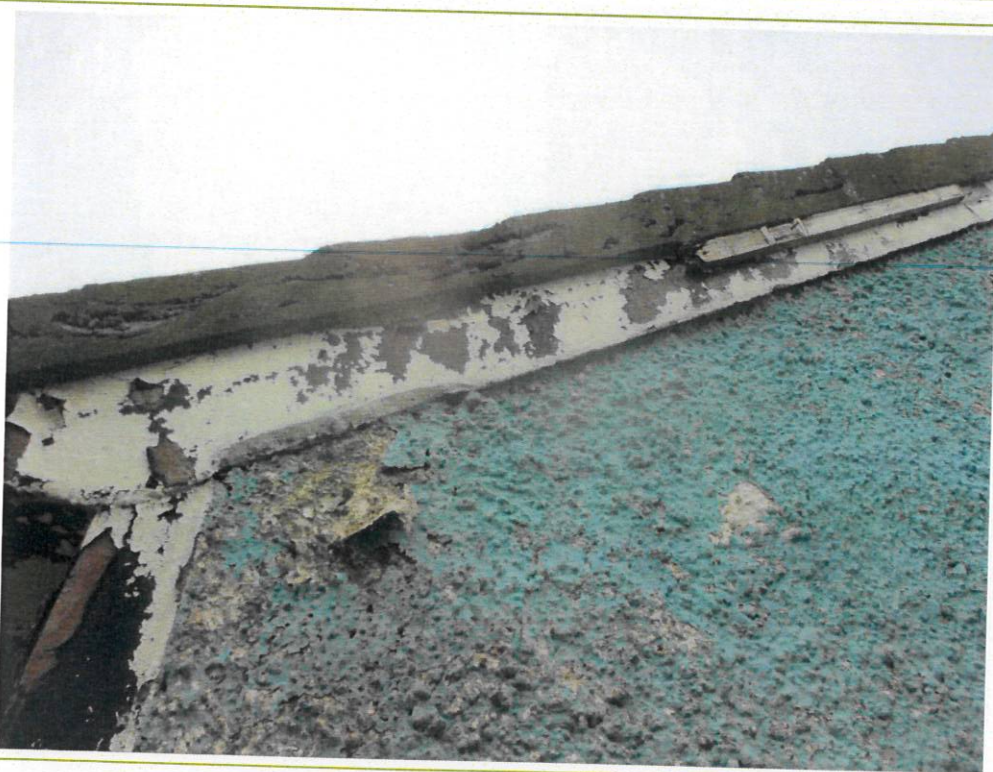
roof barge to front of property

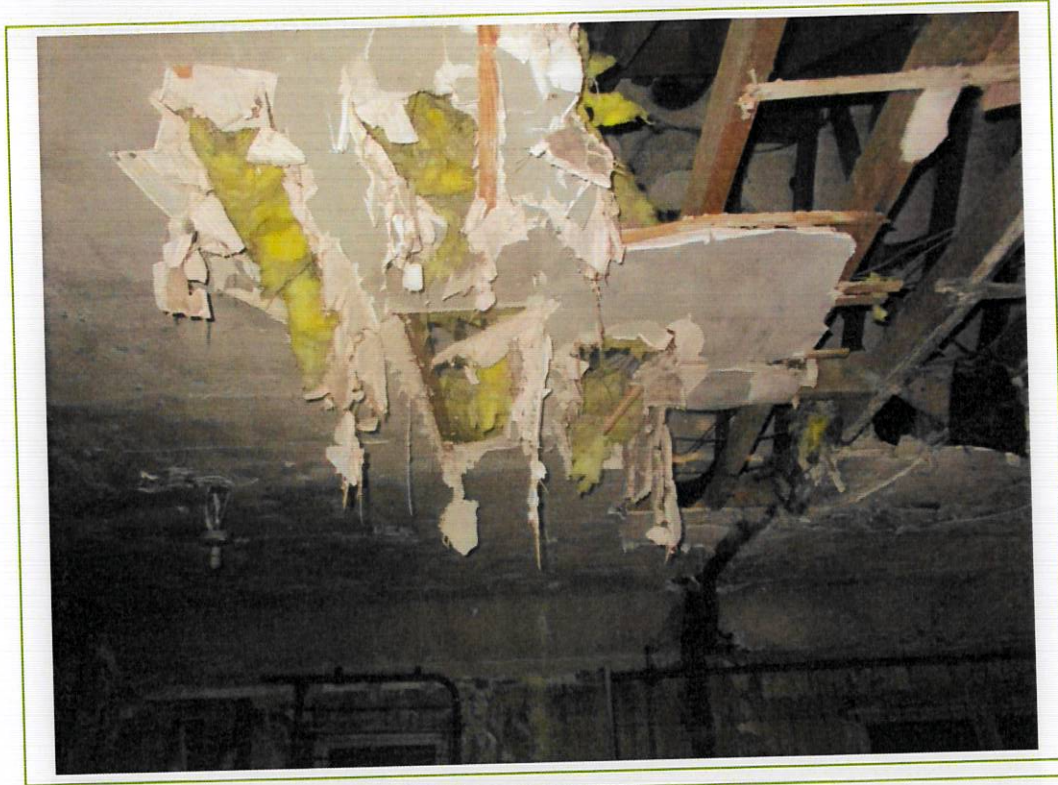
Plasterboard ceilings

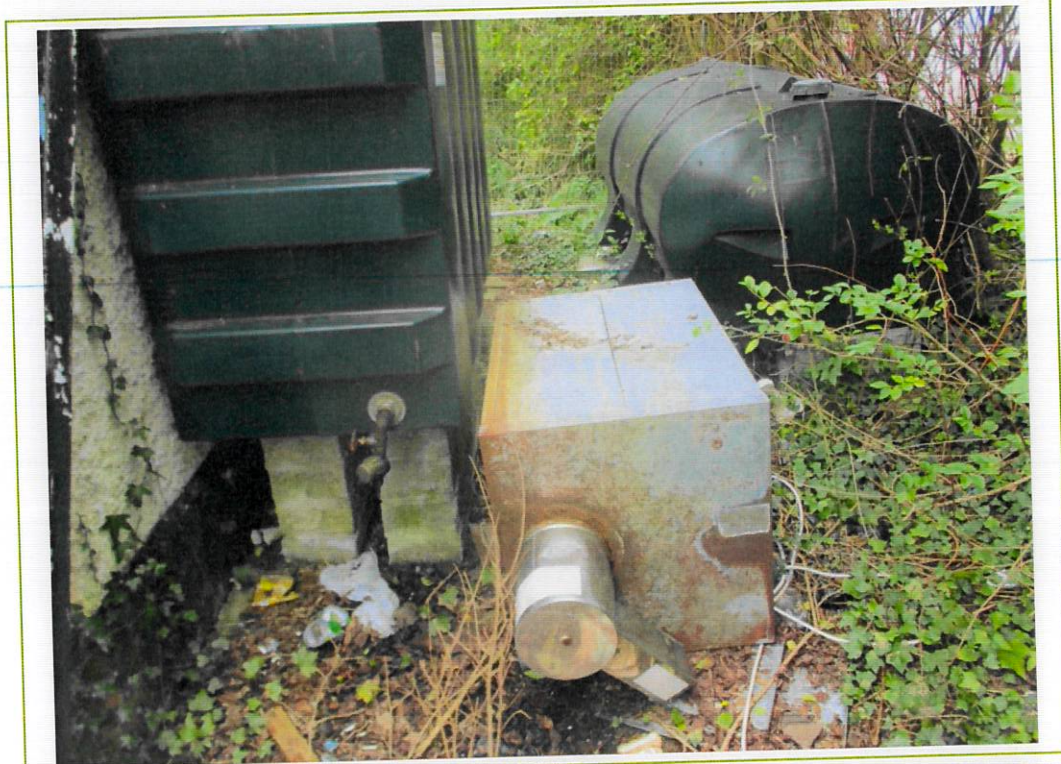
Boiler unit

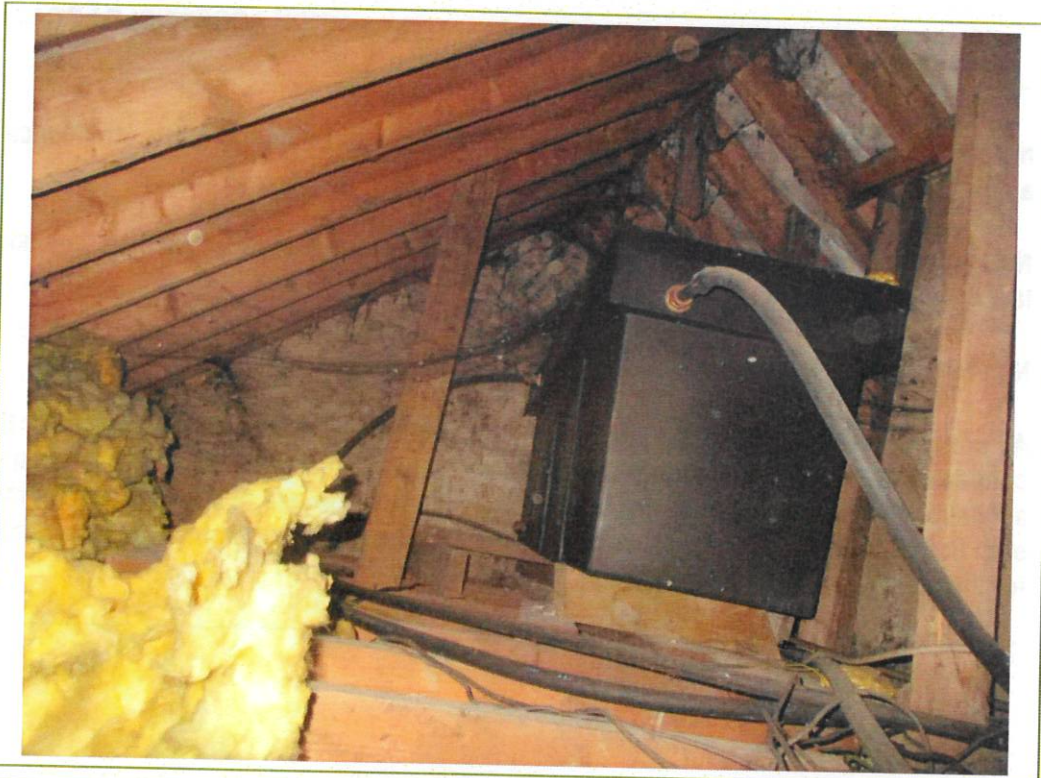
Plastic water tank

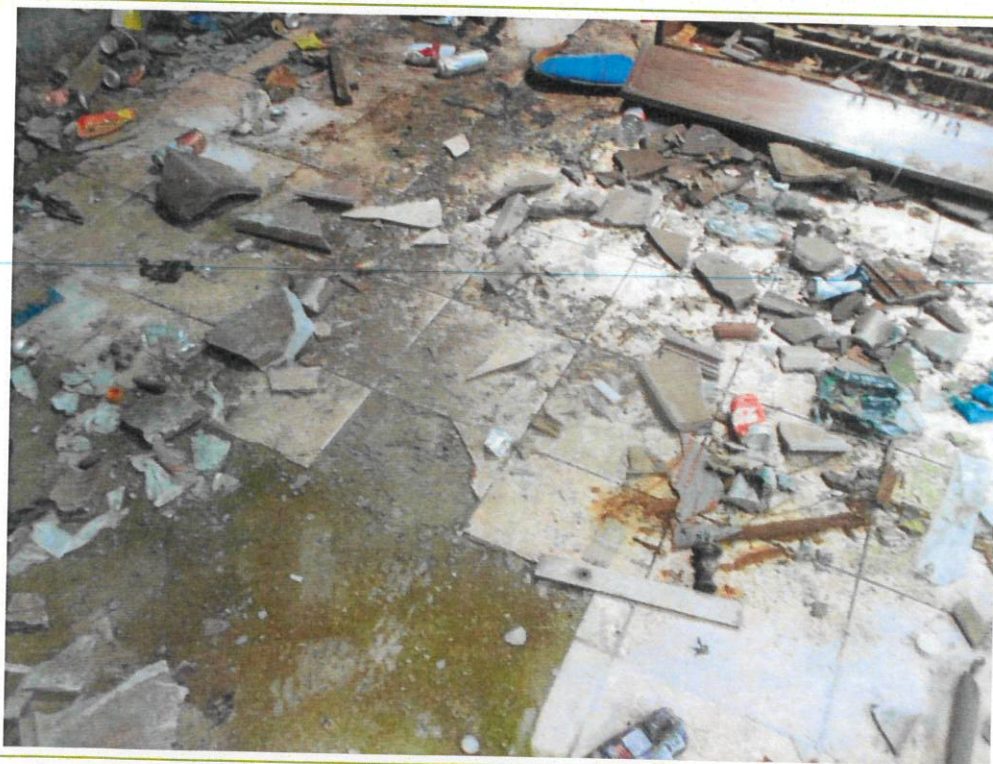
Ceramic tiles on the floors

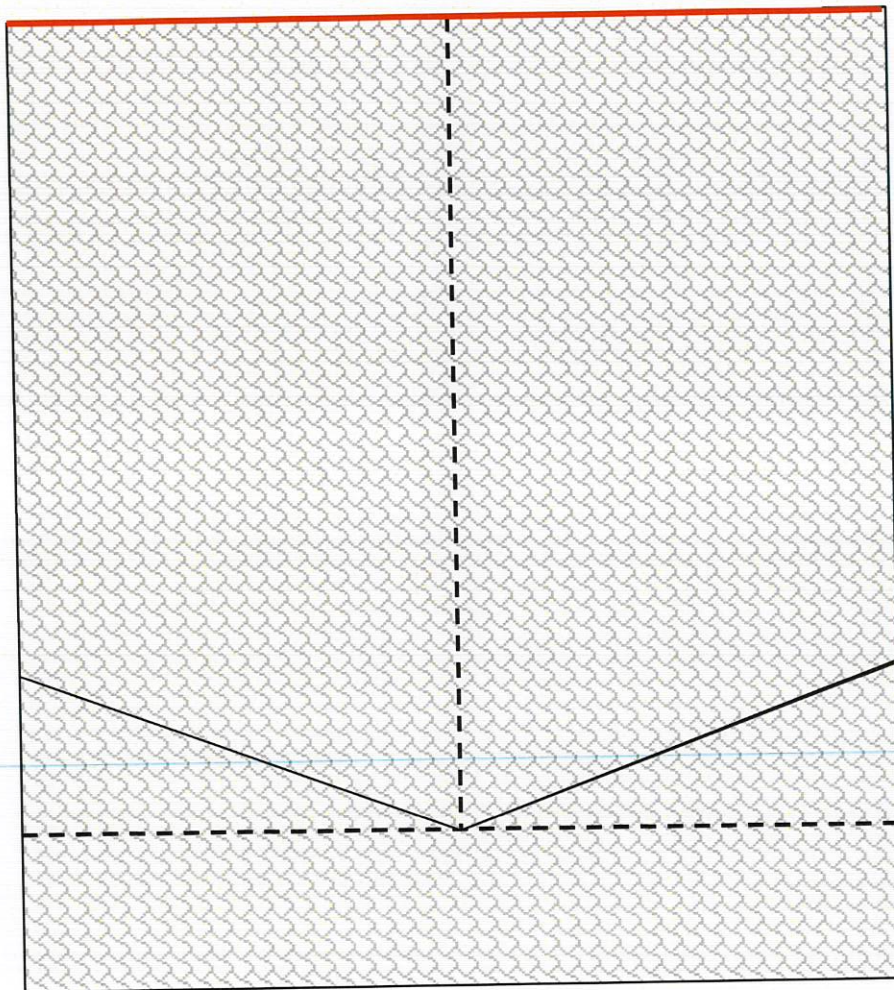
### ROOF PLAN

Areas where asbestos cement slates were identified
