Chief Executive's Report

For proposed Tree Preservation Order (TPO) in Caragh,
Naas, Co. Kildare

Planning Department,
Kildare County Council
14th July 2022

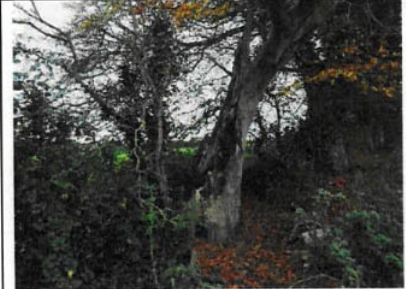
Degraded remnants of Beech tree T14

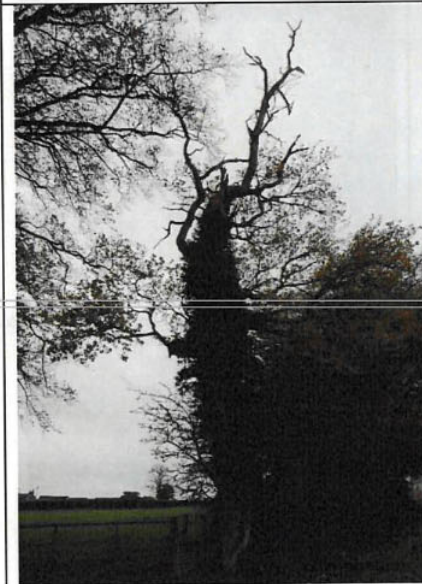
Dieback of Oak tree T15

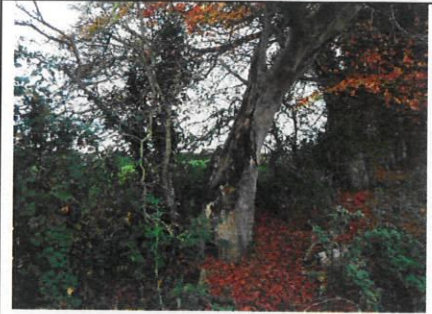
Degraded remnants of Beech tree T14

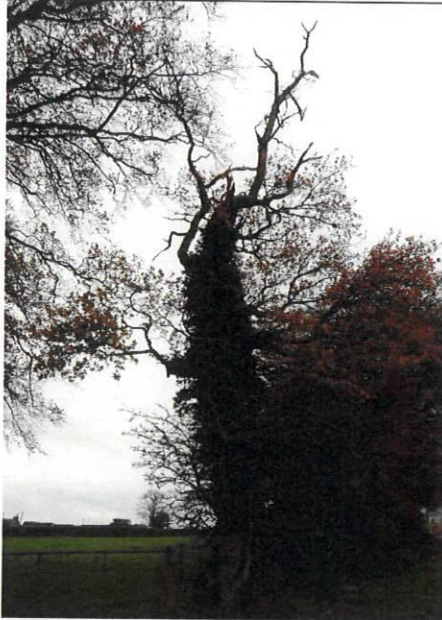
Dieback of Oak tree T15

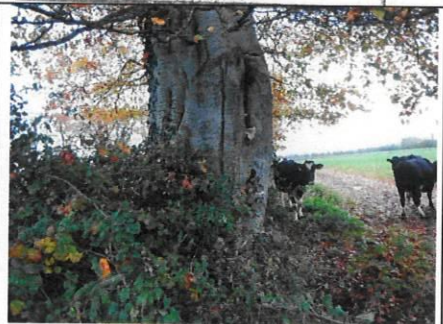
Ganoderma spp. fungi on stem of tree T21

T	21	Fagus sylvatica (Beech)	OM	21	1250	<10	Poor	Poor. Dieback in crown. <i>Ganoderma spp.</i> fruiting brackets on lower stem indicative of significant basal decay.	Not suited for long-term retention within a new development.	15	U
T	22	Fraxinus excelsior	M	15	600 est	<10	Poor	Poor. Large decay cavity at stem base. Epicormic growth and crown dieback indicative of Ash dieback disease.	Not suited for long-term retention within a new development.	7.2	U
T	23	Fraxinus excelsior	M	14	450 est	<10	Poor	Poor. Epicormic growth and crown dieback indicative of Ash dieback disease. Bark damage to stem base.	Not suited for long-term retention within a new development.	5.4	U

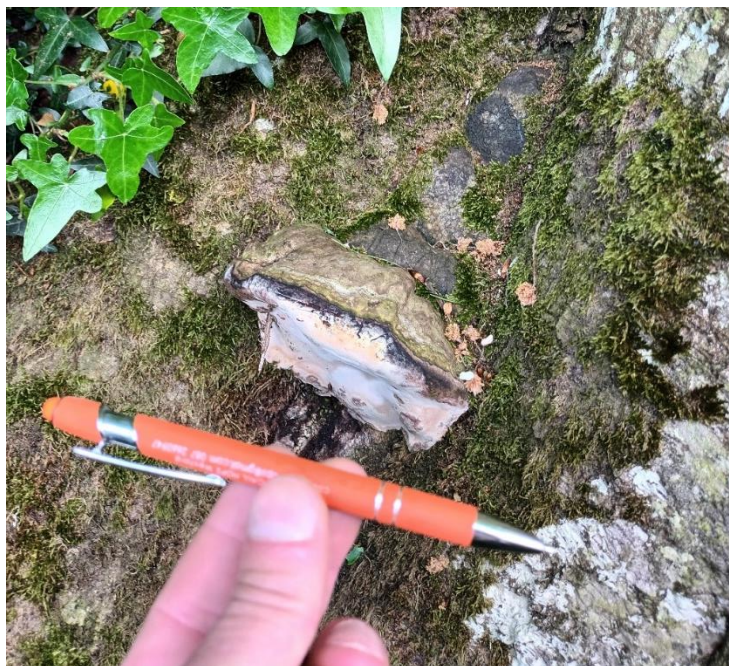
Opportunistic Decay Fungus on *Fagus sylvatica* (beech) Tree 0601

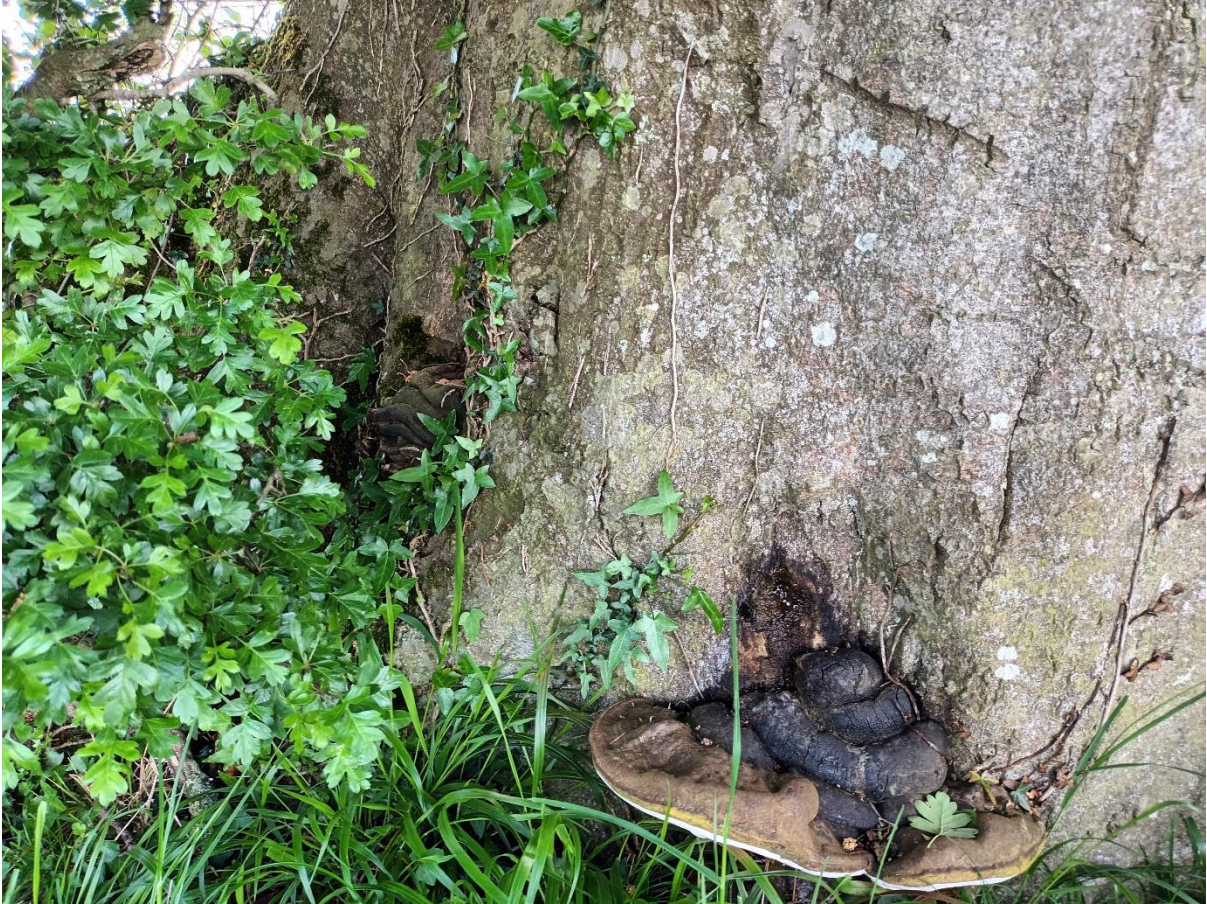
Opportunistic decay *Ganoderma* fungus on *Fagus sylvatica* (beech) Tree 0602

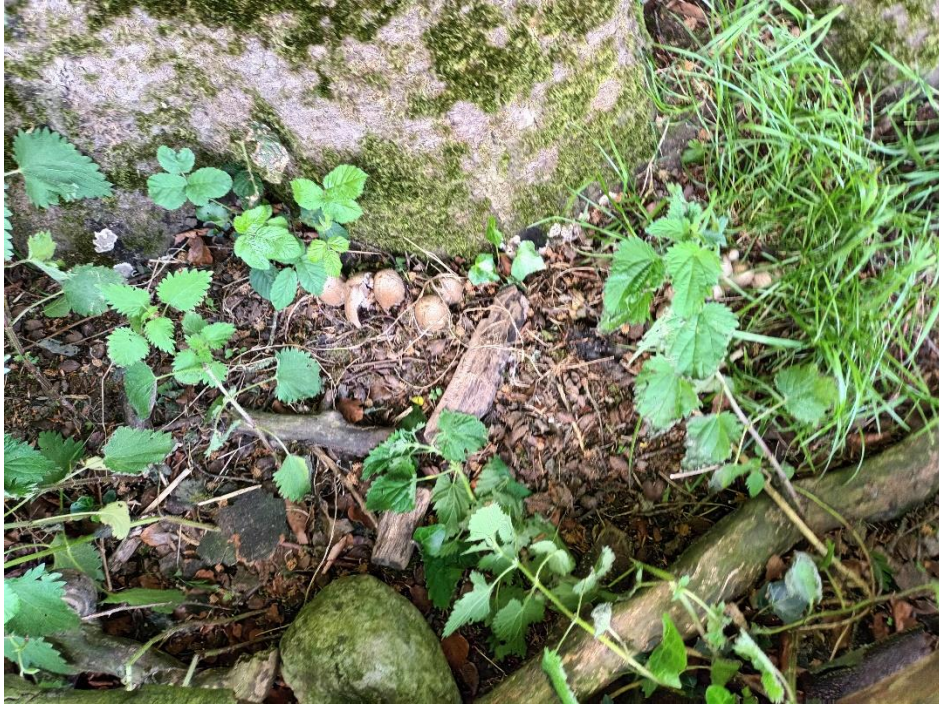
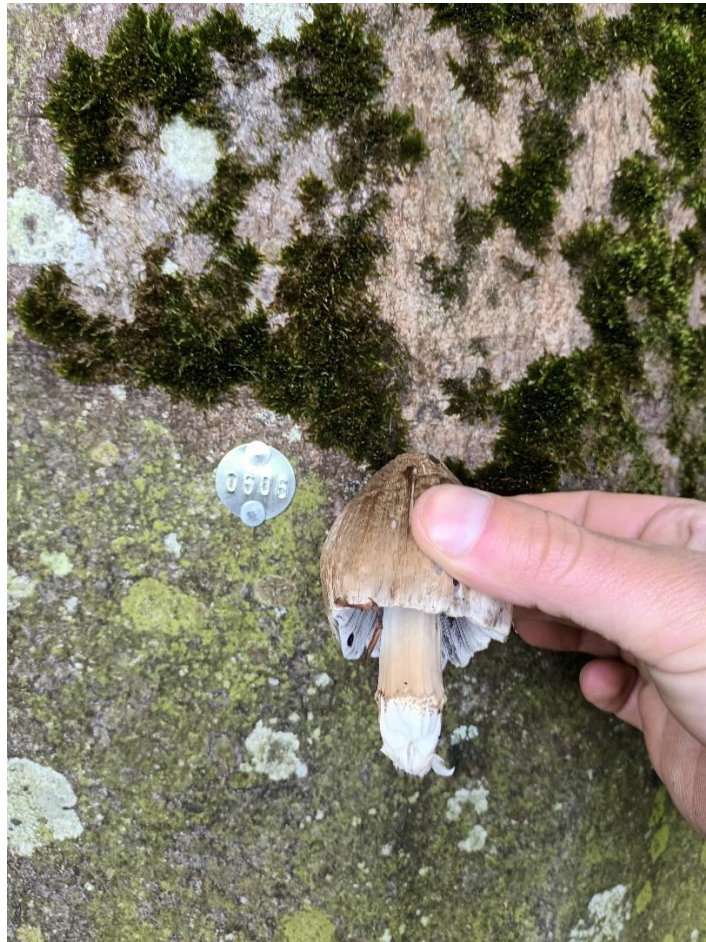
Mushrooms at the base of T0606

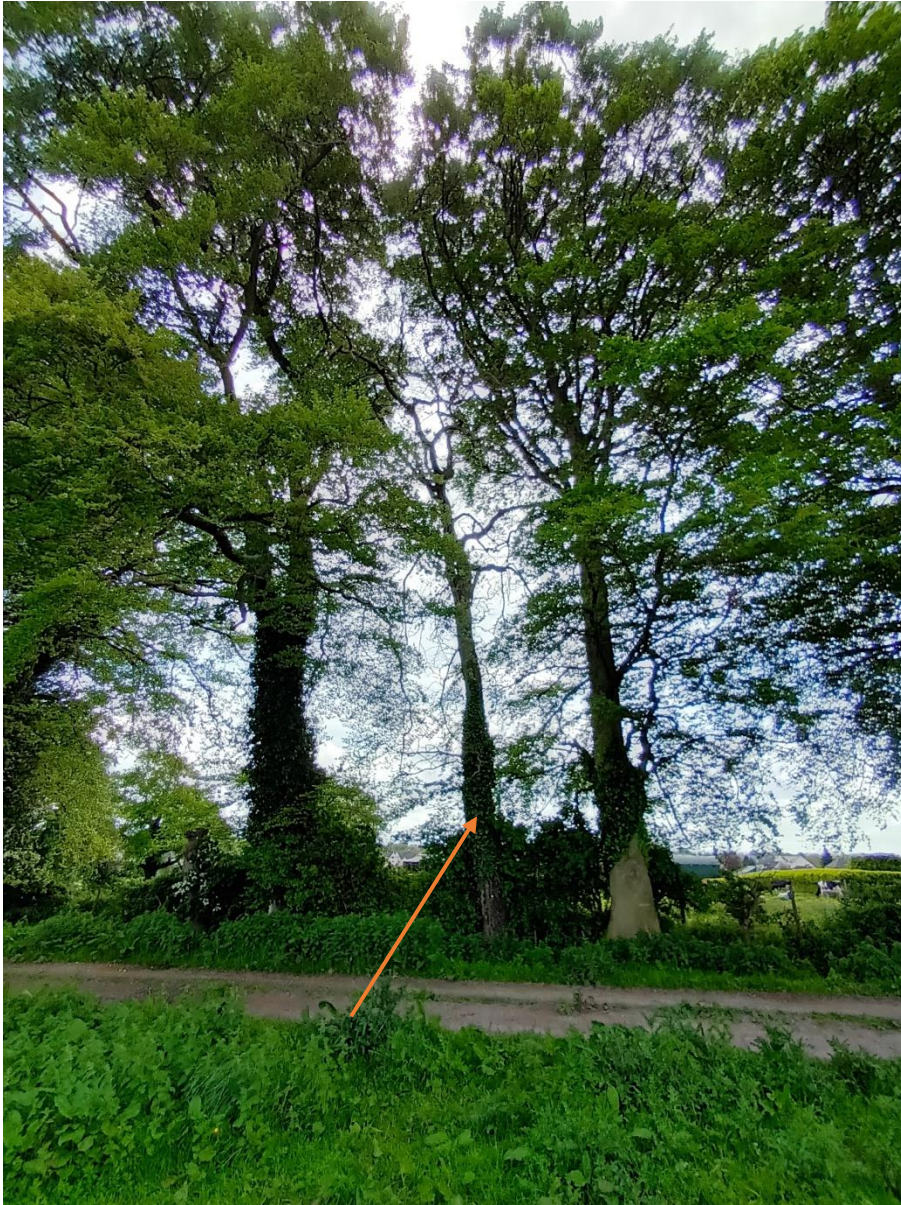
Dead tree 0609 in the centre lost in canopy of neighbouring trees

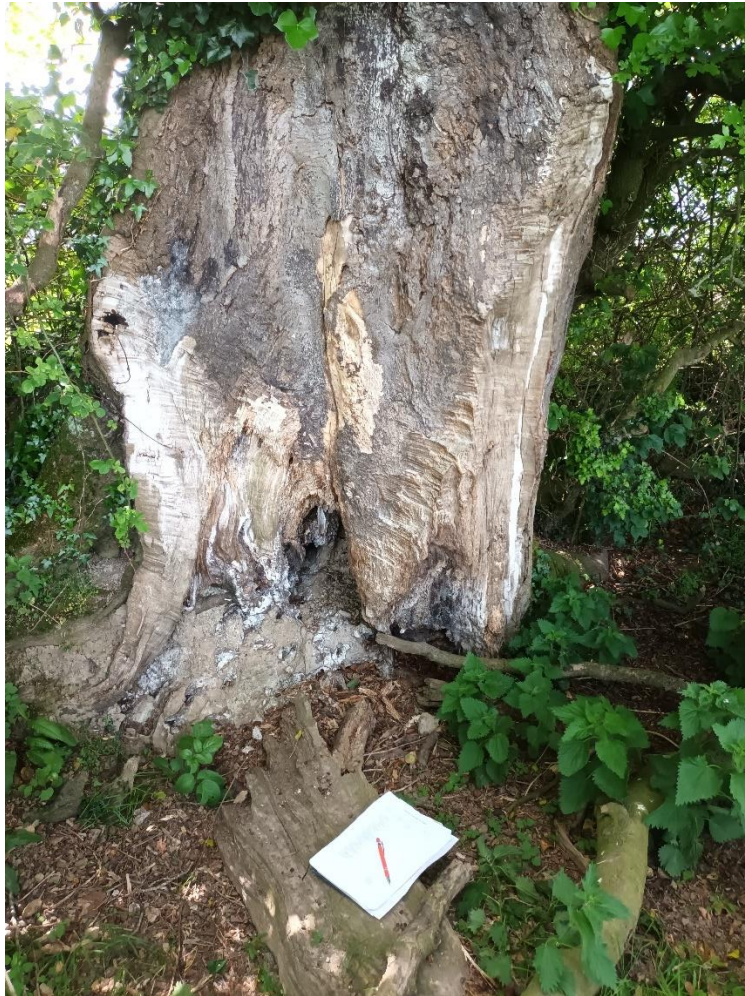
- Tree No. 9 is a *Fagus sylvatica* (Beech tree) and has significant damage to its buttress and lower trunk. The wound is approximately 2 metres high and 1.5 metres wide, with decay in the centre.
- Tree Nos. 19 and 20 are a *Fraxinus excelsior* (Ash trees) which show signs of Ash Dieback.

Significant Damage at the buttress of 0610

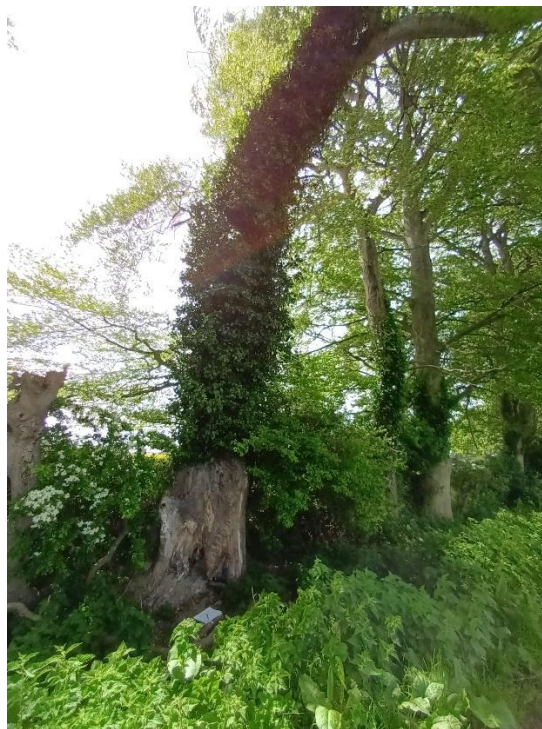
0610 leaning east

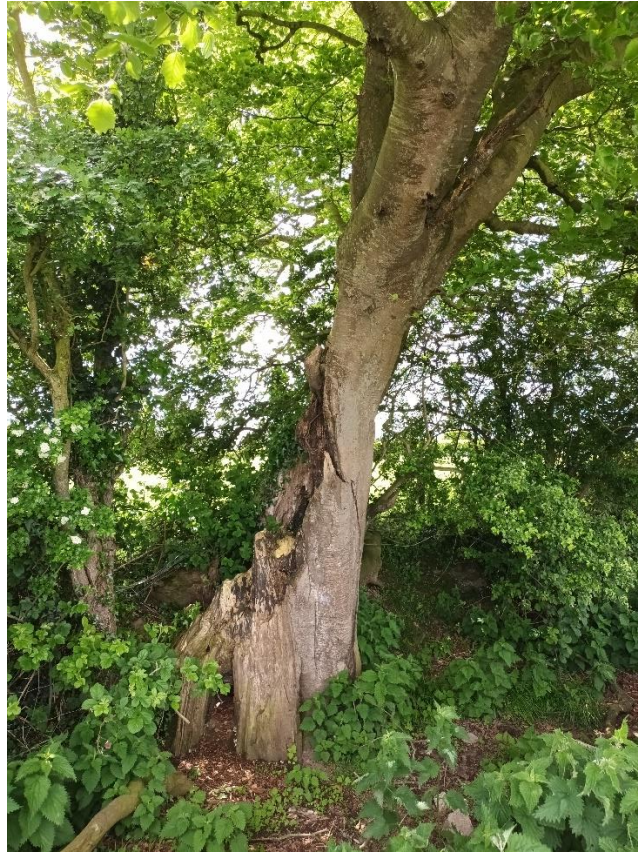
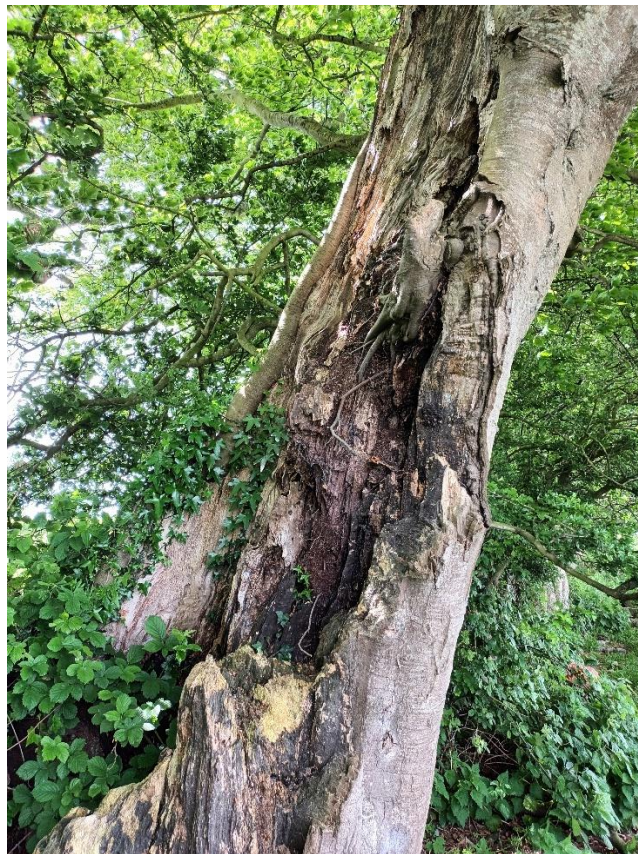
Damage to *Fagus sylvatica* (beech) 0614

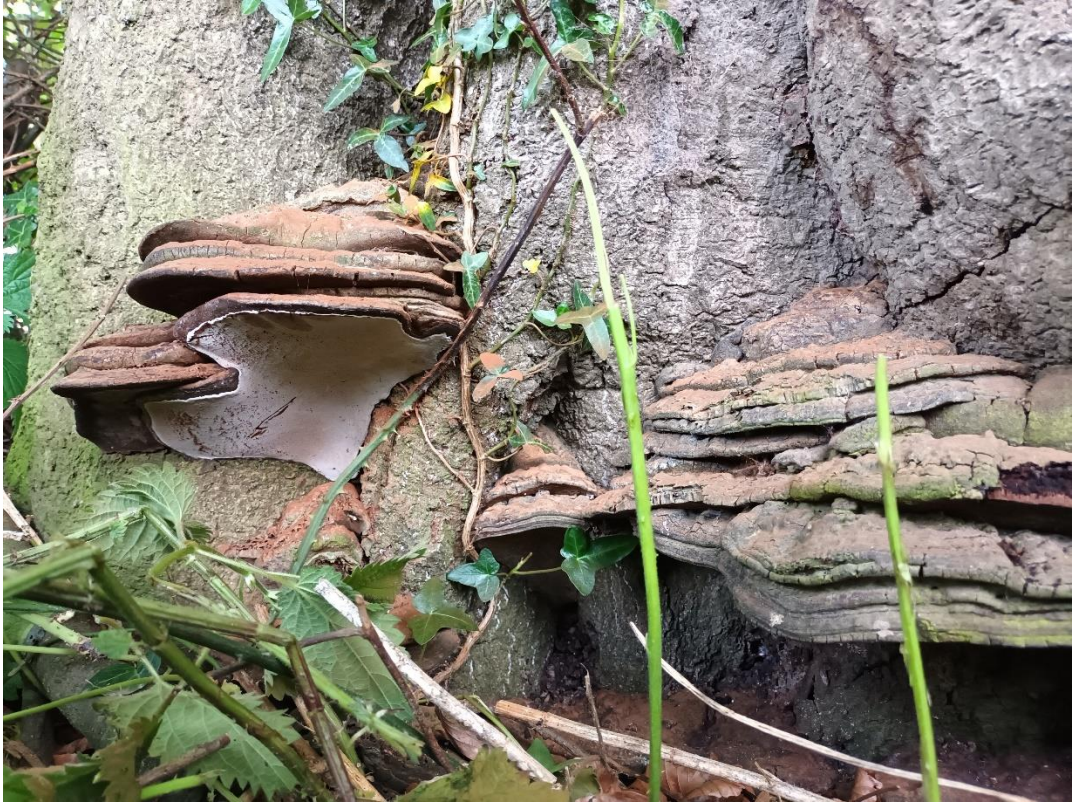
New *Ganoderma* fungi on 0621 *Quercus robur* (Oak)

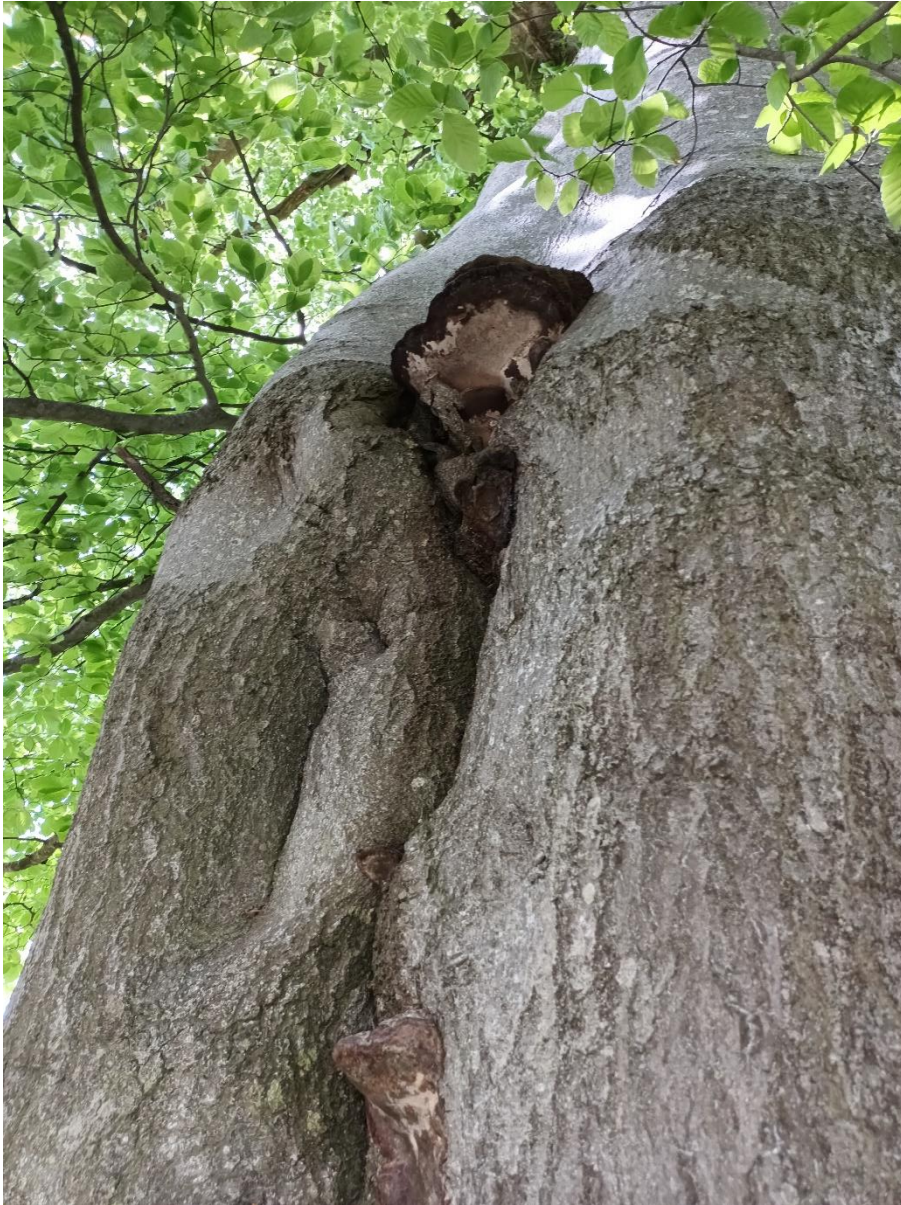
Old *Ganoderma* fungi on 0621 *Quercus robur* (Oak)
