Architectural Heritage Impact Assessment Report

No. 13, No. 18, Beaufort Cottage and Beaufort, Sallins Road, Naas, Co. Kildare

1201-PP-20260310-sf

10 March 2026

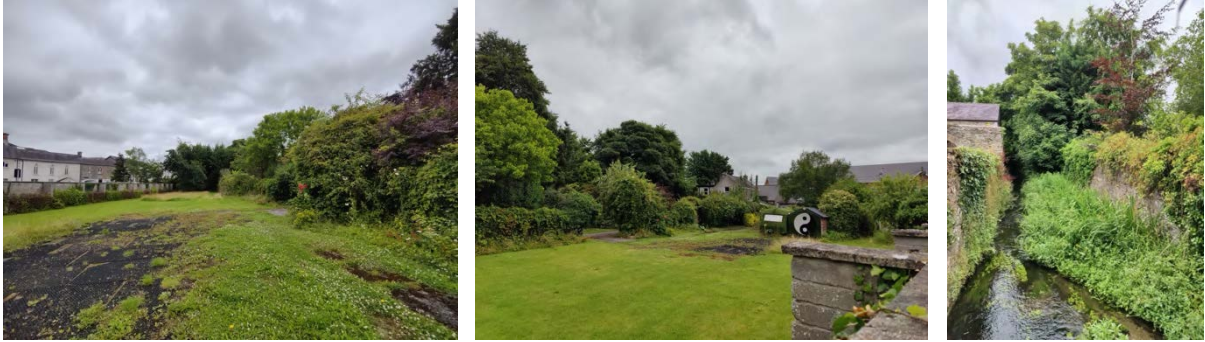
To the back the extension walls are covered in a dash render with uPVC windows and a painted timber door. Window sills are concrete with a raised concrete or smooth plaster plinth. Rain water goods appear to be metal, painted green. Each cottage has a small private garden at the back, opening into a shared garden behind. At the back of Beaufort Cottage there are concrete ground surfaces, with a small, low corrugated out-building attached to the north boundary, which is shared with Beaufort. The private garden is bound by mature planting. Behind this there is a large open lawn and well-kept planting and trees. The south boundary of the shared gardens is a modern concrete block wall with block piers.

Above: Photographs showing the shared back garden, behind the terrace taken in July 2024

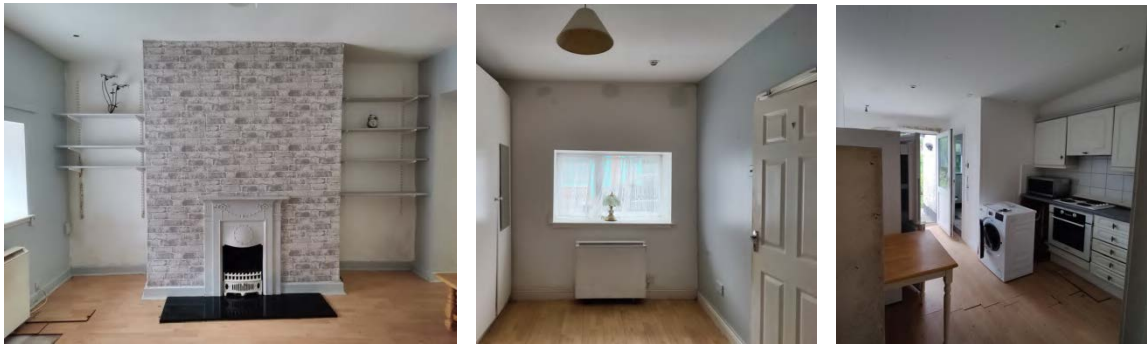
No. 13 Sallins Road has two rooms to the front and three in the extension at the back. Internally the fittings and finishes have been recently renewed and are in good condition. The walls and ceilings are modern plaster board to the front with sheeting added to the walls and ceilings at the back. The flooring is laminate over a concrete floor slab. Sanitary fittings, kitchens and internal joinery are modern replacements. There is a Victorian era cast iron fireplace in the front reception room, with a replacement polished marble hearth. Opening up has been carried out for an asbestos survey.

Above: Photographs showing the interior of 13 Sallins Road taken in July 2024. All wall, floor and ceiling finishes are modern replacements.

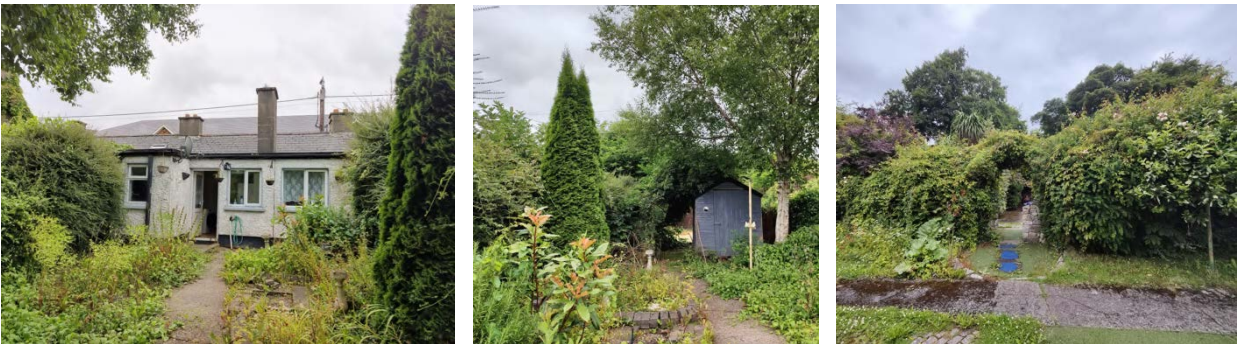
The back elevation of No. 13 is covered in a painted dash render with a smooth plaster plinth and concrete cills and reveals to the windows which are uPVC casements. Rainwater goods are black plastic. There is a tall chimney stack rising from the middle of the rear extension roof. It is rendered with a concrete cap. Ground surfaces to the back are concrete paths with brick kerbs and gravel filled beds. At the back of the cottage it is overgrown. There is a detached free-standing timber shed and a partially paved mixed terrace behind. The boundaries are make-shift mixed material.

Above: Photographs showing the back of 13 Sallins Road taken in July 2024.
