**The Food, Drinks & Skills Innovation Hub
at
The Model School
Athy**

Project Report

**Including
Architectural Heritage Impact Assessment**

**for
Part 8 Public Consultation**

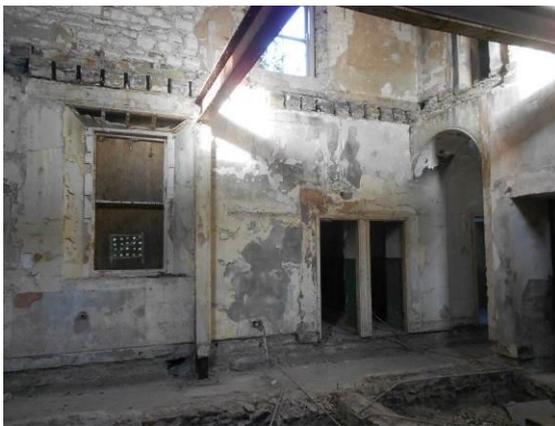
2. RG26 Cafe

The structural integrity of the steel frame in RG26, Café, cannot be assumed. It is likely that the steel frame was introduced in tandem with the removal of a structural wall between RG26 and the corridor along the north side of the room in order to create a larger space. A new first floor is proposed as set out in item 1 above and the remaining fire damaged steel will be removed.

Note in relation to access to exterior from cafe:
Following the demolition of the lean-to toilet block extension in the rear yard, the paired door openings can form a single wide opening to access the outdoor 'breakout space'.(See Pictures 2 and 15).

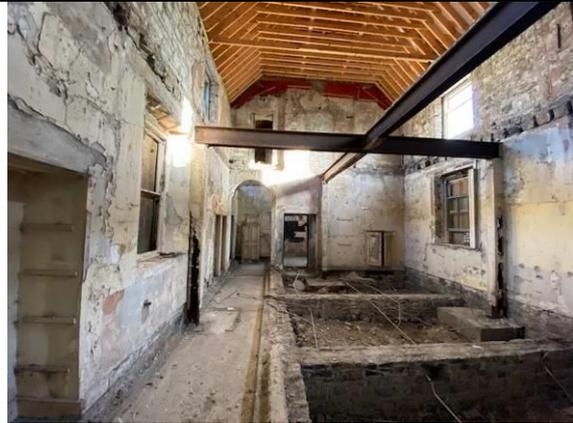
View of proposed cafe area and corridor line RG26, see also Picture 4.

Existing suspended timber floors have been removed from these areas. The design of the existing floor along the former corridor with very shallow void, combined with the extent of dry rot in the premises would indicate that there is a high risk of timber decay occurring in such a situation. Options considered include:

In this area we conclude that option 3 is the most appropriate. The reinstatement of substandard timber floors and due to the poor ventilation on the corridor section would not be appropriate as long-term issues in relation to timber rot are likely to reappear. The digging out of the floor to create a void and adjustment of the ground levels externally to facilitate adequate ventilation in these areas was never contemplated by the original construction. We therefore conclude that the provision of new concrete floor with stone slab finish is appropriate in this location. The following mitigation measures were considered:

- The reinstatement of the suspended timber floor will allow an example of the original floor construction in this area. The area currently has extensive dry rot infestation which is being treated however there is a high risk of re-infestation. Measures will include upgrading of under floor cross ventilation including provision of additional ventilation tubes for ventilation between the floor void and the rear yard to the north. To avoid the risk of timbers touching walls, it is proposed that new tassel walls shall be provided set back from all external walls and that the existing tassel walls will be lowered but not removed to allow for interpretation of the original tassel wall positions. Existing material and all existing timber debris within the void will be removed and a new permeable layer will be provided at the base of the ventilated void.

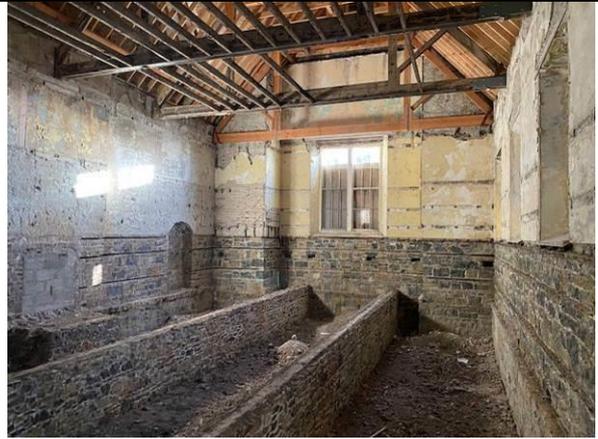
Example RG 22-25

The existing ventilated voids are deep.

Existing suspended timber floors have been removed from most of these areas. In some areas the timber floors have been partially opened up and extensive areas of rot are being treated. Options considered include:

- The fitting of the suspended concrete floor can be undertaken in the same method as a suspended timber floor.
- The area currently has extensive dry rot infestation which is being treated however there is a high risk of re-infestation. Measures will include upgrading of under floor ventilation including provision of additional cross ventilation To avoid the concrete touching the internal or external walls, it is proposed that new tassel walls shall be provided set back from all external walls and that the existing tassel walls will be lowered but not removed to allow for interpretation of the original tassel wall positions. Existing material within the void will be removed and a new permeable layer will be provided at the base of the ventilated void. On balance, this approach is considered to respect the character of the Model School while also addressing the HSE licensing requirements for food areas.

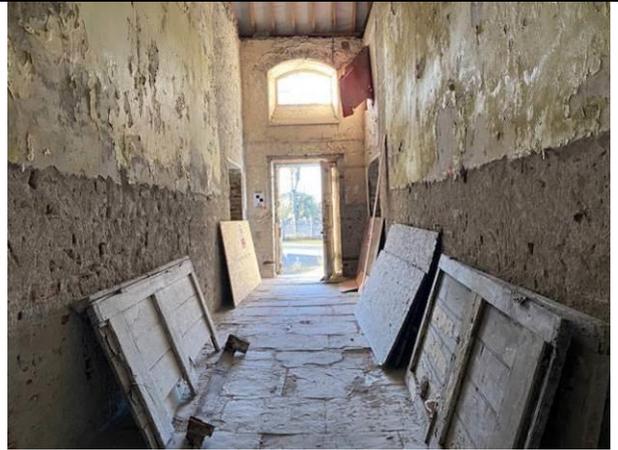
View of corridor RG20

The corridor areas have stone slabs or very shallow sub floor voids

Option 1 does not facilitate the long-term use of the building and in particular universal access. The current floor is very uneven and in the future use of the building would not be user-friendly in particular for persons with special needs or wheelchair use. In addition the slabs are damaged in locations. The lifting of the

1. Make minor repairs to stone.
2. Lift stone and re lay on weak limecrete bed on stronger limecrete slab on well compacted hardcore. Where there is inadequate stone salvaged, provide sections of modern sympathetic stone slab finish in areas where existing shallow void is in place currently.
3. Lift stone and re lay on weak limecrete bed on new concrete floor on insulation and damp proof course. Where there is inadequate stone salvaged, provide sections of modern sympathetic stone slab finish in areas where existing shallow void is in place currently.

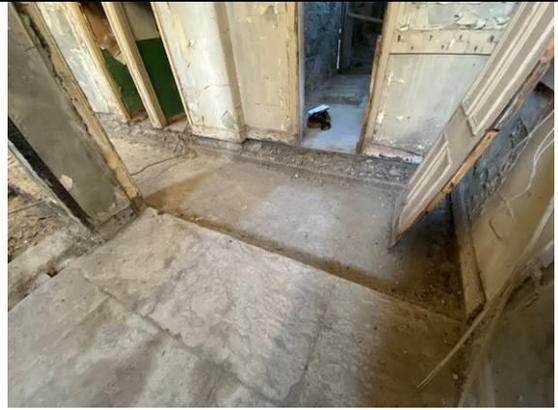
- Provision of stone slab of modern material will be used to make up for areas where the slabs are missing. (Example below of section of floor in entrance hall RG30 linking through to stairs area RG29

- Priority shall be given to refitting the original slabs to the key routes in the building with the secondary routes being provided with new slabs where necessary.

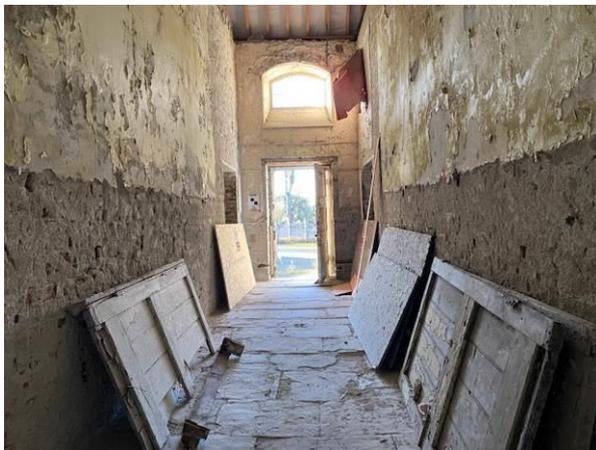
6. RG29 Hall

The hallway and main corridors retain the stone flagged floors in varying states of repair.

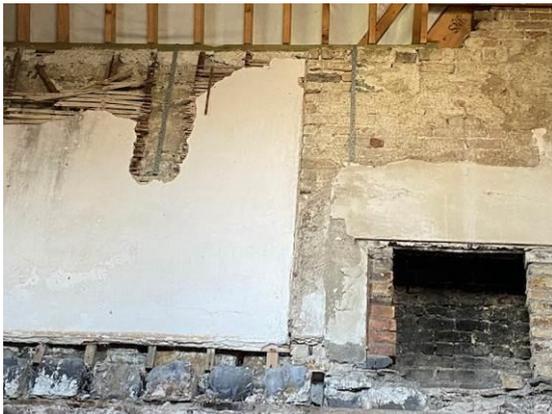
10. Example a section of lath and plaster remaining.

The approach to internal wall finishes is to repair in like manner the limited areas of lime plaster and lath & plaster which remain and where there is no indication or likelihood of dry rot.

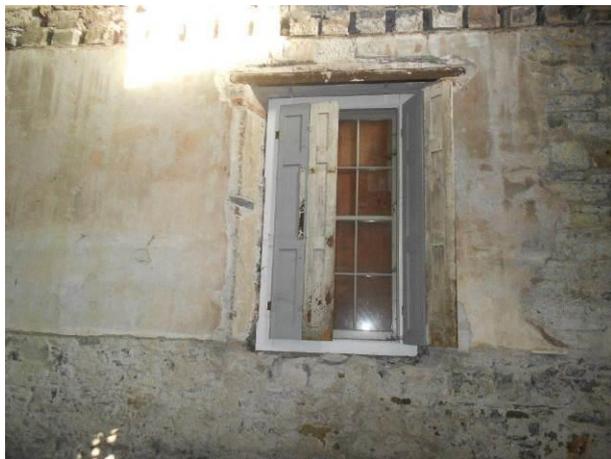
12.

Most of the windows in the single storey wings survived the fire of 2010 and will be repaired in accordance with conservation best practice.
