# ARBORICULTURAL ASSESSMENT & IMPACT REPORT

Wonderful Barn, Barnhall,  
Leixlip, Co Kildare

TWON002

17 MAY 2024

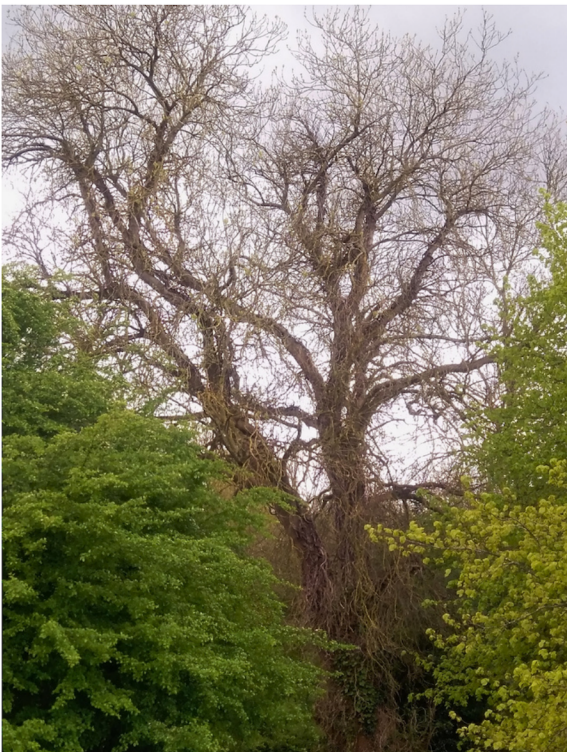
Image 4 - Ash tree #1679

The category A trees in the park generally are all of notable qualities such as Ash (*Fraxinus excelsior*) #1679 (image 4). Standing out from the trees around them in size and age features, these notable trees offer habitat for birds and bats with their ivy-covered stems and various hollows.

All category A trees within the park are of an age, condition, and significance to the local history of the area that we recommend the creation of tree preservation orders (TPOs) for their continued protection into the future.

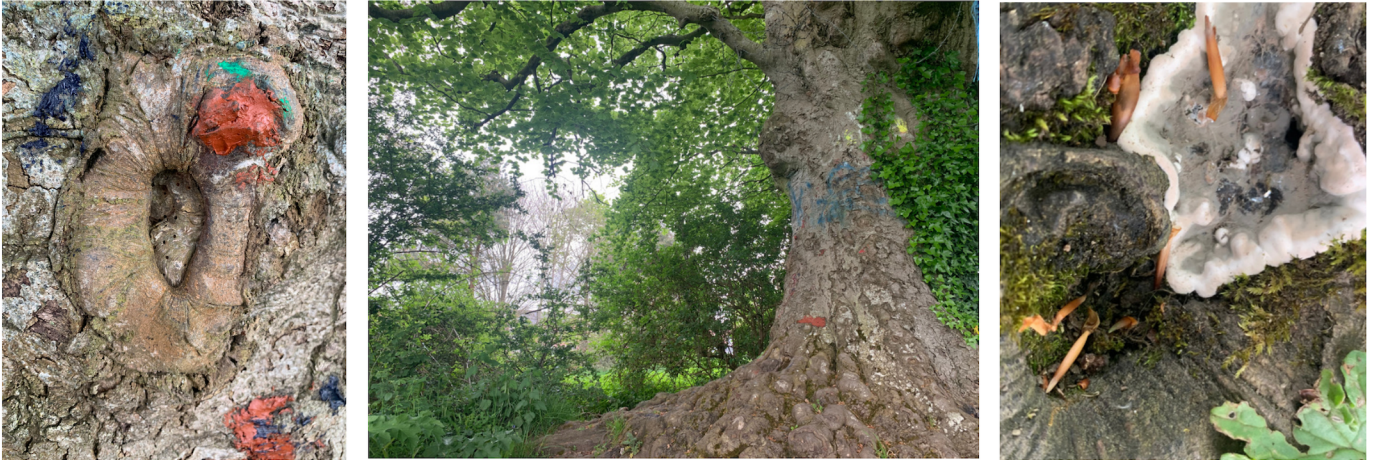
Image 8, 9, 10 - Beech tree #703 and some of its features.

The survey identified Beech #703 as having distinctly veteran tree characteristics.

Decay present at base of tree and fungal colonisation present on stem.

Retrenchment of crown and signs of previous central stem failure. The crown has since reformed.

Pockets of decay at points of limb failure throughout crown as well as fully sealed points of limb failure creating gnarled features on tree stem.

Cultural significance of tree - seen in the hanging of swing and various spray paints/painted hand prints.

Measures should be taken to protect and maintain tree #703. The barbed wire and debris in the canopy should be removed.

The root area should be protected from compaction and other damage. This can be done by: avoiding frequent and close mowing of grass in the RPA (root protection area); avoiding use of pesticides and fertilisers; restricting passage of foot traffic in the area; applying mulch to RPA as additional barrier to compaction.

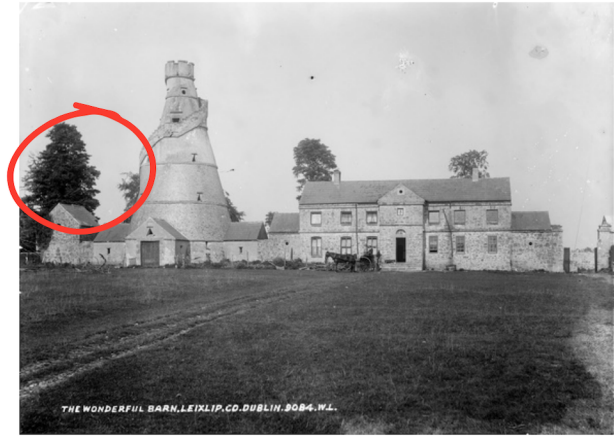
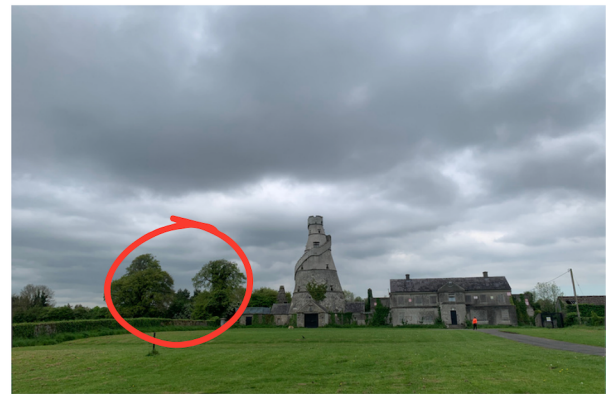
Present in the same hedge are other Beech trees which have some signs of crown retrenchment, but as the trees are largely obscured by ivy, other veteran features can not be well identified.

It should be noted that the ivy cover of these trees both provides potential habitat for birds etc. while also increasing the wind sail effect on the tree which may make the tree more likely to fail in strong winds. A balanced consideration should be taken to whether or not the ivy is removed and it is advisable that an ecologist also be consulted.

Image 11 - Photo of the Wonderful Barn circa 1900 with Beech #704/#705 visible in the background (c) National Library of Ireland

Image 12 - Photo of the Wonderful Barn 2024 with Beech #704/#705 visible in the background

Continual monitoring of these trees is recommended to ensure their continued health.
