**FORMER ESB PREMISES
LEIXLIP**

**ARCHITECTURAL HERITAGE
IMPACT ASSESSMENT**

19th October 2023

**Historic Building Consultants
Old Bawn
Old Connaught
Bray**

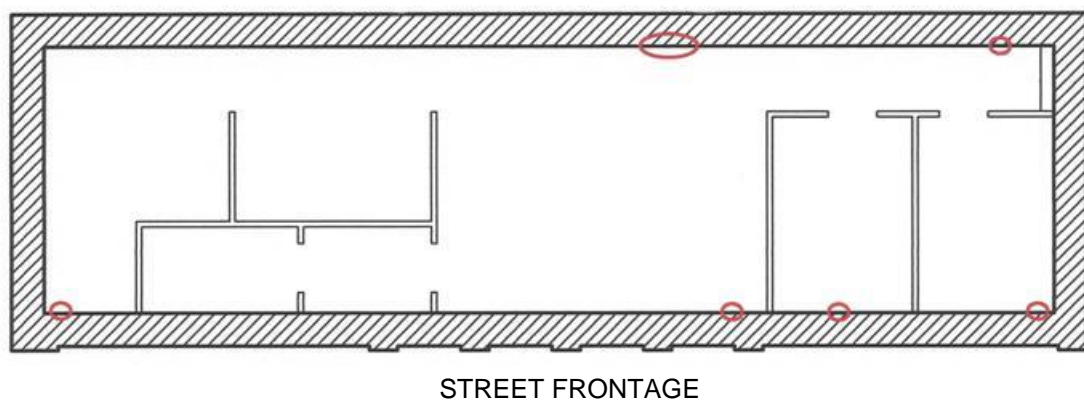
Figure 4: Sketch plan at first floor showing locations of opening up

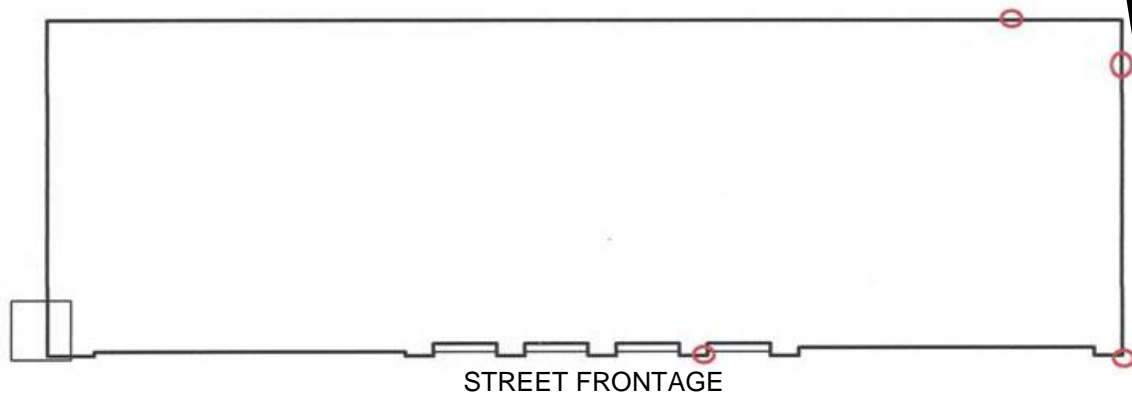
Figure 5: Sketch plan of external face at ground level showing opening up

Surprisingly, the one area at the rear of the building that was investigated proved to have concrete blockwork beneath the roughcast render. It is concluded that there is a blocked doorway at this location and the blockwork is merely the infill of the ope.

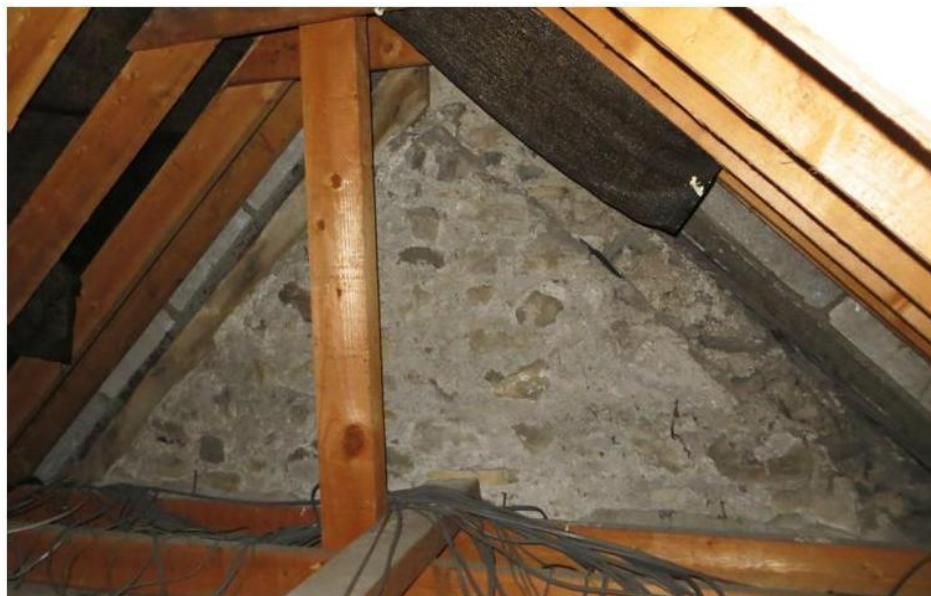
Plate 14: Inner face of eastern gable

At either end of the roof the inner face of the gable is visible and is constructed for the most part from rubble limestone set in lime-based mortar. The outer portion of the gable rises higher than the inner portion, leaving a recessed section of masonry which originally held the end rafters. On the northern slope of the eastern gable one of the rafters is still in place, though serving no purpose. This is visible in plate 4 above, to the left of the photograph. The overall height of the gable has been raised with the addition of two courses of concrete, raising the gable by 360mm from the top of the stone gable to the underside of the present roof.

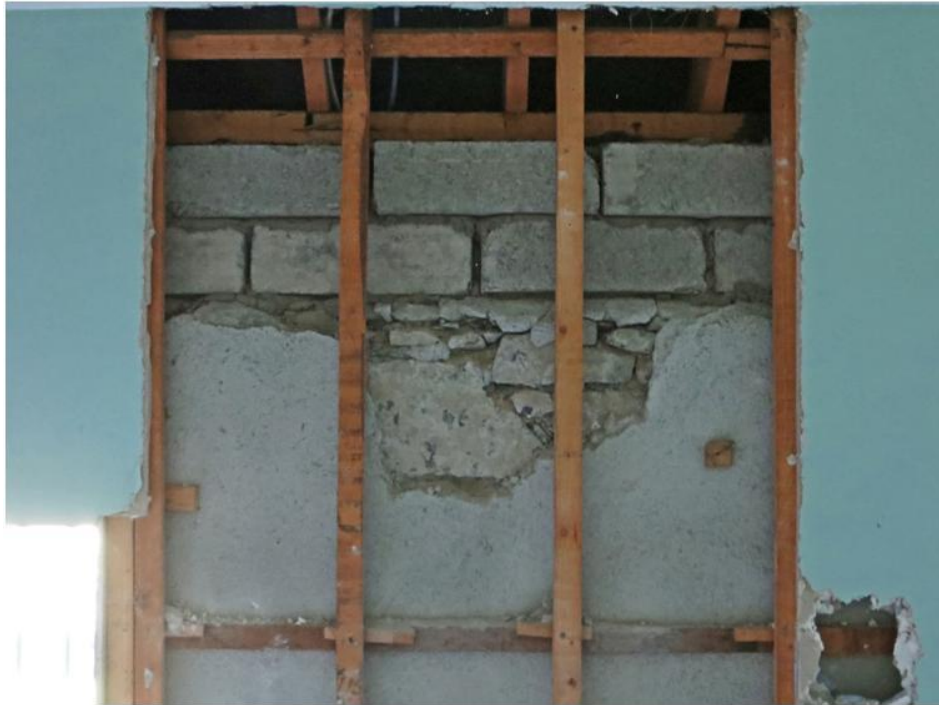
Plate 16: Opened area of rear wall at first floor level

The investigation shows that the wall had been raised by the addition of two courses of concrete blocks, thereby raising the eaves by about 450mm. Below this the inner face of the walls had been rendered with sand and cement. Beneath this render the walls are of limestone rubble, with a poor quality of stonework comprised of a mix of stone sizes, including a significant number of relatively small stones, all set in a lime-based mortar that is relatively soft and friable. The coursing did not appear to be particularly regular, though the areas opened up were too limited to be sure of the exact nature of the coursing.

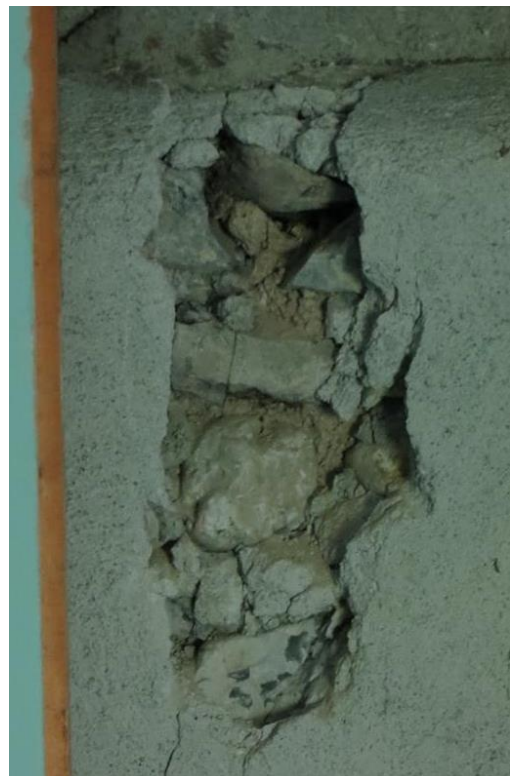
Rubble stone masonry appeared in all six areas where the wall was opened up at first floor level.

Plate 17: Detail of stonework on front wall

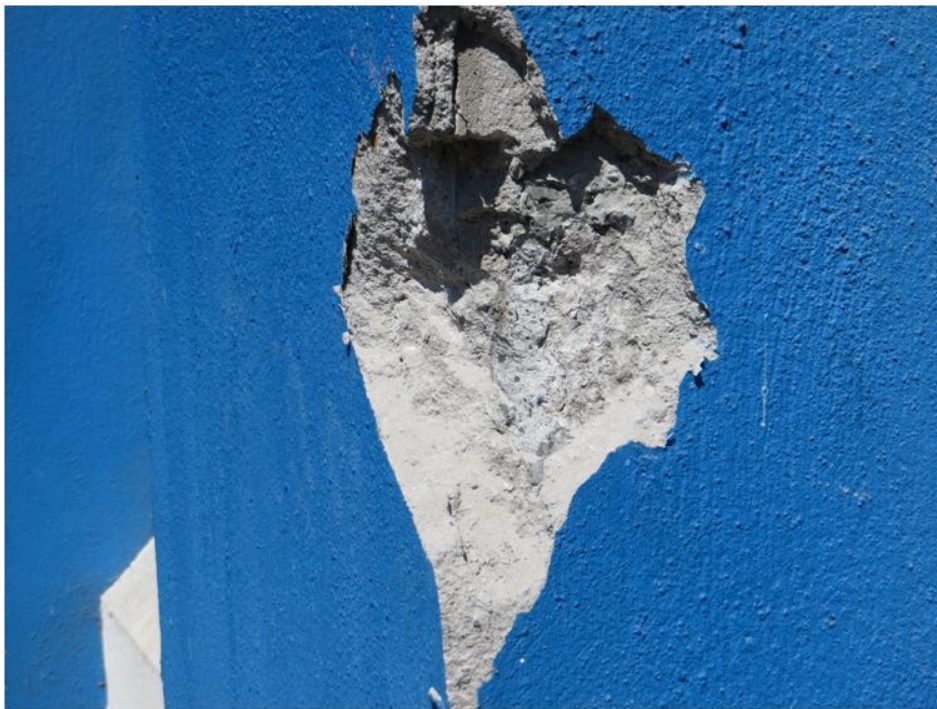
Plate 18: Detail of pier at front of building

There were several breaks in the south-eastern corner of the building where it appears that vehicles entering the gates had impacted on the wall. Examination of the revealed masonry showed that this corner of the building consists of a mass concrete pier with a facing of sand and cement render. One of the piers to the west of the shopfront was opened up, as seen in the photograph above, and this also revealed a concrete core with a sand and cement render.

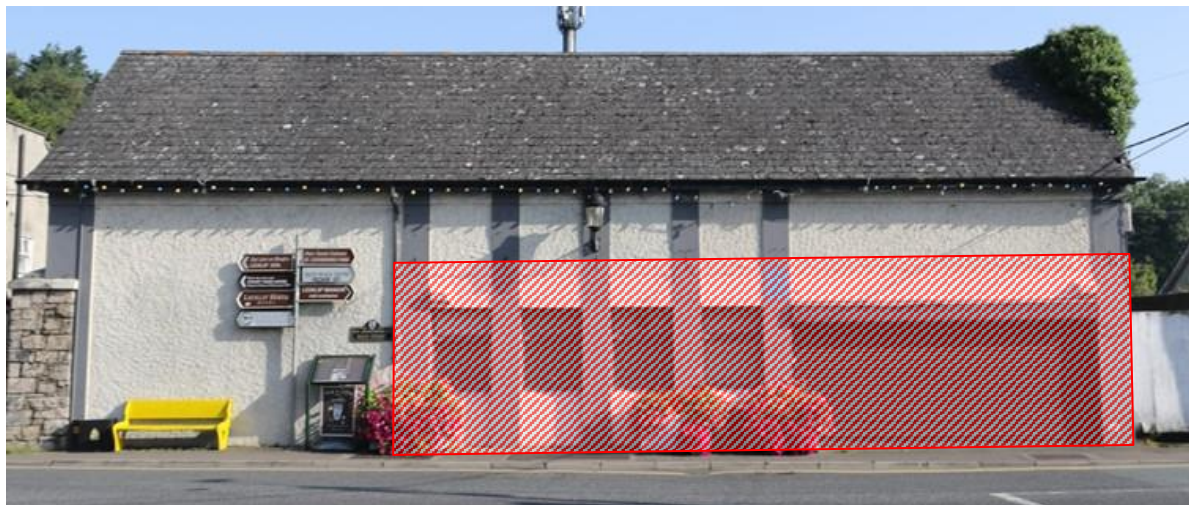
Plate 19: Front facade showing area where original walling has been removed

The photograph above shows with red hatching the area that was opened up during the construction in the 1960s, and which has been replaced with concrete and openings. As has been noted above, the roof was reconstructed in its entirety, with the total height of the roof raised by about 450mm.

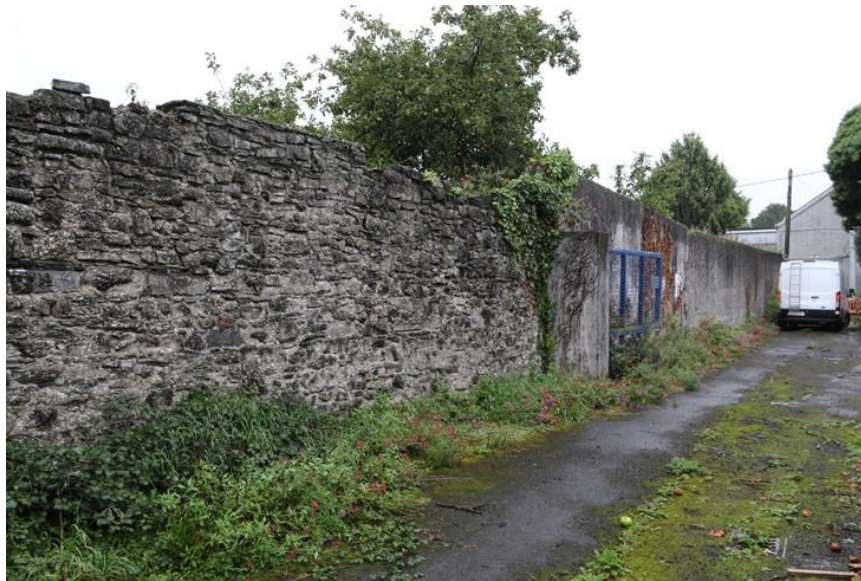
Plate 25: Eastern boundary wall

The eastern boundary wall alongside the yard is of concrete, while to the north of the gateway, in the narrow part of the site, the boundary wall is of rubble stone.

The construction of the roadway leading to the rear will not in itself affect the character of the ACA. However, it will be laid out in close proximity to the stone wall that forms part of the eastern boundary, and which is within the ACA. The significance of the wall is recognised, and the wall will be protected during construction works and all excavation works in its vicinity will be undertaken with due care to ensure that the wall is not undermined or subjected to impact damage.
