Bat and Bird Survey (with other ecological observations)

Brooke Bridge, Co. Kildare

Version : 22nd April 2021

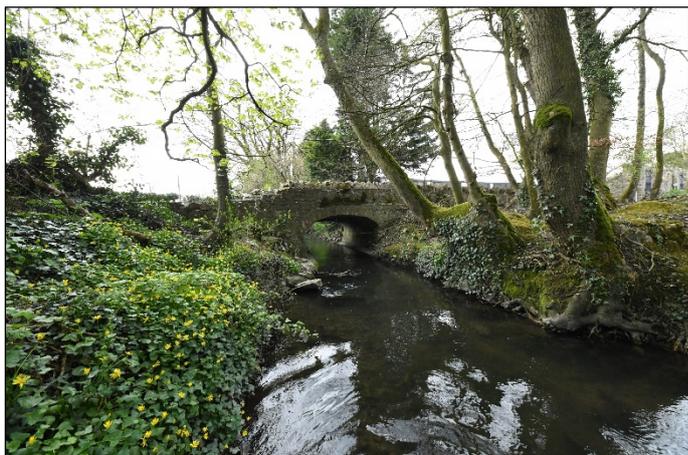
This bridge does have crevices, but they are very shallow and bat potential is limited. No bats were recorded and no evidence of previous use by bats was recorded.

Plate 1 Brooke Bridge viewed from upstream.

This bridge is rated as '1 - crevices present may be of use to bats. There were no bats in the bridge at the time of the survey and the potential for bats is limited. No birds' nests were present. It is recommended that the bridge be checked again for bats in advance of works.

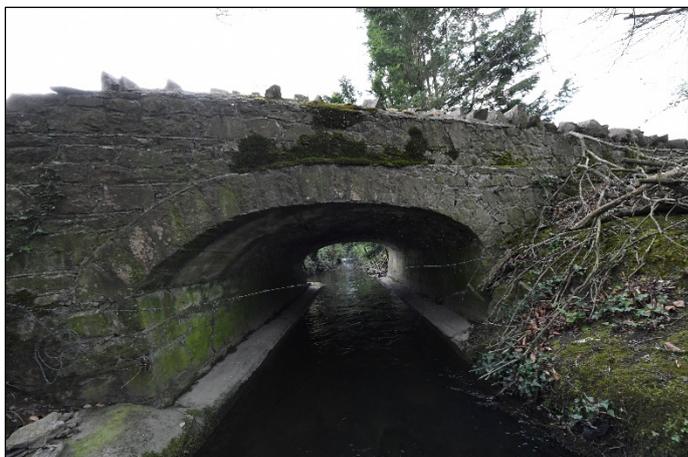
Plate 2 Brooke Bridge viewed from upstream.

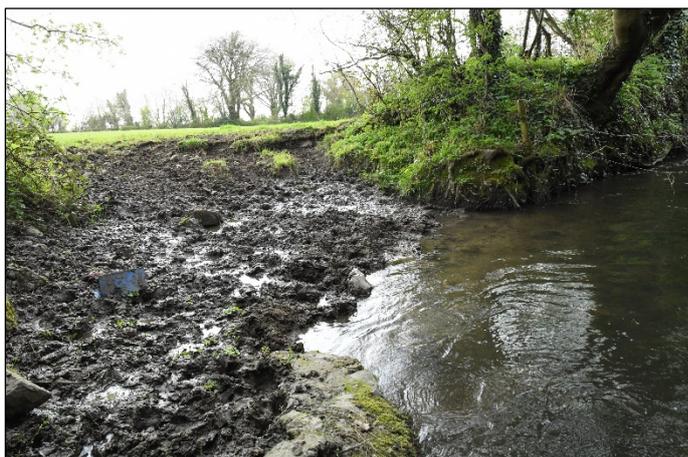
No other significant ecological observations were made. The river at this site is very silted due to agricultural inputs. However, this is a salmonid stream and lampreys could be present. This site is within the distribution of White-clawed crayfish and downstream areas are affected by crayfish plague.

Plate 3 Cattle access downstream of Brooke Bridge.
