Bat & Bird Survey (with other ecological observations)

Moone Village Bridge, Co. Kildare

Version : 26th April 2021

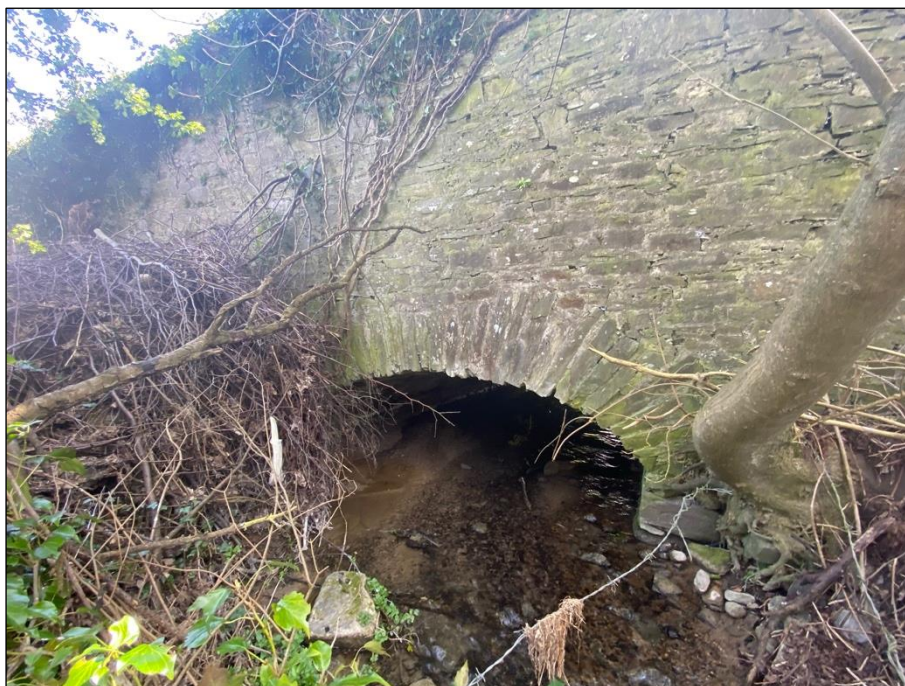
Plate 1 Moone Village bridge is very low with minimal space underneath, which is suboptimal for bats.

Moone Village bridge is very low and is unlikely to have bats. No bat droppings, staining or smearing marks were noted on site. The dense vegetation noted during the survey may also provide obstructions to bats that could use the parapet walls. There was a general paucity of crevices in the parapet walls, however. The bridge is rated as 1 = crevices present may be of use to bats as per Billington & Norman (1997). There are some crevices in the parapet walls, but these are considered unlikely to be used. Nonetheless, there is some potential and crevices should be checked in advance of works.

This bridge is rated as '1 = crevices present may be of use to bats. However, it is considered unlikely to be used by bats as the bridge is low and crevices on the parapets are suboptimal and obstructed. No derogation licenses are required at this stage. Nonetheless, there is some potential and crevices should be checked in advance of works. No birds' nests were present. Any vegetation clearance works should be undertaken outside of the bird nesting season.

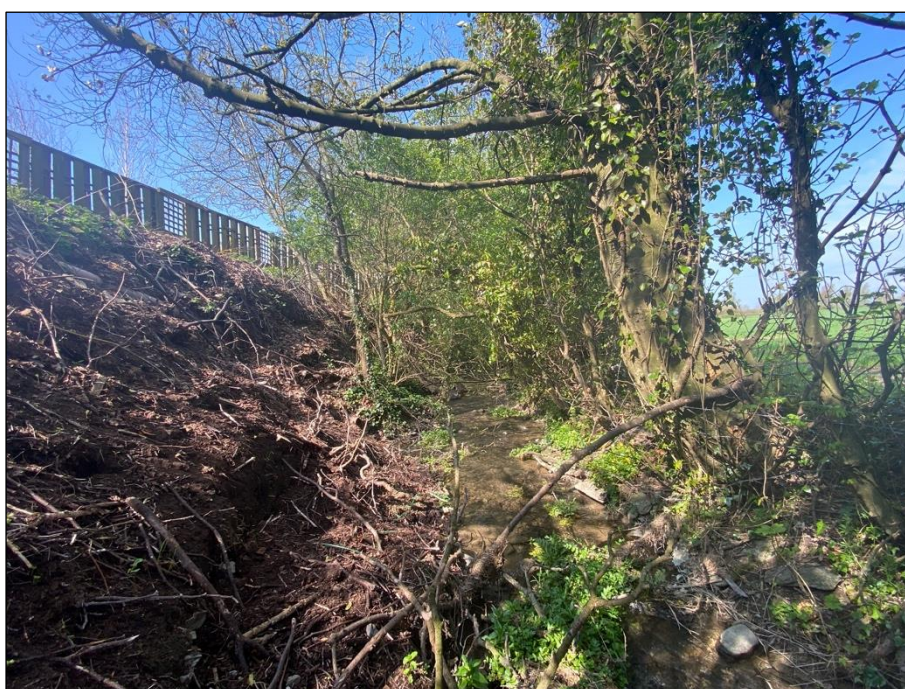
Plate 2 The upstream side showed clear evidence of recent vegetation clearance and debris. Small passerine birds could nest in the adjacent vegetation.

There were no bird nests recorded on or under the bridge structure during the site visit in late April 2021. It is noted however that there is some dense vegetation growth and ivy around the bridge that could provide nesting habitat for small passerine species, and nests could be made here later on in the bird nesting season.
