Rehabilitation Works at Monasterevin Bridge, Co. Kildare

NATURA IMPACT STATEMENT

Version: 20th March 2020

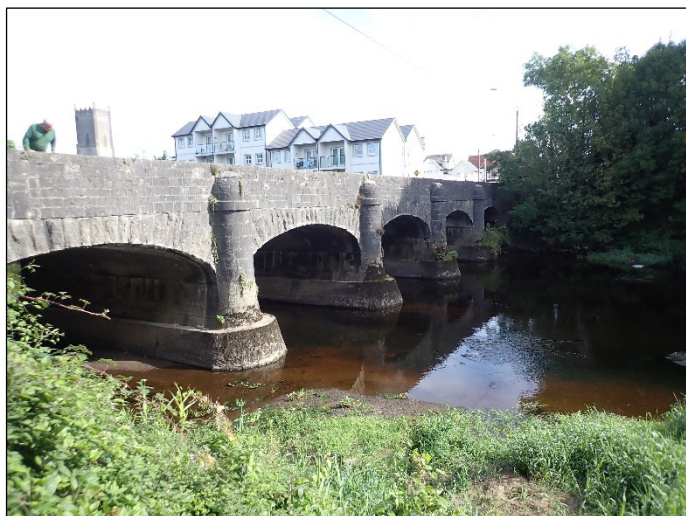
Plate 1 Monasterevin bridge viewed from downstream.

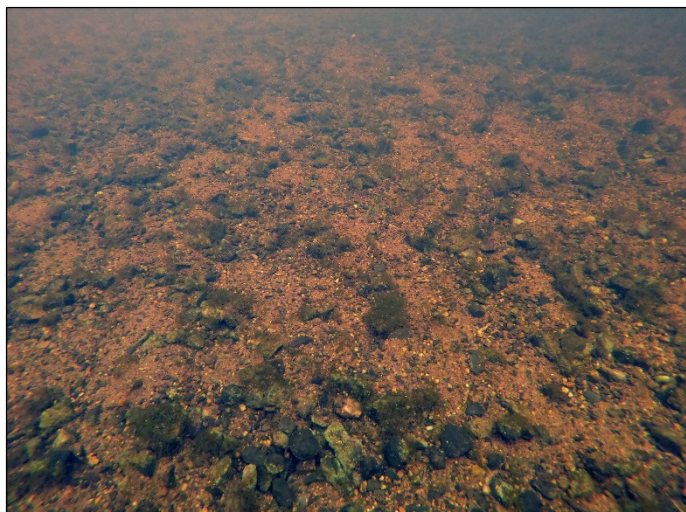
Plate 4 Example of substrate at bridge site – dominated by sand with cobbles. This is not a salmonid or lamprey spawning area and is also a sub-optimal habitat for juvenile lampreys.

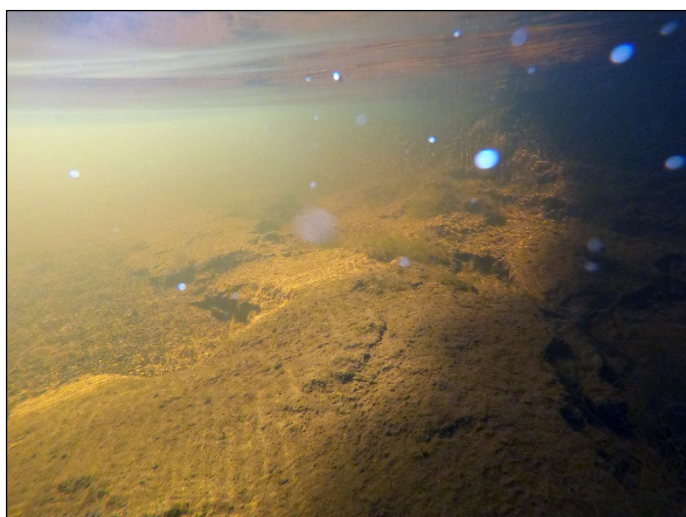
Plate 5 Example of substrate at bridge site – heavy siltation. No juvenile lampreys were present here (sampled by kick sampling) but low densities of juvenile lampreys are likely to be present.

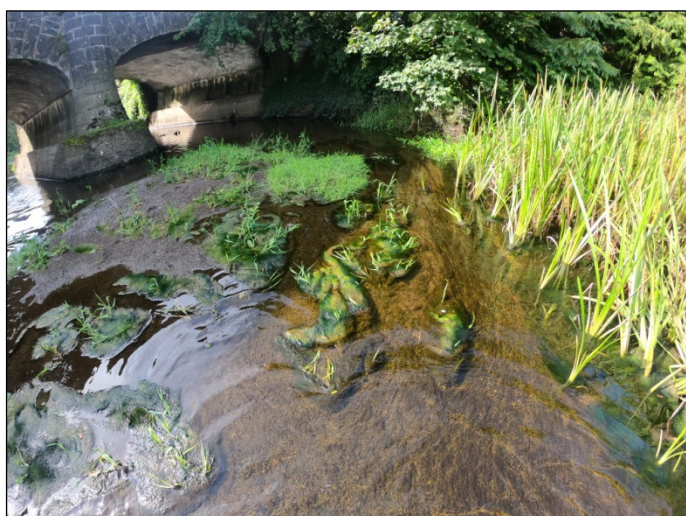
Plate 6 Eutrophication and siltation in the river upstream of Monasterevin Bridge.

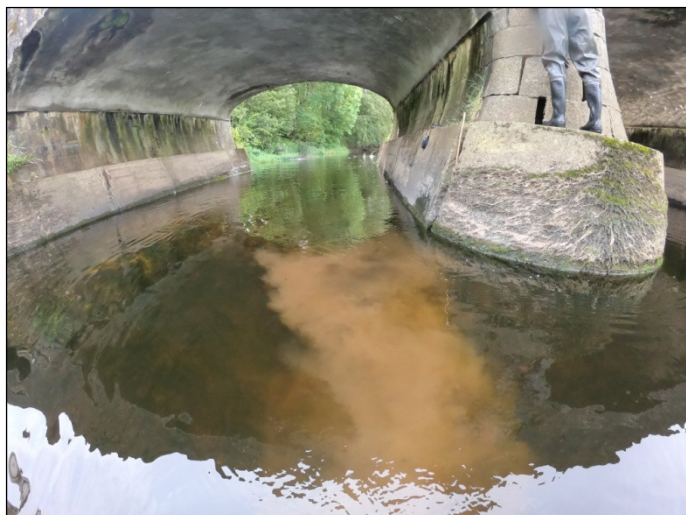
Plate 7 Silt plumes visible in the river at the site.

Prior to any instream works occurring, the site ecologist will agree a 5-day weather window of low flow conditions with the contractor to minimise the risk of works in the river during a flood event. Silt fences will be placed on the outside of the works area first, with sand bags placed inside to ensure no impacts regarding suspended solids arise. Details of the sandbags will be included in the method statement. The site ecologist will ensure the sand bags and silt fences are erected correctly.

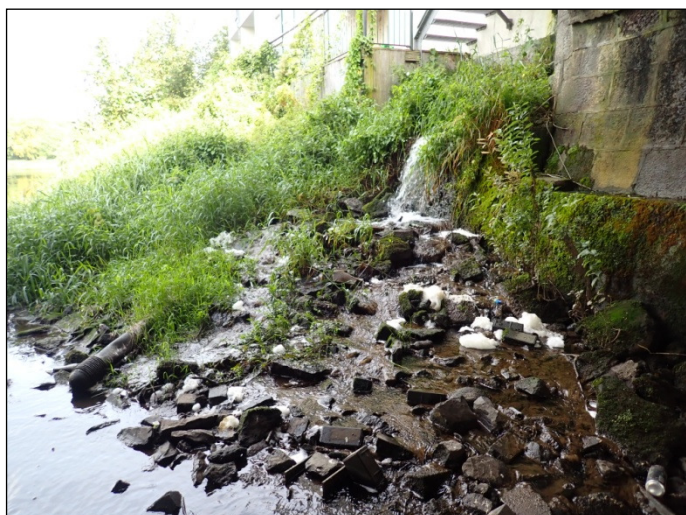
Plate 8 Sewage inlet flowing over litter and debris into the Barrow channel on the upstream left bank.

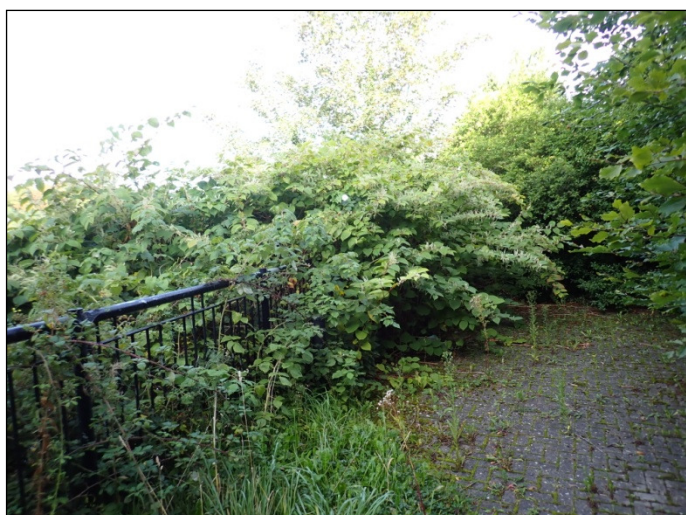
It is noted that there is a small section of Japanese Knotweed at the site, which can be easily spread to other areas and could impact aquatic habitats in the long term by populating the banks of the river. The de-vegetation works and cutback of overgrowth on the embankments could lead to significant invasive species impacts. Biosecurity mitigation measures are provided to avoid invasive species impacts.

Plate 9 Japanese knotweed *Fallopia japonica* upstream of the site on the left bank.

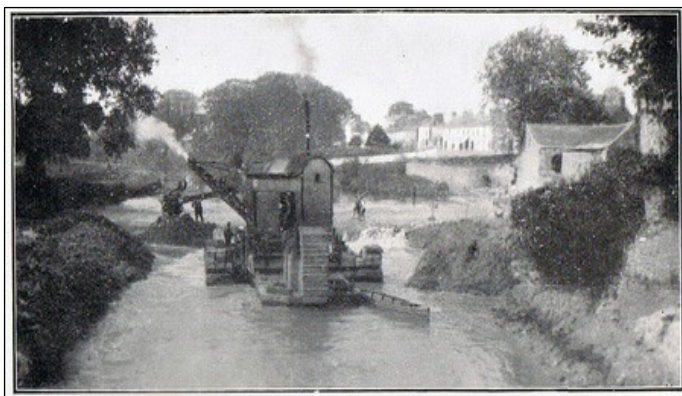
Plate 10 Dredging works at Monasterevin in the 1930s. This is the stretch of river immediately upstream of the subject bridge (Source: Irish Waterways History).

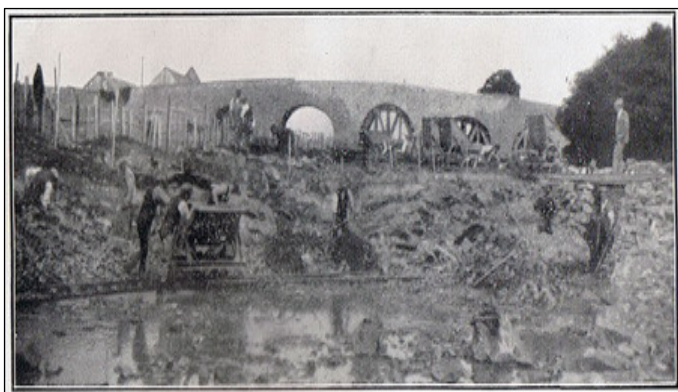
Plate 11 Dredging works at Monasterevin in the 1930s. This entire stretch of river was dredged and channelised and the effects of this scheme are still apparent today (Source: Irish Waterways History).

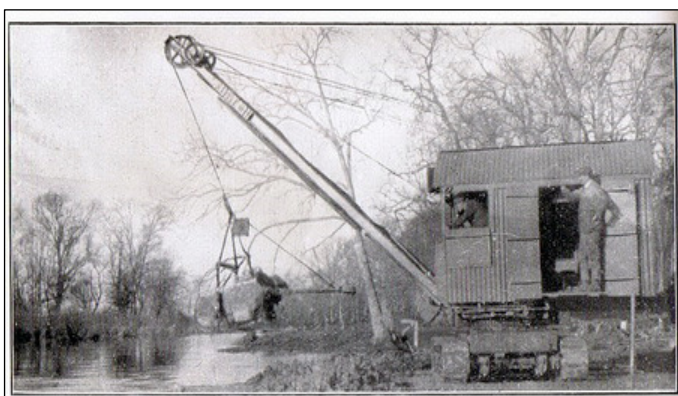
Plate 12 Dredging works at Monasterevin in the 1930s. The dredging works were undertaken using drag lines and the river was also diverted and dried out during the works. This scheme permanently altered the physical character the river (Source: Irish Waterways History).
