Ardclough, Celbridge, Co. Kildare

Archaeological Impact Assessment

Client: Kildare County Council

Licence No: 22E0267

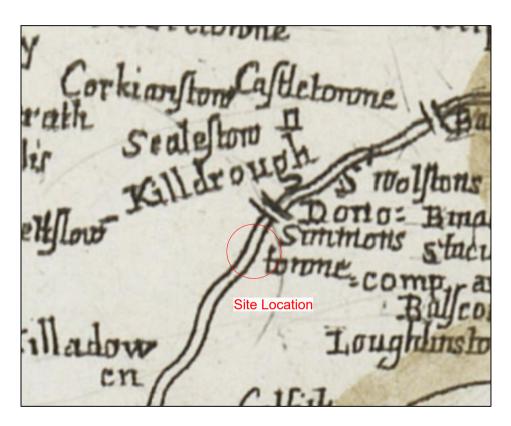
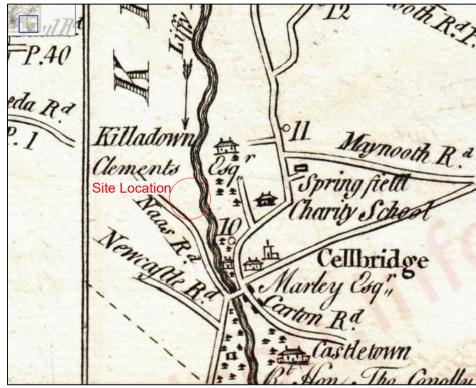
- (I) Down Survey (1656)
- (r) Taylor and Skinner (1777)

Analysis of historic mapping can show human impact on landscape over a prolonged period. Large collections of historical maps (pre- and early Ordnance Survey maps as well as estate or private maps) are held at the Glucksman Map Library, Trinity College and other sources (UCD Library, Ordnance Survey Ireland, local libraries and published material). The development of the site and its vicinity recorded through seventeenth to twentieth century cartography is described in Table 1 below (see Figure 4 & 5). No potential archaeological features were recorded within the subject site.

Мар	Date	Description		
Down Survey	1656	Celbridge is noted on this map as "Kildrough', it is depicted as a bridge crossing the River Liffey		
Taylor and Skinner Map	1777	(Map 93), Celbridge is labelled as 'Celbridge' in this map and appears to be a relatively large town, with many manor houses focused around the bridge over the River Liffey. The subject site itself is located between the 'Naas Road' and River, and opposite the estate labelled 'Clements Esquire'.		
Historic 6inch	1837	The subject site is depicted on this map as green field space, divided into three separate fields and elongated gardens relating to the houses that line the Ardclough road. The River Liffey is marked as the townland boundary. The surrounding landscape is greenfield agricultural land. Killadoon Estate and Gardens lies across the river from the site. Temple Mill and the associated workers houses is depicted to the north of the subject site.

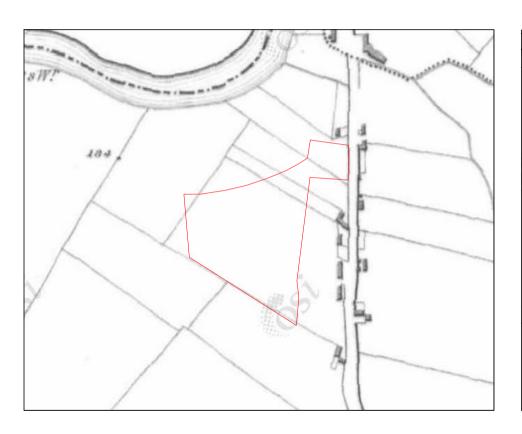
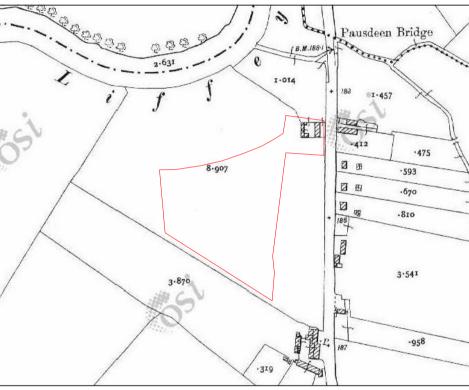
- (I) 1st Edition OS Map (1837)
- (r) 2nd Edition OS Map (1888-1913)

Historic 25inch	1888- 1913	The subject site remains a green field however the field / garden boundaries noted in the previous map have been removed to create one large field. There is no longer a row of houses lining the road. All but 2 have been demolished. Killadoon estate house and surrounding buildings have been developed further. The demesne remains heavily landscaped.		
Cassini	1930's- 40's	Little change from the previous map.

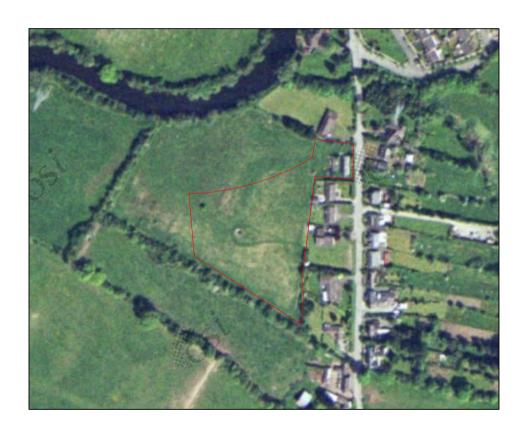
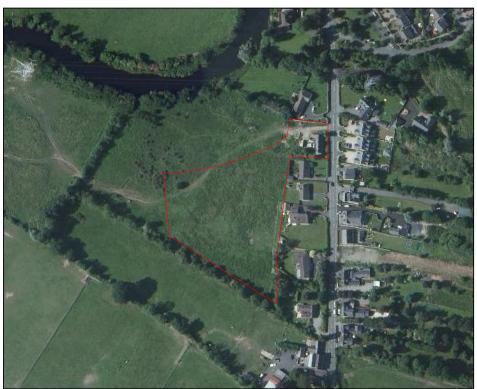
- (I) OSi Aerial Photograph (2000)
- (r) Digital Globe (2013)

Aerial photography (or other forms of remote sensing) may reveal certain archaeological features or sites (earthworks, crop marks, soil marks) that for many reasons may not be appreciated at ground level. Online orthostatic photographs of the site were examined (Ordnance Survey Ireland 1995, 2000 & 2005; Google/Bing Maps 2020). No features of archaeological potential were noted during analysis of aerial photography (Figure 6). See Table 2 below for details.

Aerial Photograph	Date	Description
OSi (B&W)	1995	The subject area is depicted as it currently stands today. There is a structure/ house within the area designated to be the entrance to the site. The surrounding landscape is greenfields for the most part with a large housing estate to the NE of the site.
OSi	2005	Little has changed from the previous photo. There are now multiple structures in the area designated to be the entrance to the site.
OSi	2005- 2012	No change from previous photograph
OSi Digital Globe	2013	Little has changed from the previous photograph. Many of the structures noted at the proposed entranceway have been removed
Google map	2020	No change from previous photograph

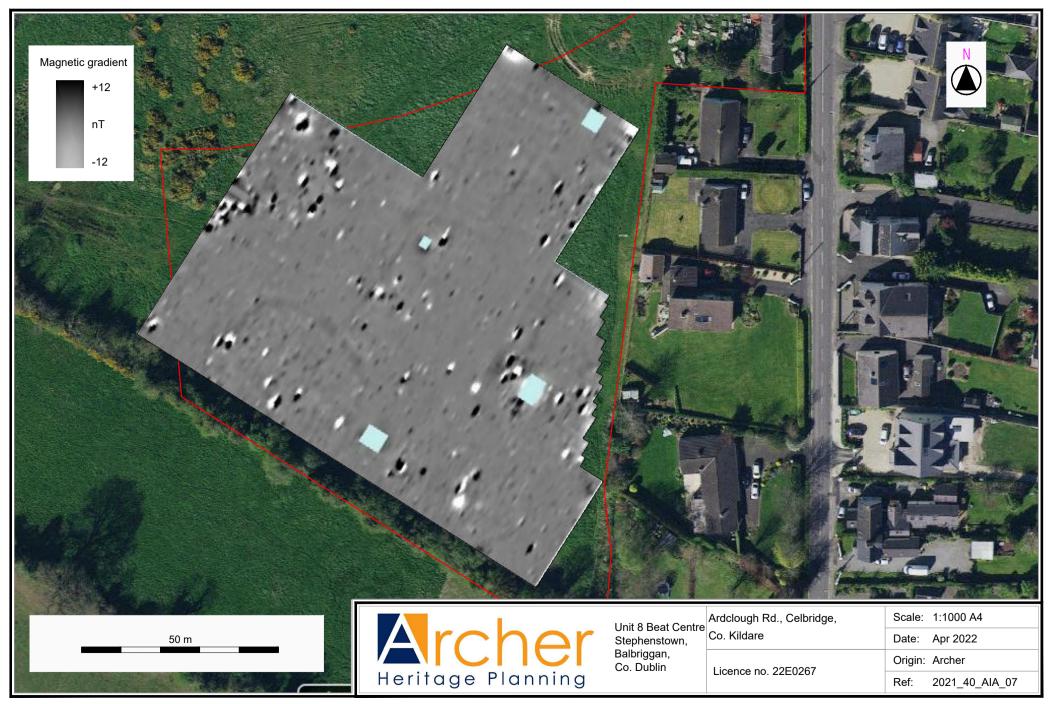
Geophysical survey (22R0042) located a variety of magnetic anomalies. A curvilinear trend and a group of spot responses in the southern portion of the surveyed area were interpreted as possibly representing buried archaeological features.

Figure 7: Greyscale image of geophysical survey 22R0042

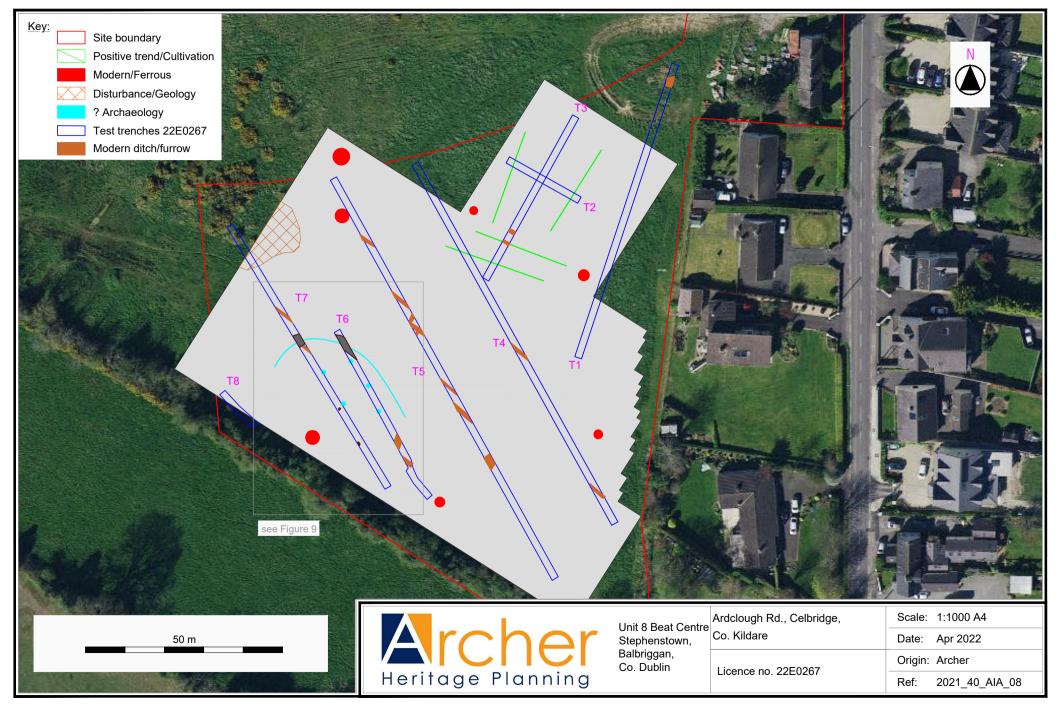
A total of 7 test trenches with a combined length of 475 linear metres were proposed (997 m sq.m, c. 7% of the 1.37 Ha subject site). The trenches were targeted on assessing the archaeological potential of the geophysical survey results (22R0042) and of the general area. They were positioned at locations agreed in advance with the NMS. Each trench was inspected for archaeological remains and all trenches were reinstated on completion. The results are listed in Table below.

Figure 8: Test trench layout 22E0267 over geophysical survey interpretation 22R0042

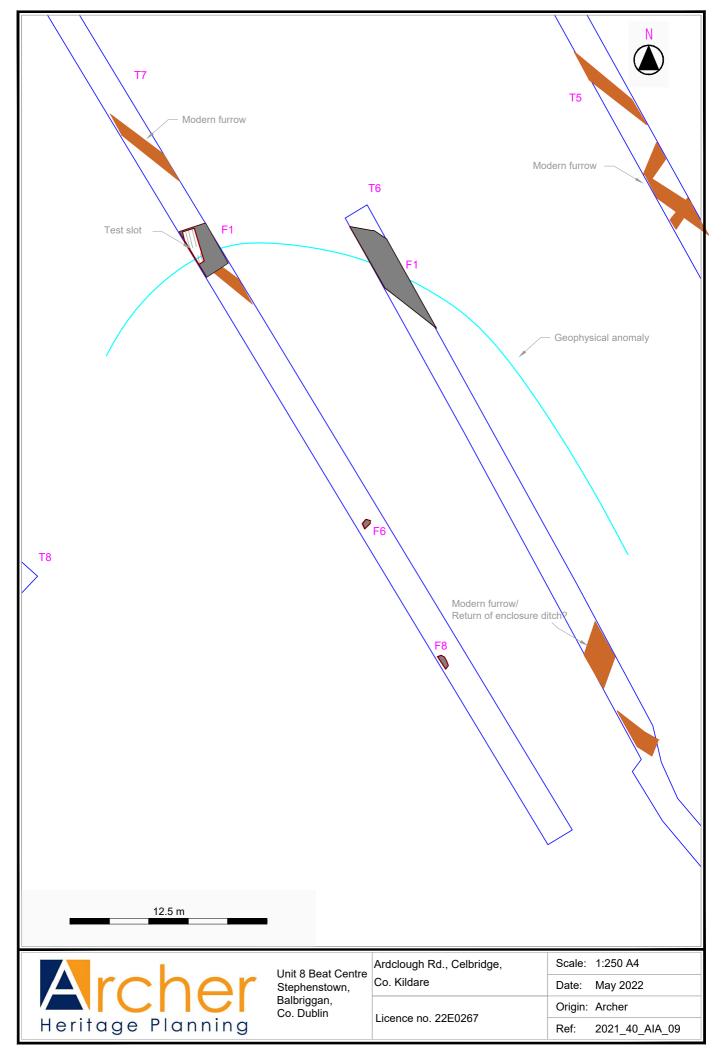
Archaeological features were recorded in Trenches 6 and 7 corresponding to the anomalies identified during the geophysical survey (see Figure 9). A curvilinear ditch (F1) was identified in these trenches with a possible return to the south-east. Measuring 3m wide and 1.43m in depth, a test slot in the ditch revealed a V-shaped cut with four fills, F2-F5. The upper fill (F2) comprised a friable brown sandy clay with a maximum depth of 0.18m. It overlay a brownish grey silty clay (F3) with a maximum depth of 0.25m. This in turn overlay a light grey silt (F4) 0.8m in maximum depth containing some medium and large limestones. As these weren't visible in the subsoil, it may be that the stones in this fill represent some type of collapsed wall or revetment, though this is highly tentative, given the limited extent of the test slot. The basal fill (F5) comprised a brownish grey stoney silty clay with a maximum depth of 0.2m. This contained occasional inclusions of animal bone fragments and other organic matter such as wood/root fragments with an associated peaty smell. The lower levels of the ditch quickly became inundated and indicate water-logged conditions conducive to the survival of organic material.

Further to the south-east lay two features, F6 and F8, which extended beyond the test trench and likely represent pits. The exposed features measured 0.56m NE/SW x 0.38m (F6) and 0.92m NW/SE x 0.37m (F8). Both had similar fills, F7 and F9, respectively, a loose dark brown silty sand with occasional charcoal and bone fragment inclusions. A test slot through F8 revealed a depth of 0.15m

Figure 9: Details of archaeology

The curvilinear ditch (F1) was initially identified during geophysical survey. Test excavation has confirmed the archaeological nature of this feature. A box-section excavated through this ditch recorded dimensions of 3m wide by 1.43m in depth. The profile of the ditch was V-shaped and fragments of animal bones were noted in the lower fills. However, the south-eastern continuation of this ditch was not recorded in the course of either the geophysical survey or test excavation. Consequently, it is not currently possible to state with certainty whether the recorded archaeological features represent a full enclosure. It is notable, however, that the lower levels of the ditch were inundated with water upon excavation. This indicates high potential for the survival of organic remains within lower levels of the ditch.

- 1. It is recommended that should development proceed at this location, this should be preceded by full archaeological excavation of the recorded archaeological features under licence to the DHLGH
- 2. Groundworks across the remainder of the site should be monitored by a suitably qualified archaeologist.

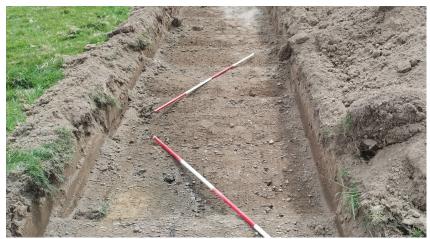
Plate 7: F1 ditch in Trench 6 looking south-east

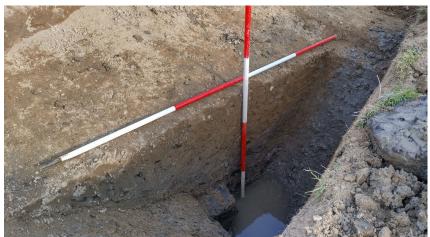
Plate 9: Test slot in ditch F1 from north-west, right (SE) side of cut unexcavated

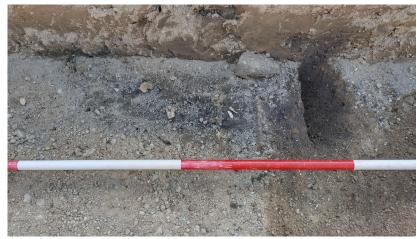
Plate 10: Pit F8 showing test slot from north-east

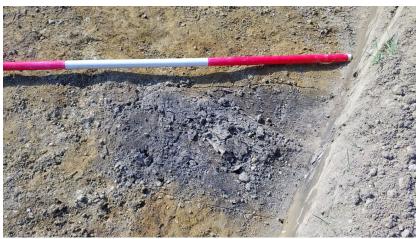
Plate 11: Pit F6 from south
