Stage 1 Quality Audit Report
Proposed Part 8 Residential
Development, Coolaghknock Glebe,
Kildare Town, Co. Kildare
For Kildare County Council

Client:	Malone O'Regan Consulting Engineers
Document No:	231860-ORS-XX-XX-RP-TR-13g-006

This report documents the findings of a Stage 1 Road Safety Audit (RSA) carried out with respect to a Proposed Residential Development at Coolaghknock Glebe, Kildare Town, County Kildare.

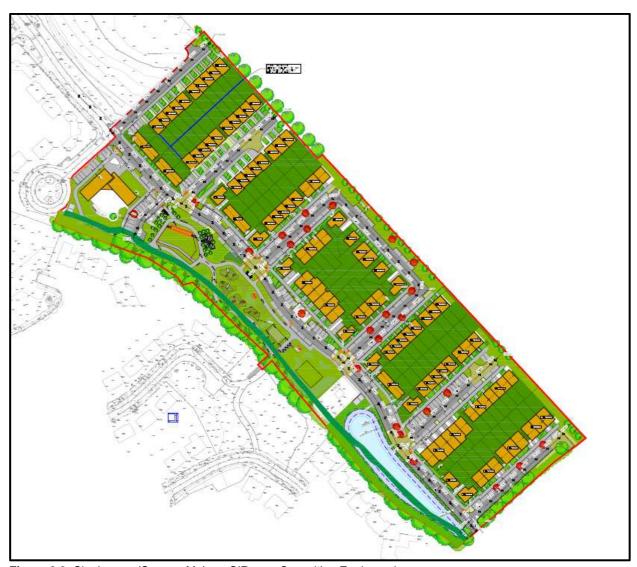
Figure 2.2: Site Layout (Source: Malone O'Regan Consulting Engineers)

Figure 2.2 shows the proposed site layout provided by Malone O'Regan Consulting Engineers.

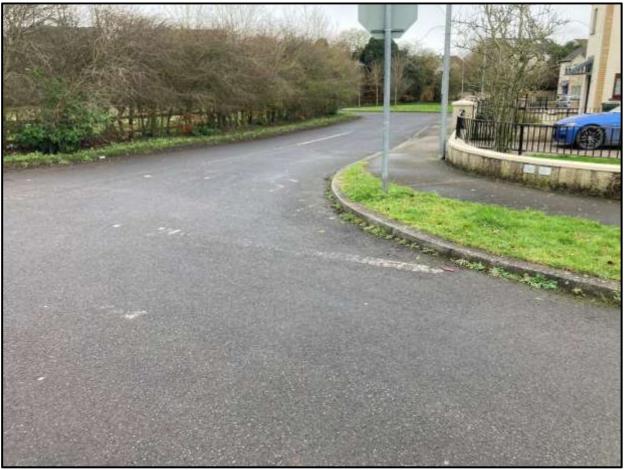
Figure 2.3: Connagh Road at the site frontage (Source: ORS, February 2024)

Figure 2.3 shows Connagh Road at the frontage of the proposed site entrance. During the site visit it was evident that the existing 'Stop' road marking had significantly worn away over time.

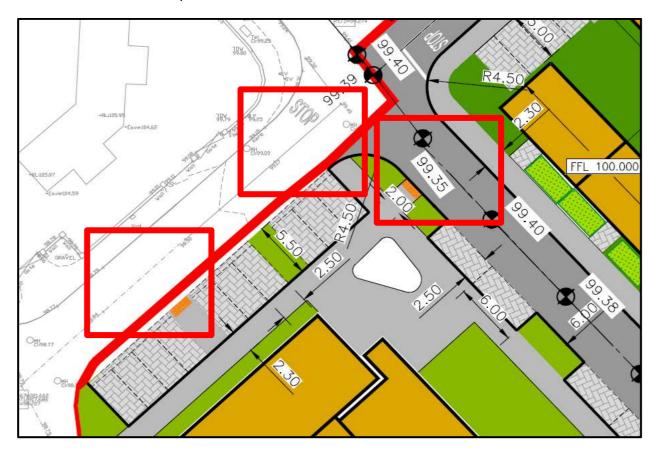
Problem No.1: Uncontrolled Crossing Points Location: Northwestern Site Boundary

The audit team note from the drawings that there are no uncontrolled crossings shown at the entrance and exit locations. The drawings also detail crossing points which do not link in with crossing facilities on the opposite side of the carriageways. The audit team is concerned that the lack of appropriate crossing points at the main exit point in particular and at the locations identified could lead to trips and falls for vulnerable users.

The design team should ensure crossing facilities are provided on both sides of the carriageway and to ensure that there are clear linkages along pedestrian desire lines to tie-in with the existing infrastructure within Coonagh Estate Road.

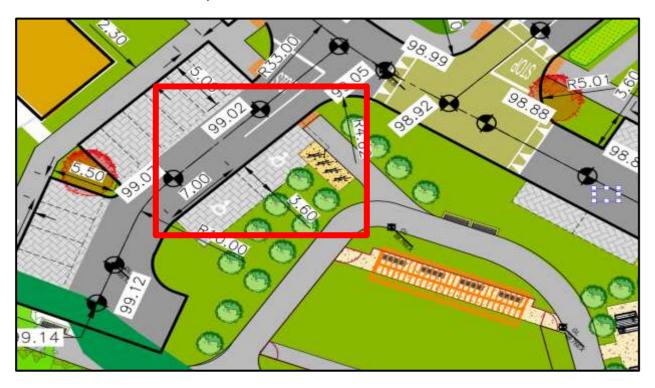
The audit team note that access to pedestrian paths from the disabled parking space is not facilitated by means of dropped kerbs or footpaths. These facilities aid users with specific mobility needs and the omission of dropped kerbs and connective paths may result in wheelchair users having to travel along the roadway to find a suitable location to mount the footpath which could increase the risk of conflicts with vehicles on the access road.

The audit team also note that the accessible parking bay identified is obstructed by other parking facilities like cycle parking facilities. This could result in hinderance while parking the vehicle into the accessible bay.

The design team should ensure that details and locations of dropped kerbs, connecting footpaths and tactile paving are provided for at the disabled parking spaces as recommended in the National Disability Authority publication 'Building for Everyone: A Universal Design Approach'. The design team should also ensure that other infrastructure or street furniture does not interfere with the safe use of the disabled parking bays.

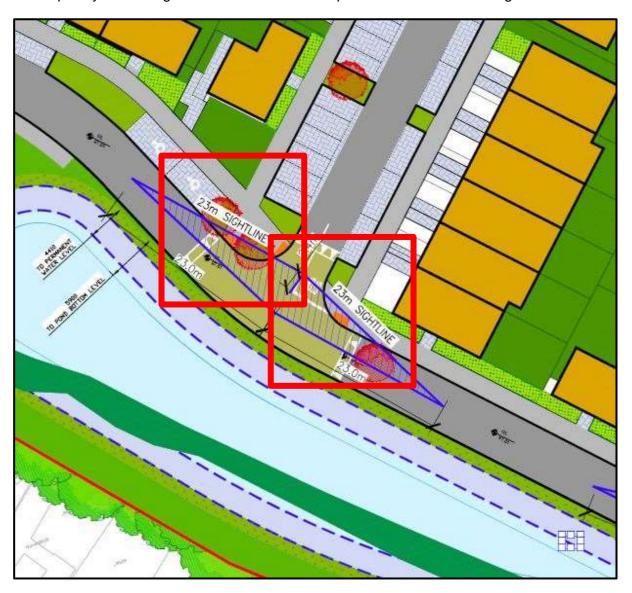
Problem No.3: Landscape - Sightlines Location: Internal Junctions

The audit team observed from the provided drawings that the proposed landscaping within the development might adversely affect the visibility of road users and pedestrians if not appropriately positioned. This could result in reduced forward visibility at the junction, consequently increasing the risk of collisions with pedestrians at the crossing.

The design team should ensure that trees are carefully chosen and strategically positioned so that they do not impede visibility for road users, pedestrians, and cyclists. The design team should also ensure that sightlines are achieved to the nearside road edge.

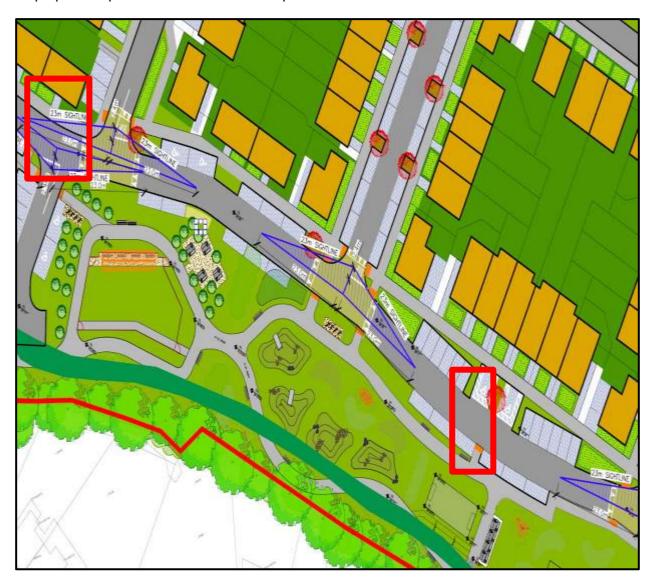
Problem No.4: Adjacent Crossing Point Location: Uncontrolled Crossing Point to adjoining Footpath/Green Area (Various Locations)

The audit team note from the drawings provided that there are several uncontrolled crossing points proposed along the main access road, but tactile paving and dropped kerbs are not replicated on the opposite side of the road. The audit team is concerned that there would be a step up to the path which could lead to trips and falls for vulnerable users.

The design team should ensure that adequate provisions are made for vulnerable users crossing at these locations.

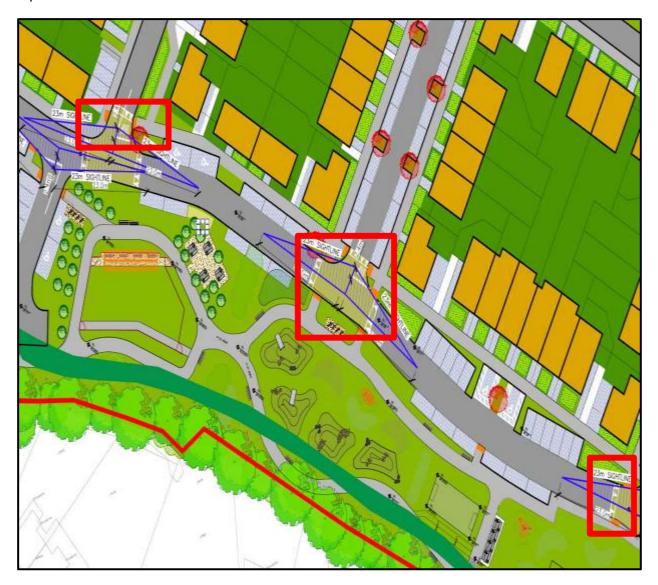
Problem No.5: Crossing Point Orientation/Location Location: Various Locations Throughout the Development

The audit team note from the drawings provided that there is a pedestrian crossing proposed at the location identified which is not at right angles to the main carriageway and is located on the ramped section which could lead to a section being at ramp height and the other being sloped. The audit team is concerned that there would be an issue due to the level which could lead to trips and falls for vulnerable users.

The design team should relocate the proposed crossing point to a more suitable location, away from the proposed ramps for raised tables and ensure that it is orientated at right angles to the main carriageway.

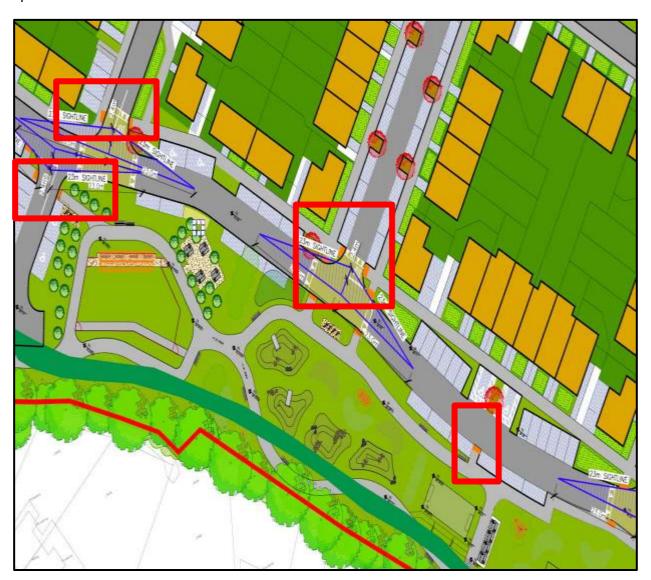
Problem No.6: Parking Spaces at Crossing Locations Location: Various Locations Throughout the Development

The audit team note from the drawings provided that there are parking spaces near the uncontrolled crossings proposed at the locations identified. The audit team has concerns that the proximity of parking spaces could restrict the visibility for users at the crossing and in particular mobility impaired users which could increase the likelihood of potential conflicts with vehicles. The audit team also note that certain crossing points are positioned to the rear of parking spaces which could potentially result in conflicts with vehicles reversing out of parking spaces.

The design team should relocate the parking spaces to a more suitable location and ensure appropriate separation distance between the parking spaces and the crossing locations to ensure appropriate visibility can be achieved.

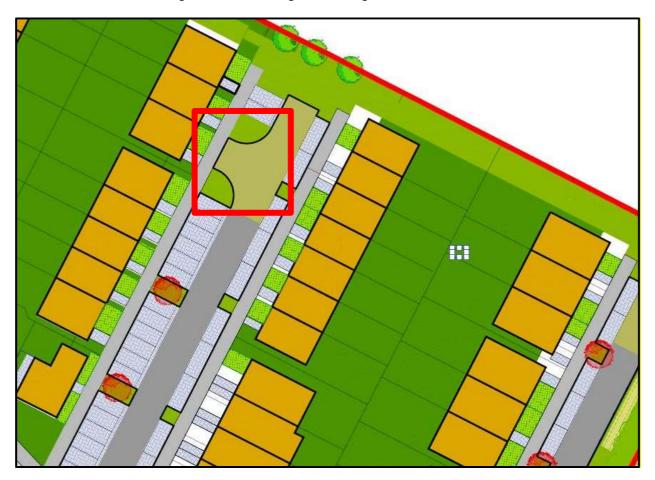
Problem No.7: Illegal Parking Location: Area Identified

The audit team note from the plans provided that part of the turning bay is in front of one of the properties which could result in illegal parking. This could potentially result in an increased risk of vehicle conflict with larger vehicles using the turning area.

The design team should reconfigure the area to mitigate the safety risk associated with illegally parked cars.

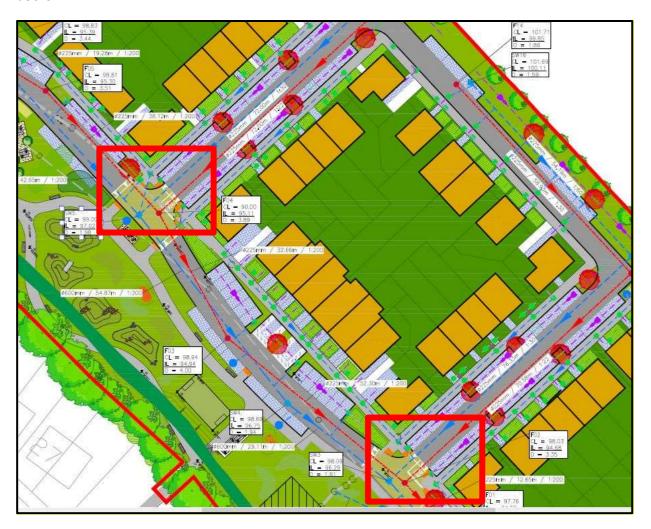
Problem No.8: Manhole/Utility Lids within Tactile Paviours Location: Uncontrolled Crossings Throughout the Estate

The audit team note from the drainage plans provided that Manholes/Utility Lids are denoted within the tactile paving. The audit team would have concerns that these manholes/utility lids placed within the tactile paving could lead to a misinterpretation of the distance to the crossing which could lead to a conflict between a vulnerable road user and vehicles. The positioning of manhole lids on pedestrian crossing points could also result in trip and falls among vulnerable users.

The design team should relocate the manholes/utility lids to ensure they are not within the tactile paving area. The design team should also ensure that manhole lids are positioned outside of pedestrian routes if possible.

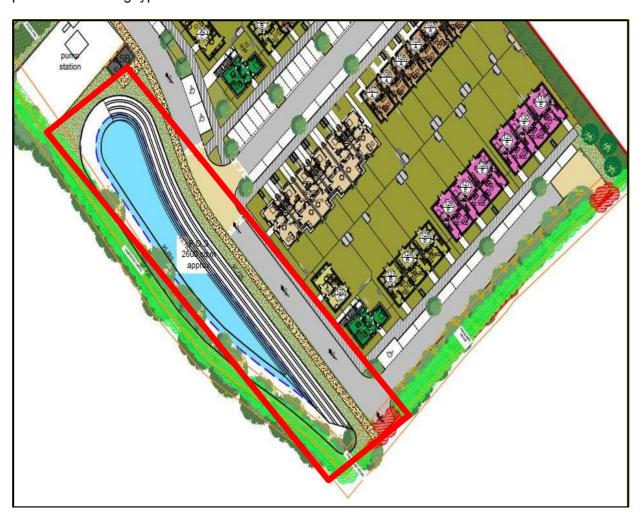
Problem No.9: Protection to Attenuation Pond Location: Southwest Corner of the Site

The audit team note that the attenuation pond runs parallel to the proposed access road and that no protection is provided for vulnerable users. The audit team would have concerns that a vulnerable road user could inadvertently enter the attenuation pond which could result in potential drowning type incidents for vulnerable users.

The design team should provide adequate protection to the attenuation pond is provided to prevent vulnerable users form entering the pond area.

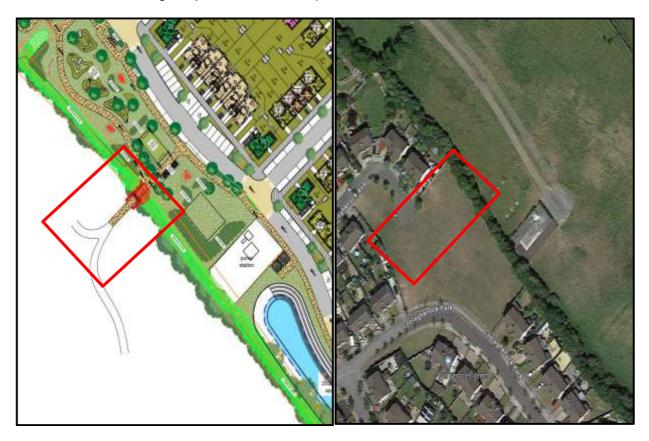
Problem No.10: Tie-in to Existing Footpath Location: To Southwest to Coolaghknock Avenue Estate

The audit team note from the drawing's that the proposed footpath connects to the existing estate via a footpath, however there is no footpath in the area in the Coolaghknock Avenue Estate. Lack of a tie-in to an existing footpath could lead to pedestrian confusion.

The design team should provide detail how it is proposed to connect the proposed pedestrian facilities to the pedestrian facilities within the Coolaghknock Avenue estate.

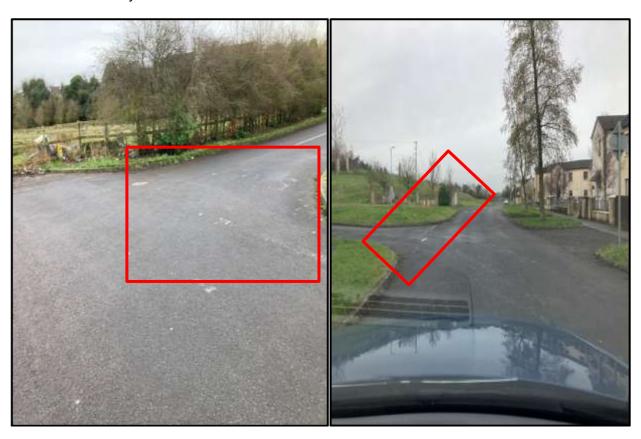
Problem No.11: Existing Road Markings Worn Location: Various Locations on the Link Road to Melitta Road

The audit team note from the site visit that the existing road markings on the link road to Melitta Road are worn. Road markings assist in informing road users of the presence of ramps and controls at junctions. Worn road markings may lead to vehicles not being alerted to oncoming hazards which may result in vehicle-to-vehicle conflicts.

The design team should ensure that the road markings on the link road are appropriately positioned and repainted.
