**Title: Combined Stage 1&2 Road Safety Audit**

**Proposed Residential Development at Ardclough Road,  
Celbridge Co. Kildare.**

**Client: Kildare County Council**

**Report reference: 1394R01**

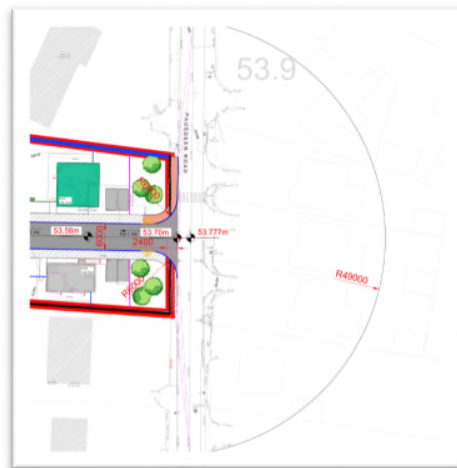
Drawing 11162-2030 P02, Sightlines at proposed junction.

The sightlines are shown to the centre of the carriageway. This is a section of carriageway with a broken line. Drivers may overtake slow moving vehicles and not be seen by drivers exiting the development leading to side-impact collisions.

It is recommended that the appropriate sightlines should be provide to the nearside edge of the carriageway.

3.1	yes	yes	Please see Drawing attached with sightlines revised, 11162-2030.	
3.2	no	no	6m radius is necessary for large vehicles, Please see attached drawing showing road markings and signage, 11162-2031.	Yes

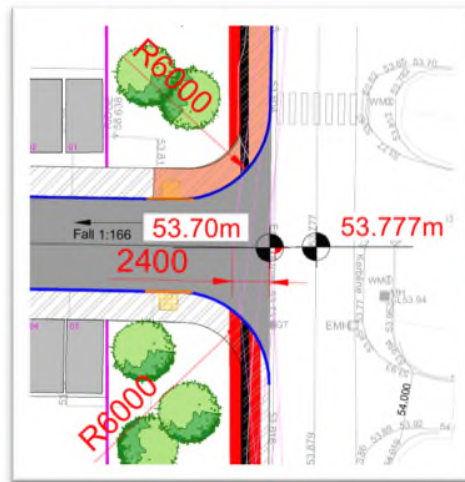
Drawing 11162-2030 P02, Corner radii.

It is proposed to provide corner radii of 6m at the priority junction with Ardclough Road. This could lead to high turning speeds resulting in high severity injuries if a crossing pedestrian is struck. It may also lead to drivers not seeing cyclists in their 'blind spots' as they turn left into the development.

It is recommended that the corner radii be reduced.

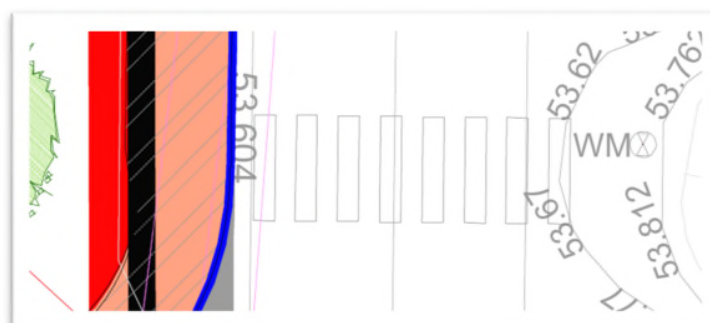
Drawing 11162-2030 P02, Pedestrian crossing of Ardclough Road.

It is unclear what type of pedestrian crossing is proposed across Ardclough Road. The proposed marking suggest a zebra type crossing however there is no proposal for beacons. The use of striped marking could lead to confusion over priority between pedestrians and drivers leading to collisions.

It is recommended that either a controlled pedestrian crossing or uncontrolled crossing be provided with dropped kerb and suitable tactile paving.

3.3	yes	yes	Please see updated drawing showing an uncontrolled crossing with drop kerbs each side, and appropriate buff tactile paving, 11162-2030.	
3.4	yes	yes	Drop kerbs have been added to back of all the perpendicular car parking spaces, please see updated drawing 11162-2030.

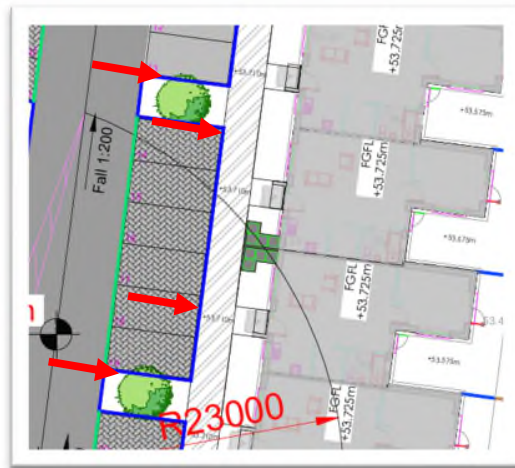
Drawing 11162-2030 P02, perpendicular parking within the development.

There are 150mm high kerbs (blue kerb lines) proposed at the perpendicular parking spaces. Vehicle occupants that want to get from the parked vehicles to their houses who may be mobility impaired such as pushing a buggy or somewhat infirm may not be able to mount high kerbs and could fall.

It is recommended that regular spaces be provided for vehicle occupant to access the footpath where perpendicular parking occurs. These access points should be flush so as not to be a trip hazard.

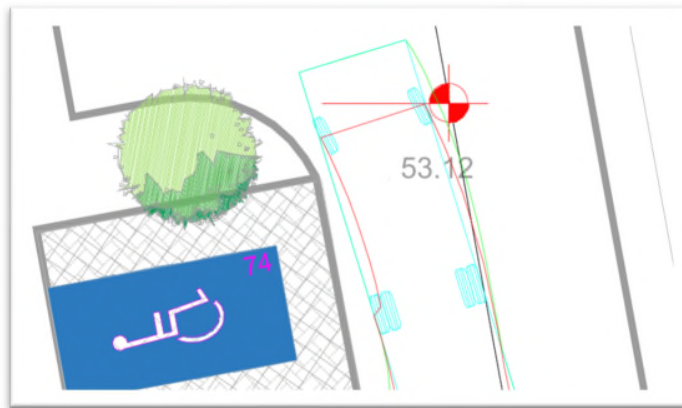
Drawing 11162-2101 P02, Refuse Truck Swept Path.

The swept path analysis for the refuse truck uses a two axel vehicle and does not show the turning manoeuvre at the turning heads. There is a risk that the commonly use three axel vehicles may not be able to turn in the space provided especially with the turning heads being partially occupied by car parking spaces.

It is recommended that the full manoeuvres be carried out for the three axle vehicles.

3.5	yes	yes	West turning bay has been updated so 3 Axle bin lorries can maneuver. See updated drawing 11162-2101	
3.6	yes	yes	Lights to be located in green areas, Not in footpaths, please see updated lighting drawing.

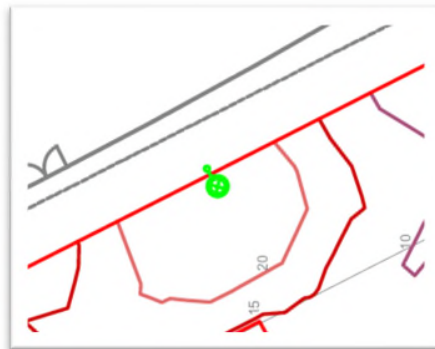
Drawing 21042-E-604 Rev P, Delap & Waller, Public Lighting.

Public lighting columns within the development could be located in the middle of the footpaths thereby making them hazards for pedestrians.

It is recommended that the columns be placed in grassed/landscaped areas or to the rear of the footpath.

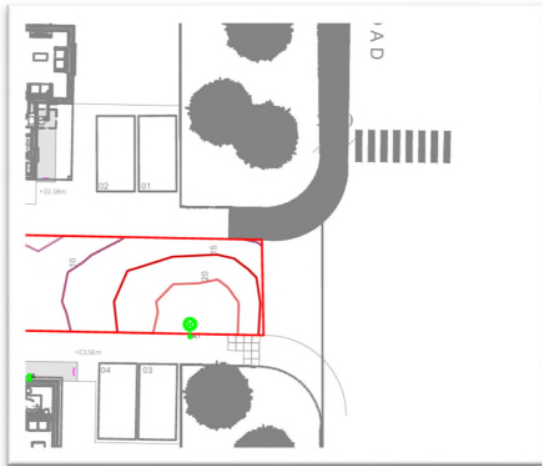
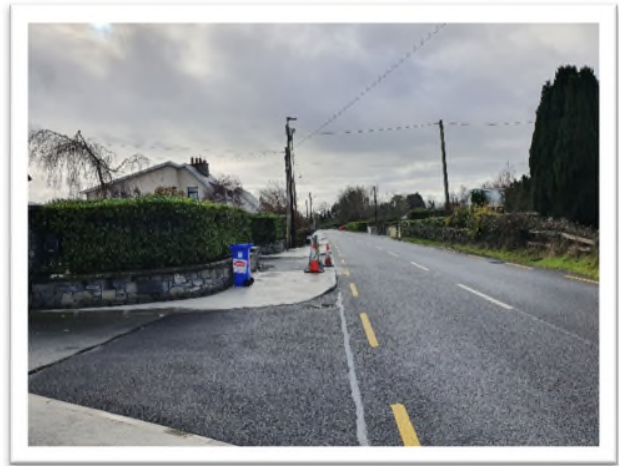
Drawing 21042-E-604 Rev P, Delap & Waller, Public Lighting.

The public lighting design only includes the proposed development. There is a risk that the new junction and proposed pedestrian crossing may not be lit to a sufficient standard and drivers may not see pedestrians leading to collisions.

It is recommended that the lighting design includes the junction and crossing to ensure that they are sufficiently lit.

3.7	yes	yes	The junction and crossing will be lit.	
3.8	Yes	yes	Crossing shall be marked as an uncontrolled crossing not as zebra crossing markings.	
3.9	yes	yes	the crossing will not be a zebra crossing and will be an uncontrolled crossing.

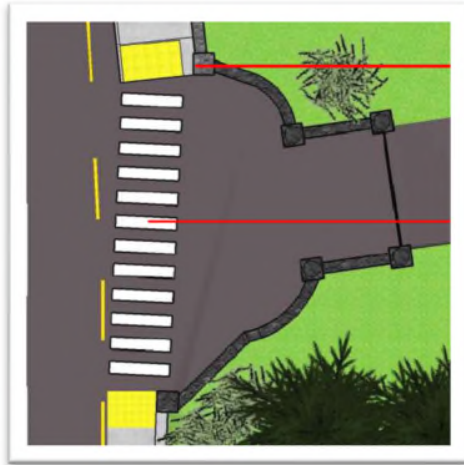
Drawing 210303-2-007 Rev – VHA, Pedestrian Bridge.

It is proposed to have a pedestrian crossing across the Bruach an Pháistín entrance. The zebra crossing type marking may lead to confusion over priority resulting in collisions.

It is recommended that an uncontrolled crossing be provided. As it is a very lightly used entrance the footpath could be made continuous to give better priority to pedestrians.

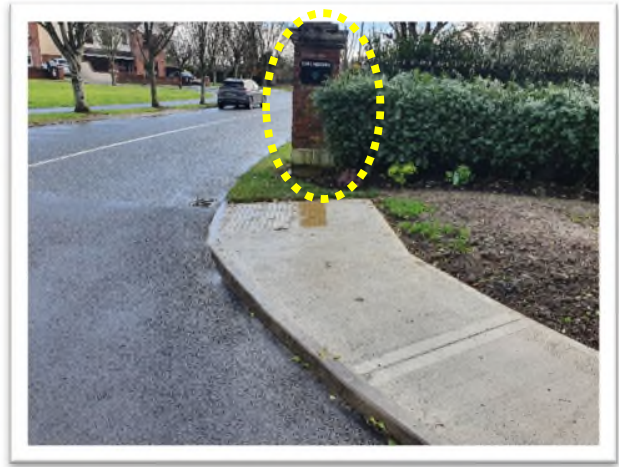
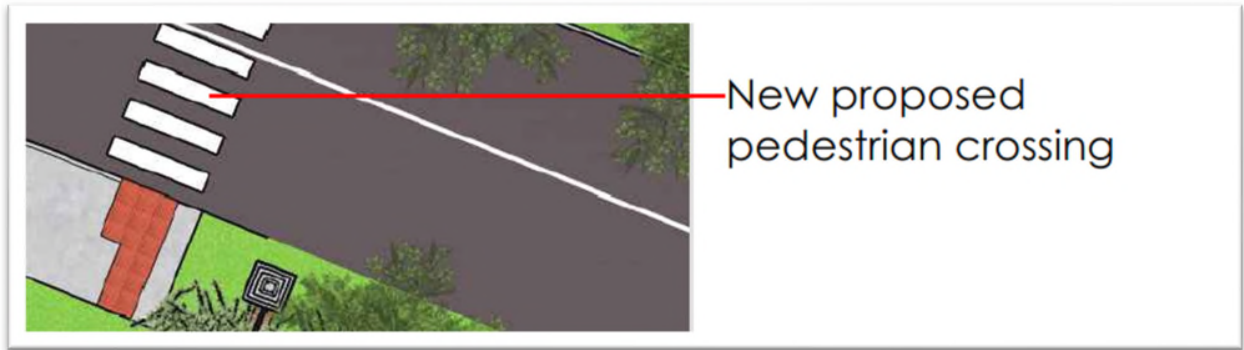
Drawing 210303-2-007 Rev – VHA, Pedestrian Bridge.

It is proposed to provide a pedestrian crossing across the Chelmsford entrance. The zebra crossing type markings and the red coloured type tactile paving may lead to confusion over priority leading to collisions. It may also lead to blind or partially sighted pedestrians assuming priority given the layout of the tactile paving. In addition, the pier may block a drivers visibility to crossing pedestrians.

It is recommended that if controlled crossing is proposed that beacons be provided. Suitable inter-visibility should also be provided for drivers and crossing pedestrians.

The pier is outside the scope of our works, and we cannot remove this	
--	--	--	---	--

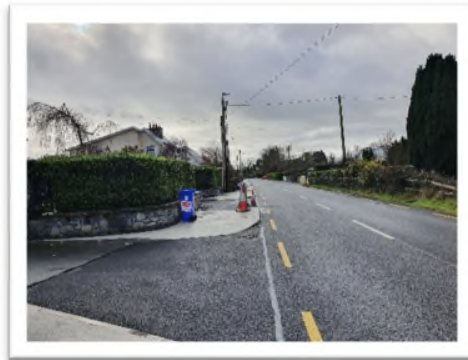
It is noted that tactile paving has not been provided at the crossing point on the new footpath along Ardclough Road.
