Archaeological Impact Assessment Report

Kildare Market Square

Kildare Town, Co. Kildare

20th December 2023

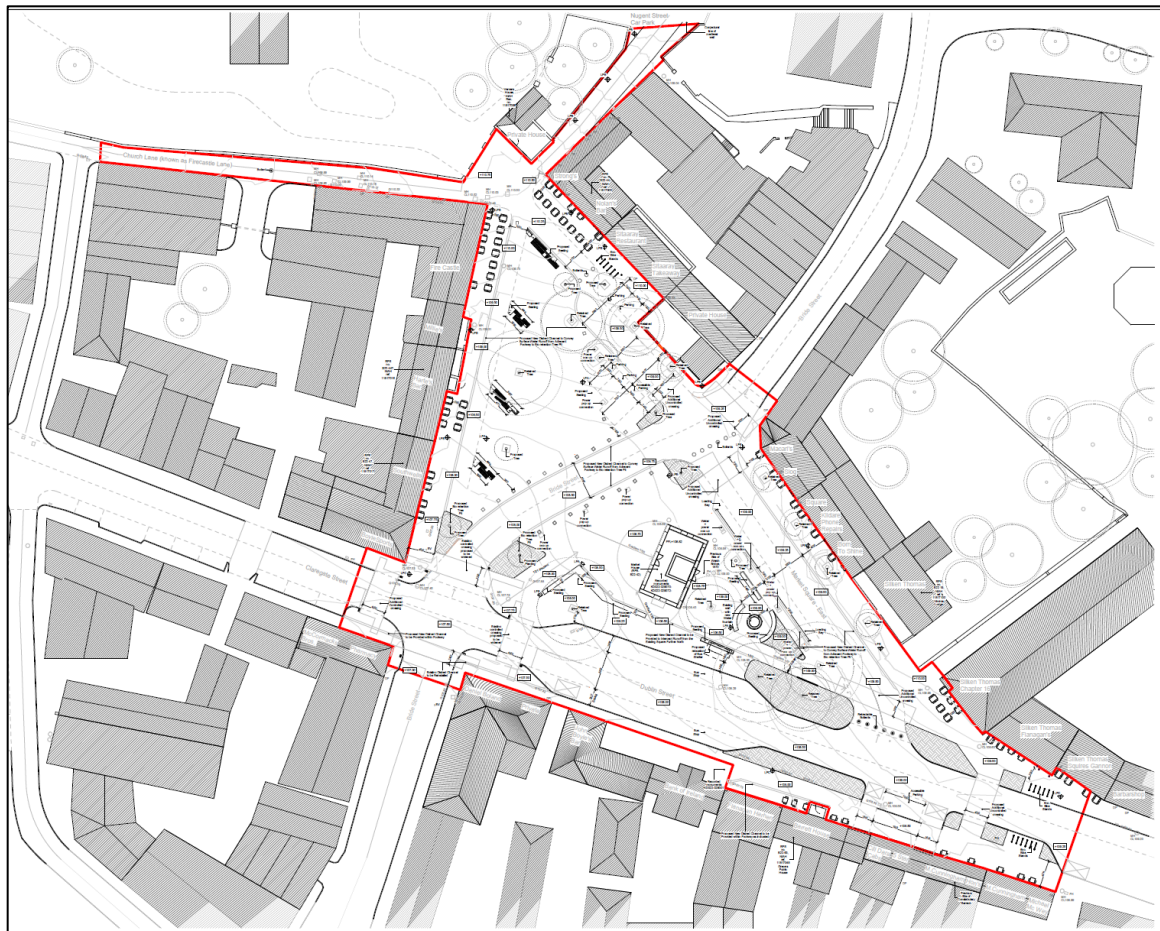
Figure 1 Proposed site location and layout at Market Square (Metropolitan Workshop Ltd)

The proposed development is located within the RMP zone of notification for the Historic Town of Kildare (KD022-029001), at the heart of the early medieval and medieval settlement (see Figures 14 & 15, Section 7.1 of this report).

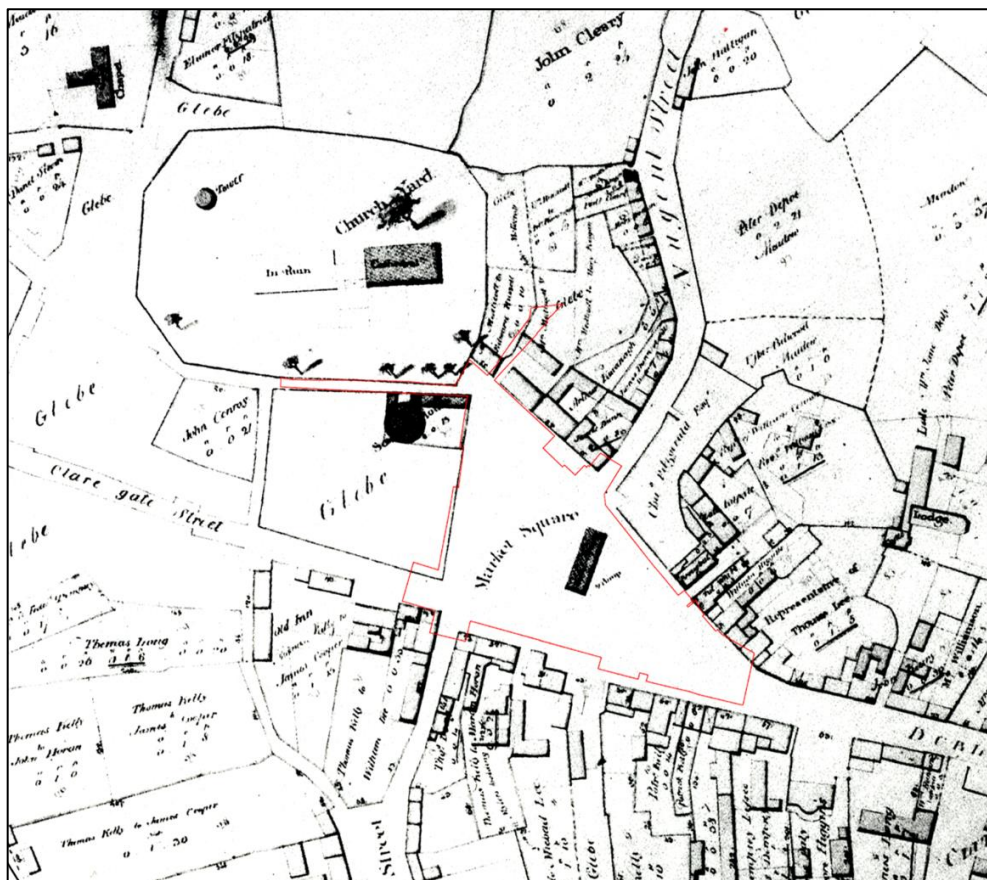
Figure 6 Survey by Sherrard, Brassington and Greene, 1817

the small square building attached to its north-east side had been removed and a much larger building is shown occupying the space, with an adjoining section to the west. It is named 'Market House' and is the same size and alignment as the present one, which is dated to 1817 (the present 19th century building may have incorporated an earlier structure). The western projection had disappeared by the time of the 1817 map by Sherrard, Brassington and Greene (Figure 6).
