BRIDGE REHABILITATION WORKS AT PASS BRIDGE, PASSLANDS, MONASTEREVIN

Environmental Impact Assessment Screening Report

KCCBFW-CCC-EN-S06-RP-0006

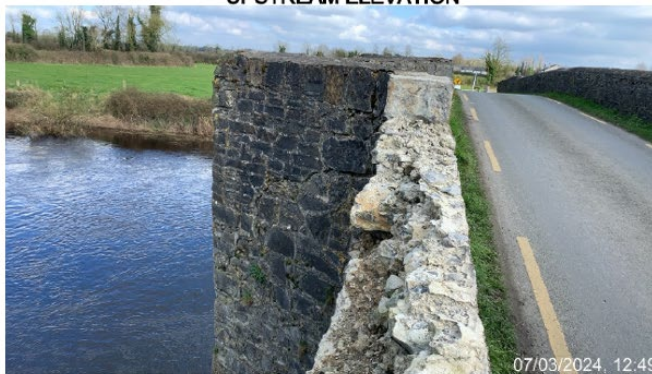
Figure 2 Preliminary Design Drawings - Defects

**PHOTO 2 (MISSING PARAPET
COPING AND CUTWATER CRACKING)**

Examples of the Preliminary Design drawing are illustrated in **Figure 2**.

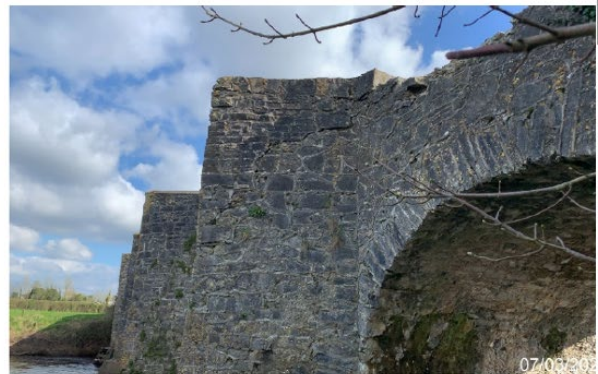
PHOTO 3 (CUTWATER CRACKING)

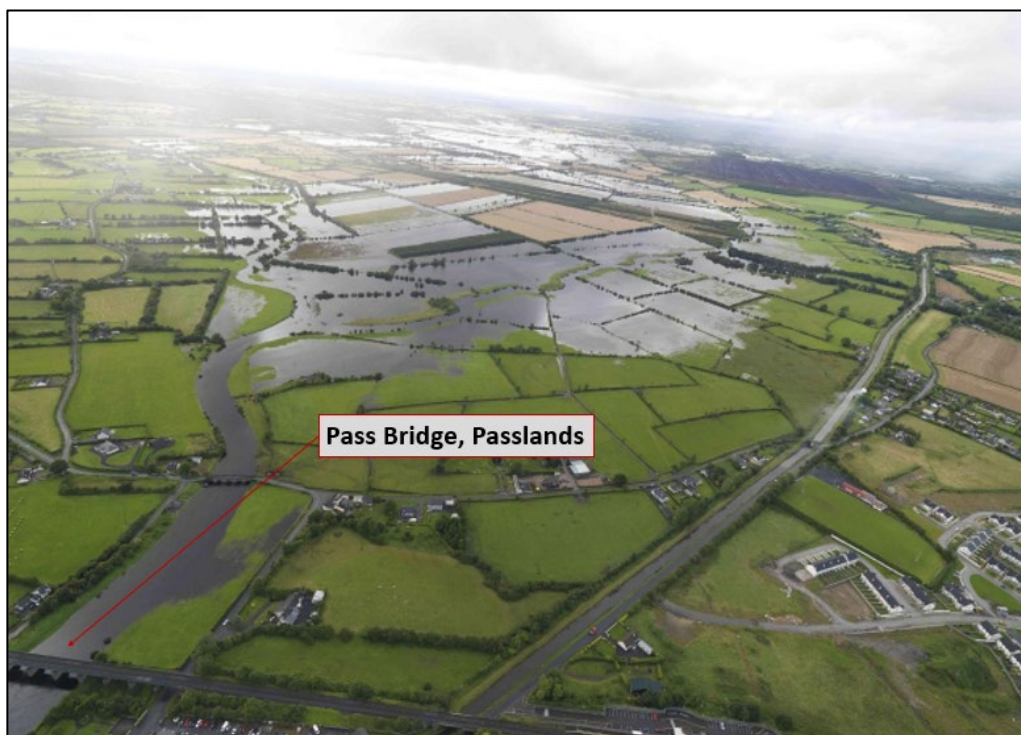
Figure 4: Aerial photograph of the bridge location following a 2008 flood event (OPW)

The bridge traverses the River Barrow north of Monasterevin, located in an area prone to flooding. A Catchment-based Flood Risk Assessment and Management (CFRAM) models flood risk adjacent to the scheme to be moderate (1-in-100-year chance of occurrence). A Strategic Flood Risk Assessment (SFRA) which was prepared in support of the Kildare County Development Plan (2023-2029) indicates a flood risk area on the flatlands upstream of Pass Bridge (Figure 44 below).

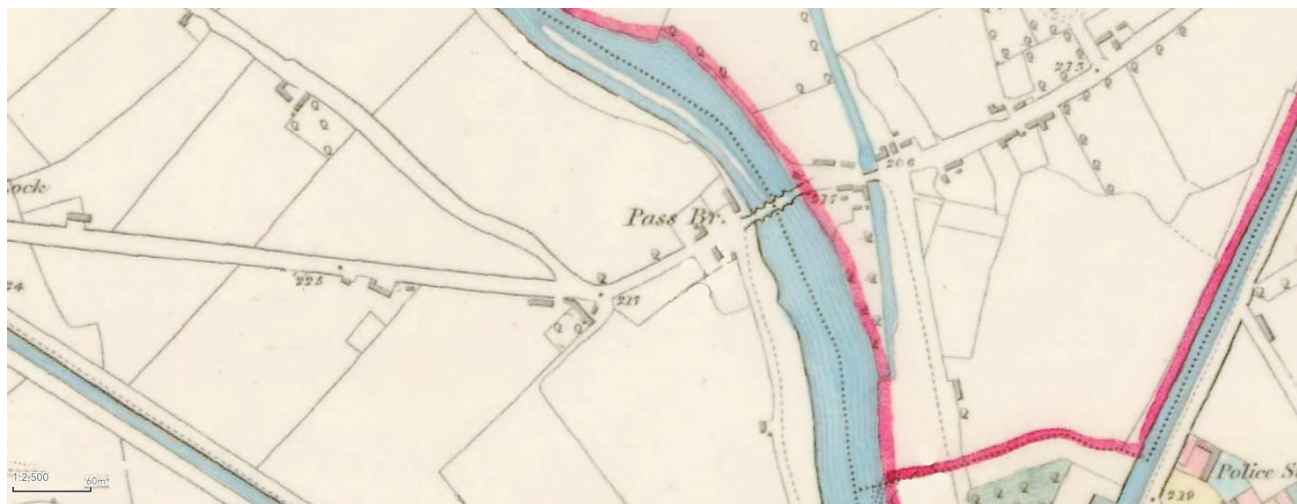
Figure 8: Extract from first edition 6-inch Ordnance Survey map (surveyed 1836 – published 1839), showing triangular cutwaters and five arches and labelled 'Pass Br.' (© Tailte Éireann)

The first edition 6-inch Ordnance Survey (OS) map surveyed in 1836 shows the bridge with up to four arches or piers and it is clearly depicted as 'Pass Br.' (Figure 8). At least four houses/buildings are illustrated on the east side of the river adjacent to the canal, while up to three others are depicted on the west side of the river. Griffith's Valuation of 1847–64 records the land on both sides of the bridge and river as owned by the Marquis of Drogheda, with the four buildings and land to the east leased by Timothy Brennan, who also sub-let two of the houses and their associated gardens to Michael Finnigan and Owen Mallen, while the land and three buildings to the northeast was leased by Arthur Rooney. A similar layout of structures is also illustrated on the third edition 25-inch OS map surveyed in 1908, though this time the railway line is illustrated to the south as are several small islands or linear deposits within the River Barrow, which has also changed course slightly (Figure 9). The bridge is named as 'Pass Bridge'. The last edition 6-inch OS map surveyed in 1942 also shows the bridge as 'Pass Bridge', while the 'Pass Cross Roads' is illustrated for the first time to the west (Figure 10).

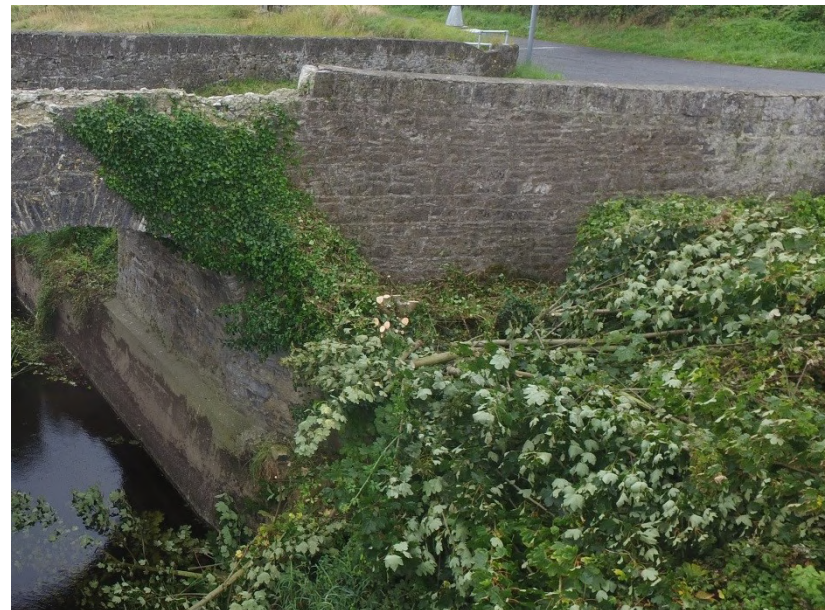
Plate 19: Detail of abutment and side wall on west side of north-facing elevation

Areas of vegetation growth, including lichens, moss and ivy, were also observed on the bridge, particularly around the base of the piers, on the spandrels, abutments and along the parapet, including in the area of the missing coping and damaged cut-water (Plates 19 and 20).

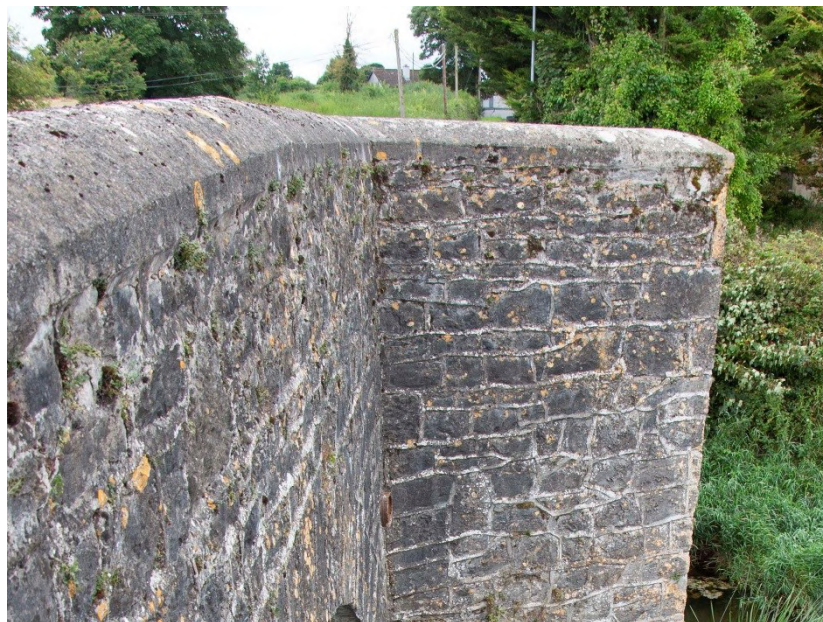
Plate 24: Detail of cut-stone coping on parapet wall and triangular cut-water

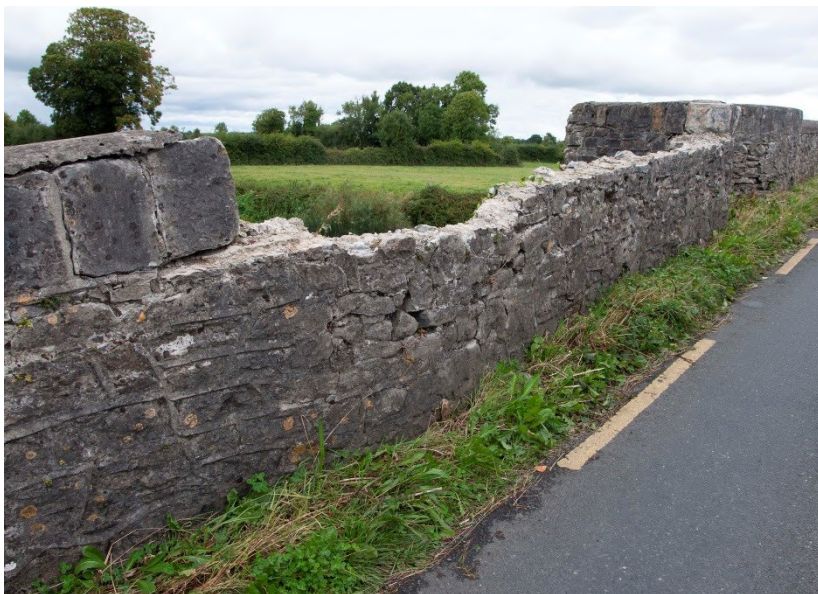
Plate 26: Detail of recent damage to north approach wall on west side of bridge

In recent times, the cut-stone coping to the north parapet wall on the west side of the bridge has been damaged and is now missing (Plate 26). This damage is not visible on Google Earth imagery dating to May 2023 (Figure 11). This has also impacted the adjacent cut-water, which shows extensive cracking (Plate 27).

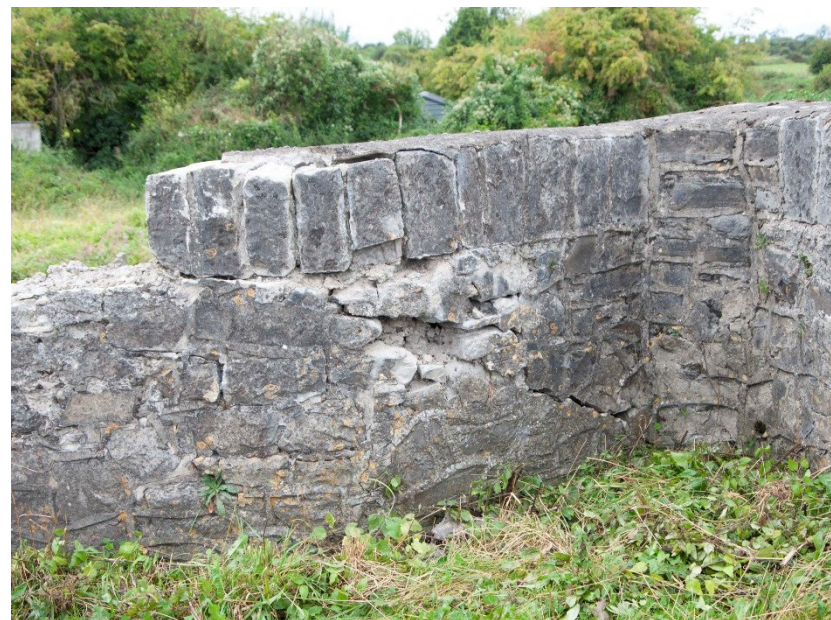
Plate 27: Cracking visible in triangular cut-water in north wall on west side of bridge

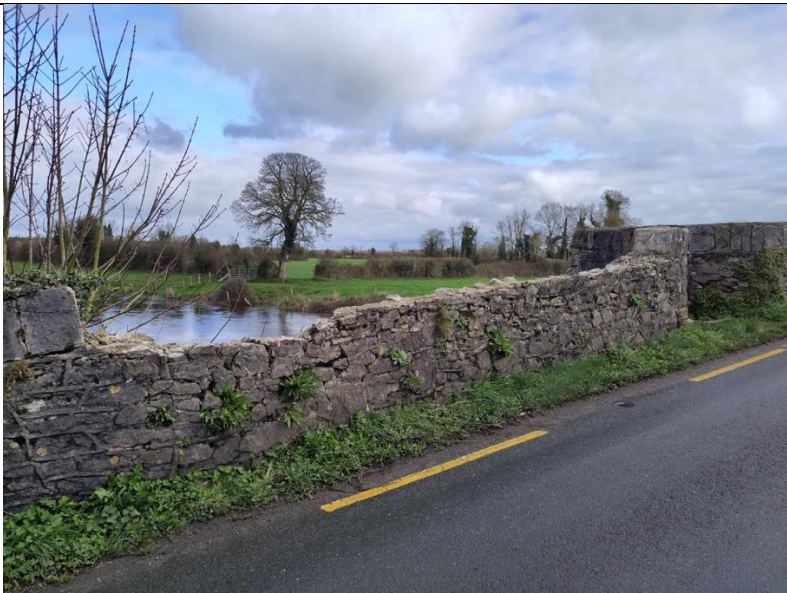
2.	Top of the left bank upstream parapet partially collapsed.

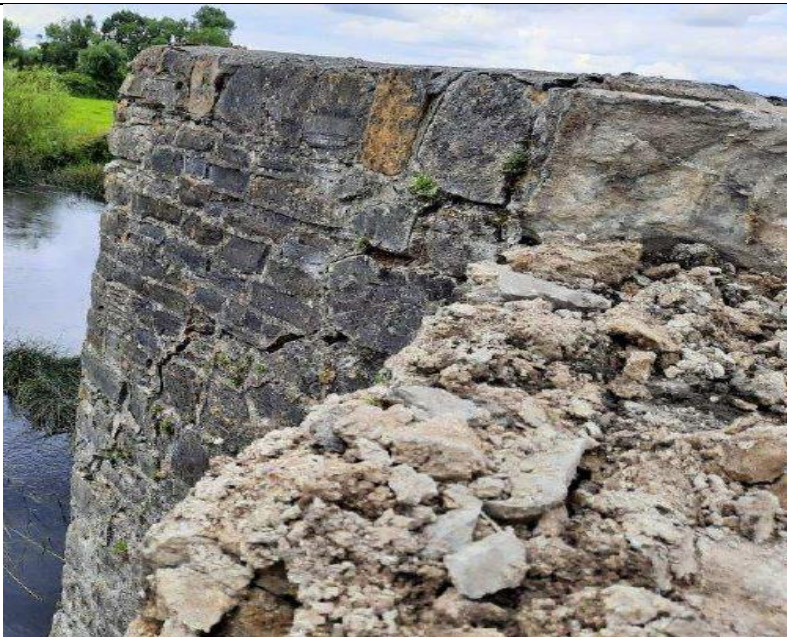
3.	Crack on the upstream wedge requiring stitching.
