Architectural Impact Assessment Report

Pass Bridge Rehabilitation Works, Monasterevin, Co. Kildare

Ian Russell
September 2024

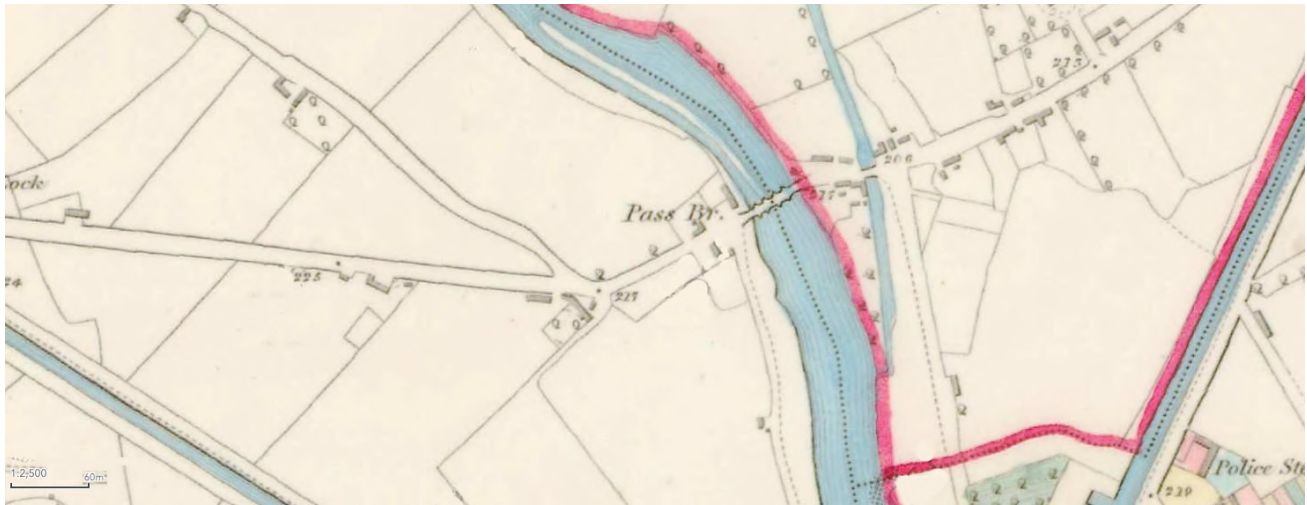
The first edition 6-inch Ordnance Survey (OS) map surveyed in 1836 shows the bridge with up to four arches or piers and it is clearly depicted as 'Pass Br.' (Figure 8). At least four houses/buildings are illustrated on the east side of the river adjacent to the canal, while up to three others are depicted on the west side of the river. Griffith's Valuation of 1847–64 records the land on both sides of the bridge and river as owned by the Marquis of Drogheda, with the four buildings and land to the east leased by Timothy Brennan, who also sub-let two of the houses and their associated gardens to Michael Finnigan and Owen Mallen, while the land and three buildings to the northeast was leased by Arthur Rooney. A similar layout of structures is also illustrated on the third edition 25-inch OS map surveyed in 1908, though this time the railway line is illustrated to the south as are several small islands or linear deposits within the River Barrow, which has also changed course slightly (Figure 9). The bridge is named as 'Pass Bridge'. The last edition 6-inch OS map surveyed in 1942 also shows the bridge as 'Pass Bridge', while the 'Pass Cross Roads' is illustrated for the first time to the west (Figure 10).

Figure 8: Extract from first edition 6-inch Ordnance Survey map (surveyed 1836 – published 1839), showing triangular cutwaters and five arches and labelled ‘Pass Br.’ (© Tailte Éireann)

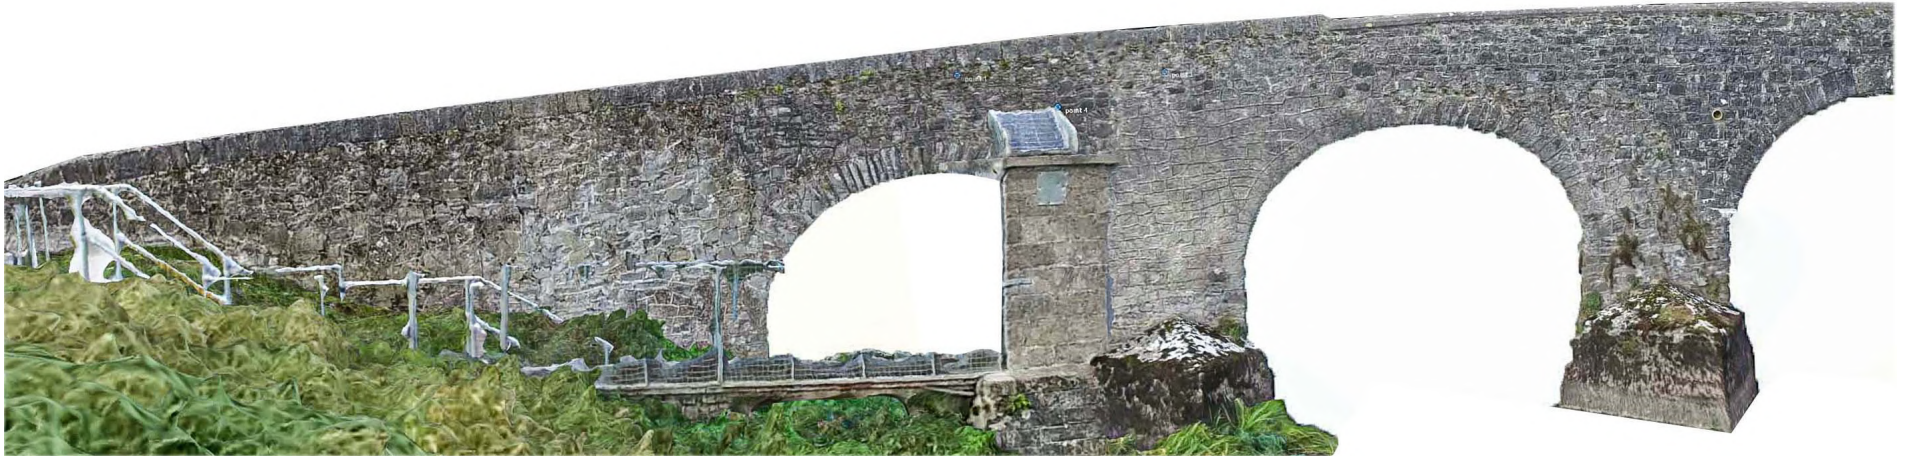
Much of the original fabric remains, although it has been rebuilt in places, repointed and the bases of the piers are encased in concrete as part of previous improvement works (Plate 16). Between 1926 and 1934, the River Barrow was the subject of an arterial drainage scheme, with 210 km of main rivers and tributaries and 175 km of smaller drains deepened and widened to improve conveyance (Shaffrey and Kehoe 2020). The concrete could date from this period, but this would need to be verified. The abutment/side wall on the west side of the south face also appears to have been repaired in the past (Plates 8 and 21). A modern water treatment or testing facility was also constructed in this area in the past, including steps, metal railing and a concrete pillar (Plates 8, 12 and 21).

Plate 8: Detail of south-facing elevation, west side

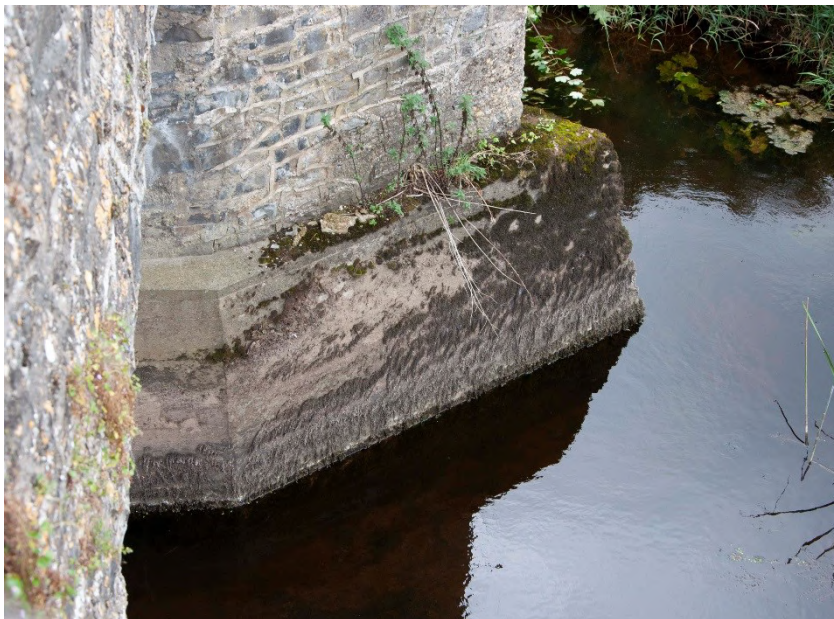
Plate 16: Close-up of concrete base of triangular cut-water/pier

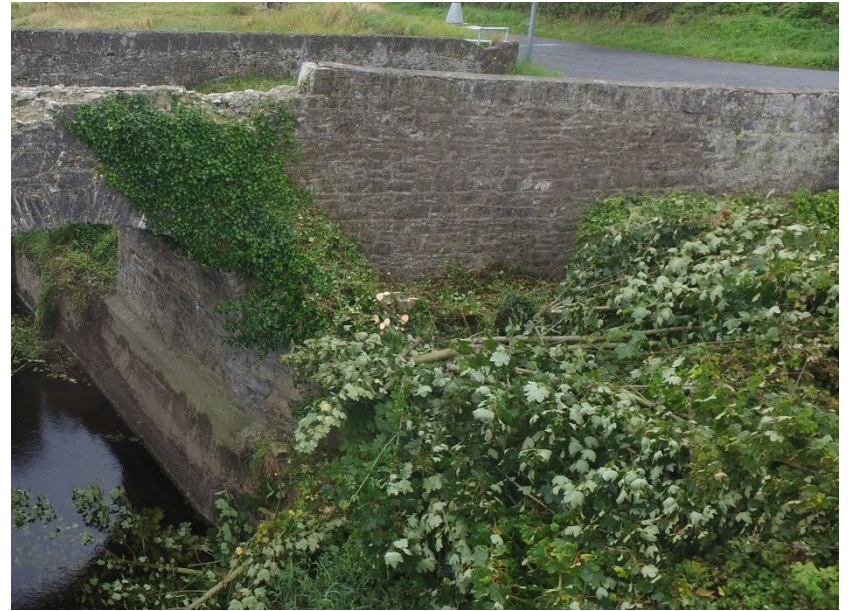
Areas of vegetation growth, including lichens, moss and ivy, were also observed on the bridge, particularly around the base of the piers, on the spandrels, abutments and along the parapet, including in the area of the missing coping and damaged cut-water (Plates 19 and 20).

Plate 19: Detail of abutment and side wall on west side of north-facing elevation

The clearing of vegetation from the parapets and spandrels is also a necessary removal alteration as it may be hiding additional structural damage as well as increasing existing cracks, particularly regarding plants with woody roots such as ivy. The removal of vegetation without proper consideration can also increase the risk of masonry collapse. All vegetation removal should therefore be carried out in accordance with best conservation practice guidelines and advice. The latter includes the 2010 advice series by the then Department of Environment, Heritage and Local Government (e.g. *Ruins: The Conservation and Repair of Masonry Buildings*).

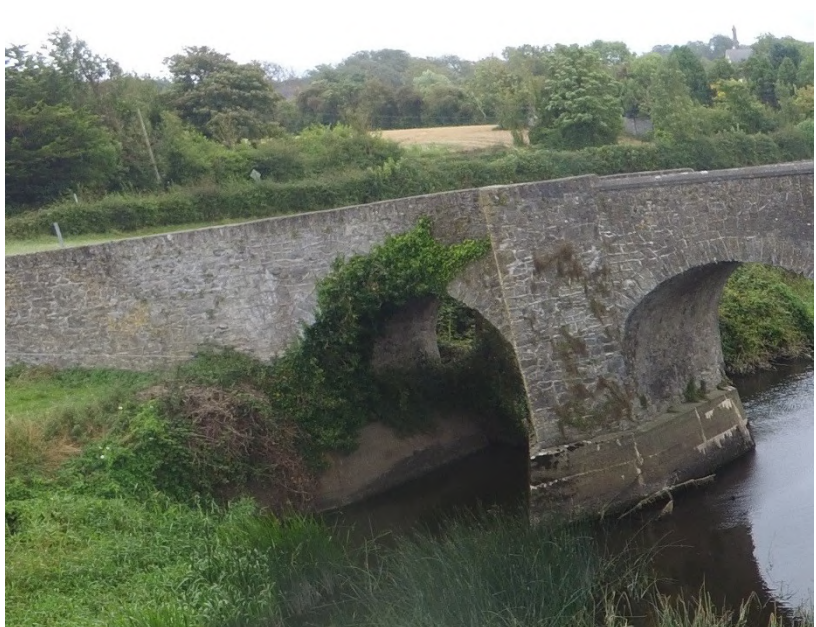
Plate 20: Detail of abutment and side wall on east side of north-facing elevation

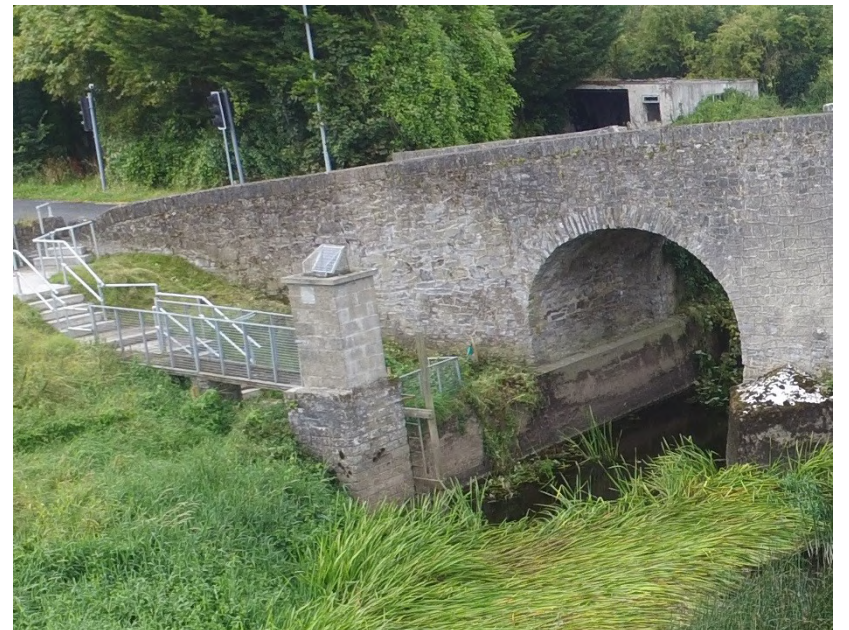
Plate 21: Detail of abutment and side wall on west side of south-facing elevation

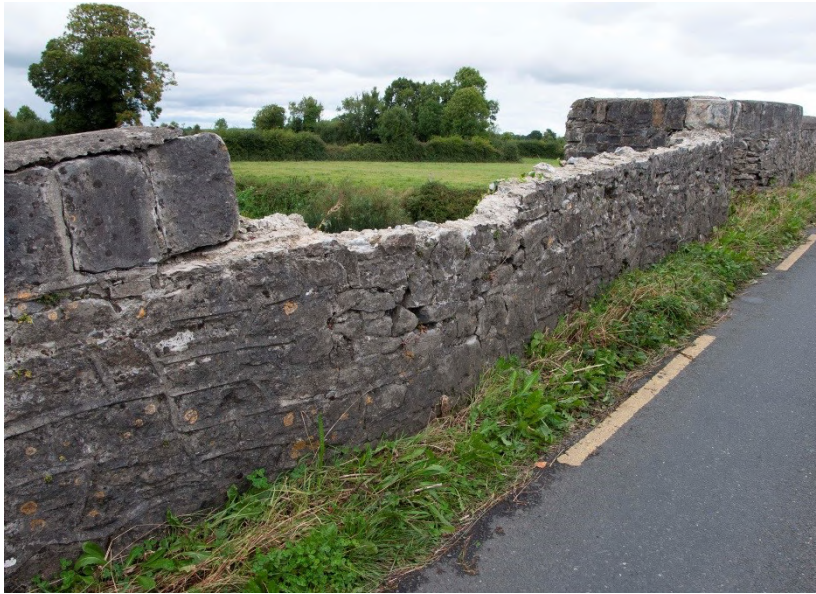
In recent times, the cut-stone coping to the north parapet wall on the west side of the bridge has been damaged and is now missing (Plate 26). This damage is not visible on Google Earth imagery dating to May 2023 (Figure 11). This has also impacted the adjacent cut-water, which shows extensive cracking (Plate 27).

Plate 26: Detail of recent damage to north approach wall on west side of bridge

Repair and reconstruction to the masonry walls, including the damaged coping on the approach wall, parapet and cut-water, will alter the fabric of the structure, however, these works are necessary to minimise further damage, particularly in the area where the wall core is exposed to water penetration and therefore at risk for further deterioration. These represent localised invasive work but will be designed to minimise impact, both visually and physical, by using appropriate materials that are compatible with the existing historic fabric of the bridge. Conservation best practice guidelines should be adhered to for all repair and reconstruction works.

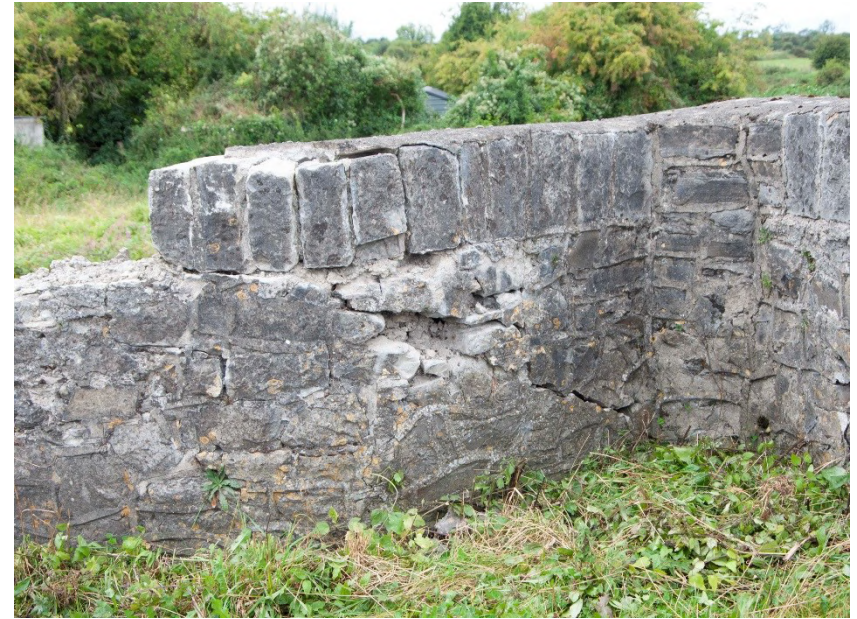
Plate 27: Cracking visible in triangular cut-water in north wall on west side of bridge

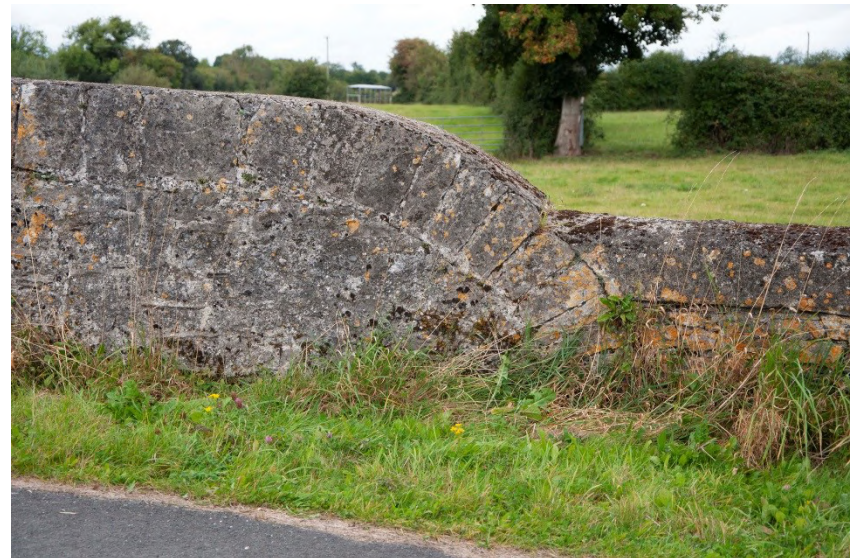
consist of roughly coursed limestone blocks (Plates 23 and 25). On the east side of the bridge, the north wall also curves down where it is joined by a lower approach wall (Plate 29). This is the only area where this feature was observed.

Plate 29: Detail of masonry in north approach wall on east side of bridge
