## Accessibility audit of Riverbank Arts Centre, Newbridge, Co Kildare.

## **Access Audit** (Revision No. 1)

Prepared for:  
**Riverbank Arts Centre.**

11<sup>th</sup> August 2016

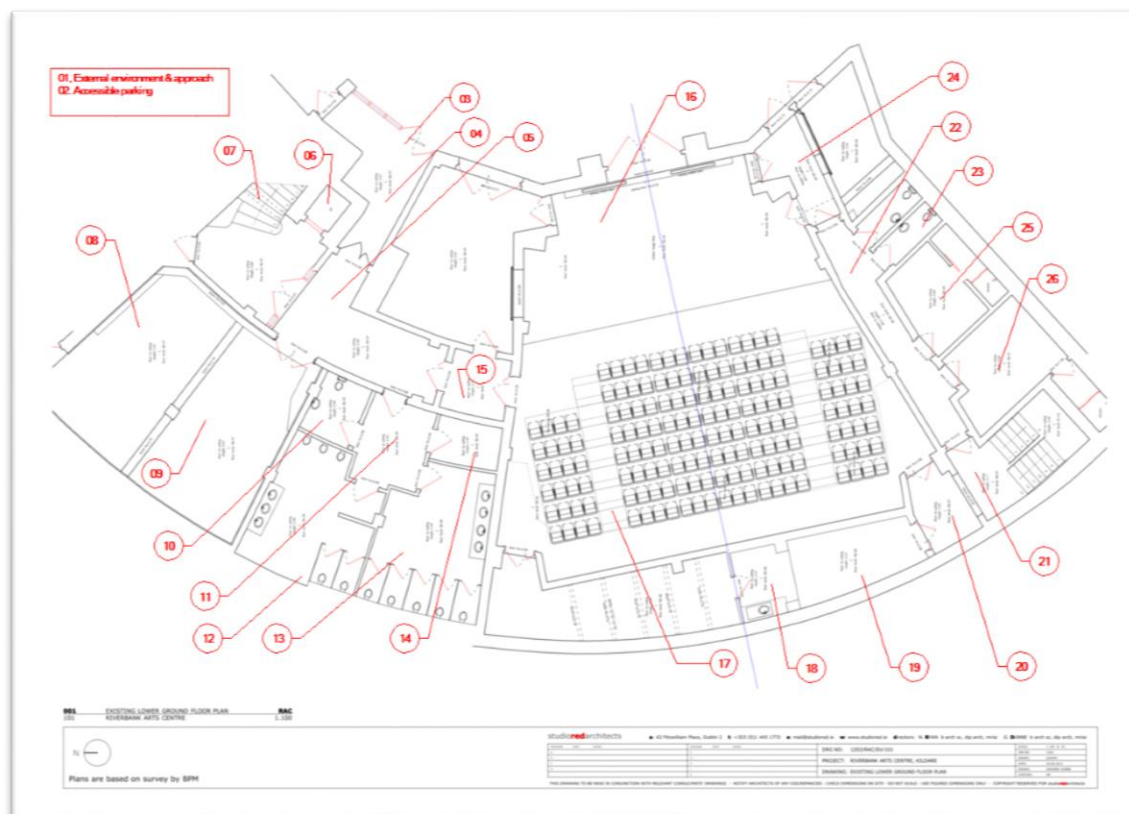
## 7 Accessibility Review – Lower Ground Floor

| 1 | External Environment & Approach | The main lower ground floor entrance is to the rear of the building and is accessed through the shared car park via Main Street. This access route is for staff only and access to members of the public is via the upper ground floor only. | | Ensure that accessible access routes to the main entrance are easily identified and that information re same is included in pre-visitor information. |

| | <p>Pedestrian access is via the public footpath on main street. Access to the car park area is access controlled. Staff members are informed of the key code and there is a call button directly linked to the box office for assistance. The key pad height is 1420mm (1200mm would be the recommended limit) and the height of the assistance buzzer is 1050mm. On exiting there is only a key pad, no push button to exit or call button for assistance which may restrict a person's ability to exit particularly in an emergency.</p> <p>No signage indicating the accessible entry route etc. is provided.</p> <p>The opening force of the gate appeared heavy and it was noted that no closer was fitted to the gate.</p> <p>A clear opening of 1320mm is provided. It was noted that the mag lock for the access control is located on the opening side of the gate at a height of 1820mm and projects approximately 75mm into the access route, this could potentially be a hazard re someone banging their head.</p> <p>The pedestrian access route through the rear car park to the entrance is not clearly defined/line marked and there is a danger that persons with vision impairment could inadvertently walk into a vehicular route.</p> <p>It is noted that the circulation area between the main lower ground floor entrance and the back</p> | | <p>Consultation with Kildare County Council should also be considered to identify if access can be improved.</p> <p>During any future upgrading works to the lower ground floor access route the following should be considered:</p> <ul style="list-style-type: none"> <li>• The access control key pad height at the pedestrian gate should be brought within the range identified in TGD Part M 2010 section 1.5.7.</li> <li>• Signage to indicate the location of the accessible public entrance.</li> <li>• The opening force required to operate the gate – the possible inclusion of power assisted opening /closing, push button release or call buzzer for assistance to be fitted on the internal side, and relocating the existing mag lock out of head height range.</li> <li>• A separate pedestrian route should be identified and clearly marked to minimise the danger of persons inadvertently waling into vehicular routes.</li> </ul> |

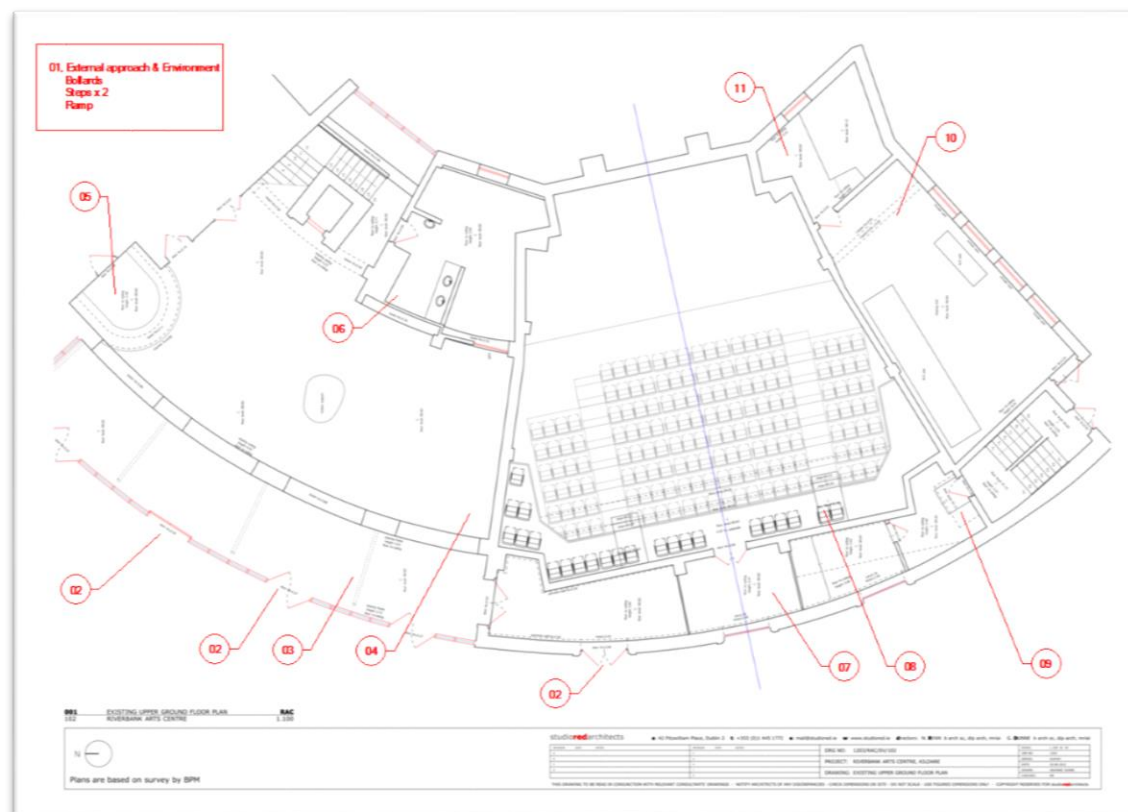
## 8 Accessibility Review – Upper Ground Floor Level

| No. | Item | OHAC Observation | Drawing Reference | OHAC Recommendation |
|---|---|---|---|---|
| 1 | External environment & Approach | The main upper ground floor entrance consists of basically 2 no. of access routes – 1 from the town direction and the other from the bridge direction. It is noted that as no access is provided to the public at lower ground floor level all audience members/visitors must access via the upper ground | | Accessible access routes to the main entrance to be identified to be included in pre-visitor information. In addition, information on accessible parking and public transport networks that service |
