HISTORIC BUILDING APPRAISAL

APPRAISAL OF HISTORIC RUINS

Sallins Amenity Lands, Osberstown, Co. Kildare

February 2021

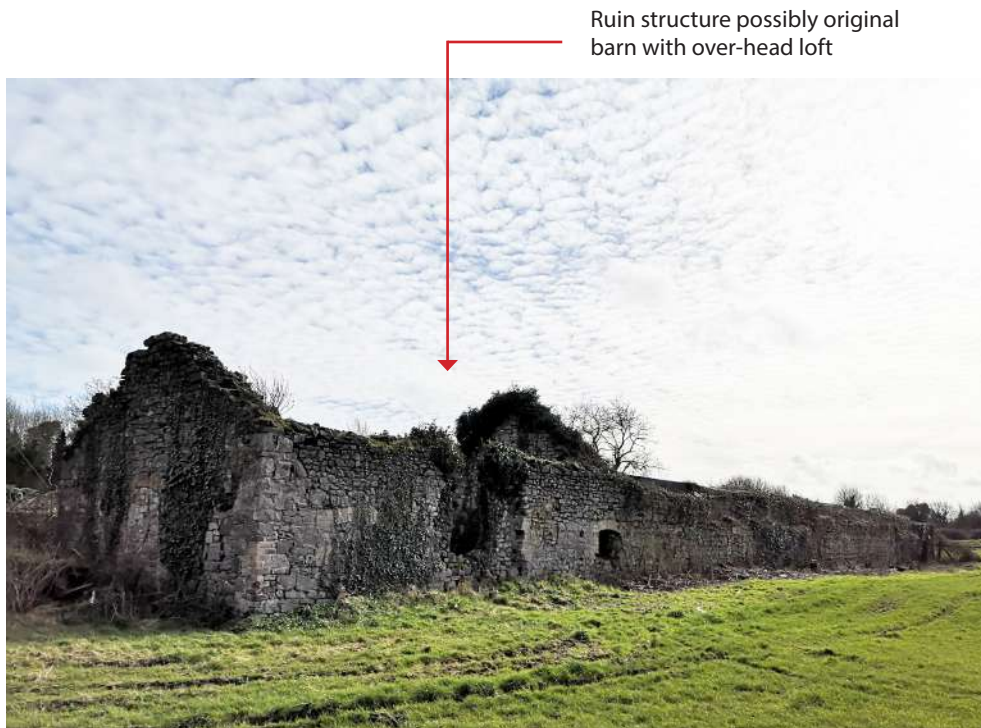
Substantial outbuilding to north-west

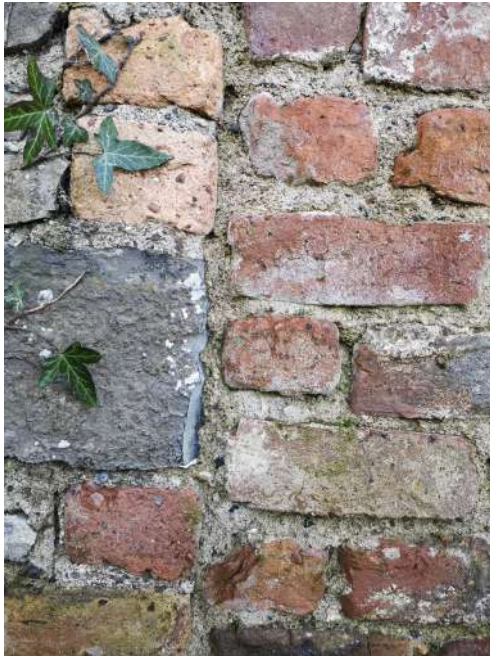
Detail of reveal to bricked arched door

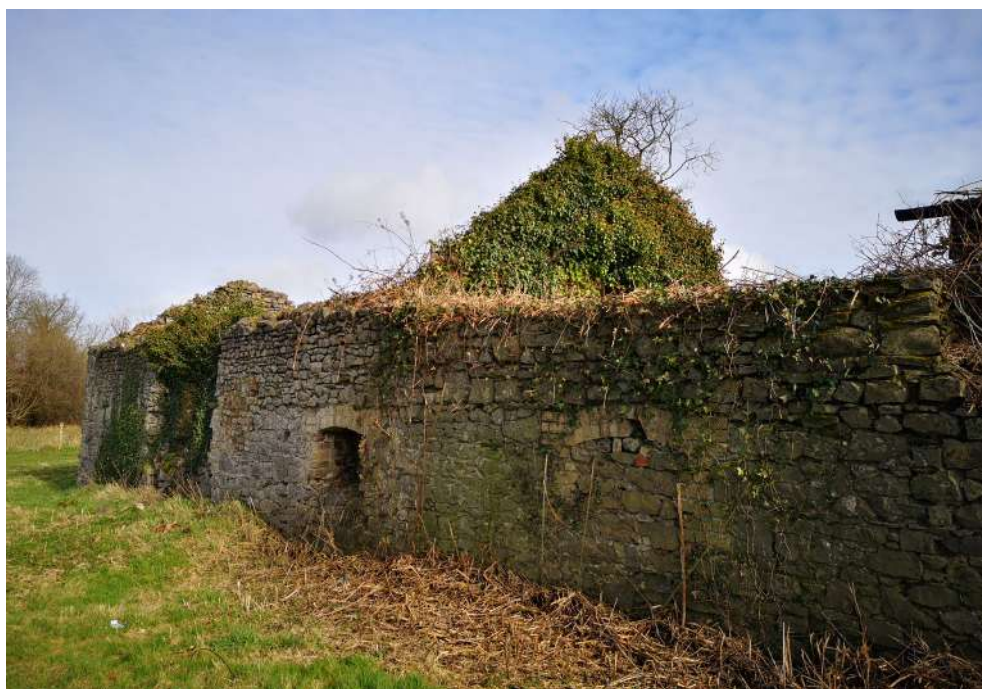
View of western ruin and arched openings

Collapsed arched opening to
centre of ruin - brick reveals still
evident

Two small arched windows are evident to the western elevation, one of which has been consolidated as it has been blocked up in stonework for some time and the other, the brick arch is decayed and in a state of collapse. There is a larger centrally located window on this side where the brick reveals are still evident, but the overhead brick arch has perished. The outer layer of stonework has collapsed to this window opening and therefore gives evidence of the make-up of these rubble stone walls where the centre comprised of smaller rounder stones heavily embedded in mortar and larger facing stones were used to both the inside and outside faces of the wall.

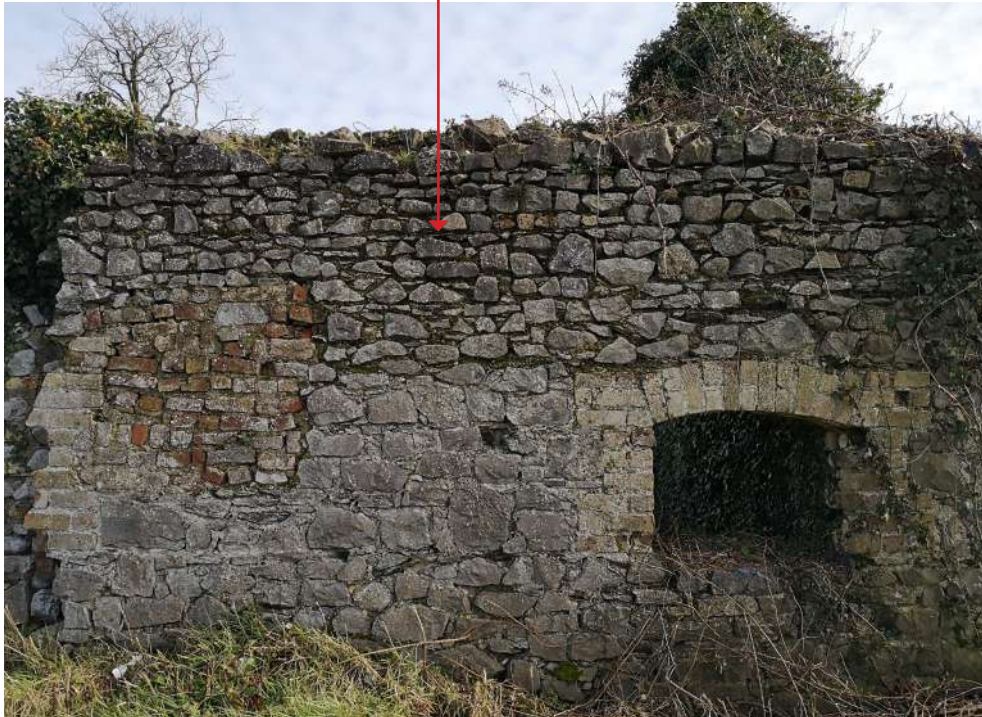
Detail of original building fabric of western ruin

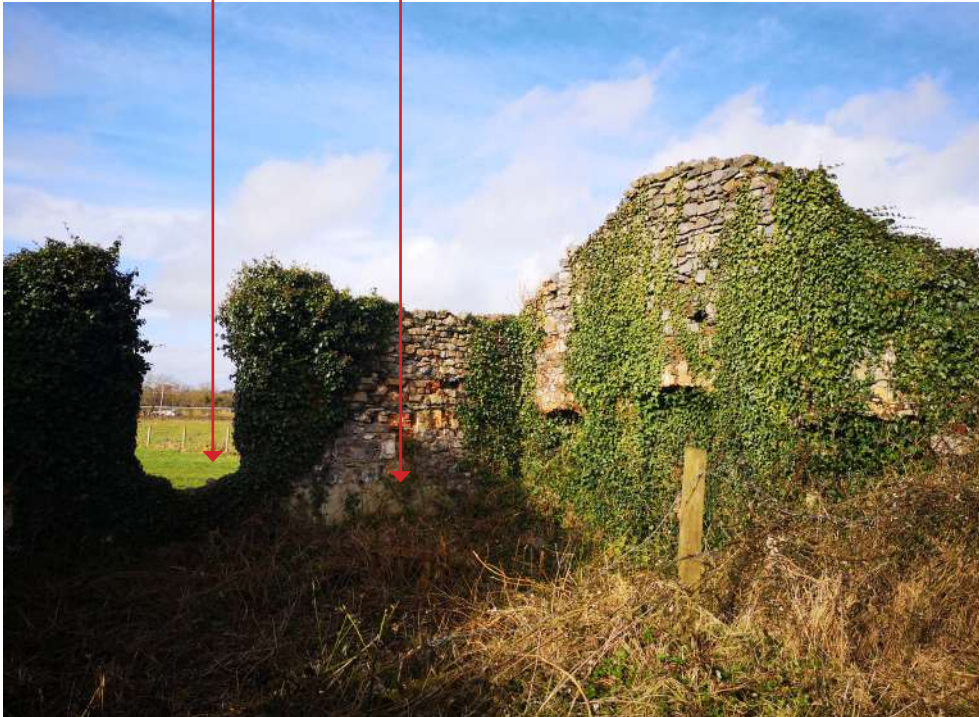
View of inside of north-west ruin

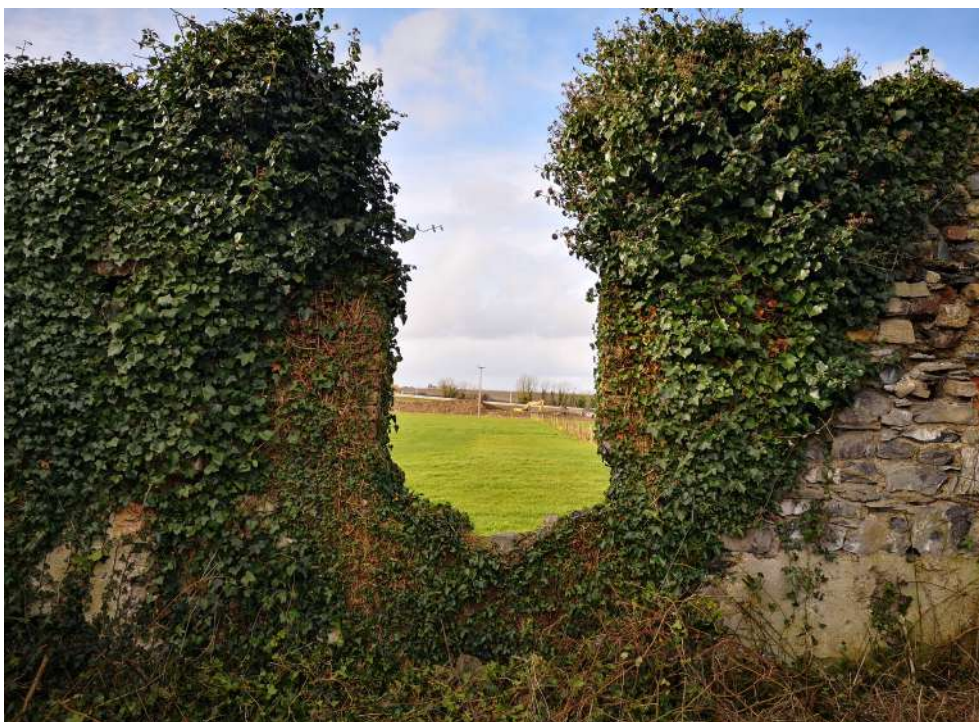
View of rear courtyard and ruined outbuildings to the Eastern boundary

Original wall fabric of stonework
and brickwork exposed - remnants
of lime render still evident

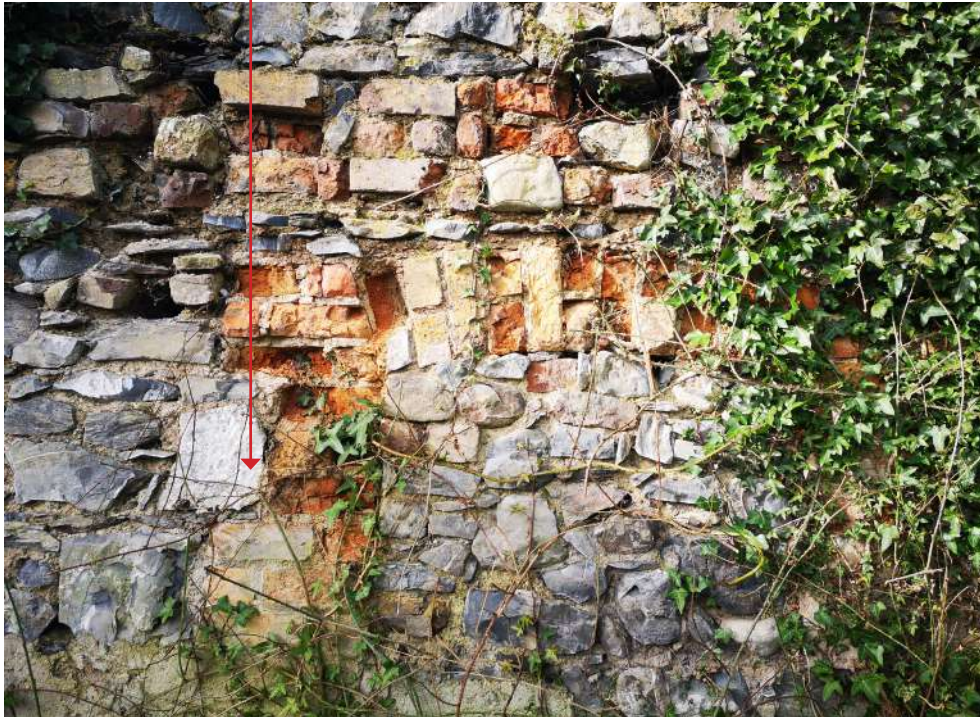
Detail of blocked brick arch

Pockets evident to masonry
wall

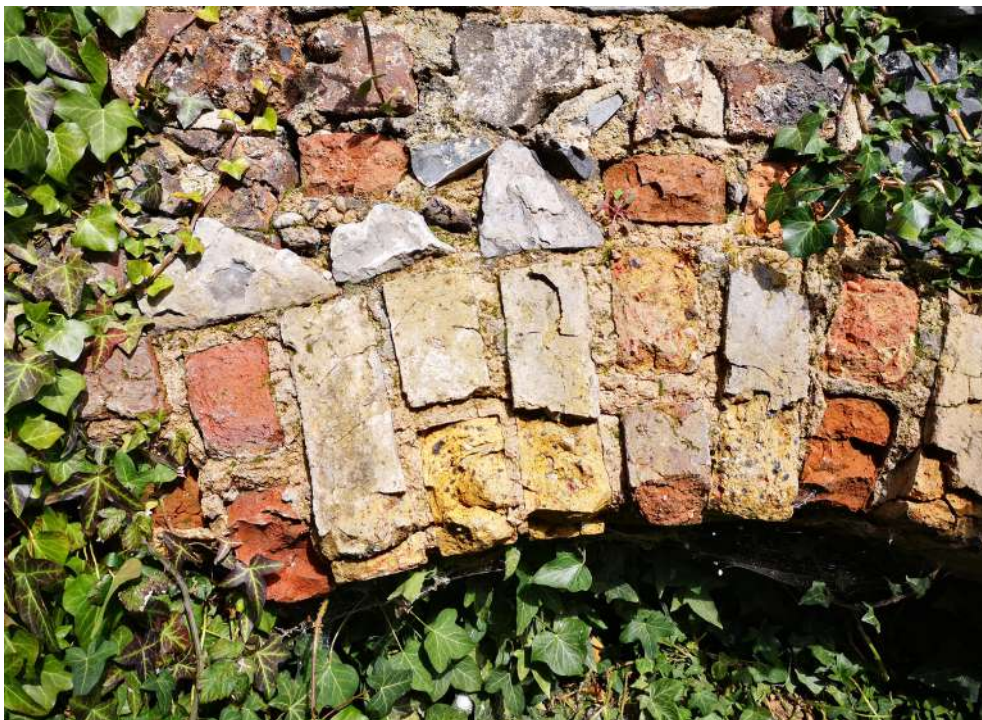
Delamination of brickwork evident at archway to window opening

Exposed stonework originally lime rendered for weather protection

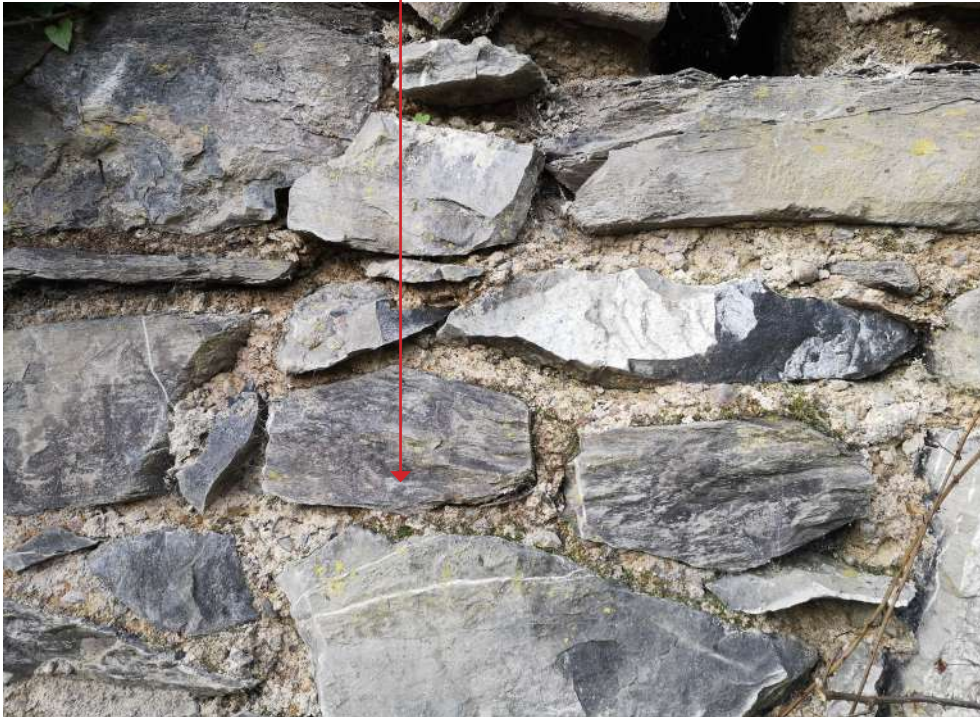
Detail of limestone exposed wall

Original brickwork embedded in lime render evident

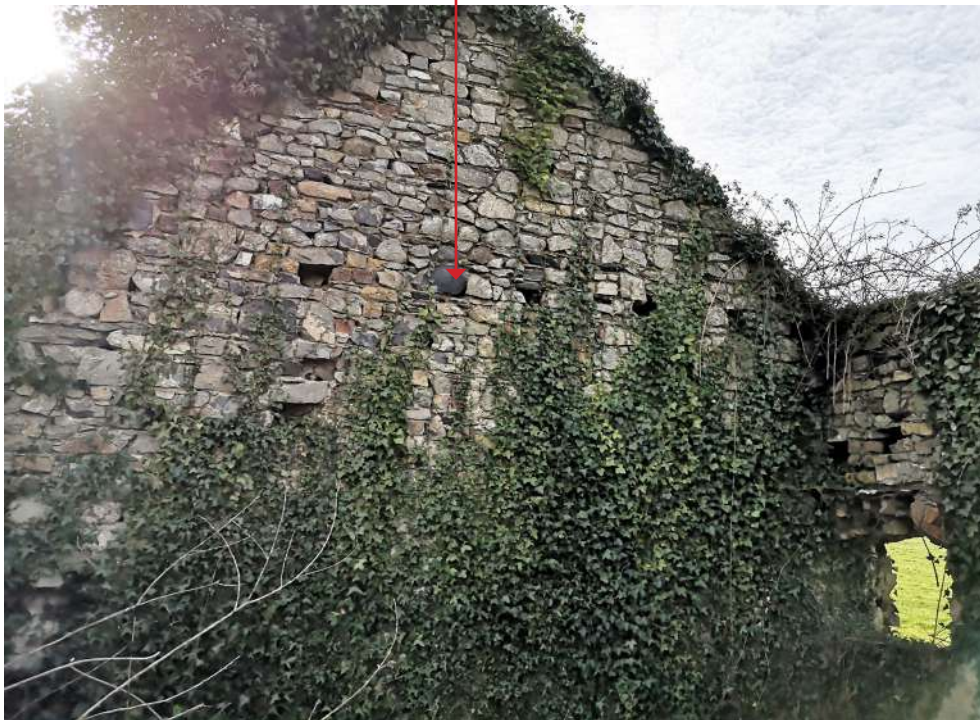
Southern gable wall of North-West Ruin

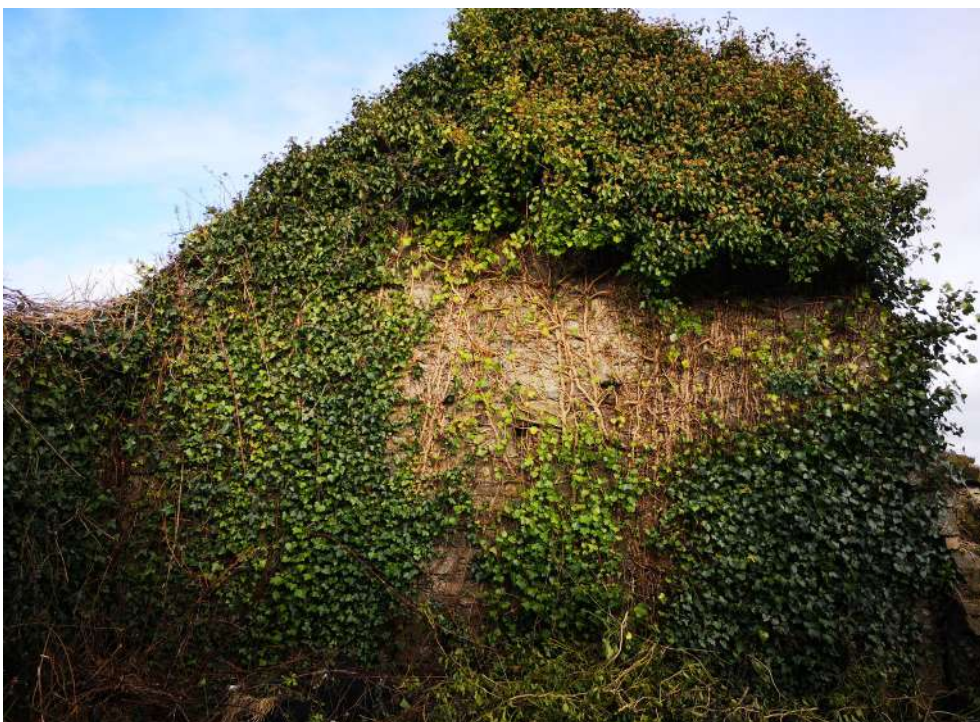
View of southern gable wall with overgrowth

Blocked opening evident adjacent to ruin at end of courtyard wall

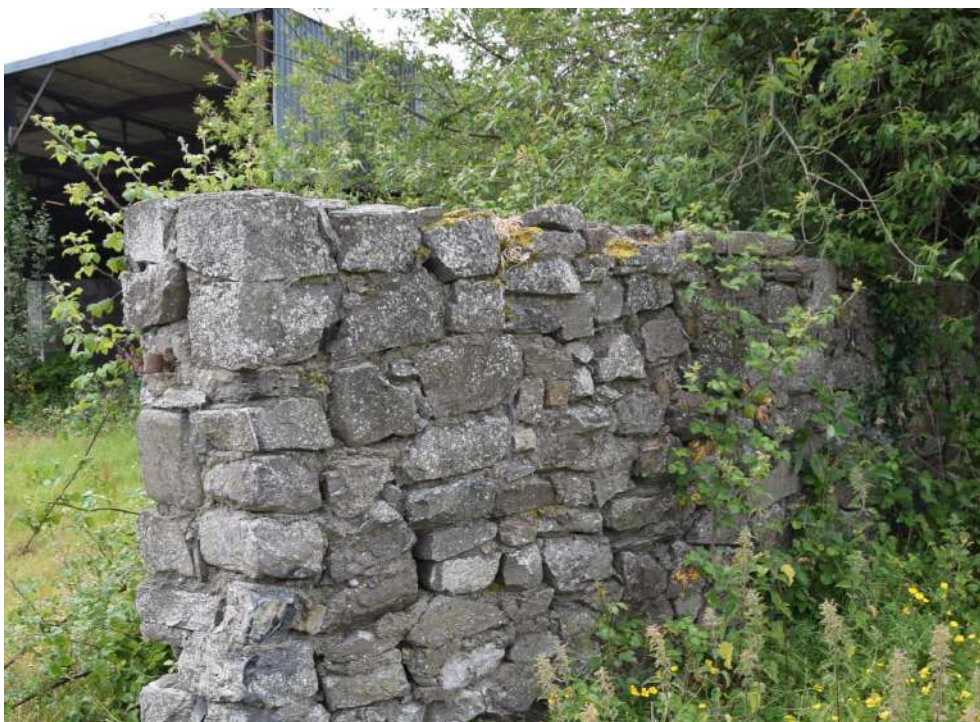
Detail of stonework to courtyard wall

Possible location of original
gable end to substantial
western outbuilding

Gabled end to
south-east ruin

The high stone wall to the southern wall of the rear courtyard enclosure is intact and there is no evidence of later stages of construction or repair works which were evident on the western wall of the western ruin. There is no evidence of a stone gabled end to complete the western ruin at this southern end, but the form and surviving opening of this ruin suggests the south-western end of this wall did terminate in a gable for an original substantial outbuilding.

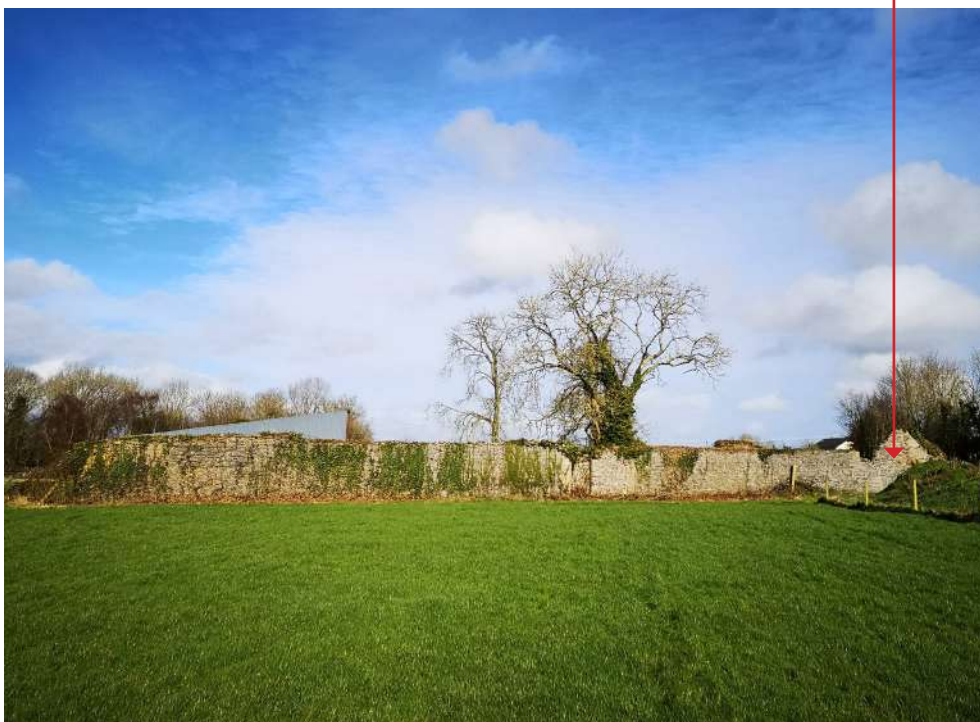
View of substantial stone wall to rear farm courtyard

Structural impact of existing tree on historic stone wall to be assessed by others

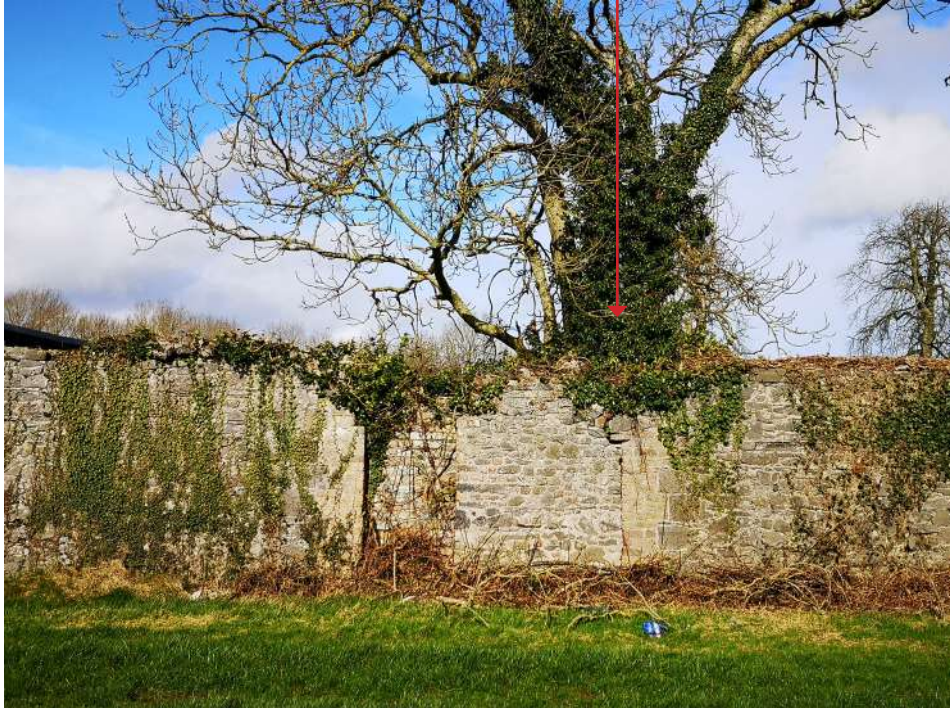
View of high stone wall to the Southern boundary of historic farmyard site

Brick reveals evident either side of opening

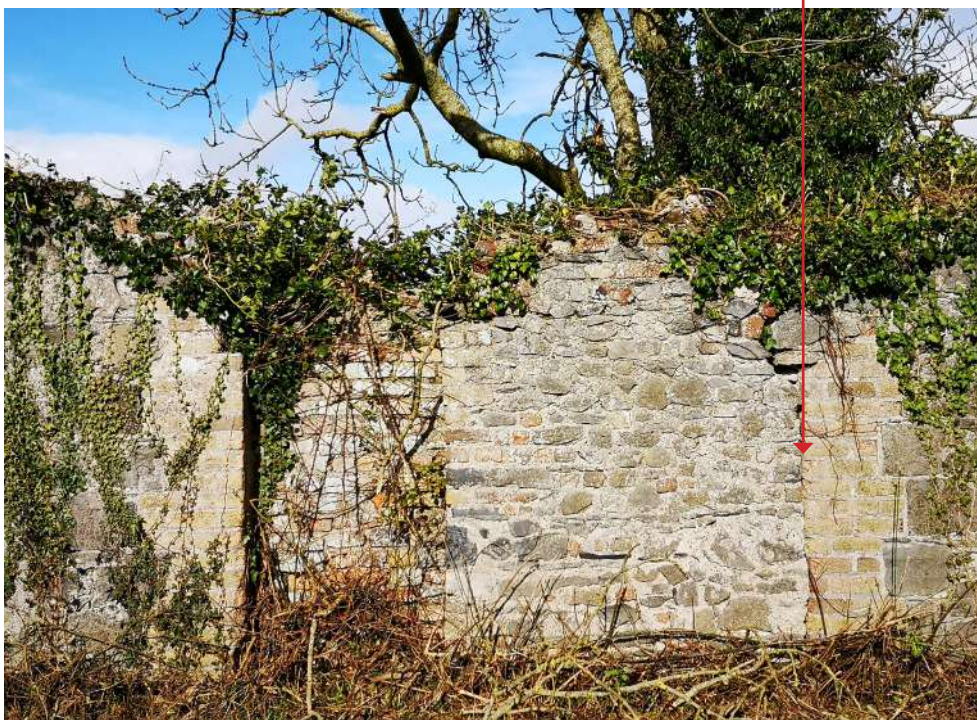
Detail of original blocked 2.8m opening to centre of southern stone wall

Location of original blocked 2.8m opening to centre of southern stone wall

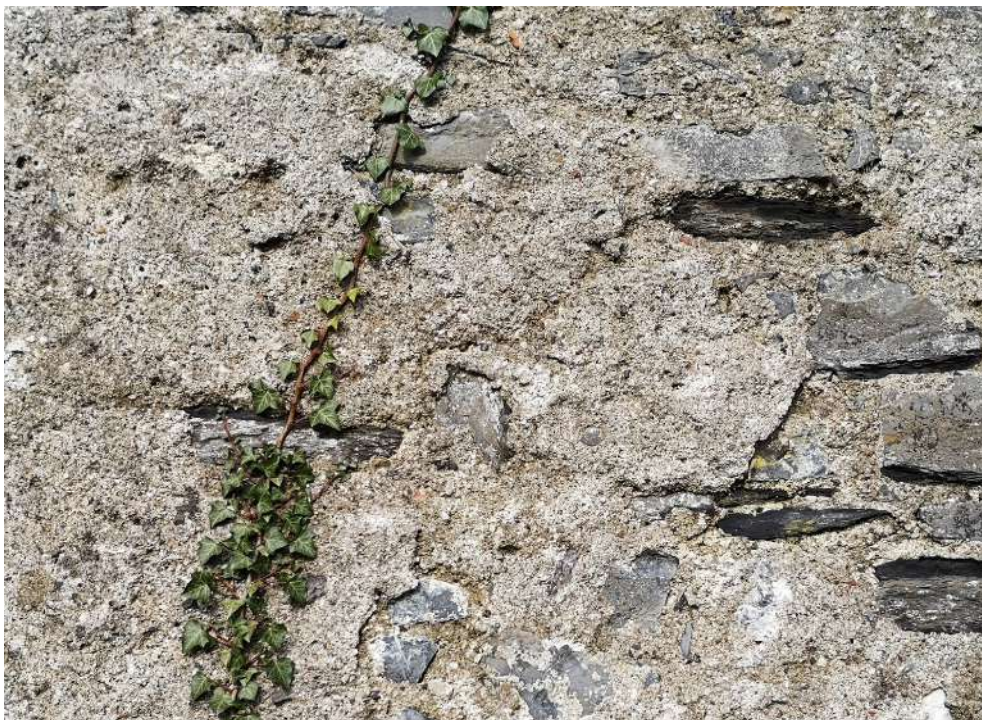
Remains of lime render to gable wall

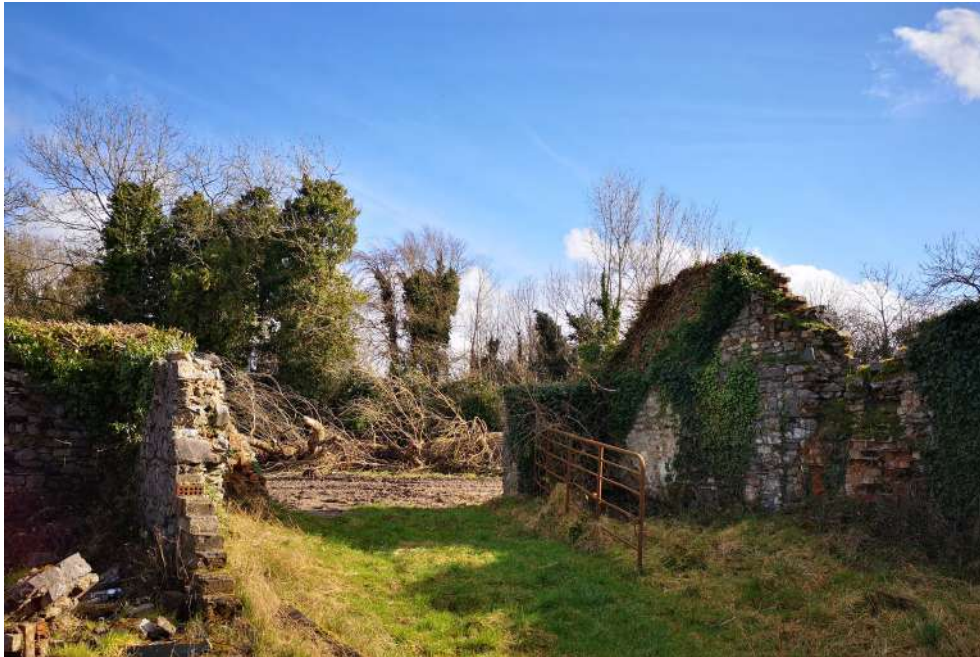
View inside remains of South-Eastern ruin

Blocked arched opening evident
at base of centre of gable wall

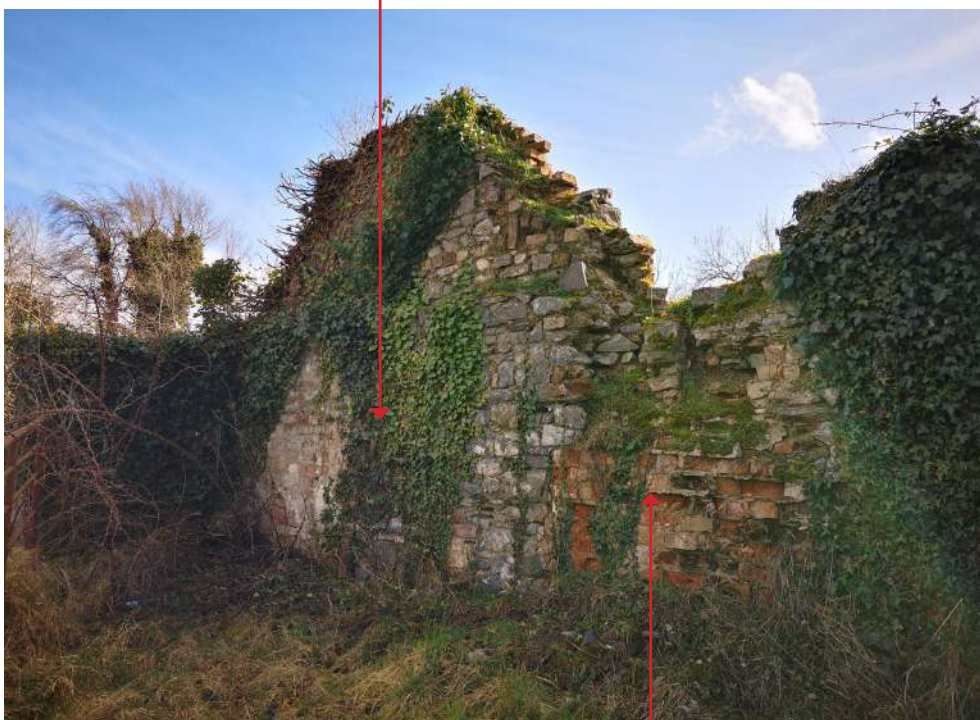
Surviving Southern Gable of South-Eastern Ruin

Remnants or earlier
structure

Original brickwork embedded
in lime render

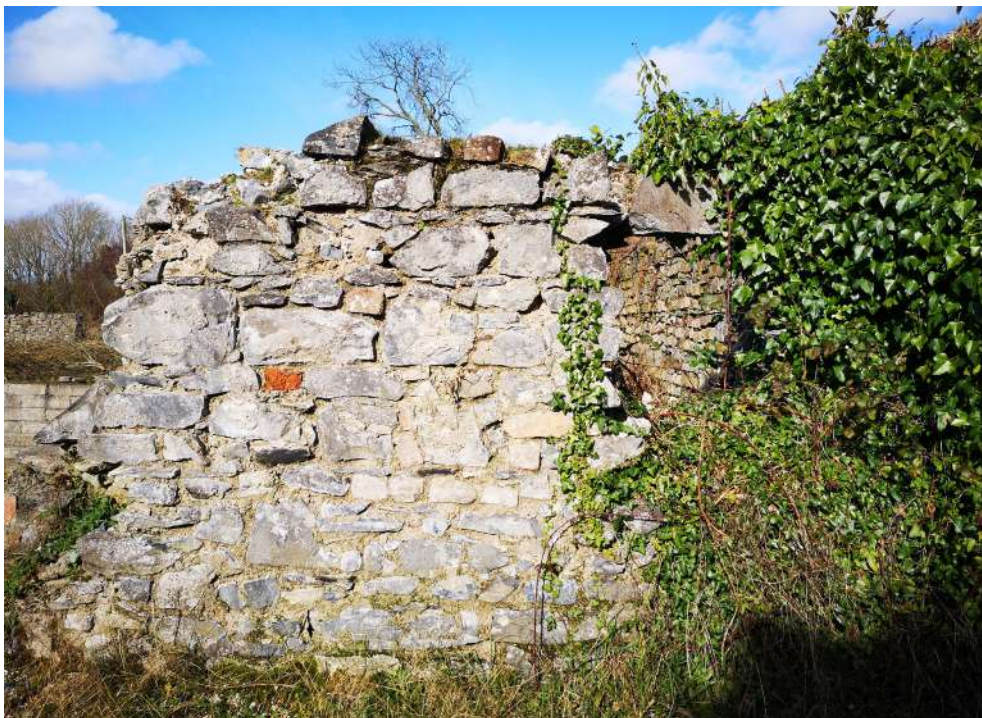
Evidence of early window opening with stone lintel

Concrete blockwork wall introduced
as part of later agricultural structures

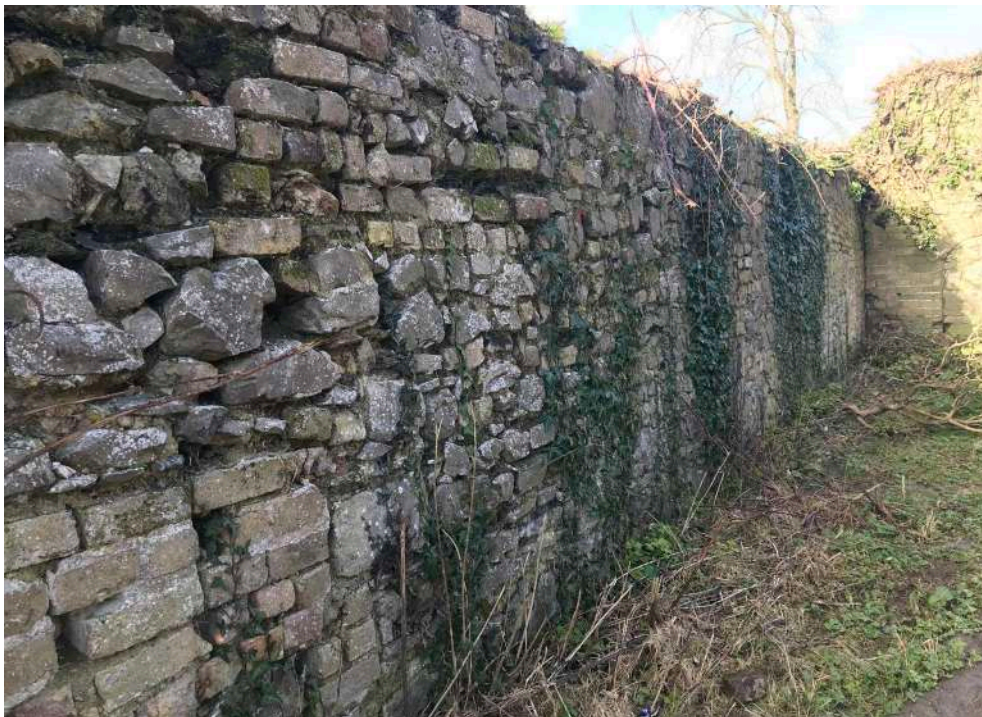
Detail of brickwork and stone to eastern courtyard wall

Low level blocked arched opening evident

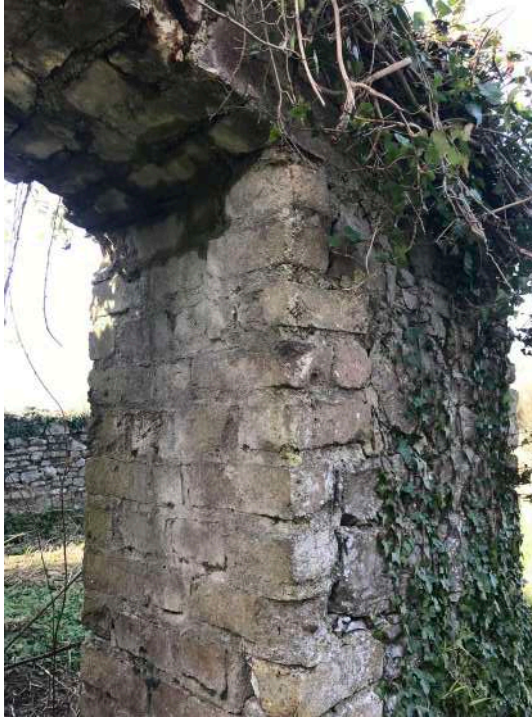
Detail of brick reveal to window arch

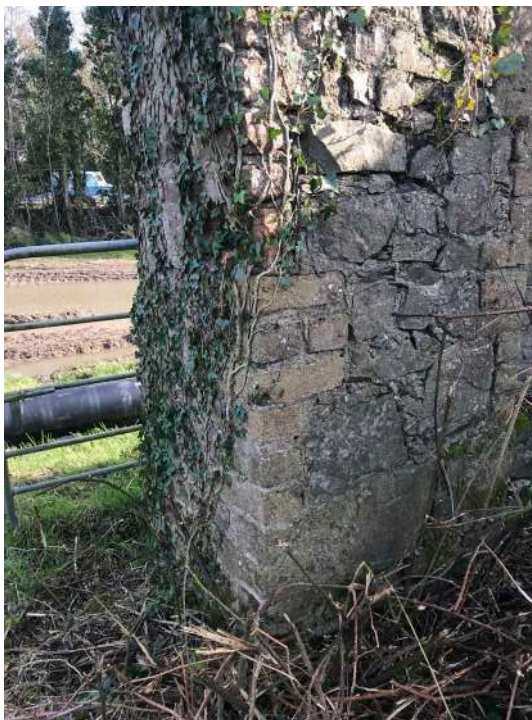
Edge of original doorway evident

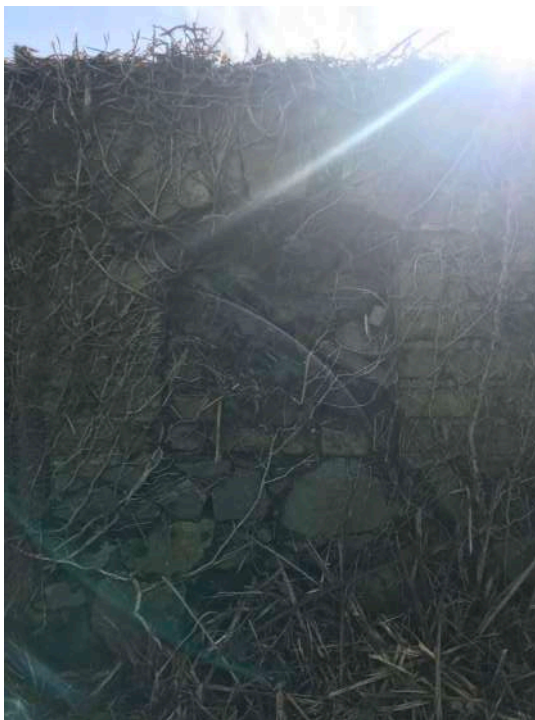
View of low level blocked archway

Later interventions to historic ruins include concrete blockwork dividing walls and steel/iron agricultural sheds

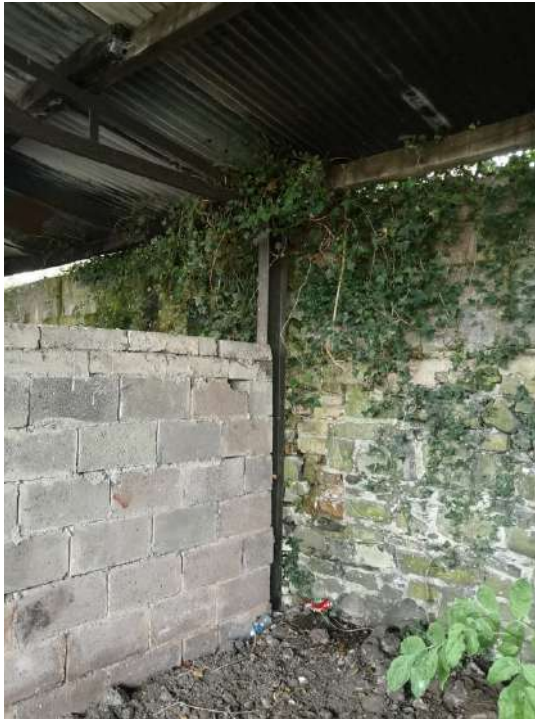
Concrete blockwork wall perpendicular to stone wall to West

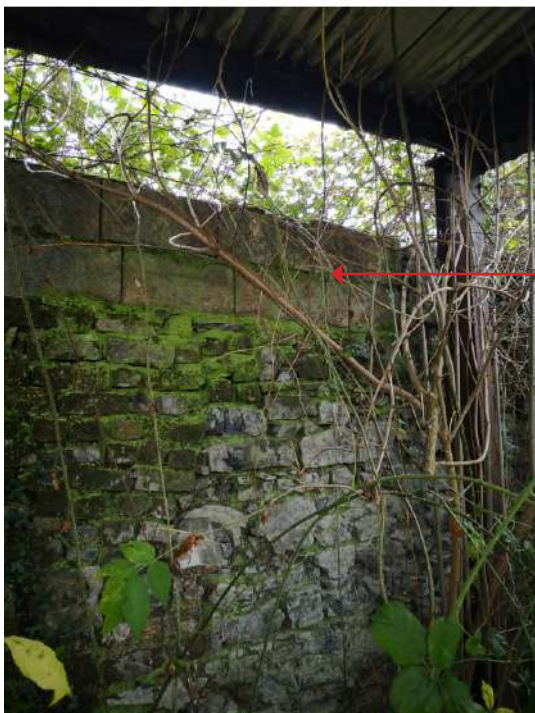
Concrete blockwork wall on stonewall to West

Existing concrete block wall to be carefully removed from original historic stone wall and original stonework to be structurally assessed and consolidated

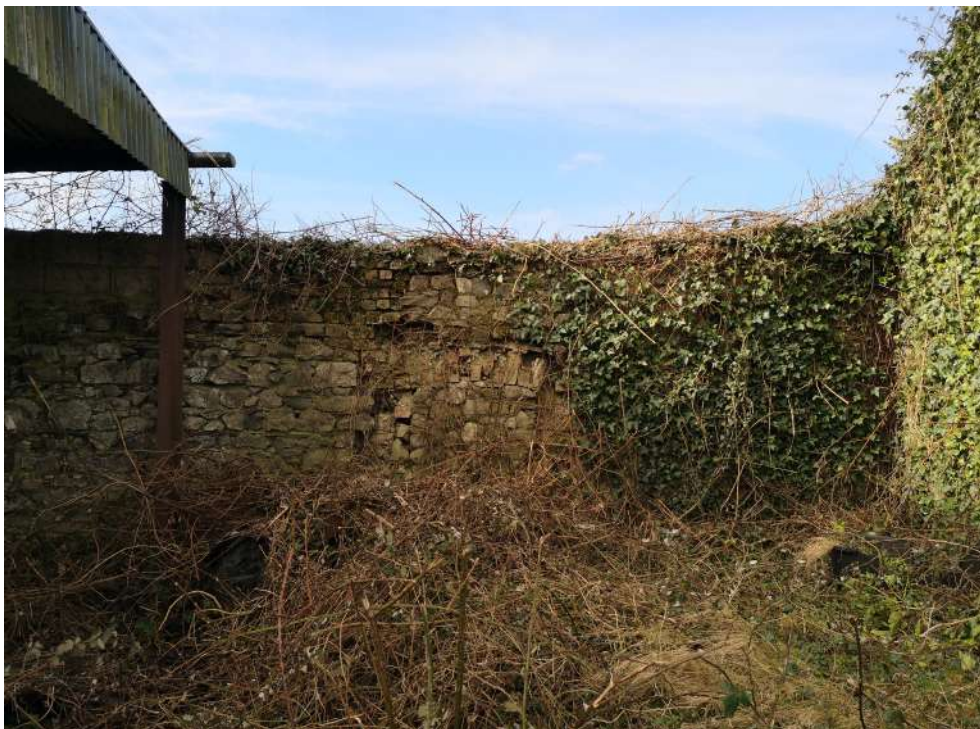
View from agricultural shed to Southern gable of North-Western ruin - extensive overgrowth has limited access to this gable elevation

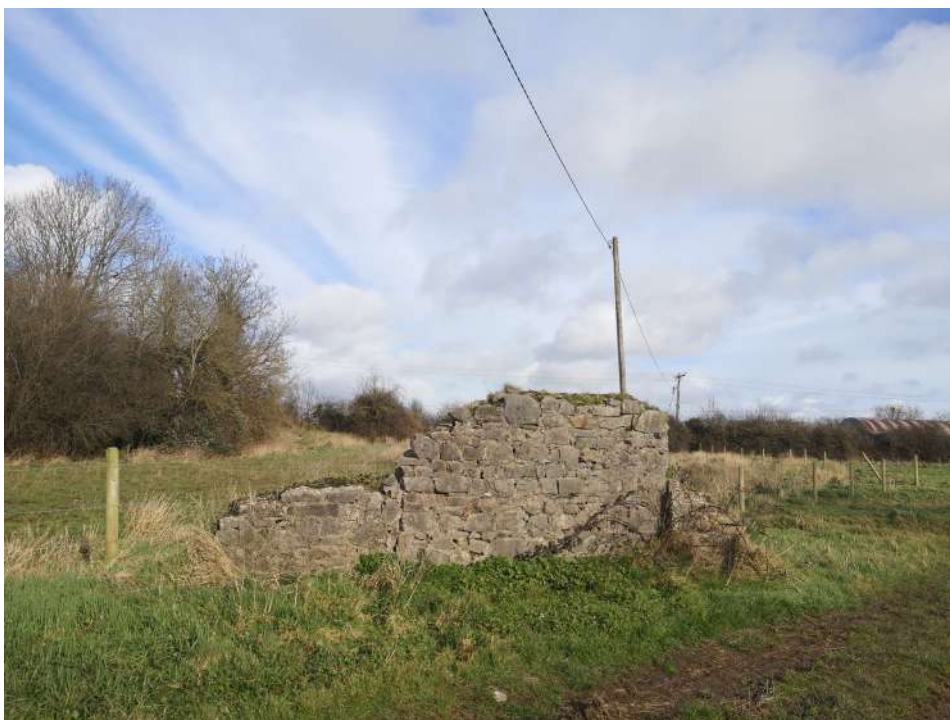
Only a modest section of stone wall has survived in the location of the original farmhouse to this settlement. (Refer to photographic record for same). These substantial two-storey farmhouses were usually constructed of brick or stone or a combination of both and rendered with a lime render internally and externally. The pitched roofs were of natural slate, which was readily available in the 19th century and were either gabled or hipped, although hipped roofs were more common-place in the eastern part of the country. Two chimneys were often present and although detached, these dwellings stood as part of a courtyard complex.

View of exposed stone work to remains of farmhouse

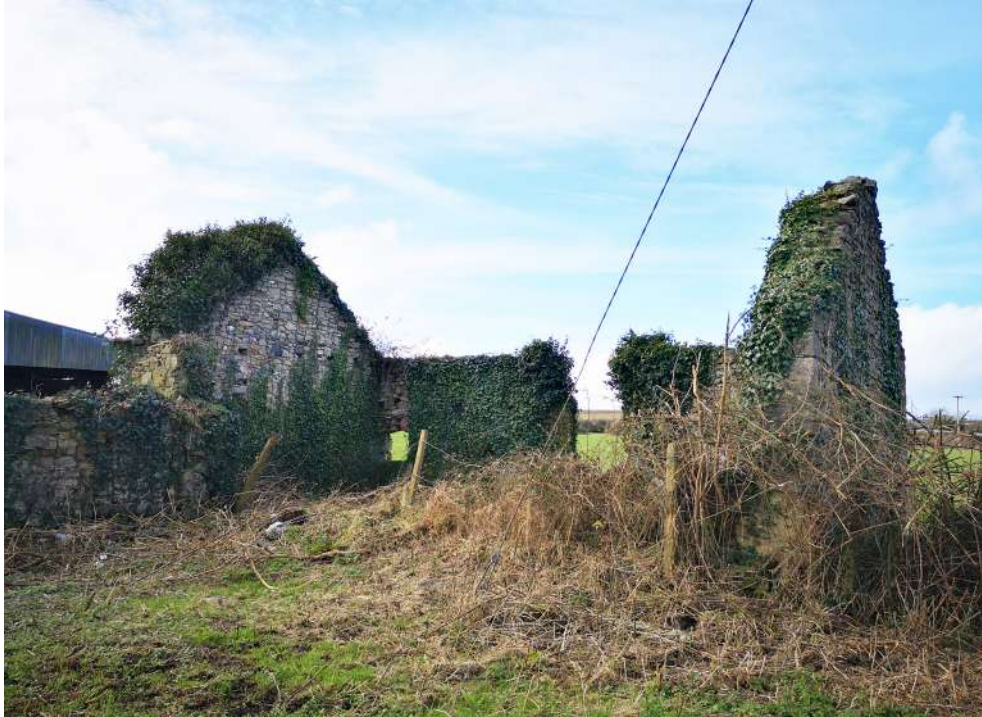
View of North-West ruin

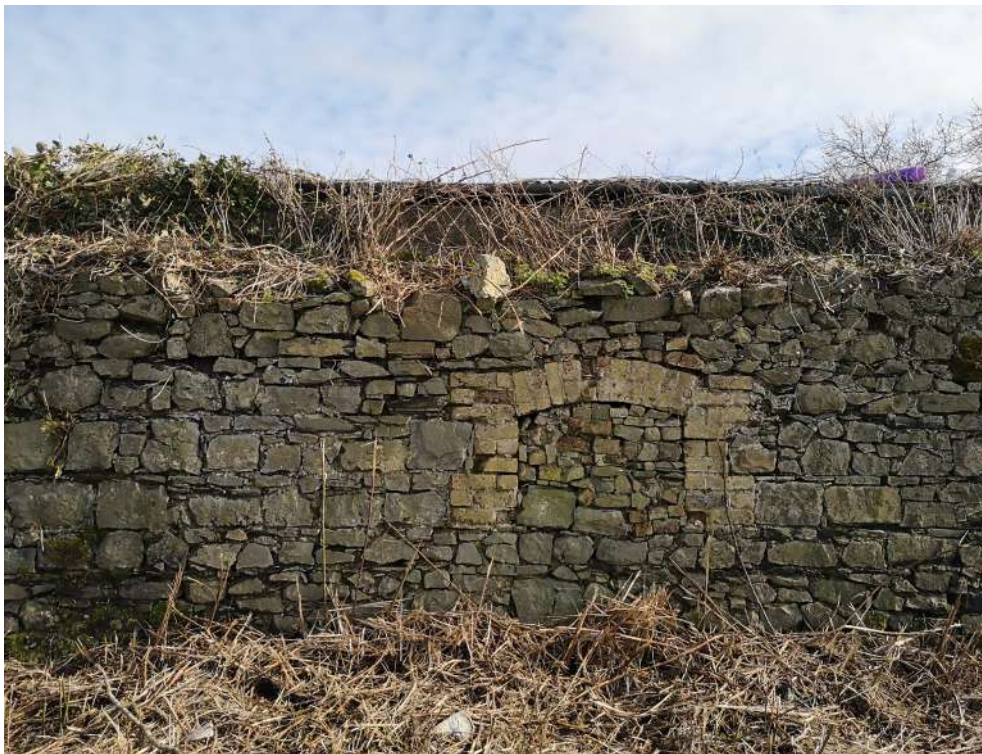
Further to the removal of significant ivy and vegetation overgrowth to the overall ruins and the wall of the western ruin, a number of blocked arched windows were revealed, at regular intervals. All of these arches and windows are of the same size, detail and material. These arched windows extend to the north-western ruin, confirming that this was once one significant outbuilding running the length of the western boundary. The north-western ruin was possibly a barn with overhead hay loft within the complex. A new steel structure and mono-pitch roof has been introduced into this ruin as an agricultural shed. Concrete blockwork has been introduced to the top of the original stone wall to the west and should be carefully removed and the structural impact on the ruin assessed by a structural engineer. There is no trace of the original roof of this substantial out-building which may have accommodated stables, coach-houses, cow houses etc, typical of the array of functions which were common to these settings. The eastern wall of this structure has perished. Sections of this ruin have a concrete floor introduced as part of the agricultural shed function. The southern element of this ruin is of solid stonework, and it is assumed that it once terminated in a gable end, which has been lost, which completed this once structure. It can be assumed the structure did extend all the way to the southern stone wall as the last arched window is in close proximity to this wall and would have been part of this enclosure.

Detail of blocked arched window
