REMEDIATION METHODOLOGY

Monasterevin Bridge Remediation

Project: K424

January 2021

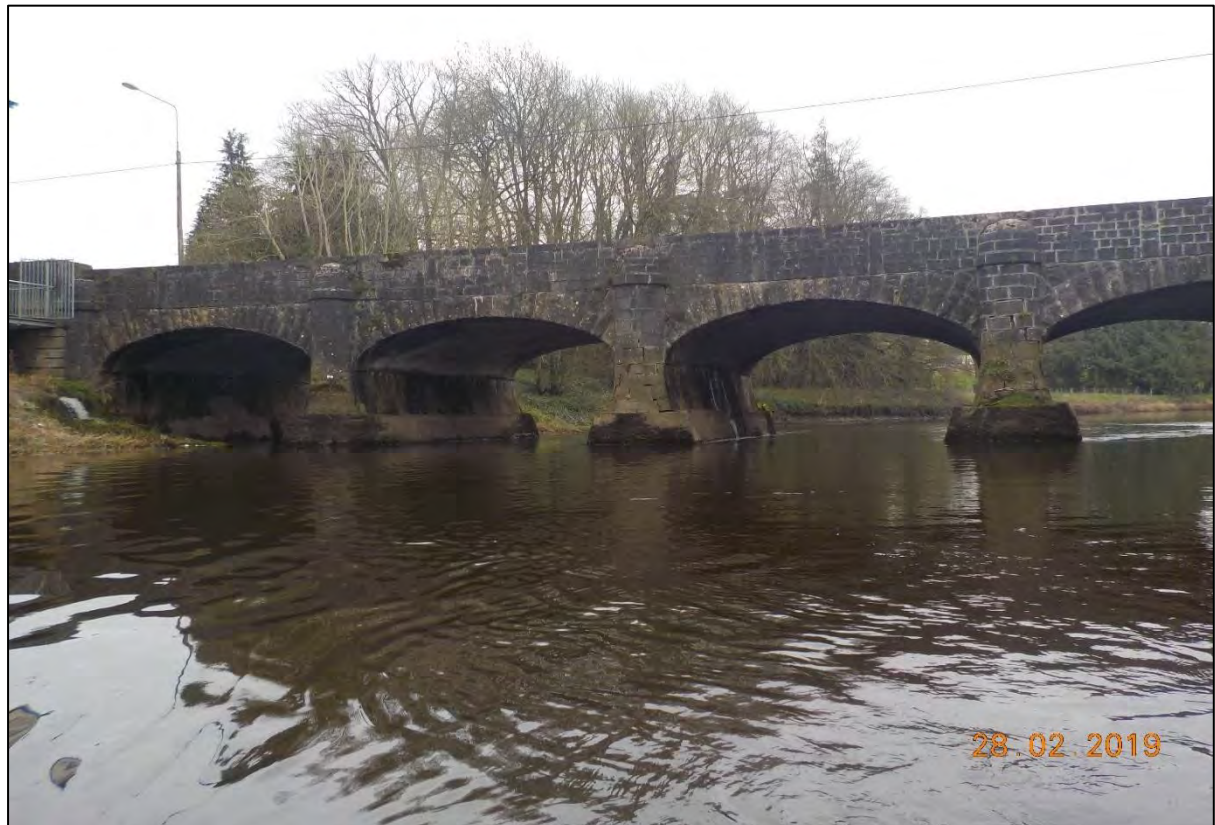
Figure 1: Monasterevin Bridge Upstream Elevation

Monasterevin Bridge carries the R445 over the River Barrow located in the south western area of Monasterevin town, Co. Kildare. The bridge is a five-span cut-stone road bridge built circa 1832. The superstructure is supported by 2 no. masonry abutments and 4 no. masonry piers. The arches are elliptical in shape with cut stone voussoirs. The original bridge deck was made of rubble stone that has since been rendered over. Concrete skirts have been retrofitted to the 2 no. abutments and 4 no. piers to provide scour protection. See figure 1 below for photo of Monasterevin Upstream Elevation.

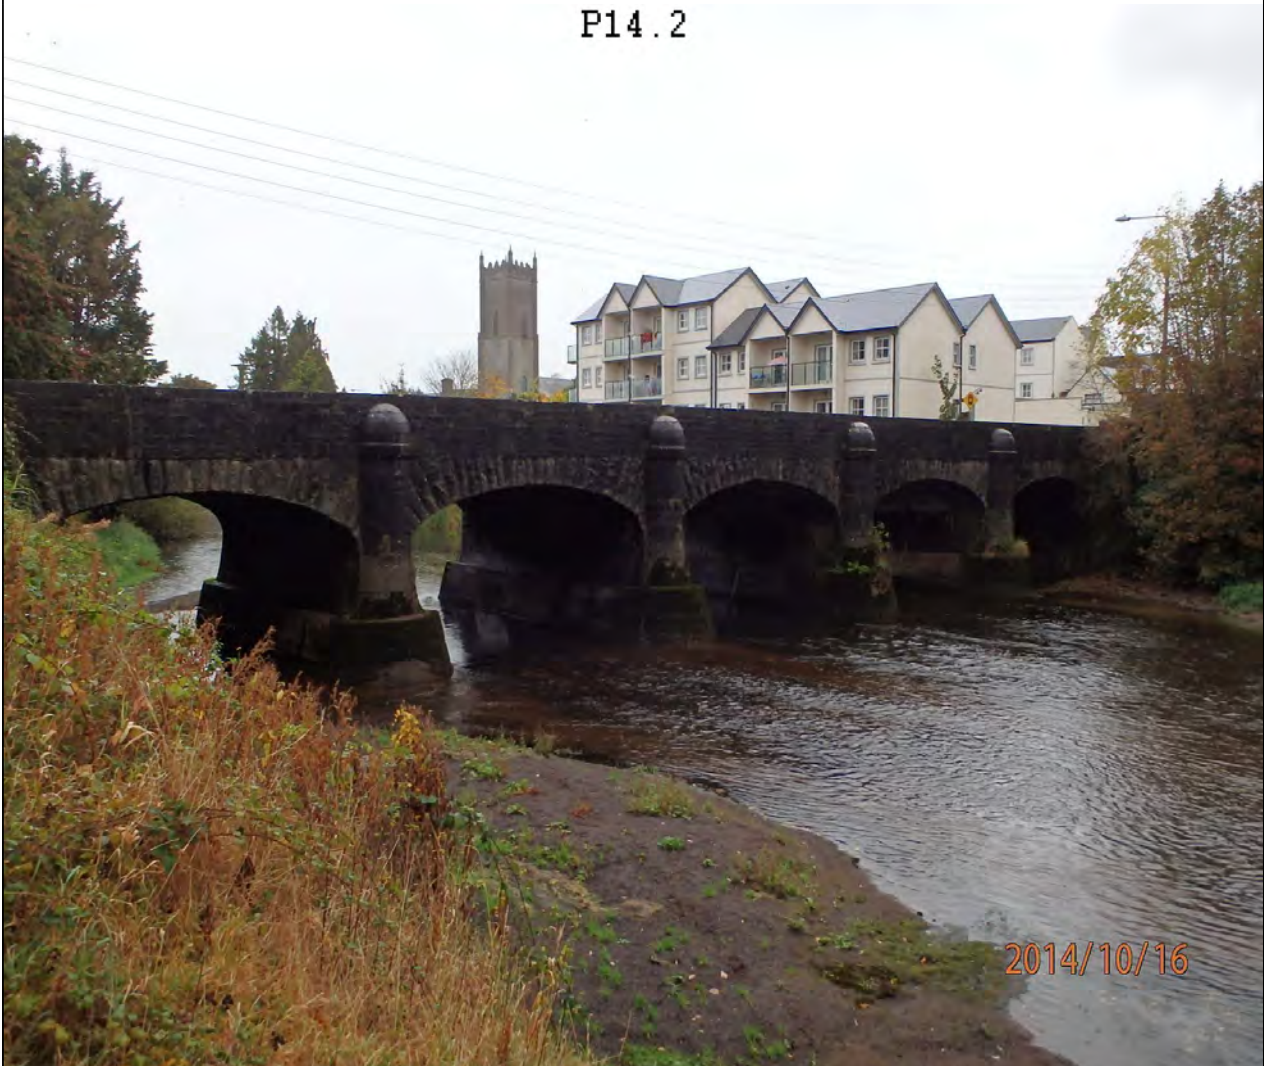
P14.2

Photo 14.1 - Upstream elevation
Photo 14.2 - Downstream elevation
Condition/Mainten. 4 / Y
