# BRIDGE REHABILITATION WORKS IN CO. KILDARE

## Pass Bridge Remediation Methodology

KCCBFW-CCC-ST-S06-RP-S-0001

Client: Kildare County Council  
Date: 22.11.2024

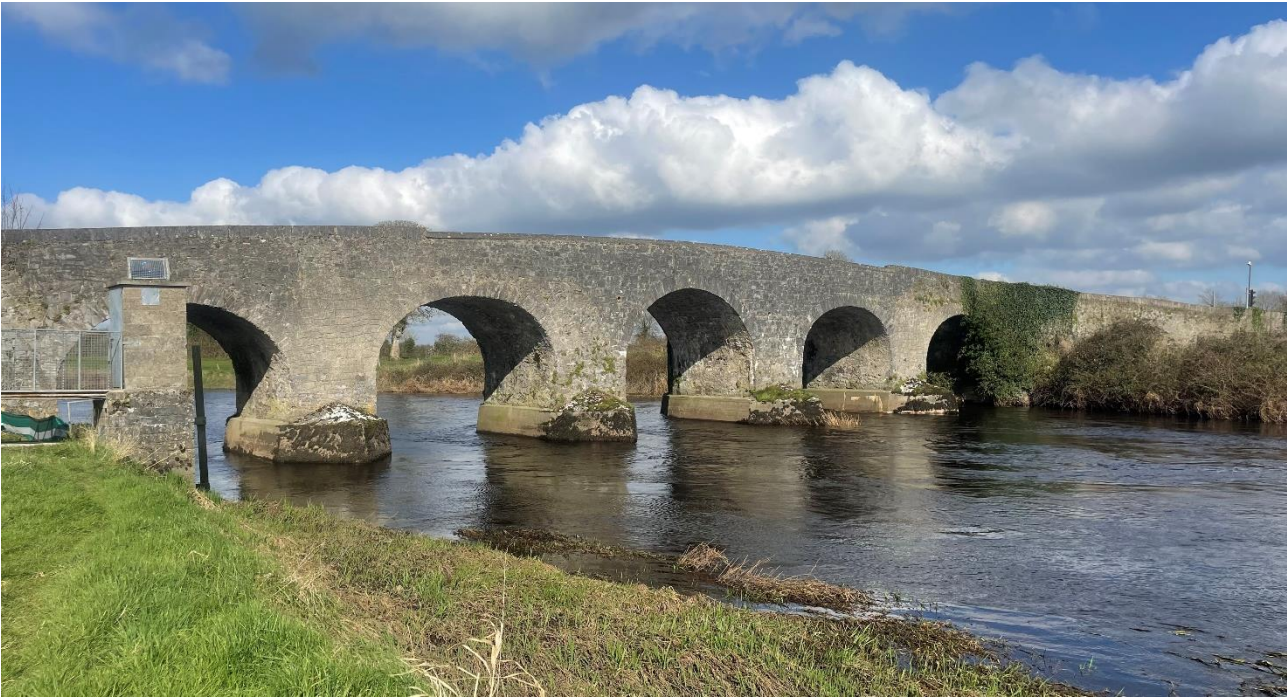
Figure 2: Downstream Elevation

The first RHS cutwater is damaged and a section of the upstream parapet coping stone is missing at the same location.

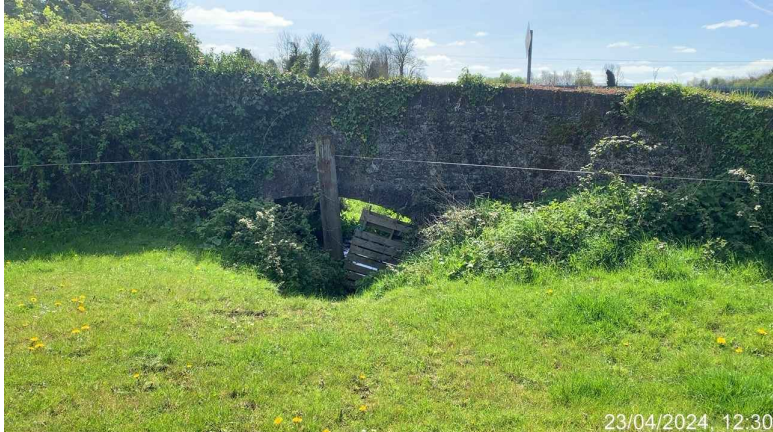
PHOTO 04  
RELIEF ARCH UNDERMINING /  
COLLAPSED ABUTMENT

During the Engineering Inspection on 23/04/24, additional defects were recorded in the flood relief span on the northern approach to the bridge. Vegetation, missing pointing and soft verges were noted as well as the localised collapse of the south abutment **Figure 10**.

- i) No water or flow was present during the inspection. The flood relief span repairs should be carried out on dry;
- ii) Collapsed stones should be recovered, cleaned and stored safely;
- iii) Appropriate machinery should be used to expose the abutment foundation stone and remove any soft sediments in the span;
- iv) Appropriate debris protection measures should be installed to avoid the contamination of the stream bed;
- v) The abutment should be reconstructed with the original stone and NHL 5 mortar;
- vi) Repointing of the arch barrel will be carried out during the abutment repair stage to avoid
- vii) Remove stream protection measures and reinstate the stream bed level;
