## **Former ESB building, Main Street, Leixlip**

### **Architectural heritage assessment**

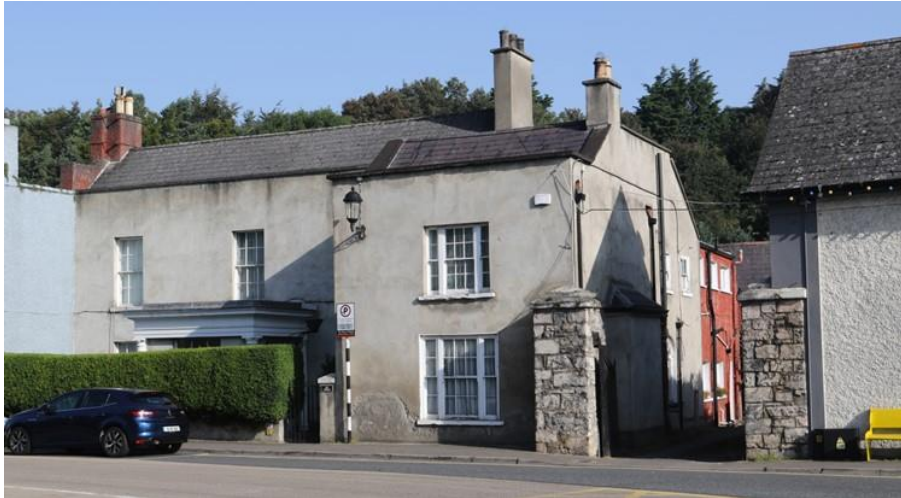
*Plate 2: Ivy House with the ESB building at right*

The front part of the ESB site at Leixlip was previously part of the grounds of Ivy House, which stands next to the site, on its western side. The entrance to the grounds of Ivy House still runs between the house and the ESB building. The western corner of the ESB showroom building is built around the stone gate pier on the right-hand side of the access. The map below is an extract from the Valuation Office map of Leixlip, dating from about the 1850s, and showing the grounds of Ivy House outlined in red and a building on the site of the ESB showroom, which is indicated by a blue arrow.

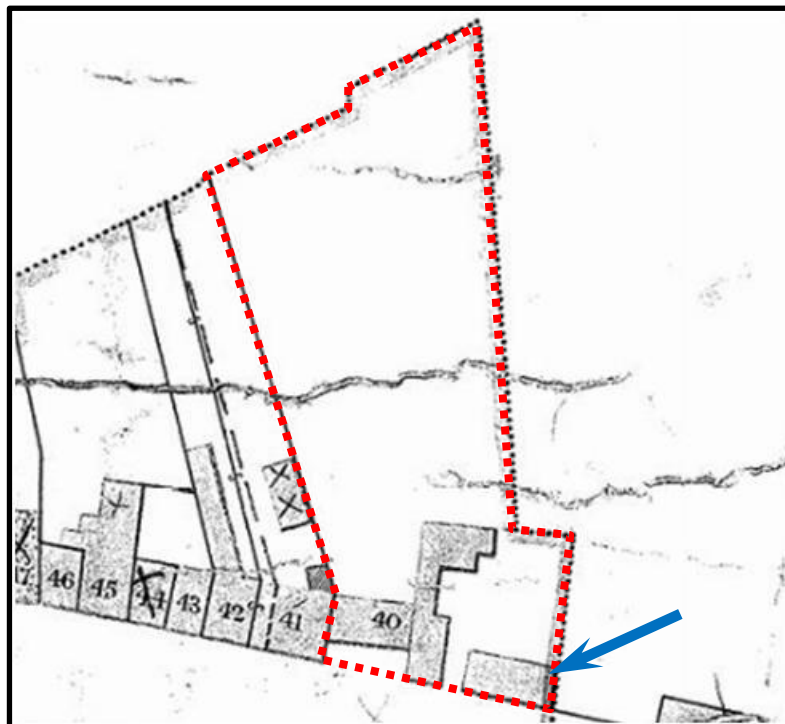
*Figure 1: Valuation map showing grounds of Ivy House*

The land enclosed by the red line remained unchanged for a period of well over a century, extending to approximately 0.28 hectares.

The building marked by the arrow in the map extract is on the same site as the ESB showroom and offices. This building is shown on the first edition Ordnance Survey six-inch map of 1837 and is seen again on later Ordnance Survey maps, including the larger scale map at 1:2500 scale that was published in 1907. Although it is difficult to be certain from maps of this small scale, the old building and the present ESB building appear to be the same size and in the same location.
