Chief Executive's Report

For proposed Tree Preservation Order (TPO) in Caragh,
Naas, Co. Kildare

Planning Department,
Kildare County Council
14th July 2022

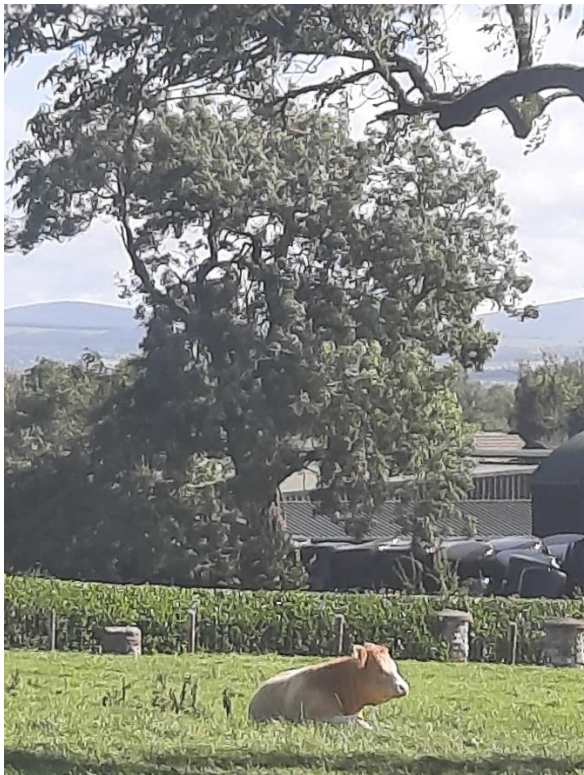
- Tree No. 9 is a *Fagus sylvatica* (Beech tree) and has significant damage to its buttress and lower trunk. The wound is approximately 2 metres high and 1.5 metres wide, with decay in the centre.
- Tree Nos. 19 and 20 are a *Fraxinus excelsior* (Ash trees) which show signs of Ash Dieback.

Figure9: Single tree in southern field boundary (No. 19 on Map) subject of proposed TPO

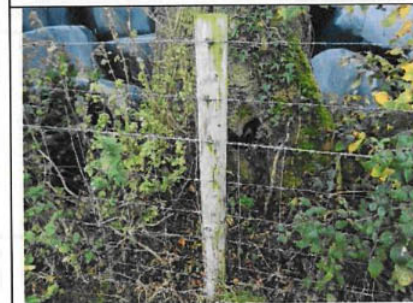
Cavity at base of Ash tree T22

T	22	Fraxinus excelsior	M	15	600 est	<10	Poor	Poor. Large decay cavity at stem base. Epicormic growth and crown dieback indicative of Ash dieback disease.	Not suited for long-term retention.	7.2	U
T	23	Fraxinus excelsior	M	14	450 est	<10	Poor	Poor. Epicormic growth and crown dieback indicative of Ash dieback disease. Bark damage to stem base.	Not suited for long-term retention.	5.4	U

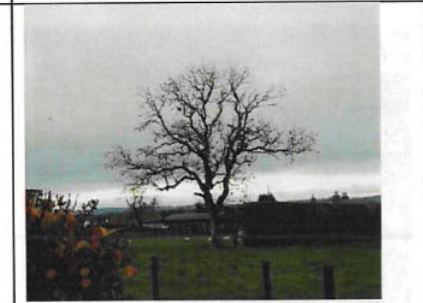
Crown dieback of Ash tree T23

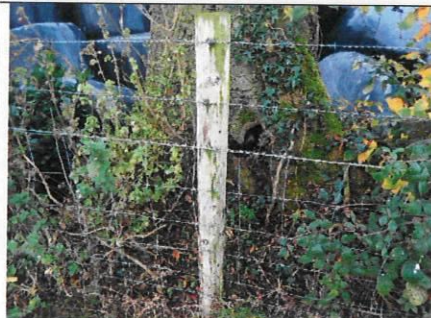
Cavity at base of Ash tree T22

T	21	Fagus sylvatica (Beech)	OM	21	1250	<10	Poor	Poor. Dieback in crown. <i>Ganoderma spp.</i> fruiting brackets on lower stem indicative of significant basal decay.	Not suited for long-term retention within a new development.	15	U
T	22	Fraxinus excelsior	M	15	600 est	<10	Poor	Poor. Large decay cavity at stem base. Epicormic growth and crown dieback indicative of Ash dieback disease.	Not suited for long-term retention within a new development.	7.2	U
T	23	Fraxinus excelsior	M	14	450 est	<10	Poor	Poor. Epicormic growth and crown dieback indicative of Ash dieback disease. Bark damage to stem base.	Not suited for long-term retention within a new development.	5.4	U

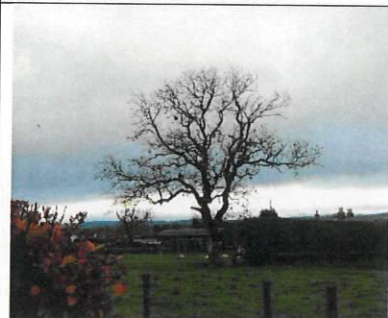
Crown dieback of Ash tree T23
