Monasterevin Bridge Rehabilitation Works

Preliminary Remedial Works Report

Client: Kildare County Council

Project: K424

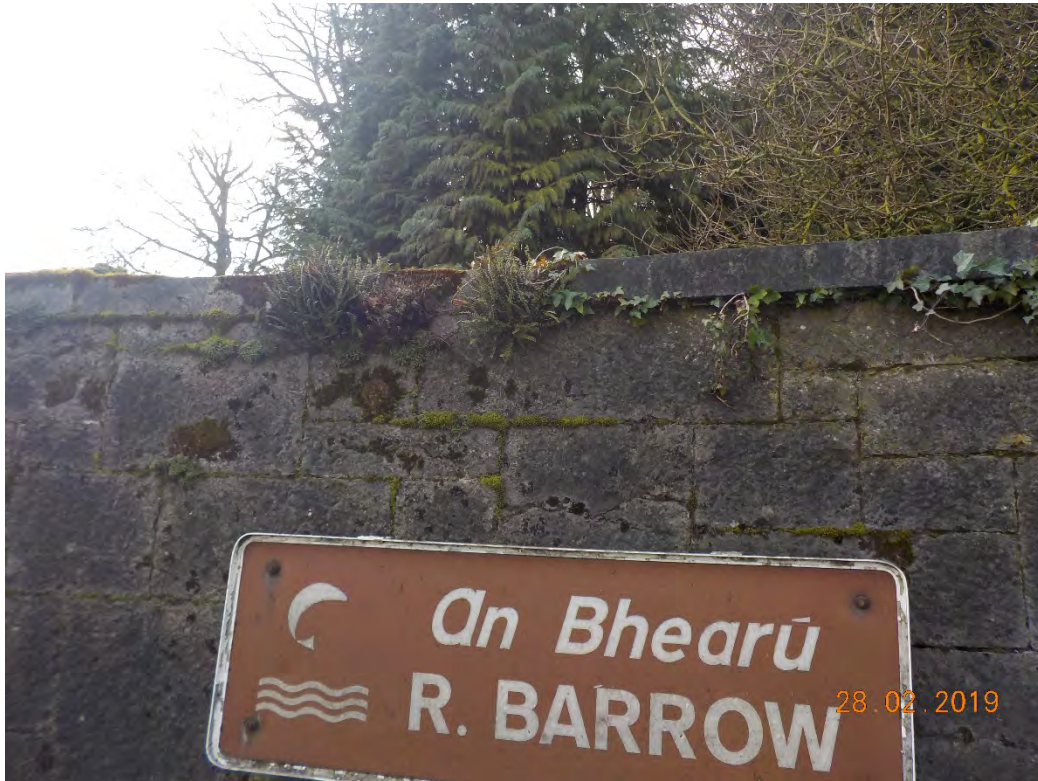
- i. Vegetation on Downstream Roadside West capping, See photographs 3.5, 3.6, 3.7 and 3.8
- ii. Tree roots growing between capping on West roadside parapet, See photographs 3.9 and 3.10
- iii. Missing Masonry on Downstream West Parapet, See photograph 3.11
- iv. Bunker settling on Downstream side West, See photographs 3.12, 3.13, 3.14 and 3.15
- v. Joints in poor condition on downstream roadside parapet, See photographs 3.16, 3.17 and 3.18
- vi. Masonry dislodged at section of downstream East parapet, See photograph 3.19 and 3.20
- vii. Bulging on section of downstream East parapet, See photograph 3.21
- viii. East parapet settling away from capping, See photograph 3.22
- ix. East parapet wall joints in poor condition, See photograph 3.23, 3.24 and 3.25
- x. Downstream East parapet wall collapsing, See photograph 3.26

Photograph 3-5: Downstream Capping on Road Side Parapet

- i. Vegetation to removed, raking and repointing of joints, 2m x 5m
- ii. Capping to be removed to allow for removal of vegetation growth underneath. Original capping to be reinstated after, 10mm dia tree root to be removed.
- iii. Masonry to be reinstated to match existing, 0.15m x 0.2m.
- iv. Due to the heavy overgrowth on the riverside bank of the bunker, the full extent of the remediation works cannot be deemed. From inspection on the roadside, it can be seen that the foundation should be underpinned, Crack 50mm-10mm and 4.2m long
- v. Rake and repoint joints, 10% of joints.
- vi. Section of wall to be demolished and reconstructed, 0.35m x 0.4m
- vii. Section of wall to be demolished and reconstructed, 2.6m x 1.1m x 1.4m

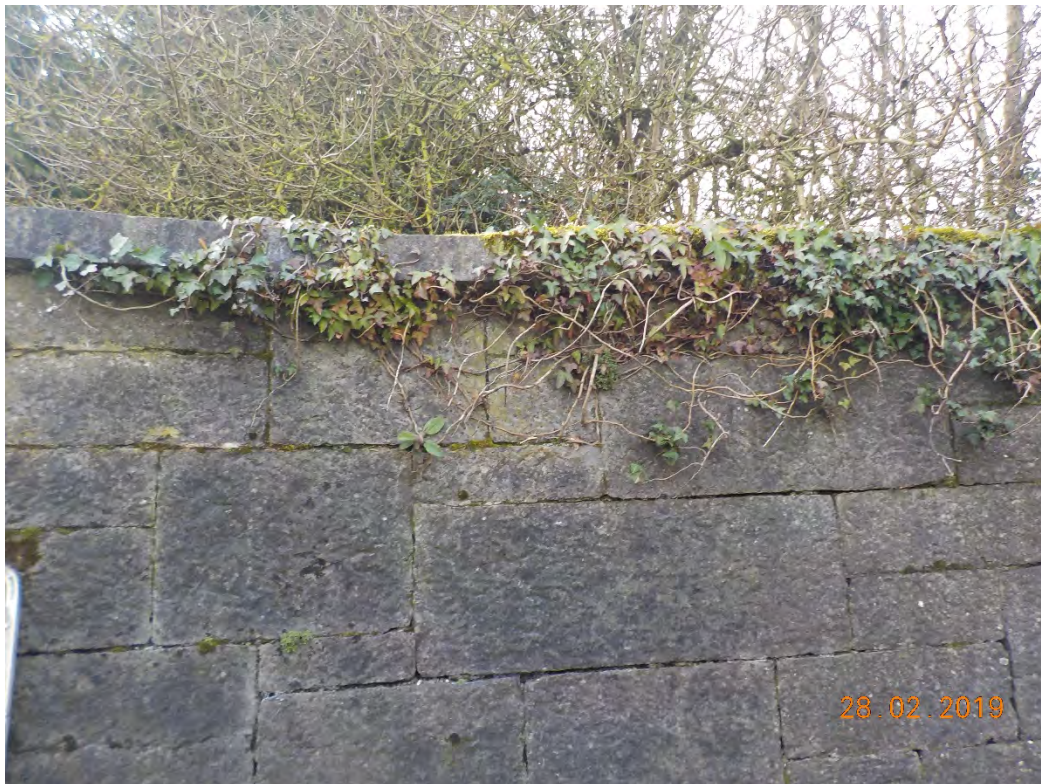
Photograph 3-6: Downstream Capping on Road Side Parapet

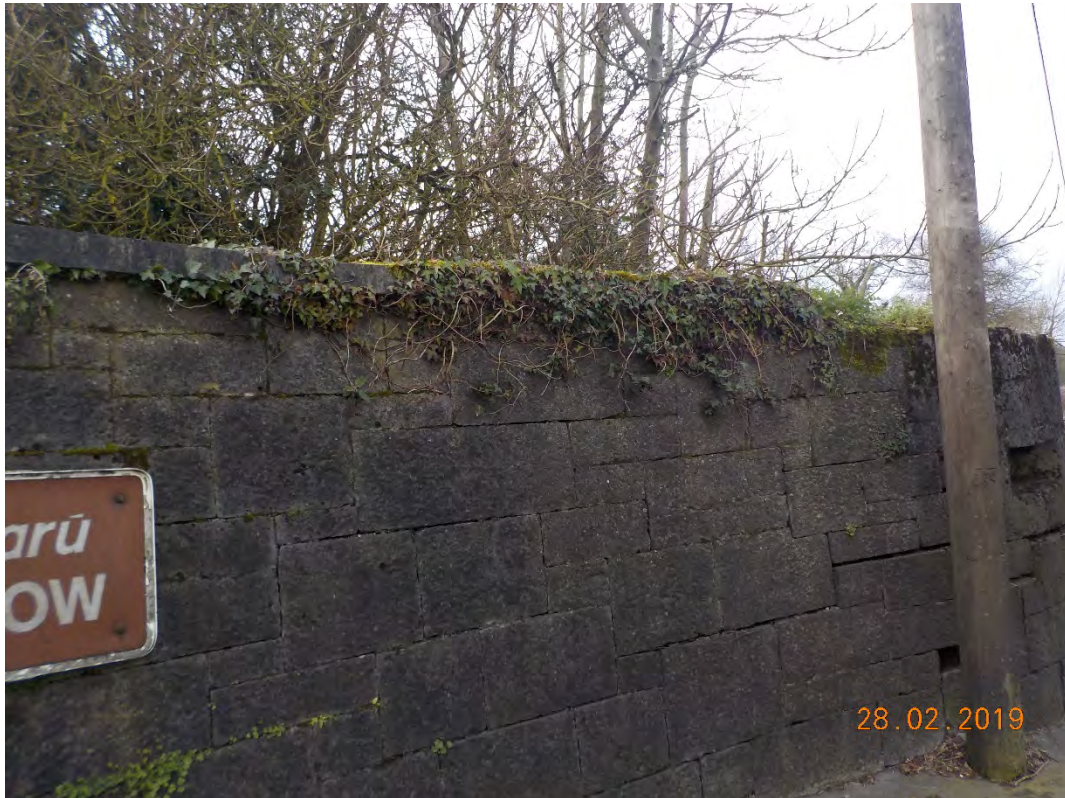
Photograph 3-7: Downstream Capping on Road Side Parapet

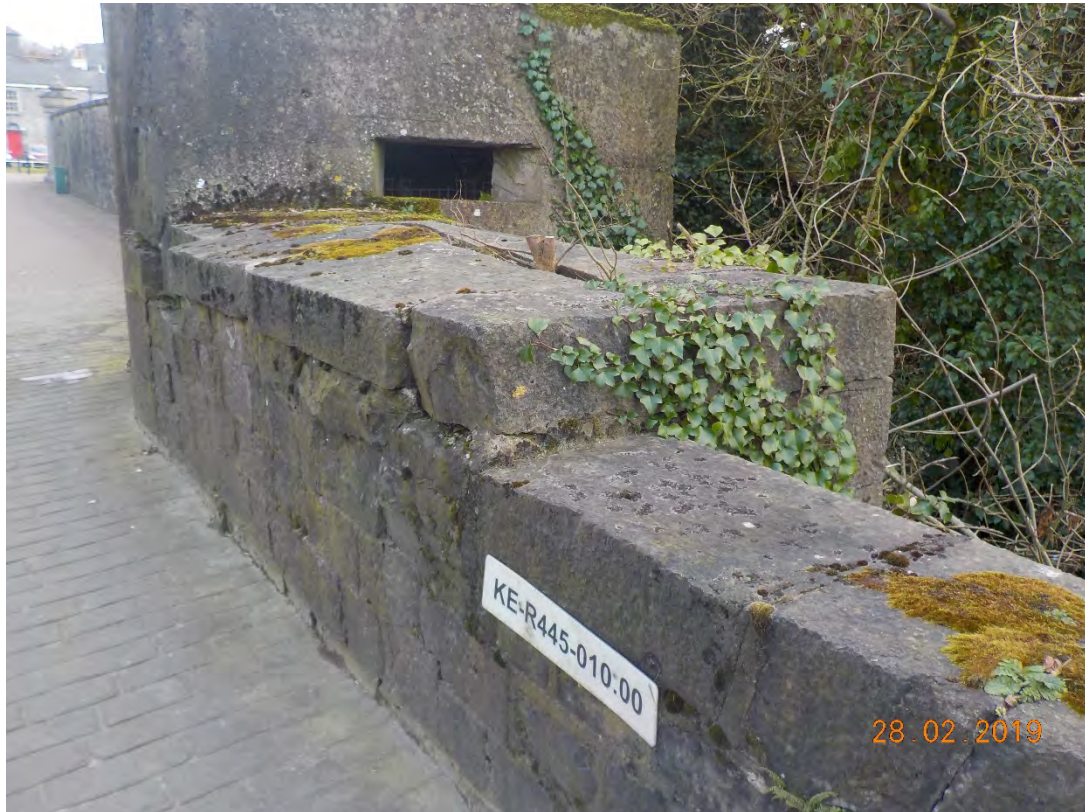
Photograph 3-9: Downstream roadside West Parapet

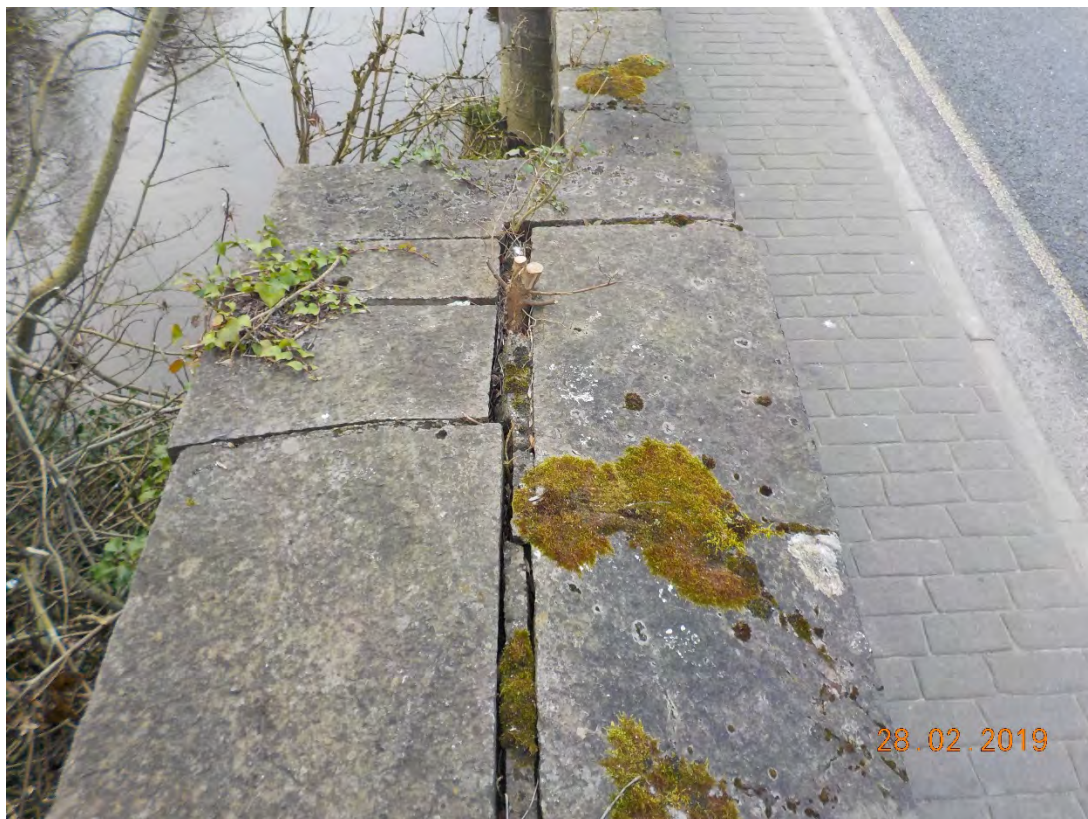
Photograph 3-10: Downstream Parapet Roadside Approach

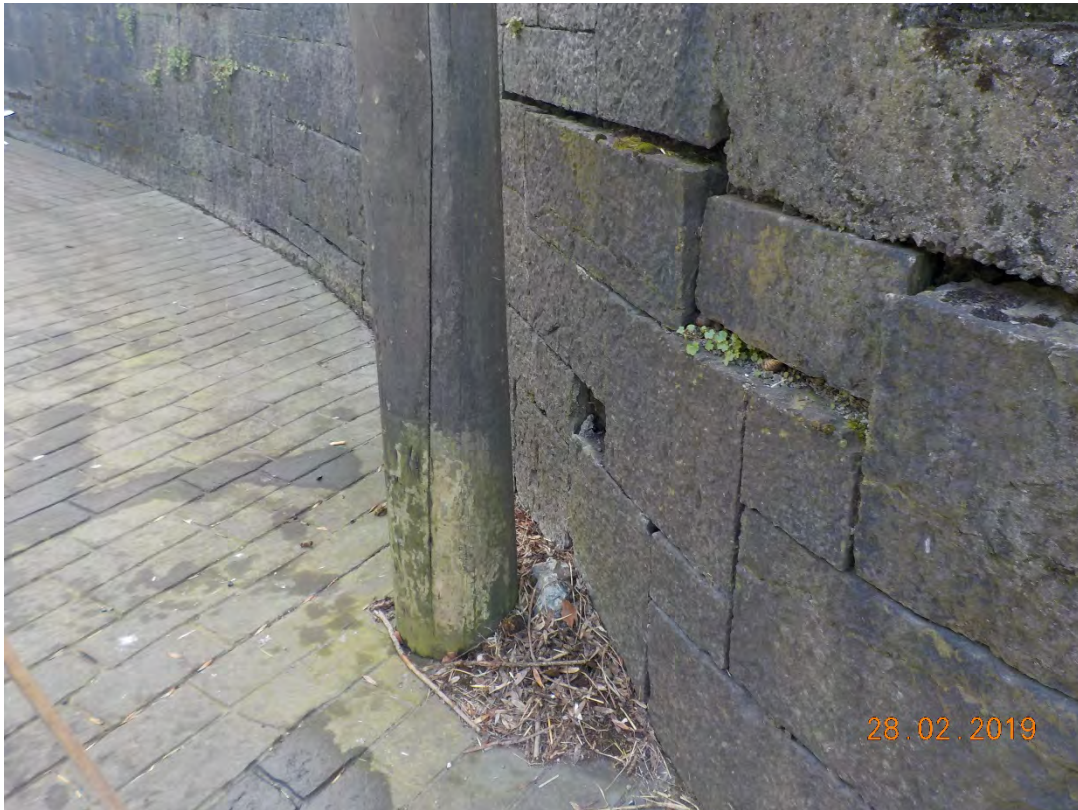
Photograph 3-11: Missing Masonry on Downstream Roadside Parapet

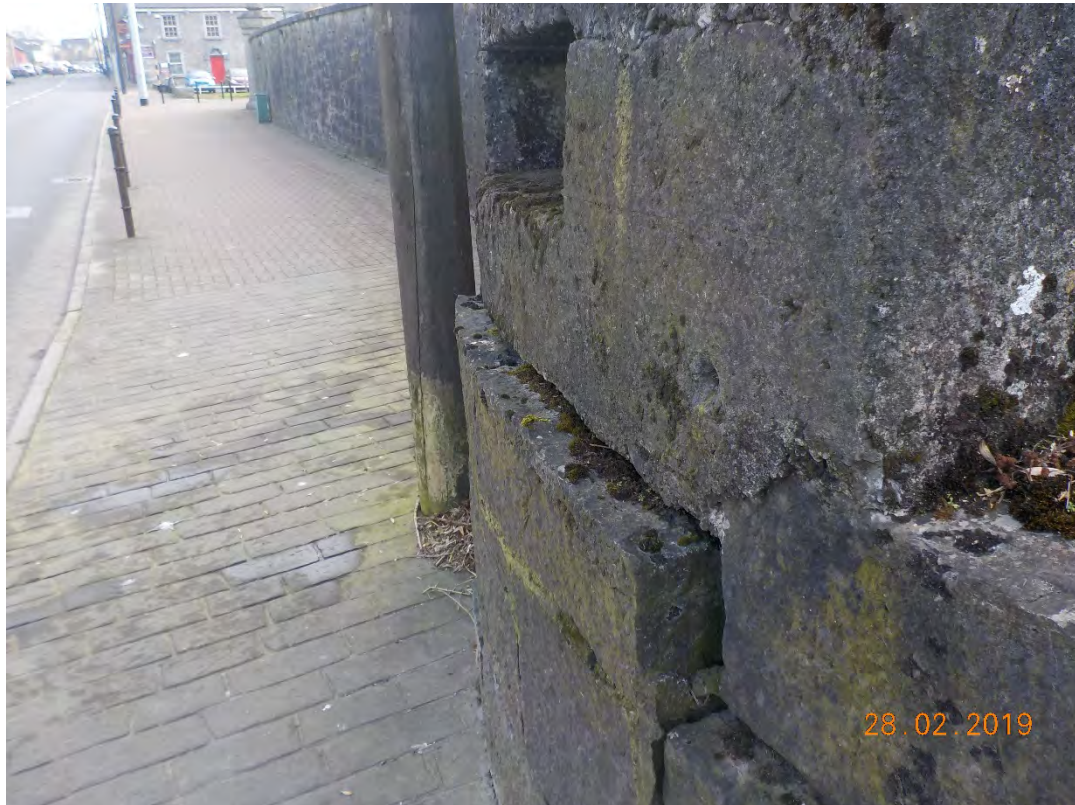
Photograph 3-13: Settlement of Bunker on Downstream side

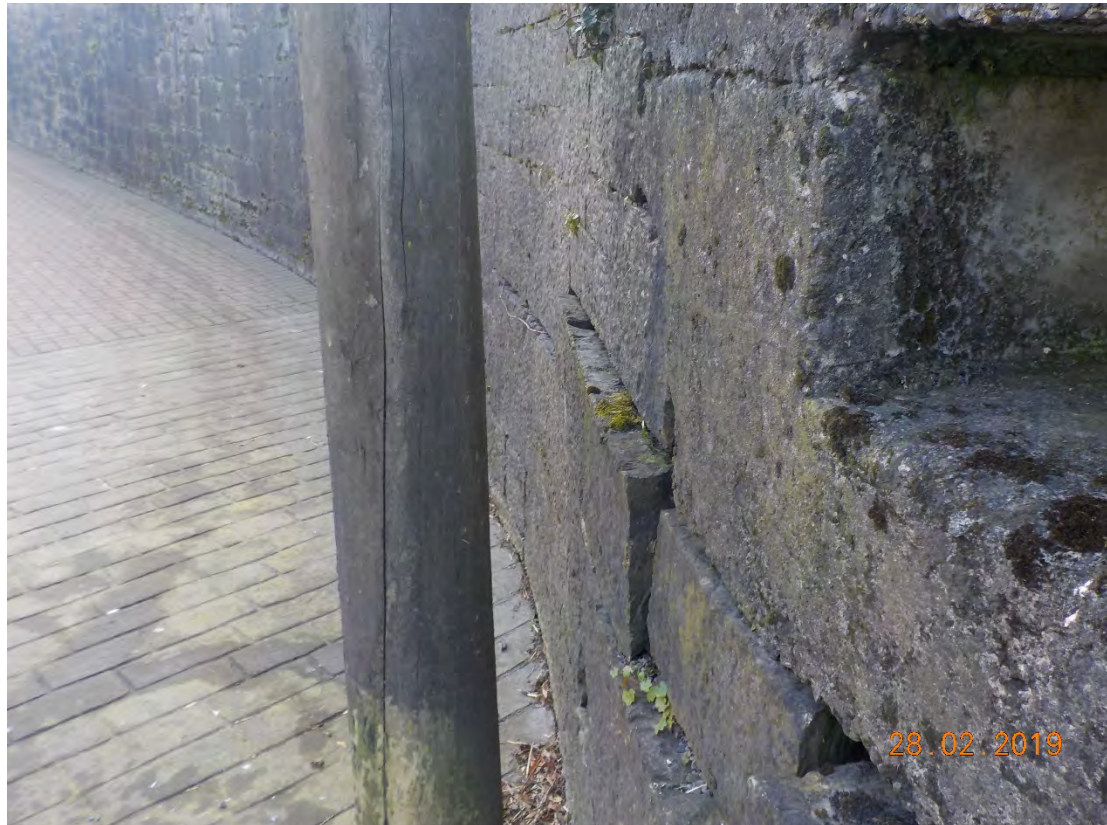
Photograph 3-14: Settlement of Bunker on Downstream side

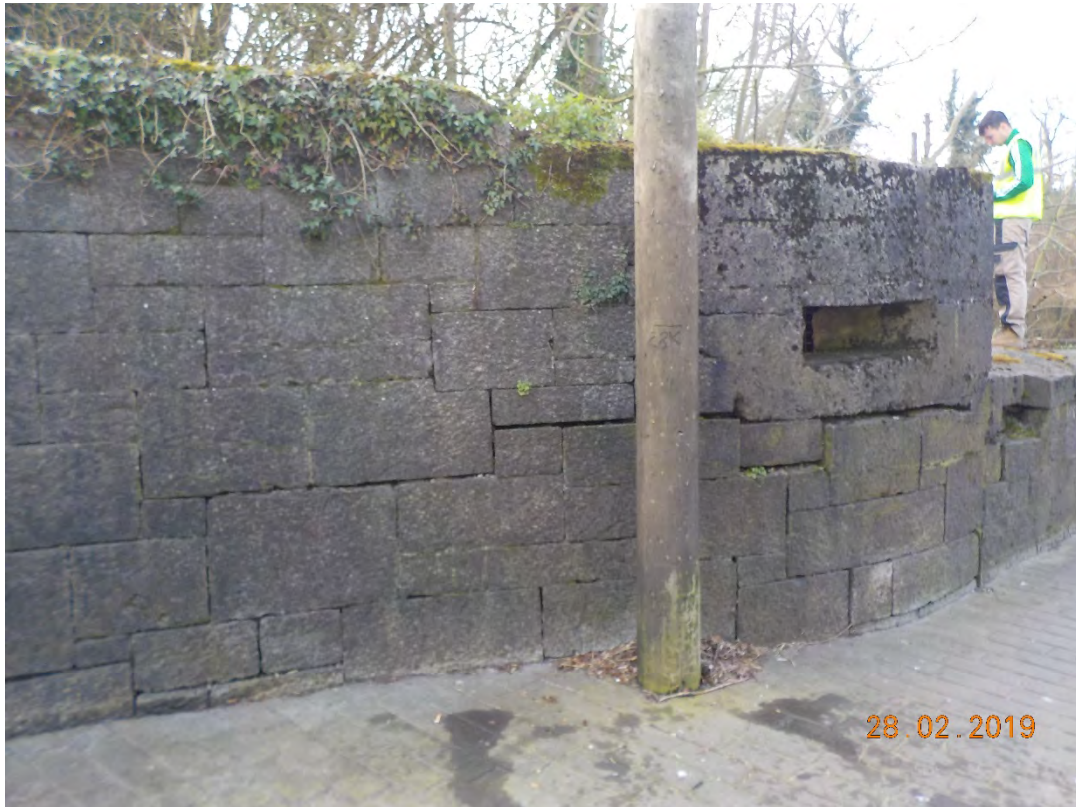
Photograph 3-15: Overall View of Bunker Settlement

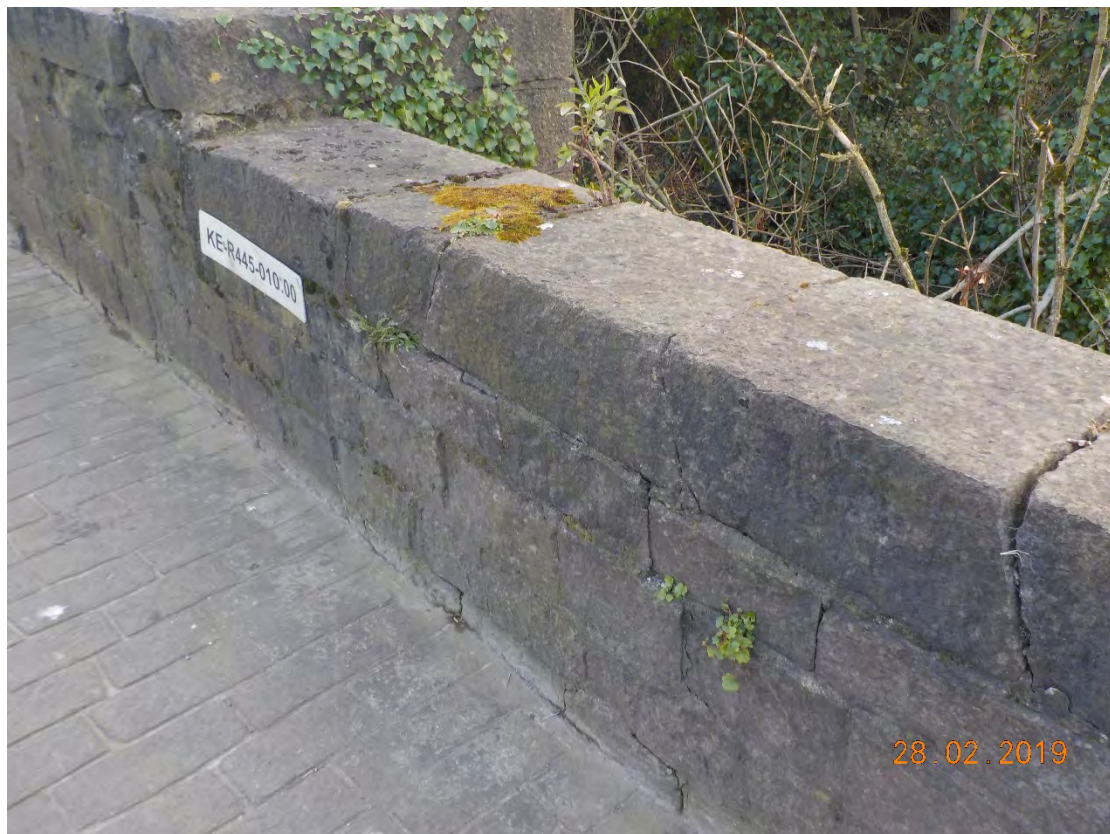
Photograph 3-16: Rake and Repoint joints in Downstream Road side Parapet

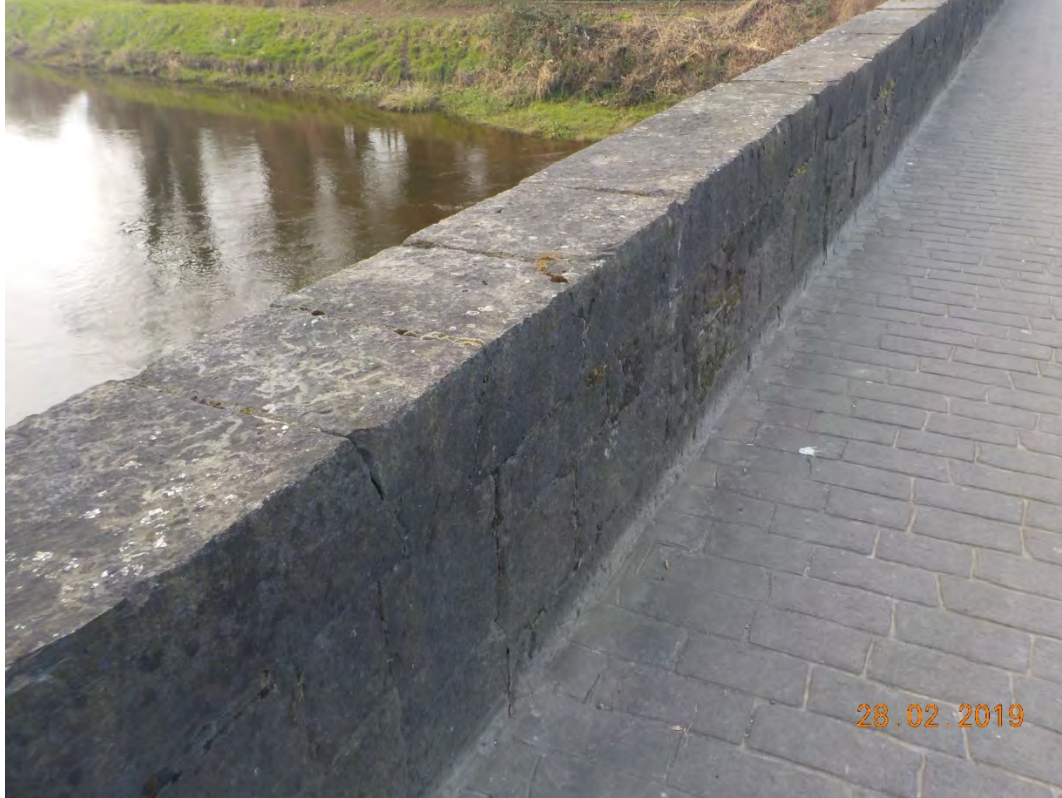
Photograph 3-17: Rake and Repoint joints in Downstream Road side Parapet

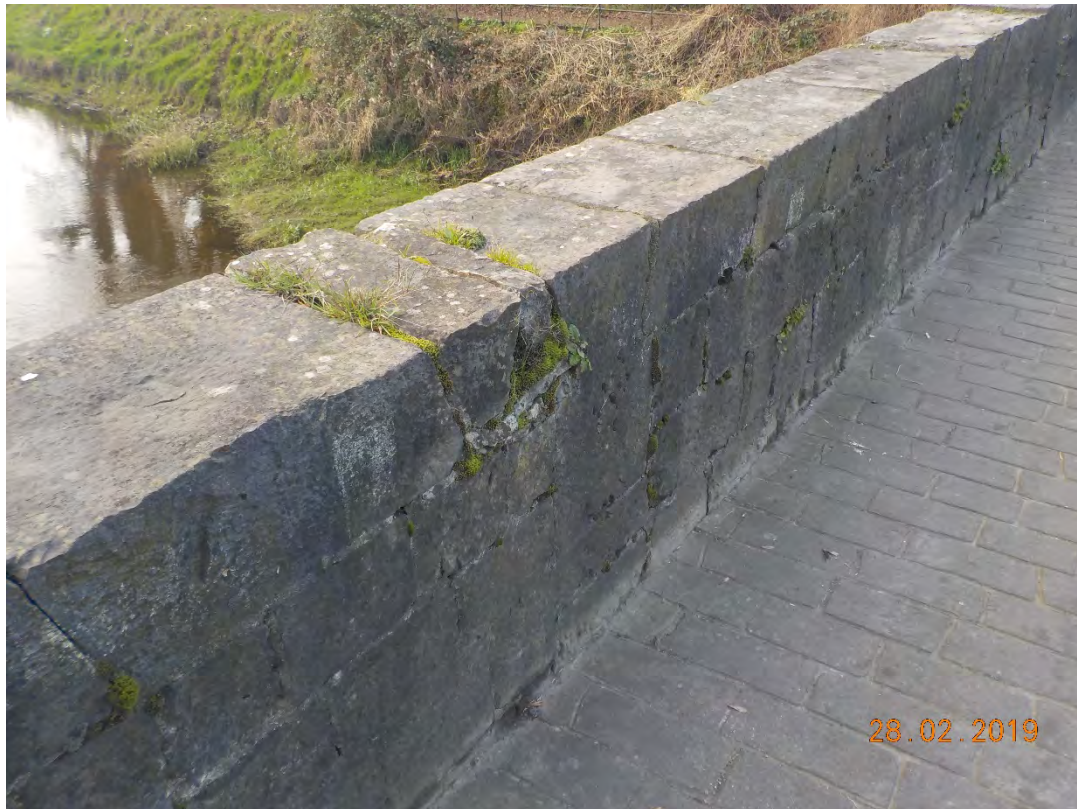
Photograph 3-18: Rake and Repoint Joints in Downstream Road Side Parapet

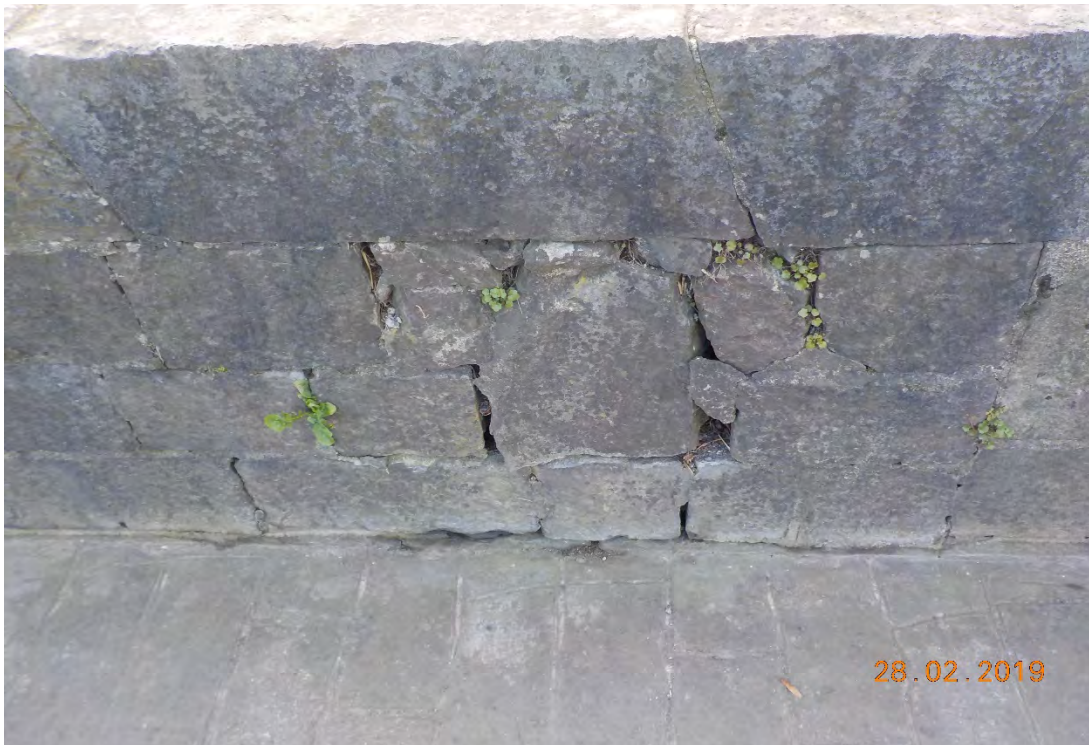
Photograph 3-19: Masonry Dislodged on Downstream Roadside Parapet

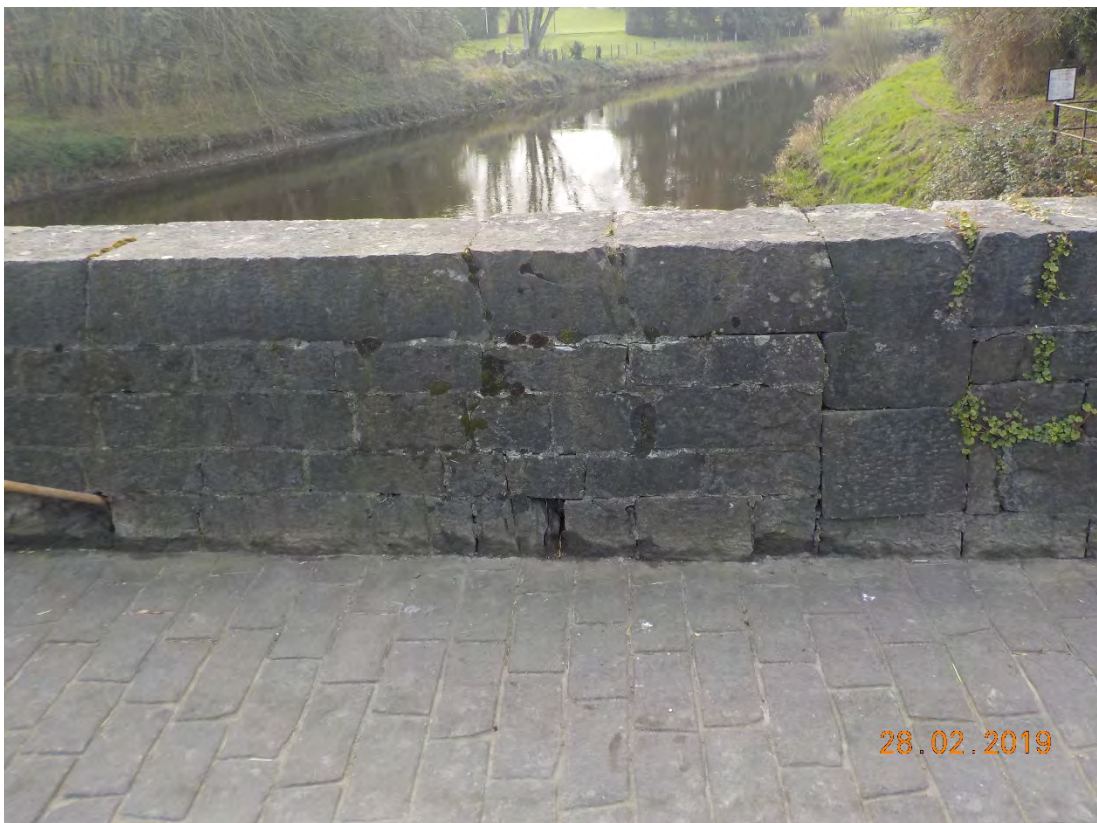
Photograph 3-20: Section of Wall to be reconstructed on the Downstream Side

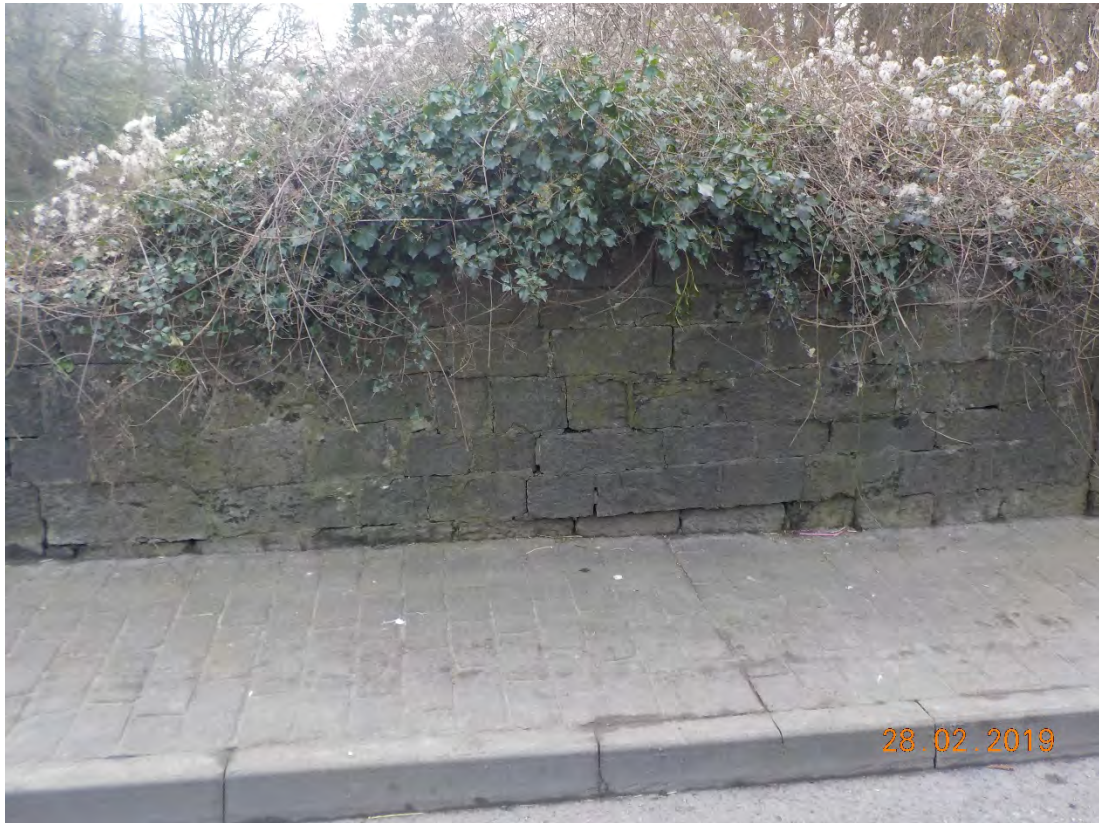
Photograph 3-21: Bulging on Section of Downstream Parapet Wall

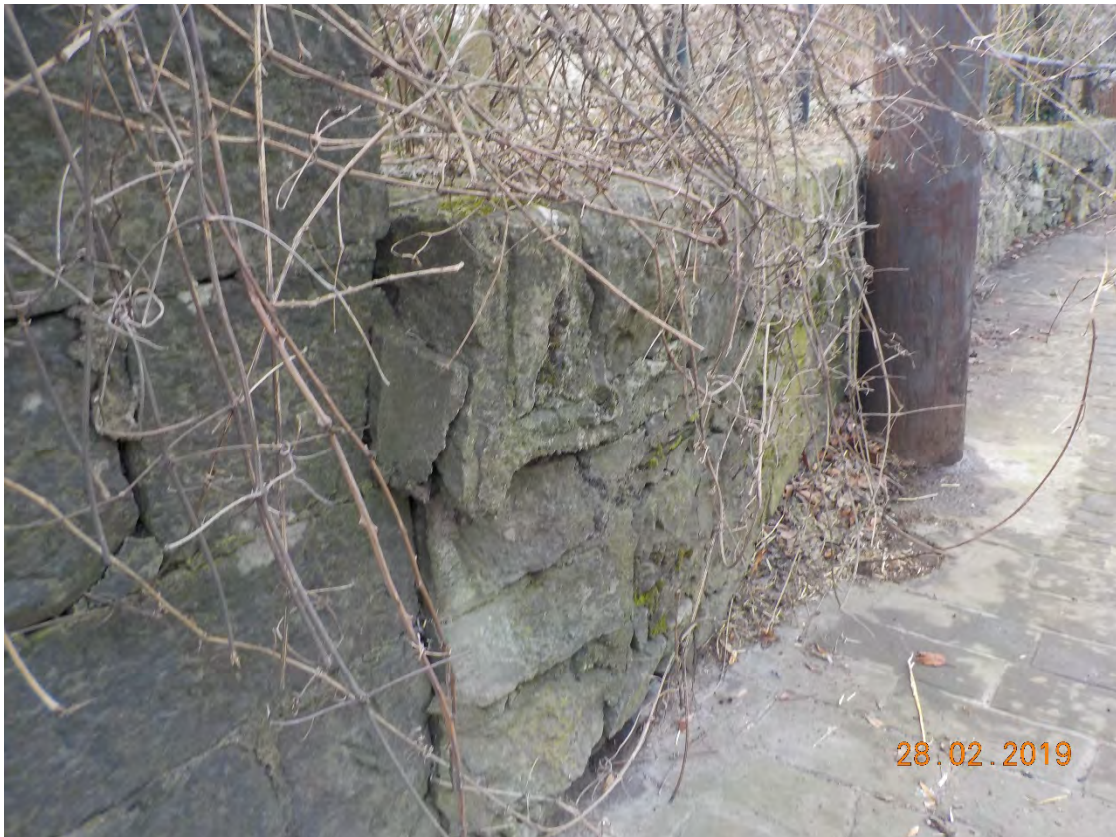
Photograph 3-22: Capping to be reset on Downstream Parapet

- viii. Capping to be reset, 0.5m x 0.5m
- ix. Wall to be raked and repointed, 60% of joints
- x. Section of wall to be reconstructed, 4m x 0.3m.

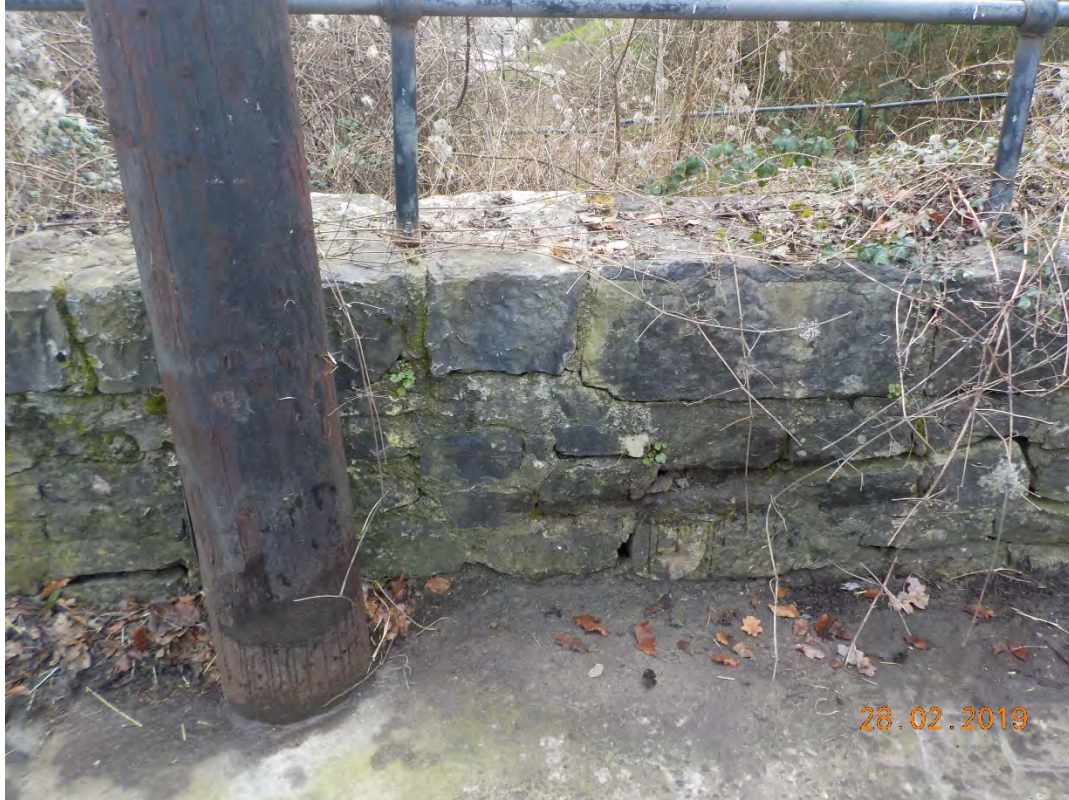
Photograph 3-23: Wall to be Raked and Repointed

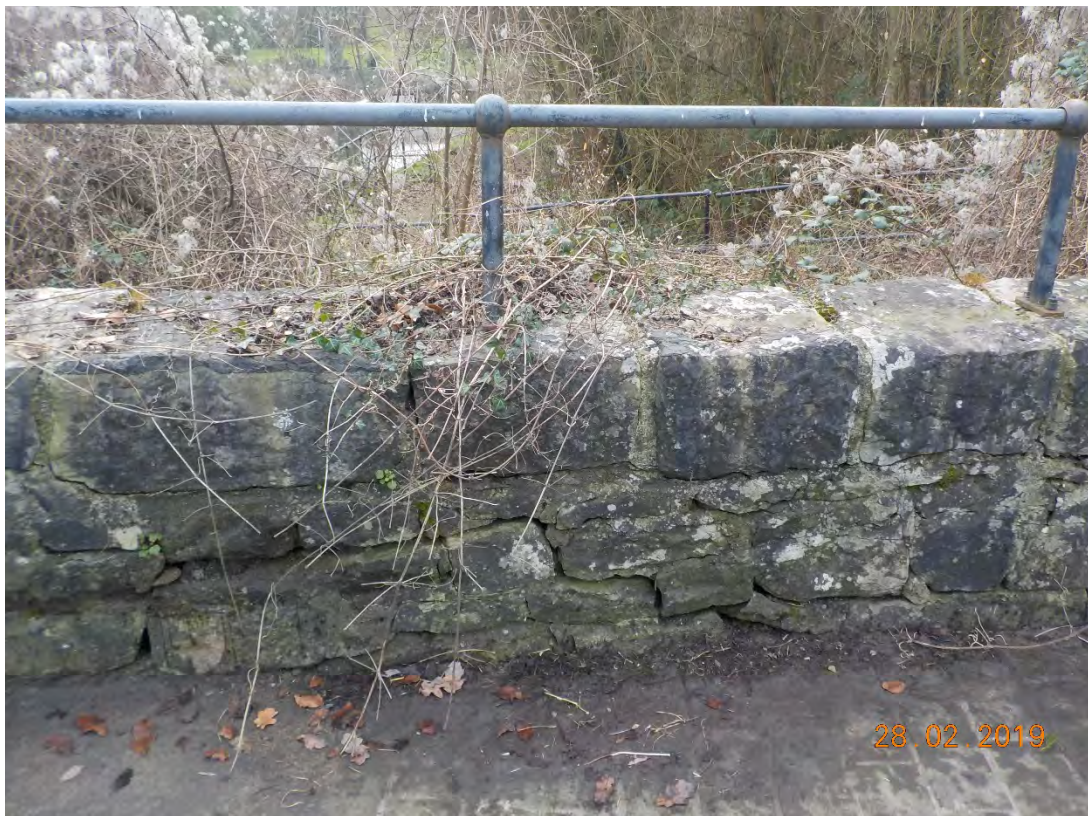
Photograph 3-24: Wall to be Raked and Repointed

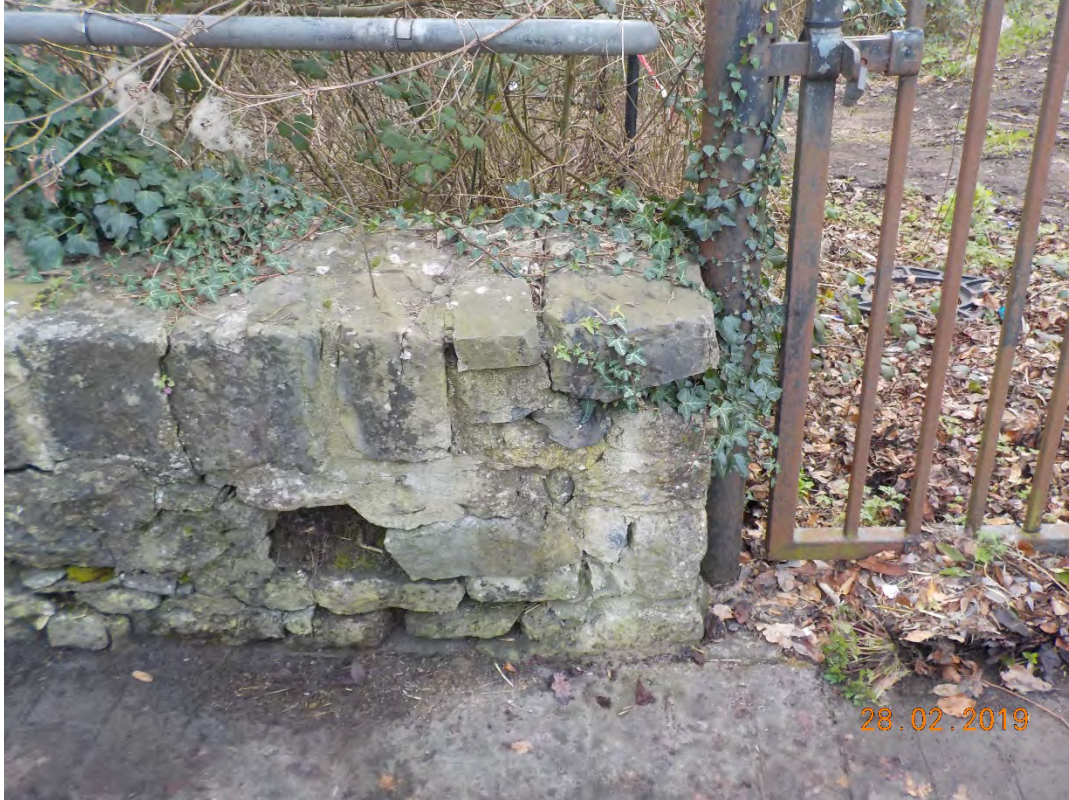
Photograph 3-25: Wall to be Raked and Repointed

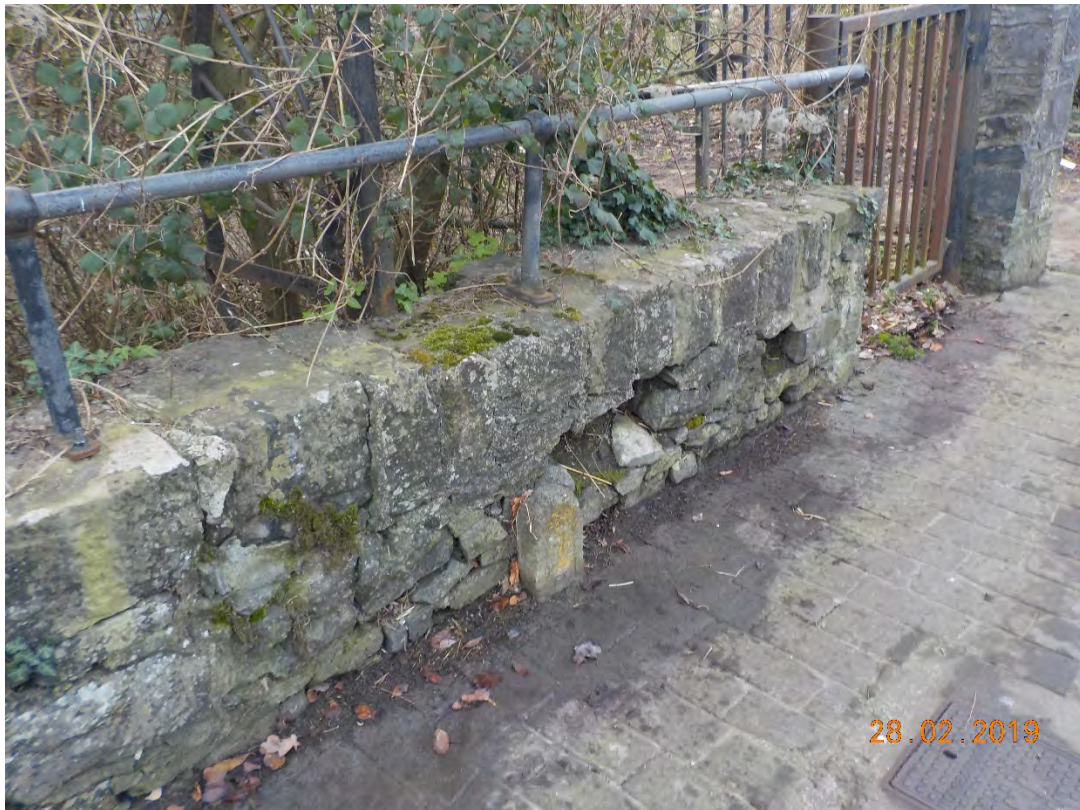
Photograph 3-26: Wall to be reconstructed on downstream side

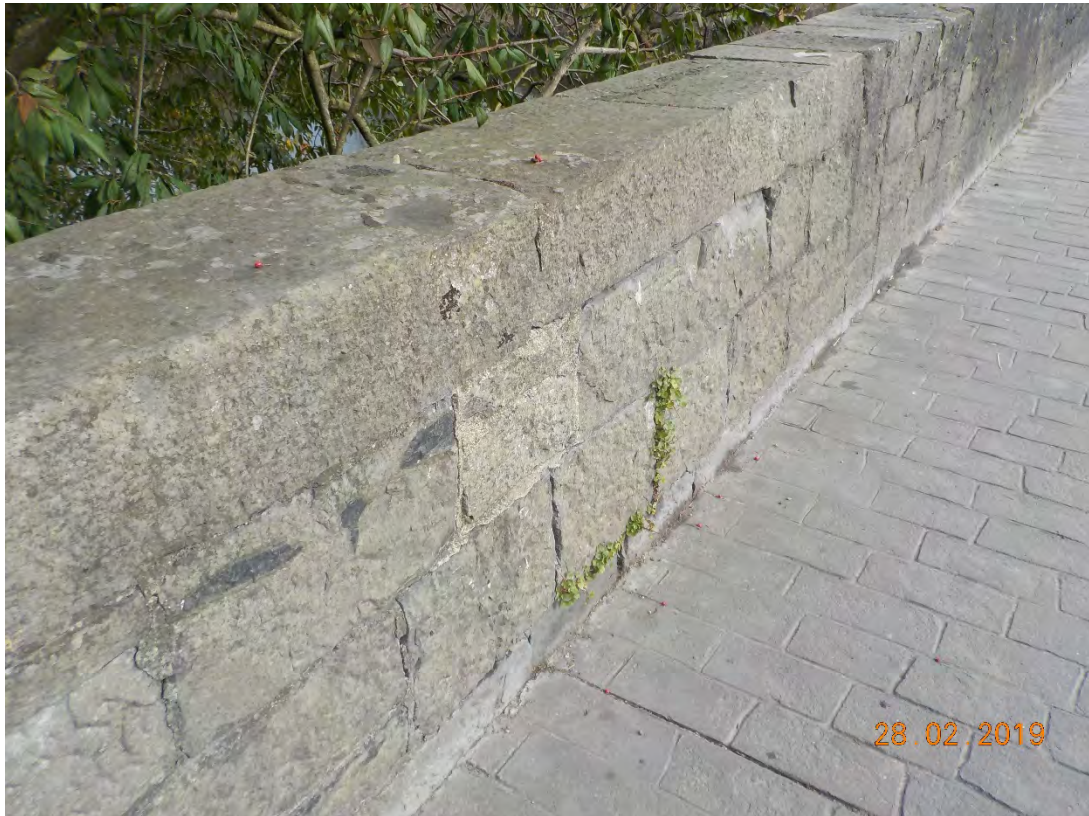
Photograph 3-29: Upstream Roadside Parapet Wall

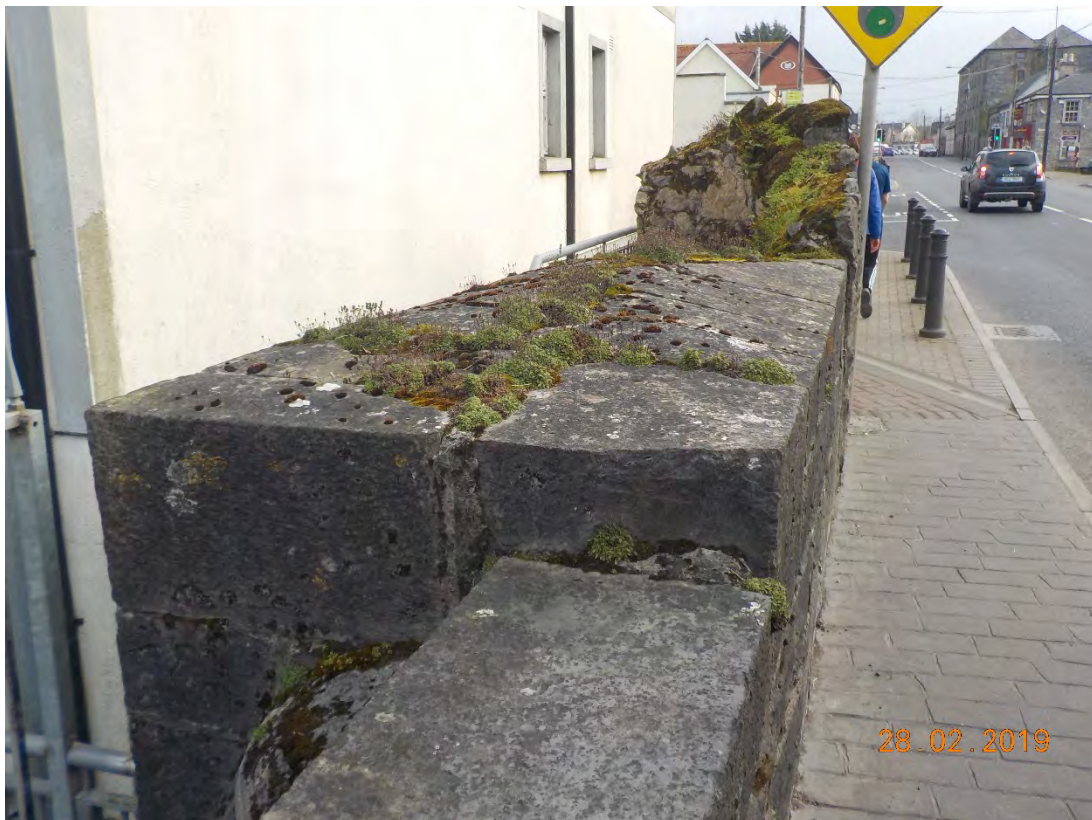
Photograph 3-30: Capping on Upstream Roadside Parapet

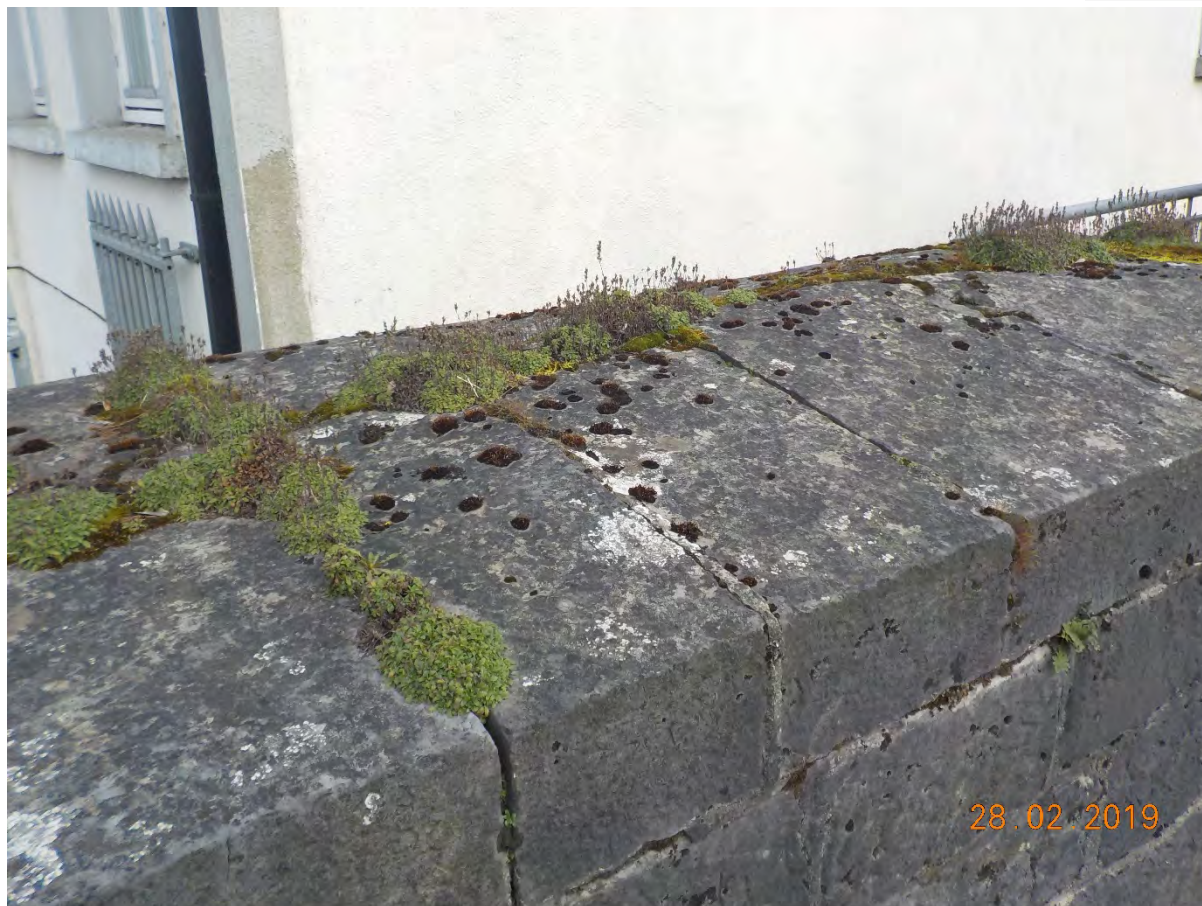
Photograph 3-31: Capping on Upstream Roadside Parapet

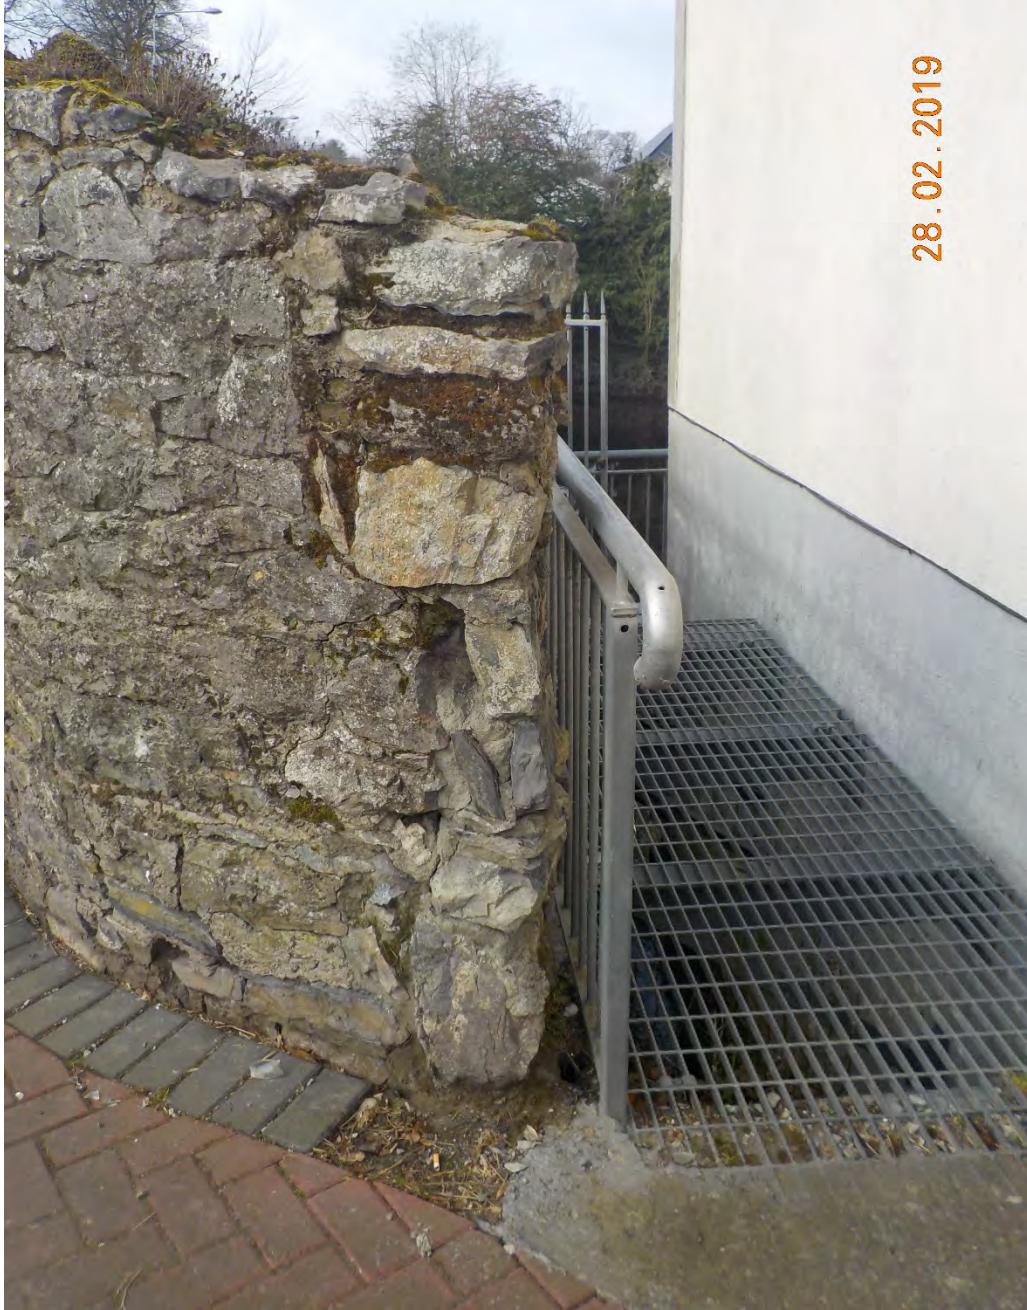
Photograph 3-32: Upstream Roadside Parapet Wall
