Monasterevin Bridge Rehabilitation Works

Preliminary Remedial Works Report

Client: Kildare County Council

Project: K424

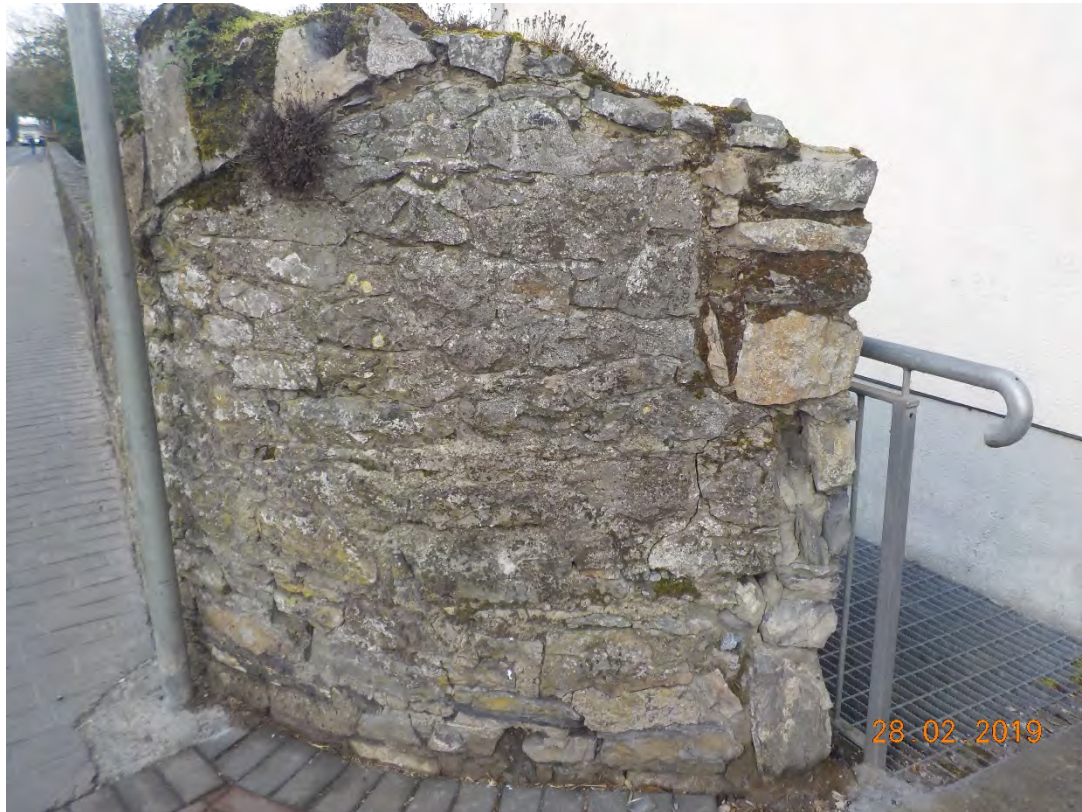
- i. Vegetation on upstream West side parapet capping, See photograph 3.27
- ii. Tree roots growing within capping on upstream West side parapet, See photograph 3.28
- iii. Joints in poor condition on Upstream roadside parapet wall, See photograph 3.29
- iv. Vegetation growing on Upstream capping eastroadside parapet, See photograph 3.30 and 3.31
- v. Edge stones in poor condition on upstream East parapet, See photograph 3.32
- vi. Joints on upstream West roadside parapet in poor condition, See photograph 3.33 and 3.34

Photograph 3-33: Upstream Roadside Parapet Wall

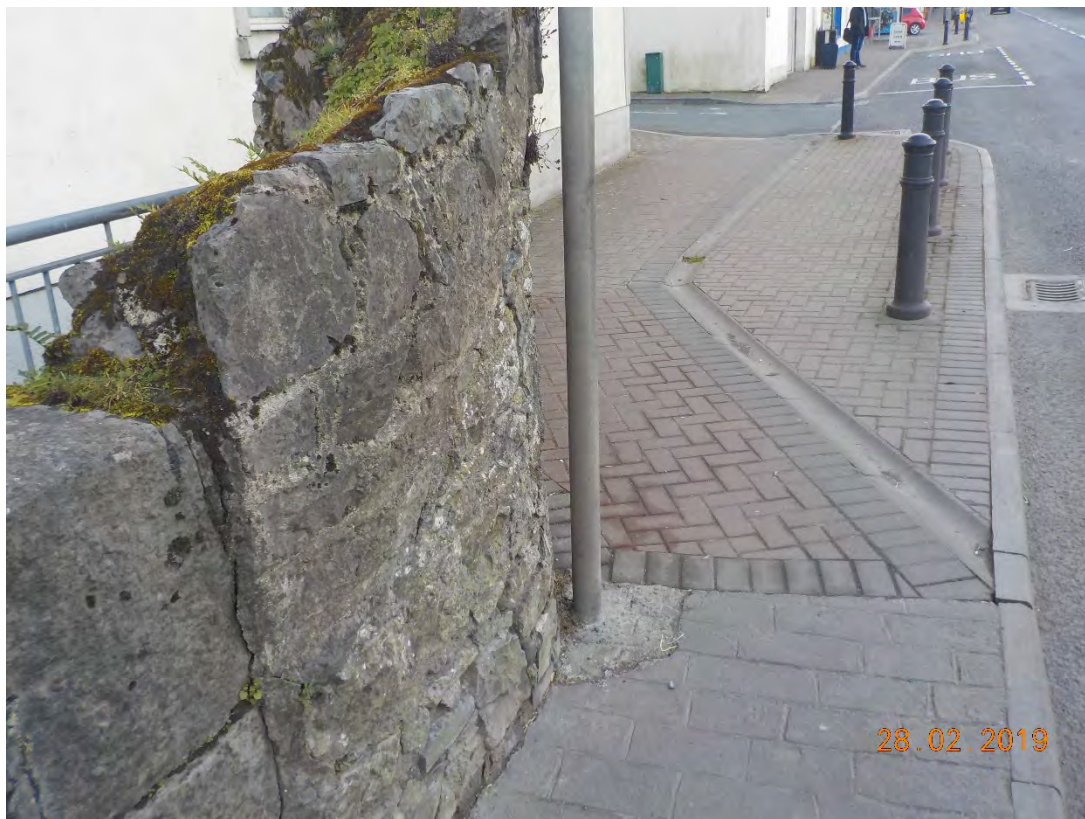
Photograph 3-34: Upstream Roadside Parapet Wall

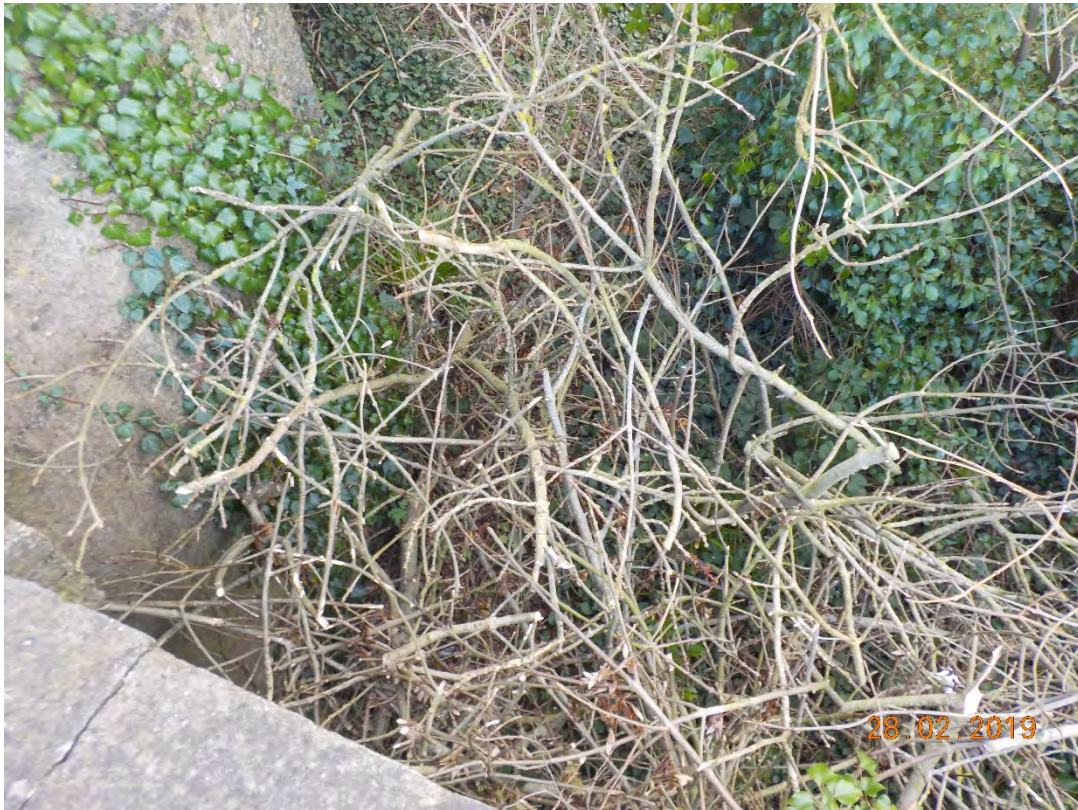
- i. Heavy overgrowth on downstream west left embankment causing a blockage for accessing the embankment, See photograph 3.35, 3.36 and 3.37
- ii. Retaining wall failing on downstream west left embankment, See photograph 3.38 and 3.77
- iii. Tree's overgrowing on downstream west left embankment, See photograph 3.39 and 3.40
- iv. Tree's and overgrowth growing wild on downstream east embankment, See photographs 3.41, 3.42 and 3.43
- v. Outfall pipe has collapsed on downstream left embankment, See photographs 3.78 and 3.79

Photograph 3-35: Downstream Left Embankment

- i. Remove area of overgrowth on the embankment to allow ease of access
- ii. Retaining wall to be reconstructed, 1m x 1.5m x 2m.
- iii. Remove 2 no overgrown tree's.
- iv. Tree's to be cut back and partially removed
- v. Outfall pipe to be reconstructed in embankment, 225 diameter.

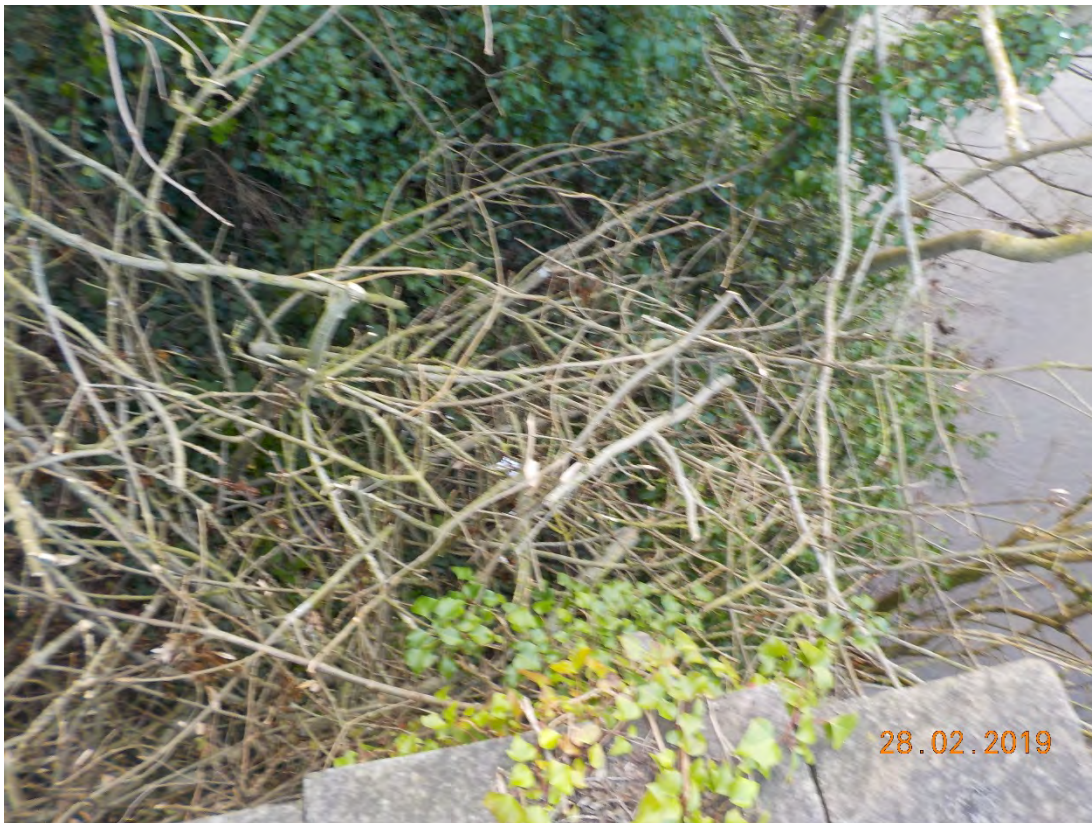
Photograph 3-36: Downstream Left Embankment

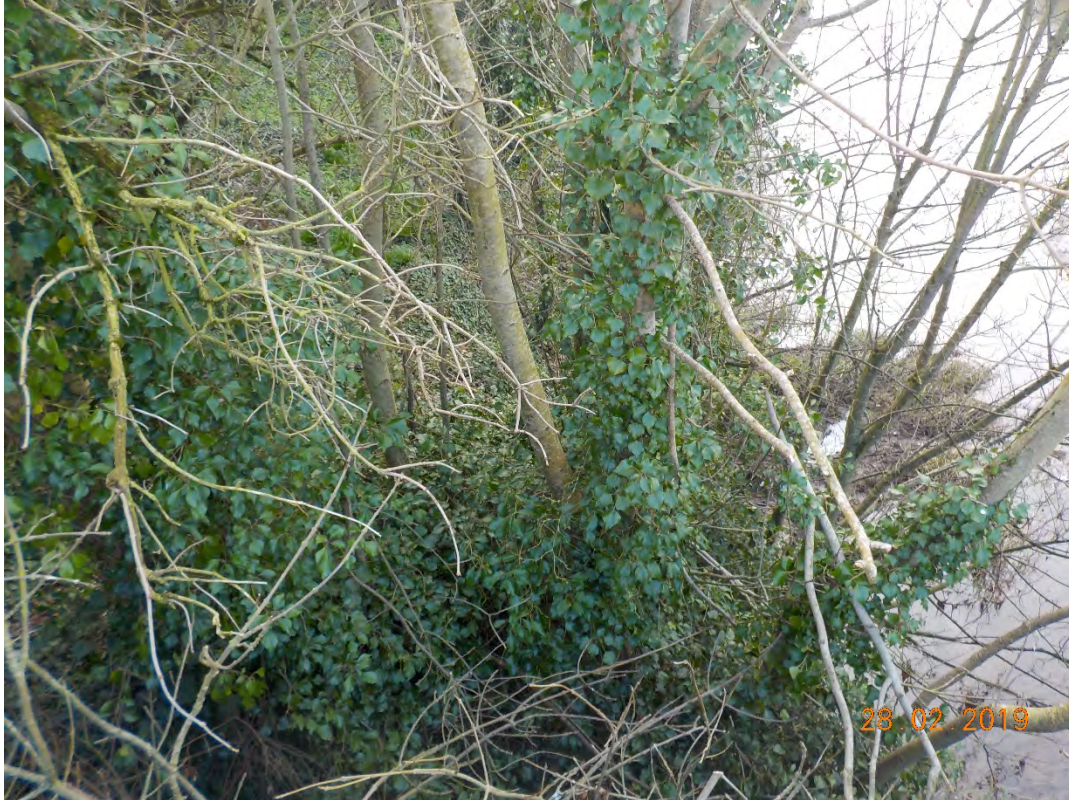
Photograph 3-37: Remove Tree's on Downstream Left Embankment

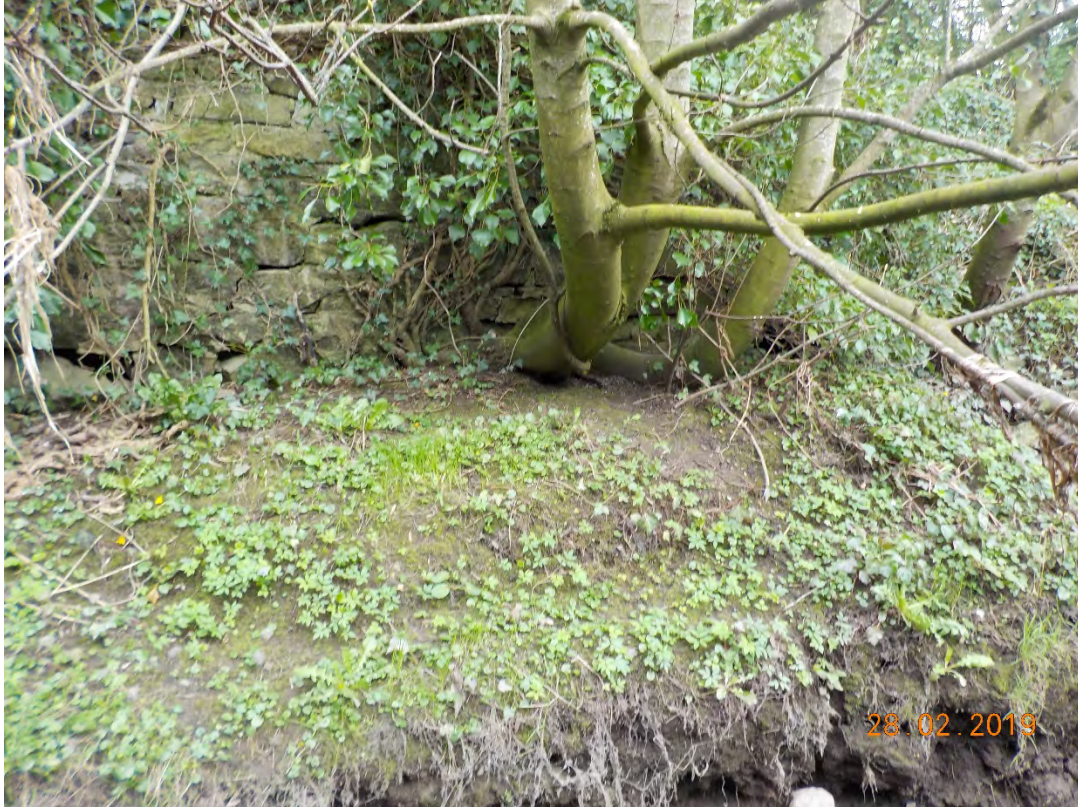
Photograph 3-39: Tree's to be removed on Downstream Left Embankment

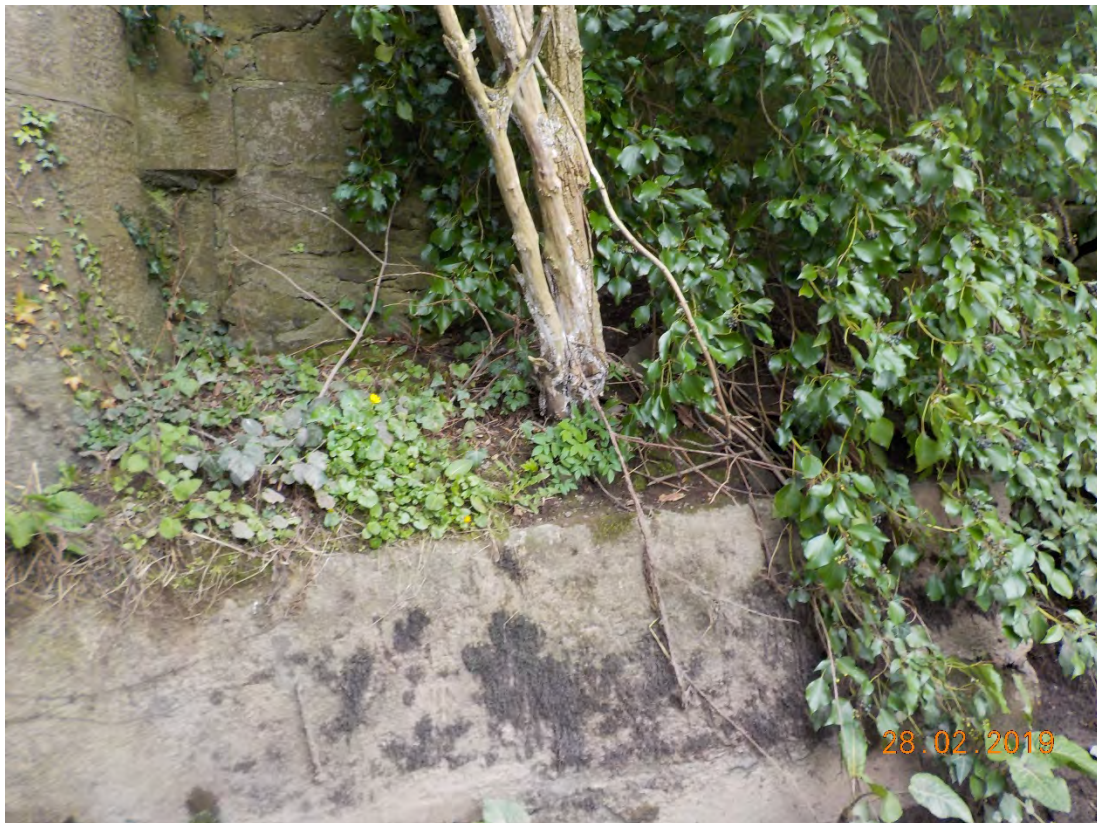
Photograph 3-40: Tree's to be removed on Downstream Left Embankment

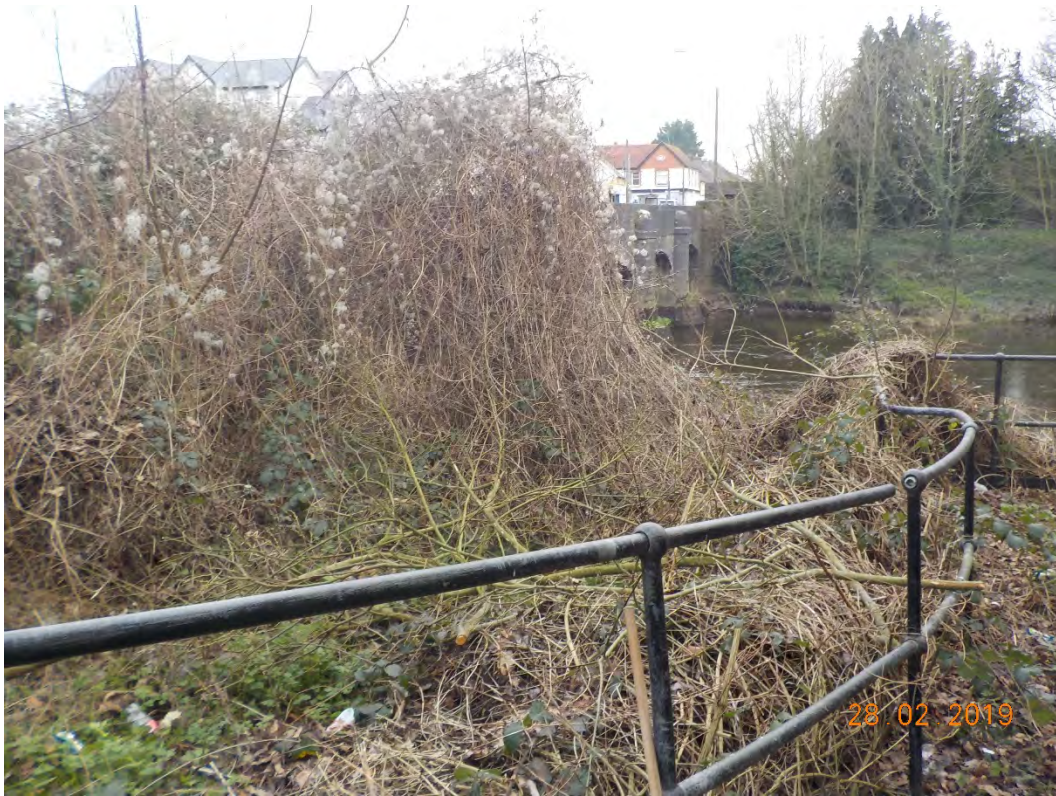
Photograph 3-41: Overgrown Vegetation on Downstream Right Embankment

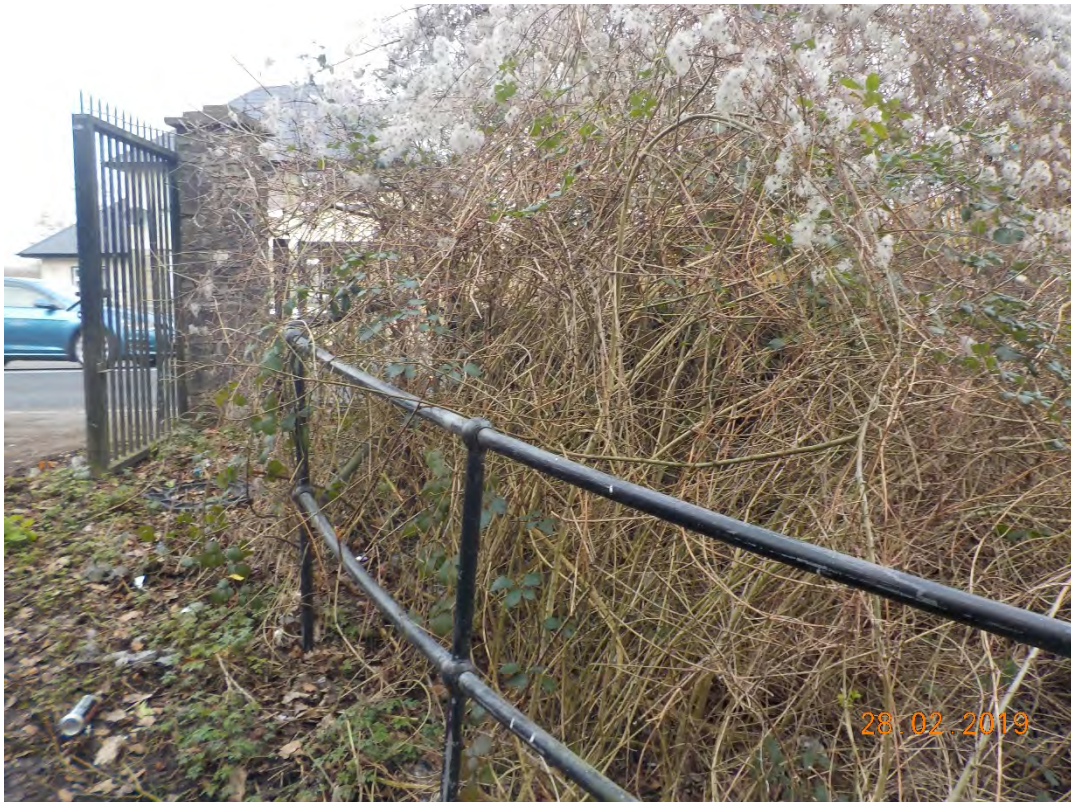
Photograph 3-42: Overgrown Vegetation on Downstream Right Embankment

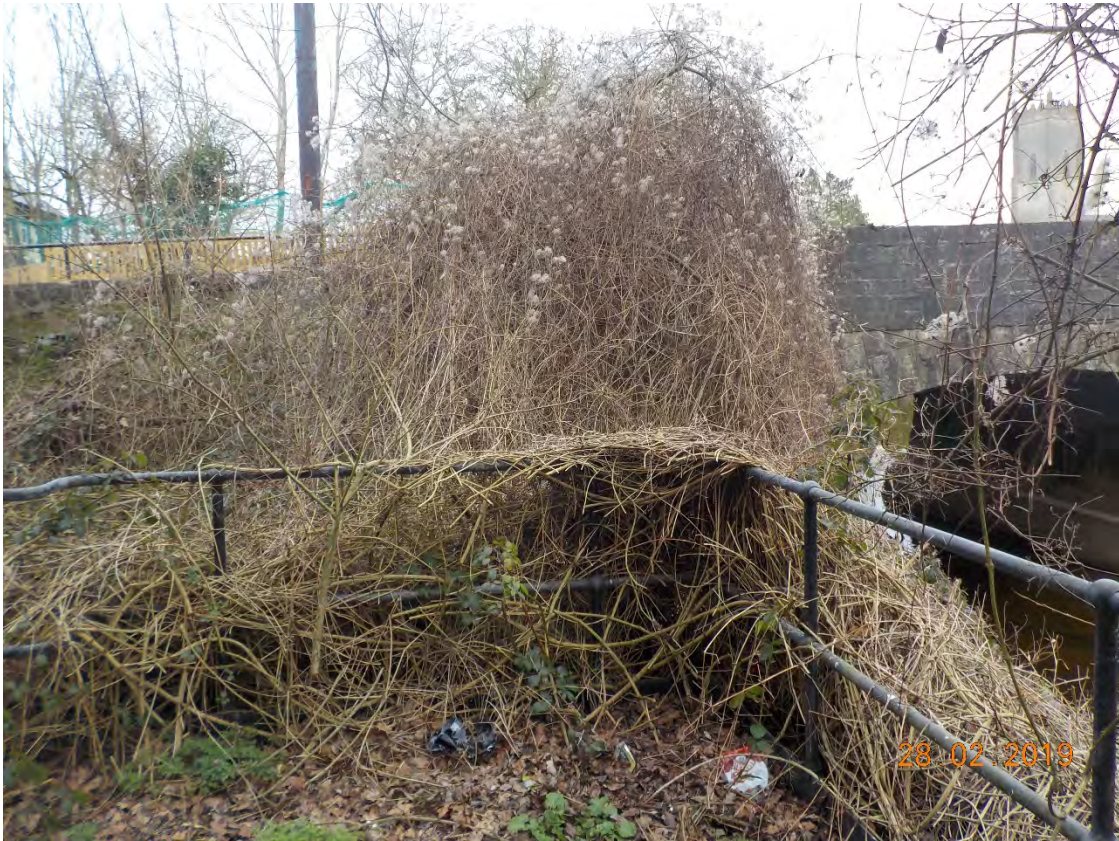
Photograph 3-43: Tree's to be removed on Downstream Left Embankment

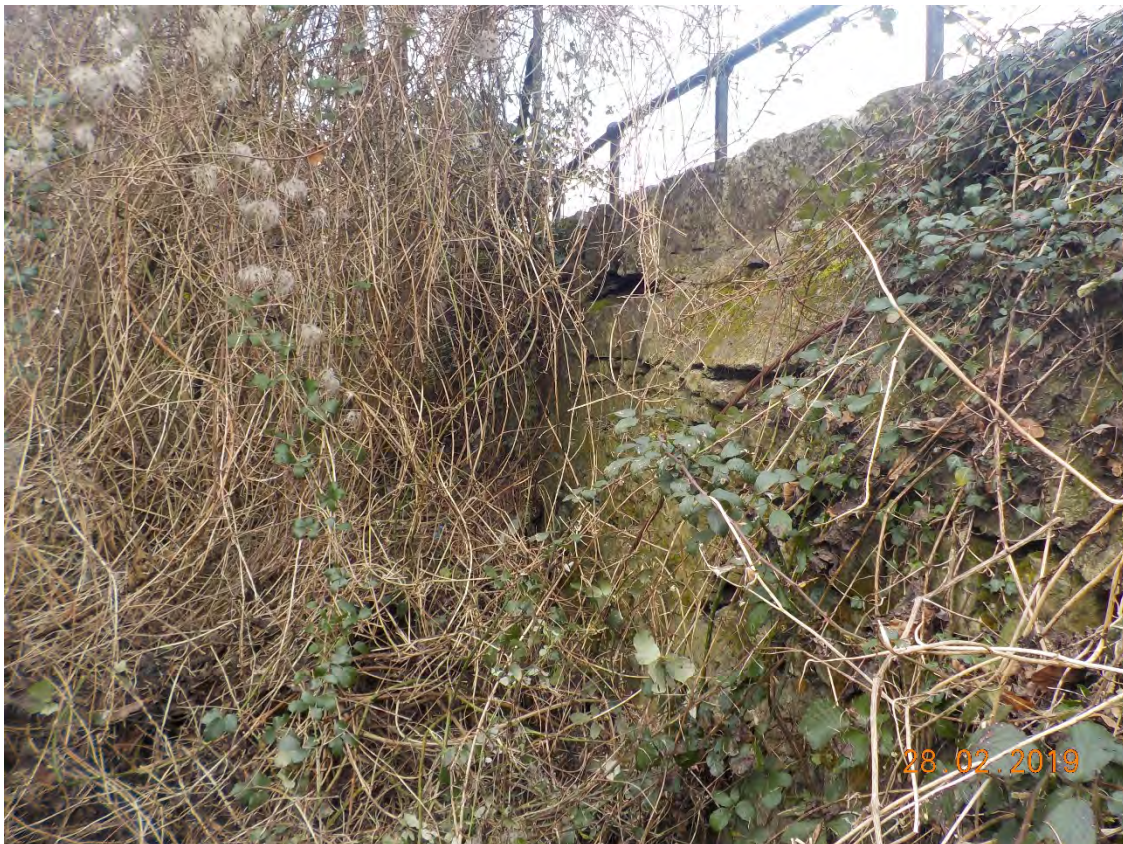
- i. Vegetation growing on downstream riverside parapet, See photograph 3.44 and 3.45

Photograph 3-44: Downstream Riverside Parapet

- i. Vegetation to be removed and joints to be raked and repointed, 14m x 2m + 10% of joints.

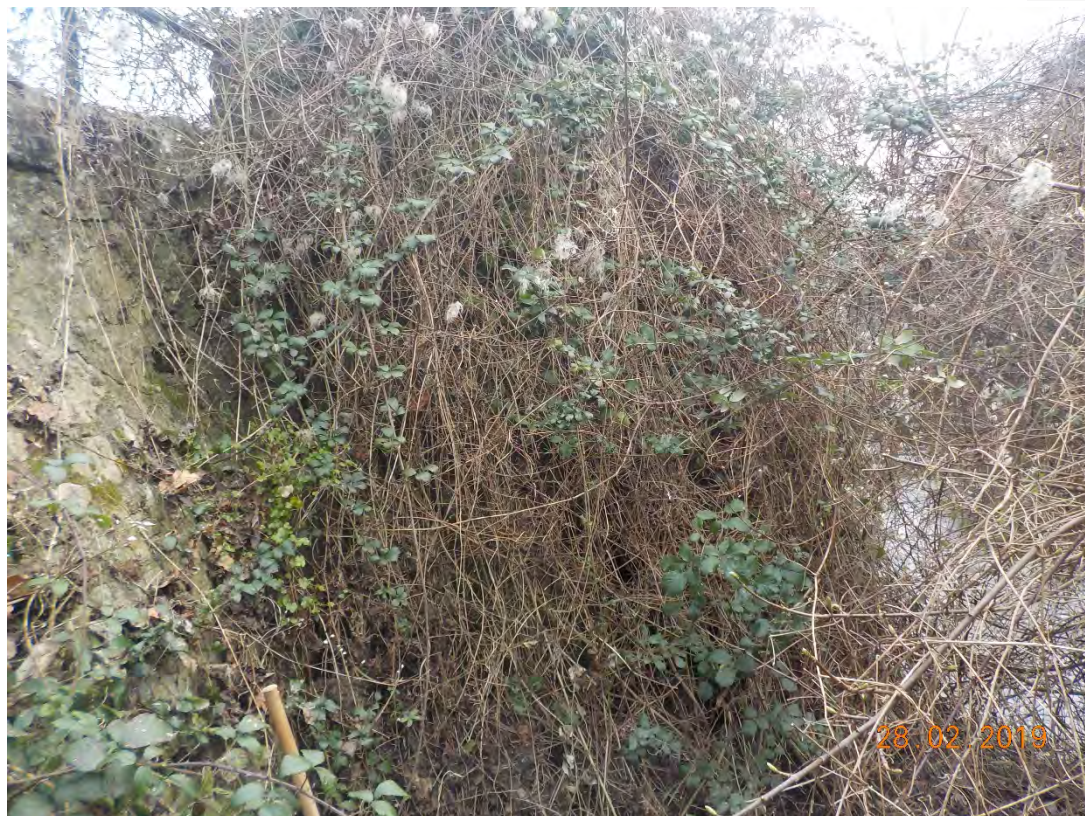
Photograph 3-45: Downstream Riverside Parapet

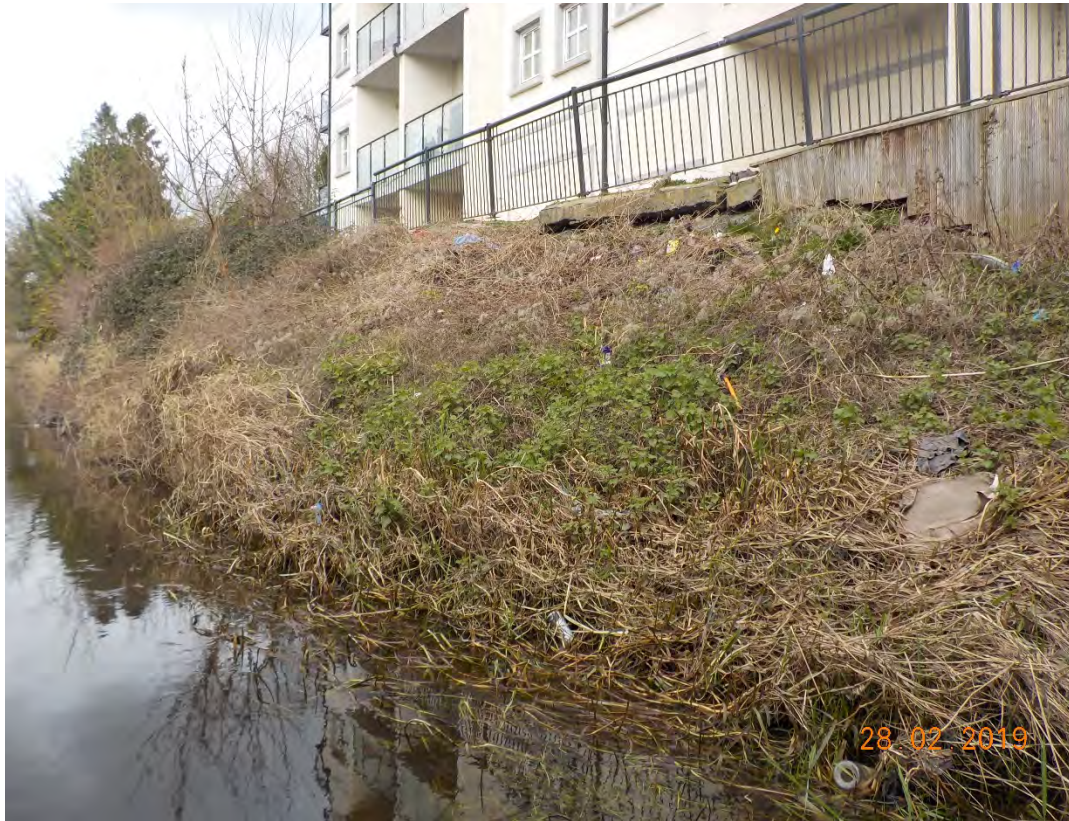
- i. Heavy overgrowth on upstream east embankment, See photograph 3.47
- ii. Culvert on upstream embankment failing, See photograph 3.48 and 4.49
- iii. Wall at outfall of culvert has collapsed, See photograph 3.50
- iv. Tree growing from upstream east parapet, See photograph 3.51

Photograph 3-47: Upstream East Embankment

- i. Remove vegetation and overgrowth from embankment
- ii. Reconstruct failing section of culvert 3.48 & 3.49
- iii. Wall to be reconstructed at outfall of culvert, 1.2m x 1.4m x 0.6m.
- iv. Tree to be poisoned and killed off, 1m diameter.

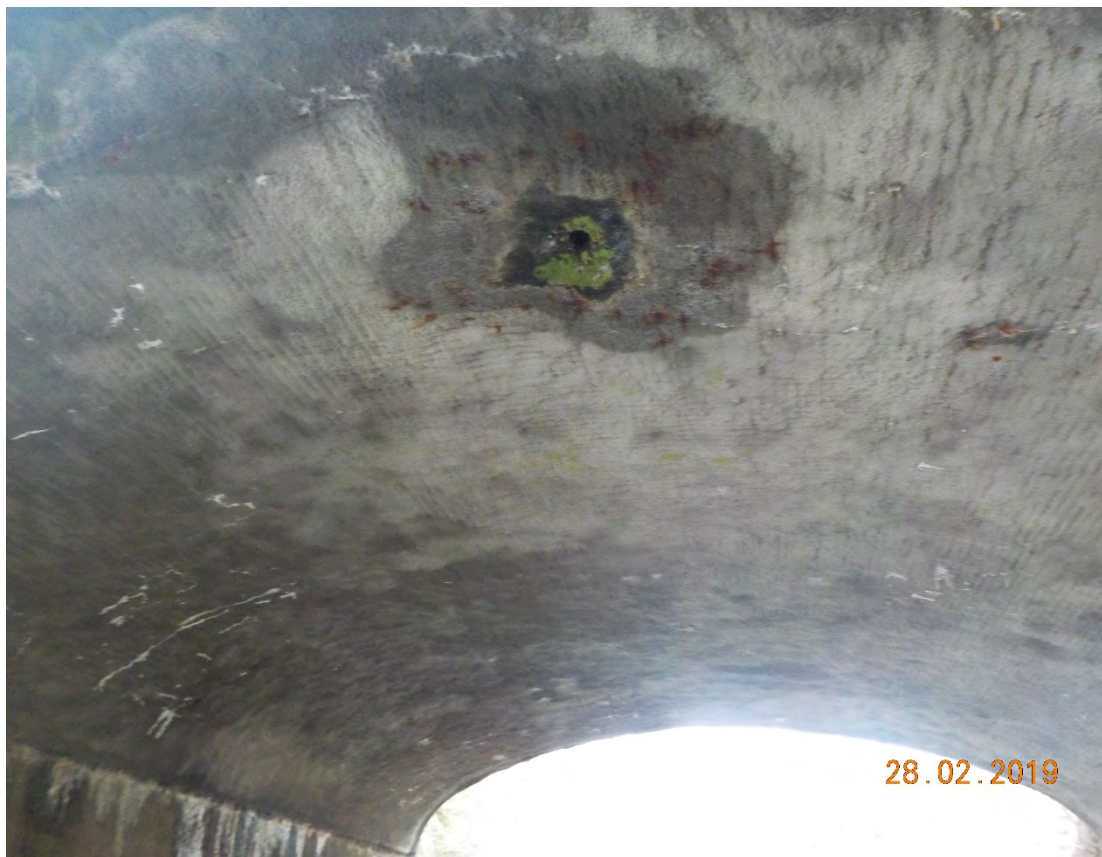
Photograph 3-52: Arch 1 - Hole in Upstream Bridge Deck

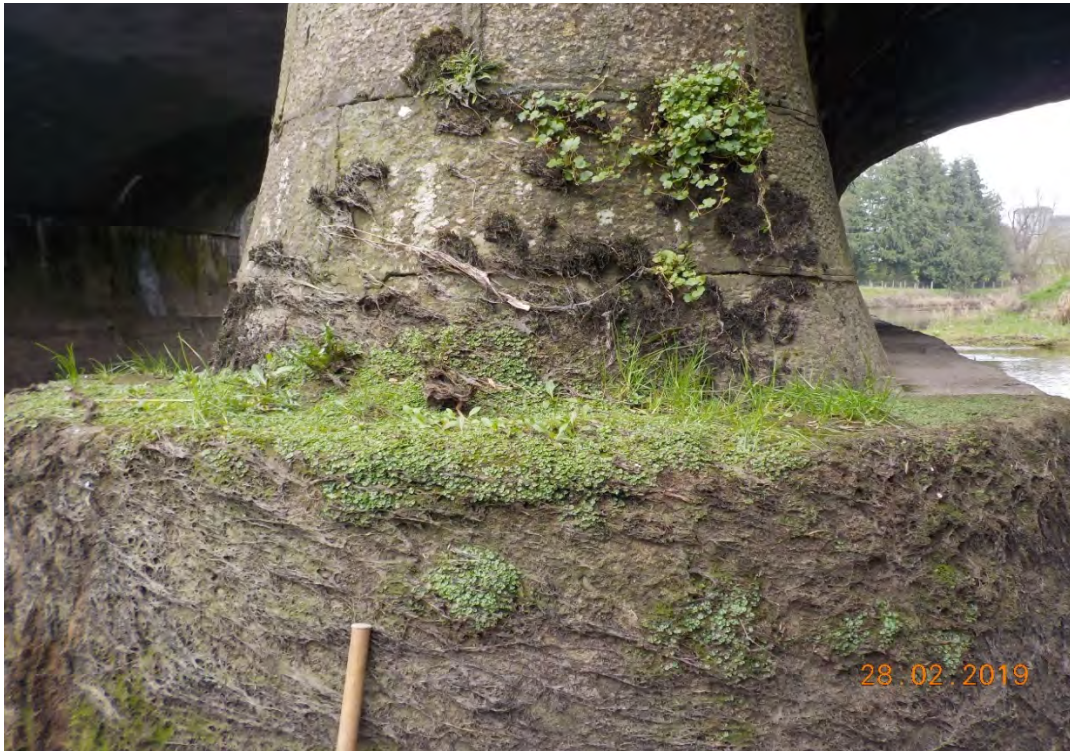
- i. Vegetation growing around Pier 1, See photograph 3.53
- ii. Pier 2 upstream cutwater undermined and separating from bridge pier, See photograph 3.54 and 3.55
- iii. Vegetation growing on downstream Pier 2, See photograph 3.57 and 3.58
- iv. Scouring occurring at upstream cutwater Pier 3, See photograph 3.66, 3.67 and 3.68
- v. Vegetation growing on downstream Pier 4, See photograph 3.62
- vi. Vegetation growing on upstream Pier 4 and a small crack commencing in the upstream cutwater, See photographs 3.69, 3.70 and 3.71

Photograph 3-53: Pier 1 – Rake and Repoint

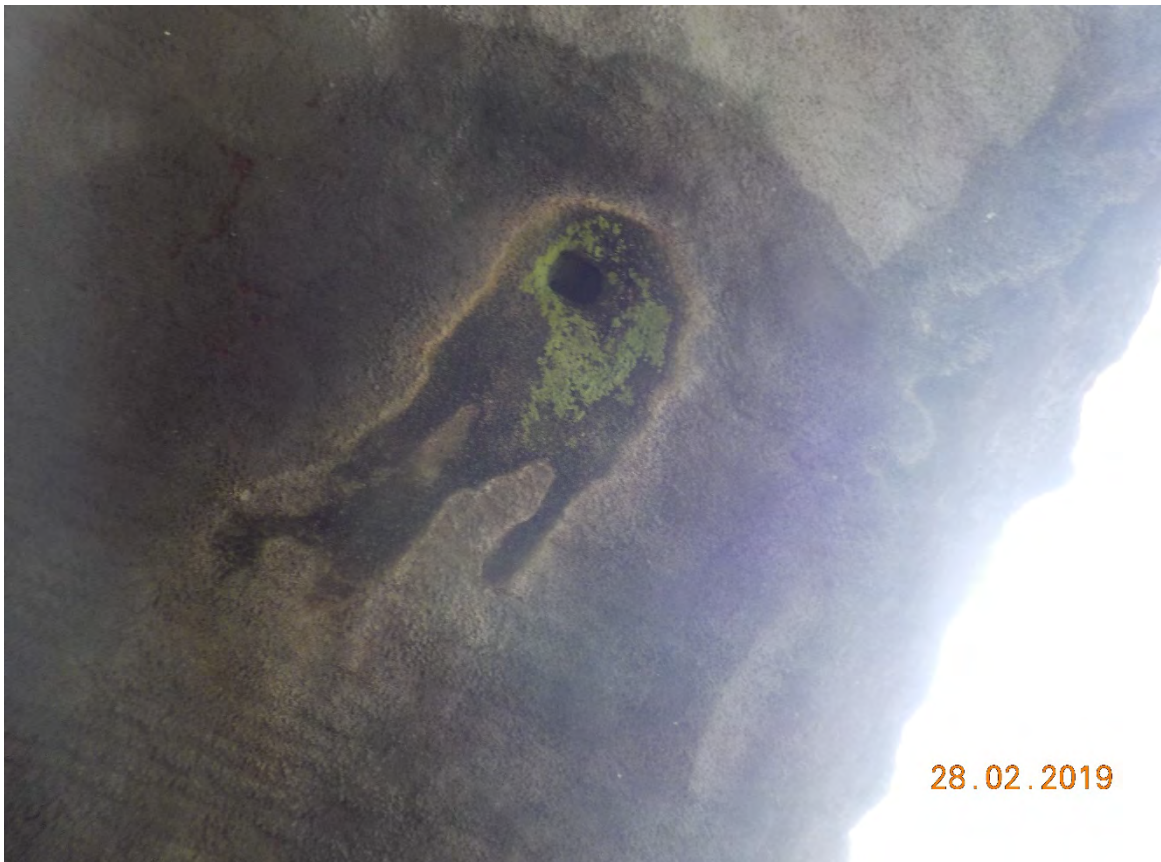
Photograph 3-56: Hole in Upstream and Downstream of Bridge Deck 2

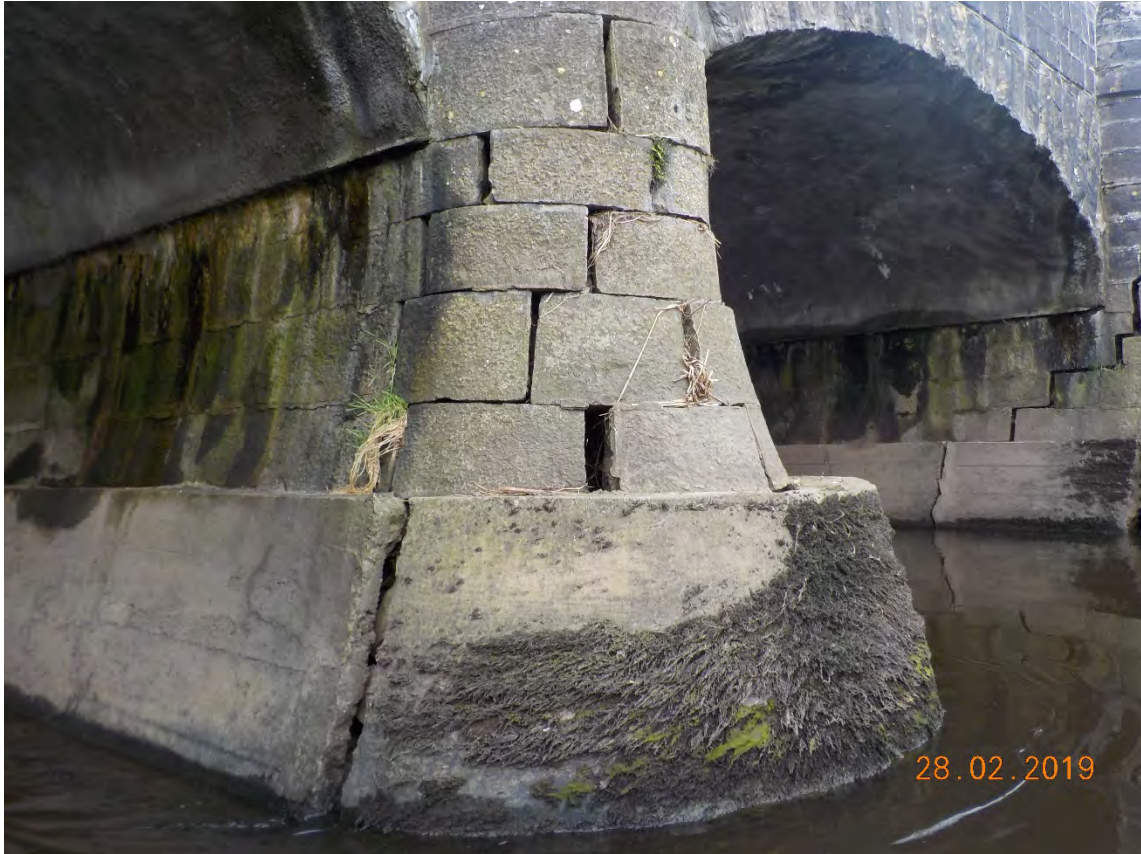
Photograph 3-68: Pier 3 – Natural Scouring
