**The Food, Drinks & Skills Innovation Hub
at
The Model School
Athy**

Project Report

**Including
Architectural Heritage Impact Assessment**

**for
Part 8 Public Consultation**

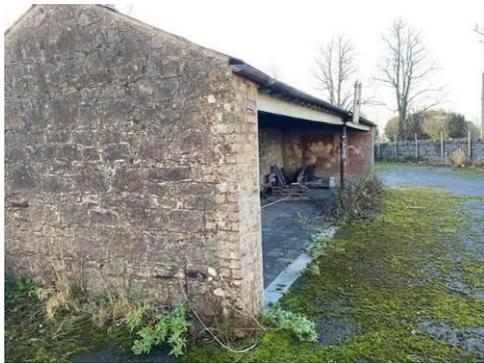
49.

2. At the north-east corner of the site adjacent to the staff car park.

A location within the small green area at the north end of the site was considered. This is close to the service entrance and would be convenient for gas delivery. However the area is very close to the neighbouring property and safety issues arise.

Moreover, the sycamore tree close to the boundary, although presently untidy with an over mantle of ivy, is a good specimen and worthy of retention.
