**FORMER ESB PREMISES
LEIXLIP**

**ARCHITECTURAL HERITAGE
IMPACT ASSESSMENT**

19th October 2023

**Historic Building Consultants
Old Bawn
Old Connaught
Bray**

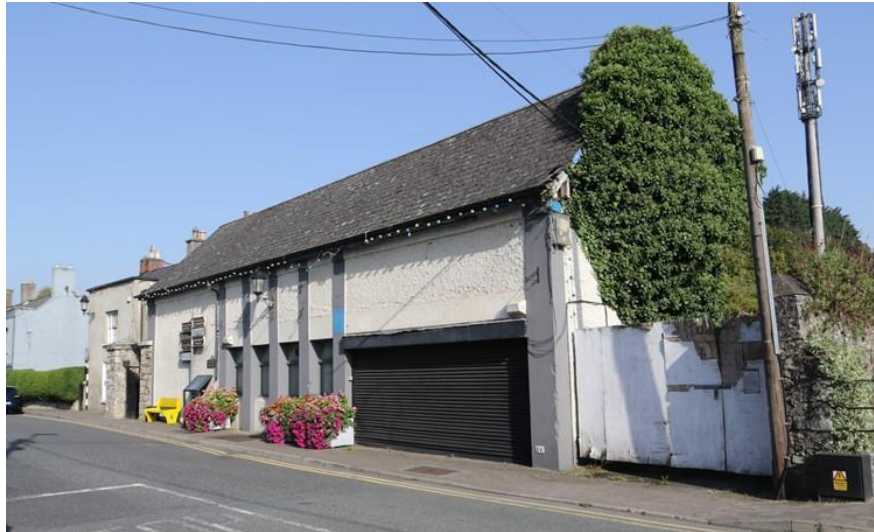
Plate 2: Former ESB showroom

Examination of the outside of the building showed that it is entirely faced in materials dating from the 1960s, except for the gate pier embedded in the corner. The facade is a mix of roughcast render and smooth render, which is cement-based and is typical of a form of architecture that was common in the 1960s.

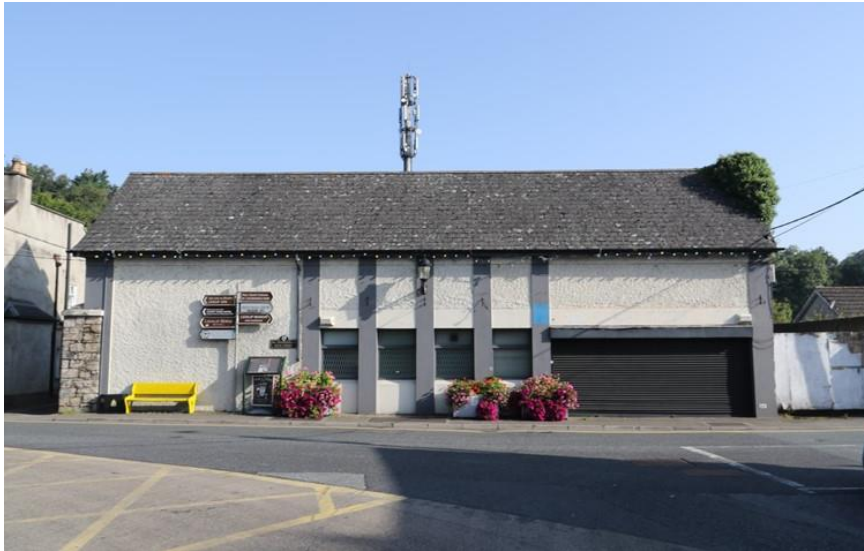
Plate 3: Street frontage of former ESB showroom

The former showroom is two storeys in height, with a covering of fibre-cement tiles. The front façade has a shopfront window on the ground floor, to the west of which is a series of four casement windows protected by metal grilles. The shopfront is concealed behind steel roller shutters. The façade is roughcast rendered, with smooth-rendered pilasters rising to full height flanking the windows. There are two windows in the western elevation on the upper floor, this elevation being roughcast rendered as per the frontage.

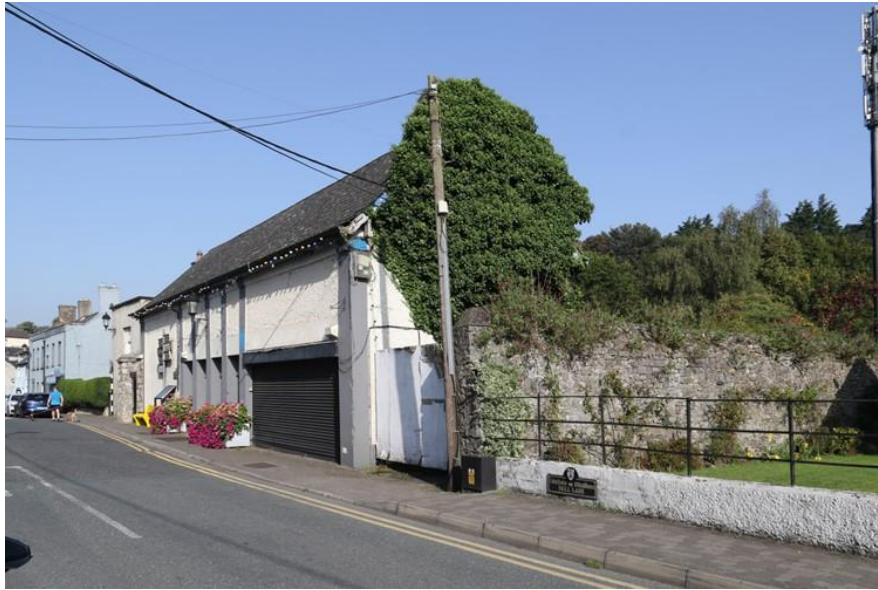
Plate 5: View of showroom from the east

The eastern elevation of the building is concealed beneath a heavy growth of ivy. There are no windows in this elevation. The access to the site at the rear is to the east of the building and is closed by a pair of gates.

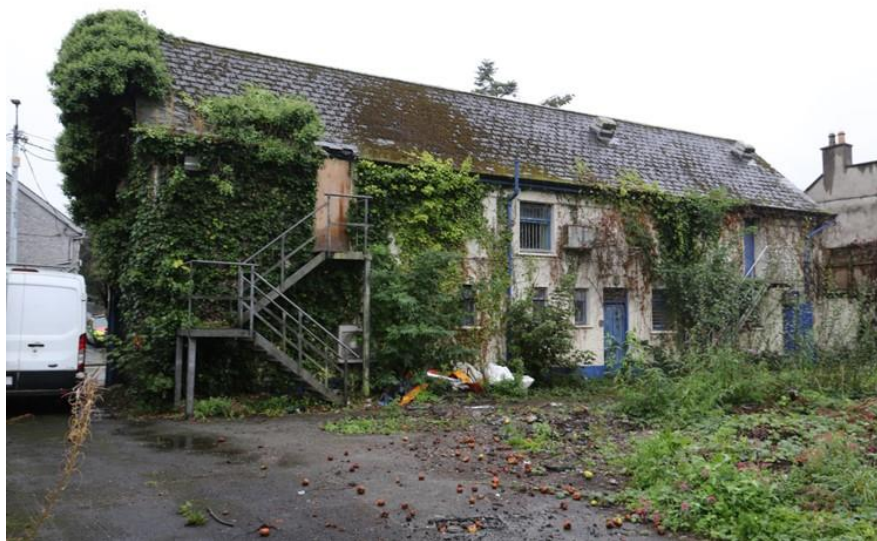
Plate 6: Rear view of former showroom

The rear of the building has a number of timber casement windows on each of the two floors. Two external steel stairways give access to doors on the upper floor, one at each end of the building, while there are two doors on the lower floor, both close to the western end. The rear elevation is roughcast rendered.

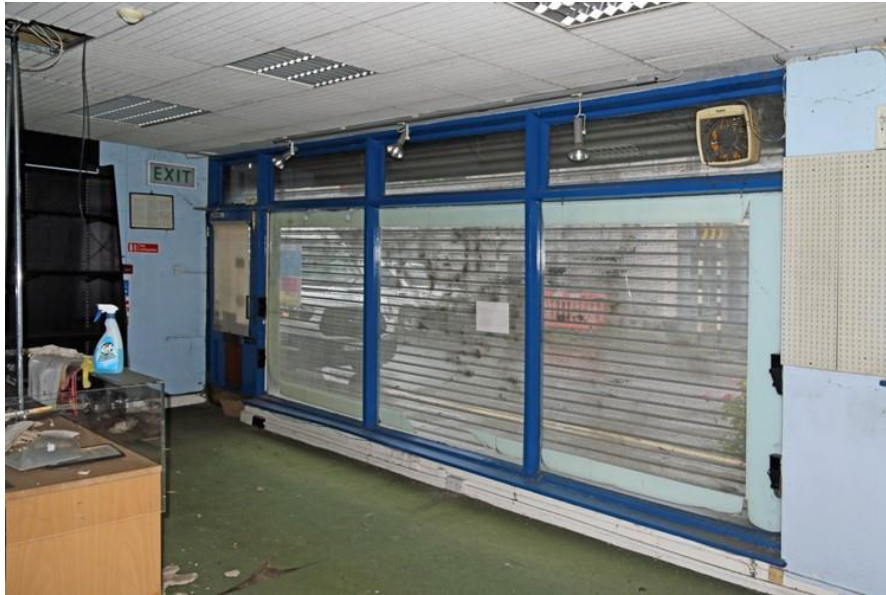
Plate 7: Internal view of shopfront

On the ground floor level, the eastern end of the building was the former showroom and public counter, and this area is lit by the shopfront, with some light penetrating the perforated steel roller shutters. The ceiling in this area is drooped and surfaced with acoustic tiles.

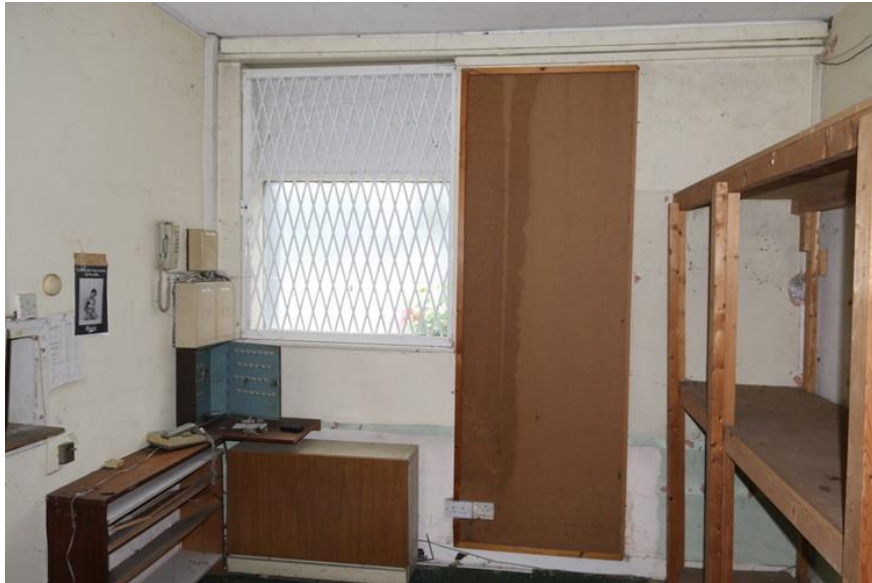
Plate 9: Office at ground-floor level

The western part of the ground floor is divided by means of timber stud partitions with plasterboard facings to provide offices, stores, a WC and a corridor. The doors are hollow with plywood facings and are set in simple timber architraves. The ceilings are of plasterboard.

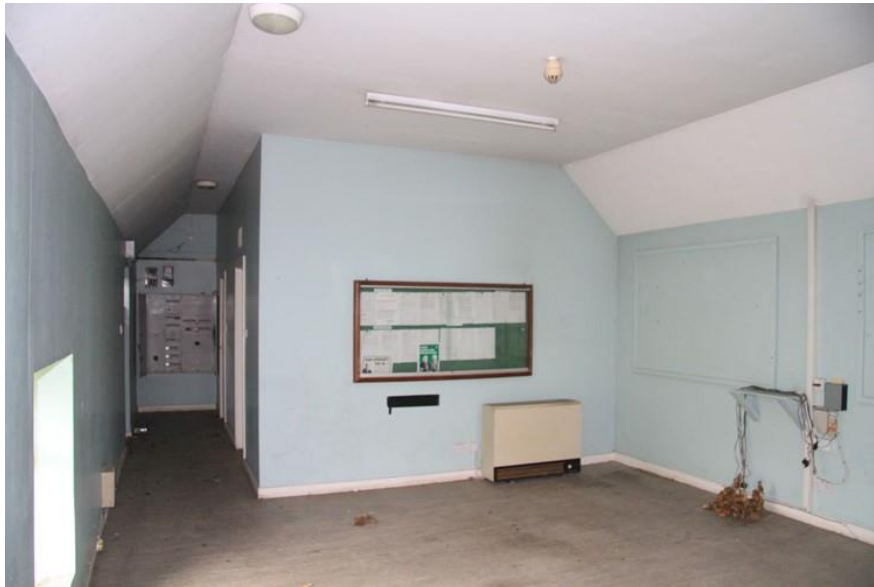
Plate 11: First floor of former showroom

As noted above, the first floor is approached via two external steel stairways. The interior is divided into a number of rooms and spaces by timber stud walls faced with plasterboard. The ceiling is of plasterboard and slopes at the northern and southern sides. The floor is boarded. There is a kitchen at the western end of the building, lit by two timber casement windows facing west. The other windows on this level are on the northern elevation.

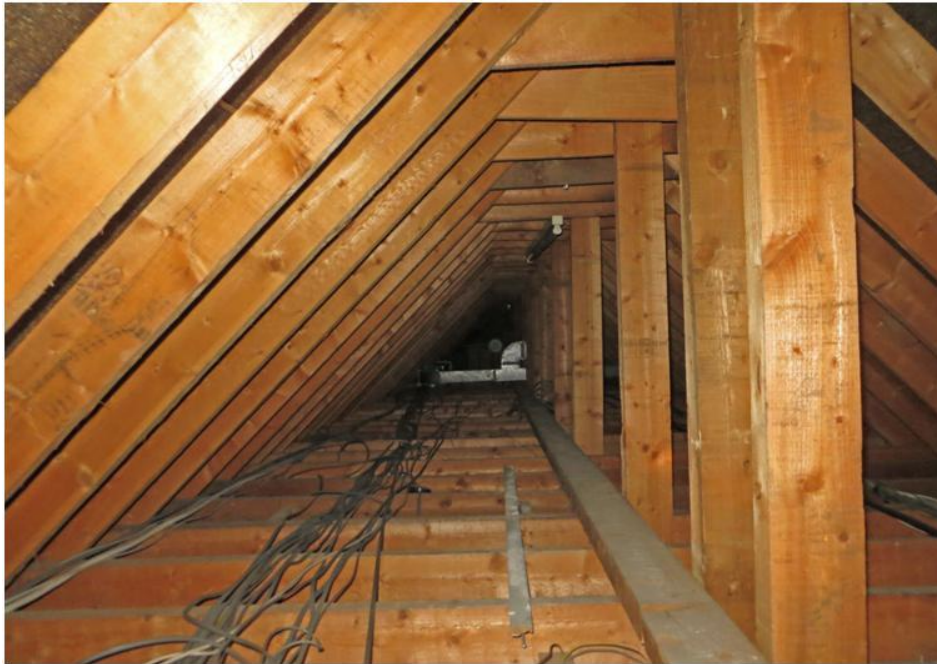
Plate 13: Timber structure of roof

The roof has a comparatively steep pitch and is constructed with coupled rafters and collars, which are set high. Hangers are suspended from the collars to support the ceiling joists at mid-point. The ceiling joists are set well above the eaves and would function as a second line of collars to cross-brace the rafters. All of these timbers are of mid-twentieth century date, suggesting that the roof was entirely rebuilt during the conversion to ESB showroom in the mid-1960s. The ceiling attached to the joists is entirely of plasterboard.

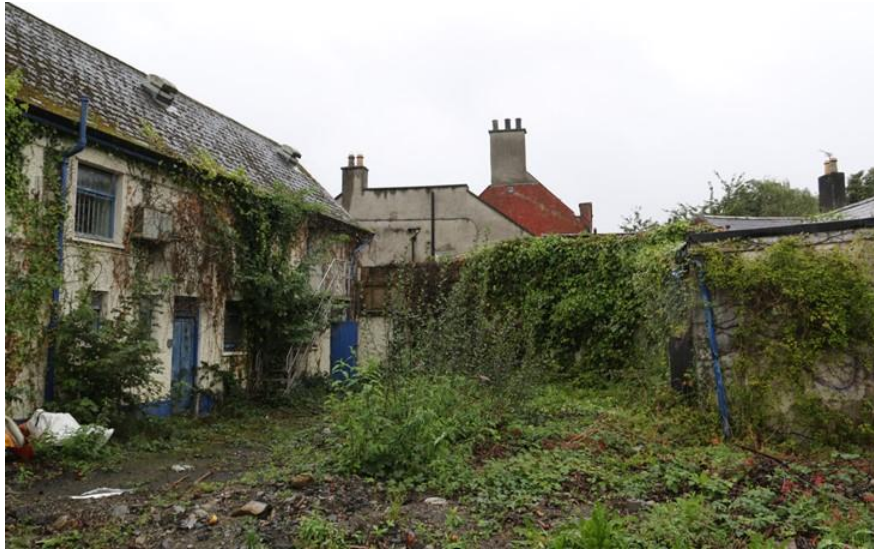
Plate 20: View to west across rear yard

The site frontage has the width of the former showroom plus the width of the laneway leading to the side of the building, as has been noted above. To the rear of the building there is a yard which extends to this full width, while running back more than twenty metres to the north. Beyond this yard the site narrows, continuing northward at the eastern end, before widening significantly to the east. The yard at the rear is bounded on the west by a stone wall that has been raised with timber fencing, beyond which is the protected structure at Ivy House. To the east the boundary wall is of rubble stone at the southern end, while of concrete along most of its length within the yard. At the rear, or north, of the yard are concrete sheds.

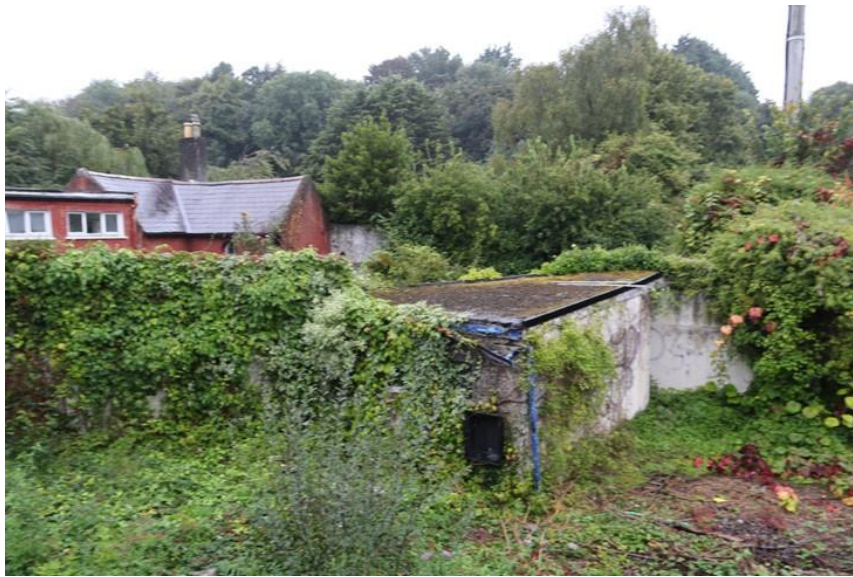
Plate 22: View to north-west from upper level

The photograph above shows the concrete sheds at the rear of the yard, with the outbuilding to the rear of Ivy House at left, with part of a later rear addition behind Ivy House. The photograph below shows the narrower part of the site, at right, gated at the entrance to the yard, and running back toward the field, or open part of the site, to the north. The concrete sheds are seen at left in the foreground. Beyond the sheds is a small area, enclosed by fencing, within which is a telecommunications mast. The building, the yard and the narrow section of the site, including the telecommunications mast, lie within the architectural conservation area (ACA), while the open land at the northern end of the site lies beyond the ACA boundaries.

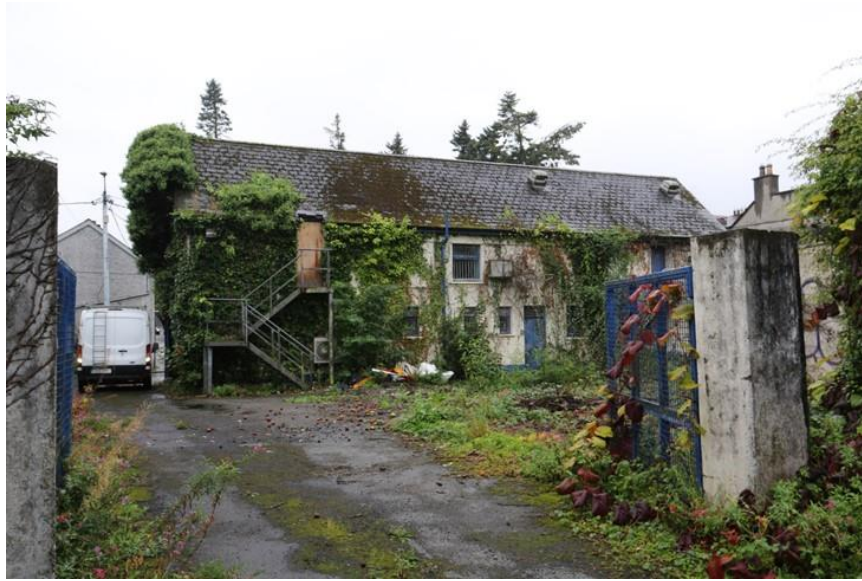
Plate 24: View into yard from rear of site

The photograph above shows the view southward through the gateway into the yard at the rear of the former showroom. This area is separated from the land at the rear, with the telecommunications mast, by a gateway with concrete piers supporting steel gates.

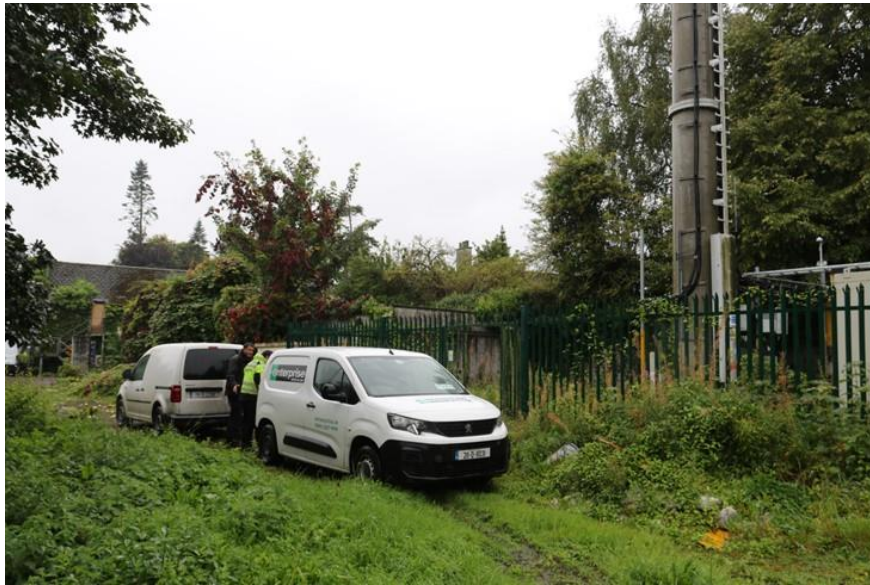
Plate 26: Link route between yard and rear site

The narrower part of the site is seen in the photograph above, with the concrete sheds visible to the rear of the vans and the fenced area with the telecommunications mast at right.

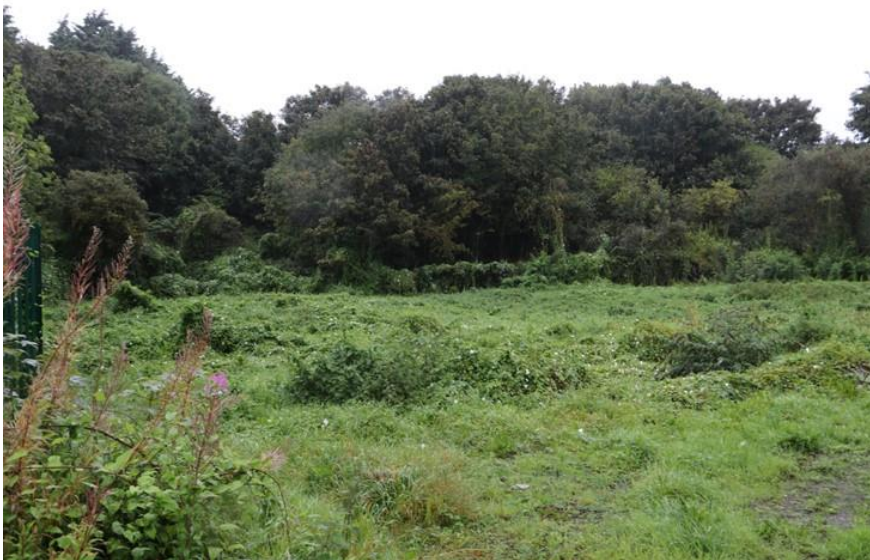
Plate 27: View to north across the rear site

Beyond the narrow area, to the north, the site widens out into a substantial field. The field margins are overgrown, with a densely wooded area to the north, beyond the boundary, as seen in the photograph above.

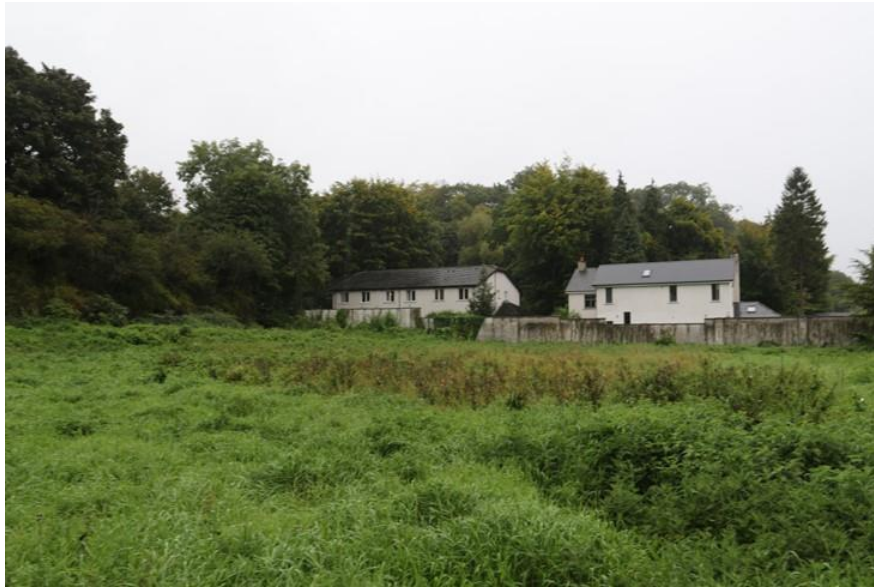
Plate 28: View to east across rear site

To the east of this field is a group of houses in Silkechain Lane, backing onto the site. The rear boundaries of those properties are marked by concrete walls.

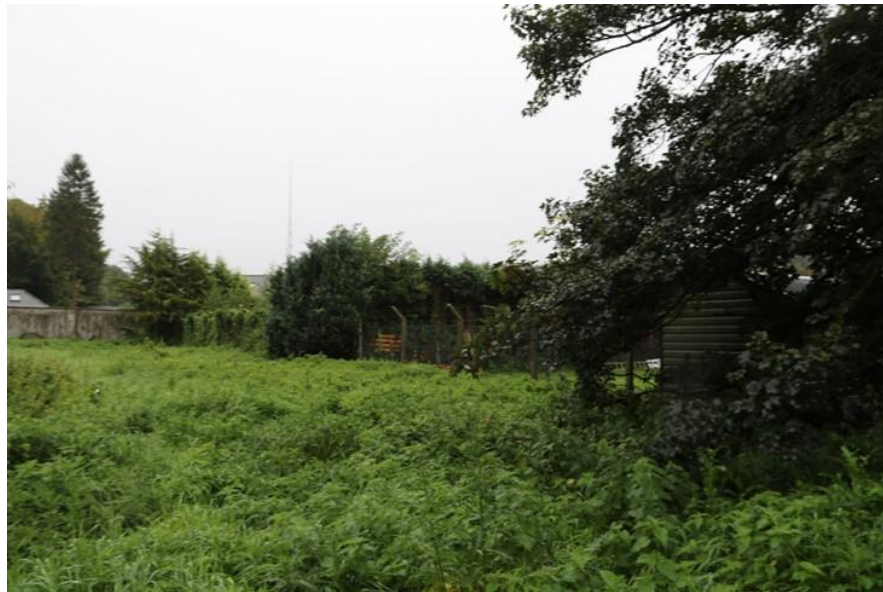
Plate 29: Southern boundary of rear site

The southern boundary of the field is marked by a chain-link fence supported on concrete posts.
