#### RELOCATION OF LEIXLIP PLAYGROUND (PART 8)

#### LEIXLIP AMENITIES CENTRE

#### **Engineering Report**

Job No. 2023/02 March 2023

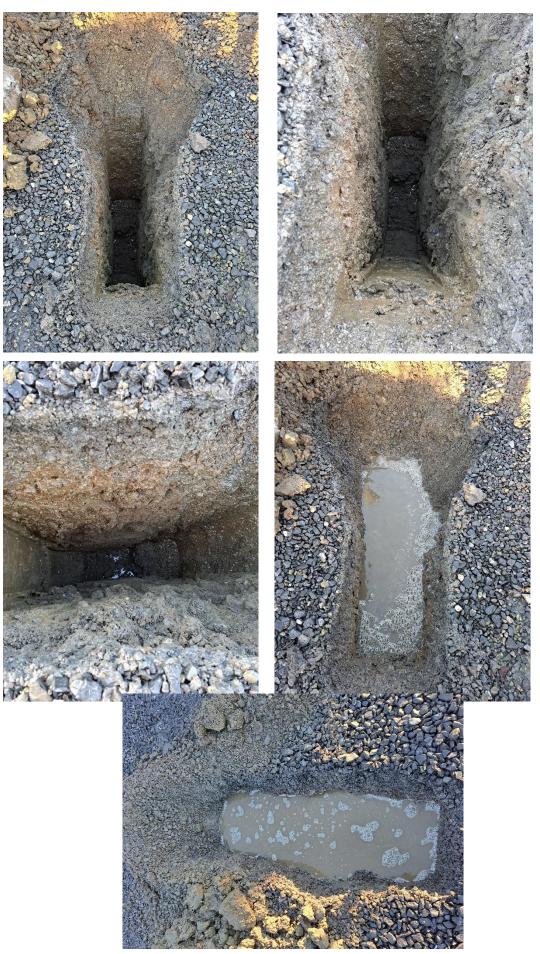
SA01

### Leixlip Playground Soakaways– Trial Pit Photographs

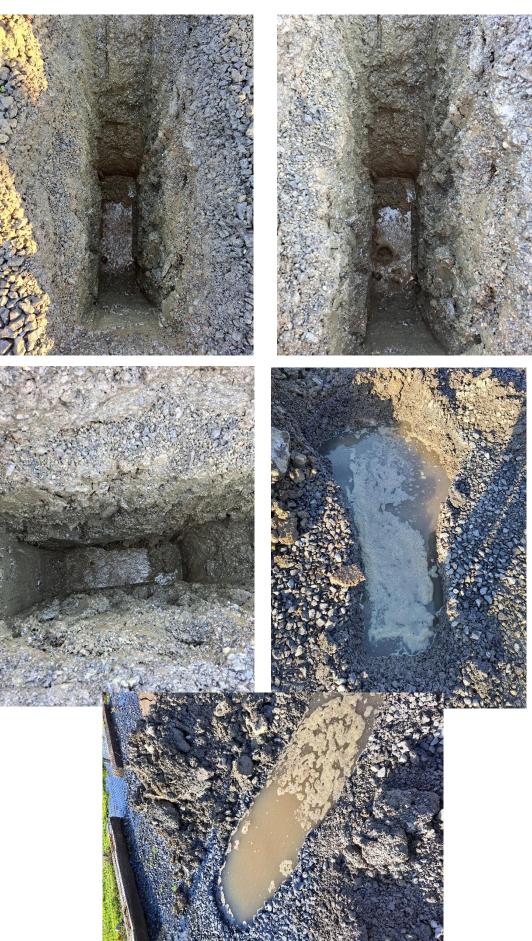
SA02

### Leixlip Playground Soakaways– Trial Pit Photographs
