An Bord Pleanála Section 177AE Application
for the Remediation of Brooke Bridge
Monasterevin, County Kildare

K424-OCSC-XX-XX-RP-PL-0010

April 2021

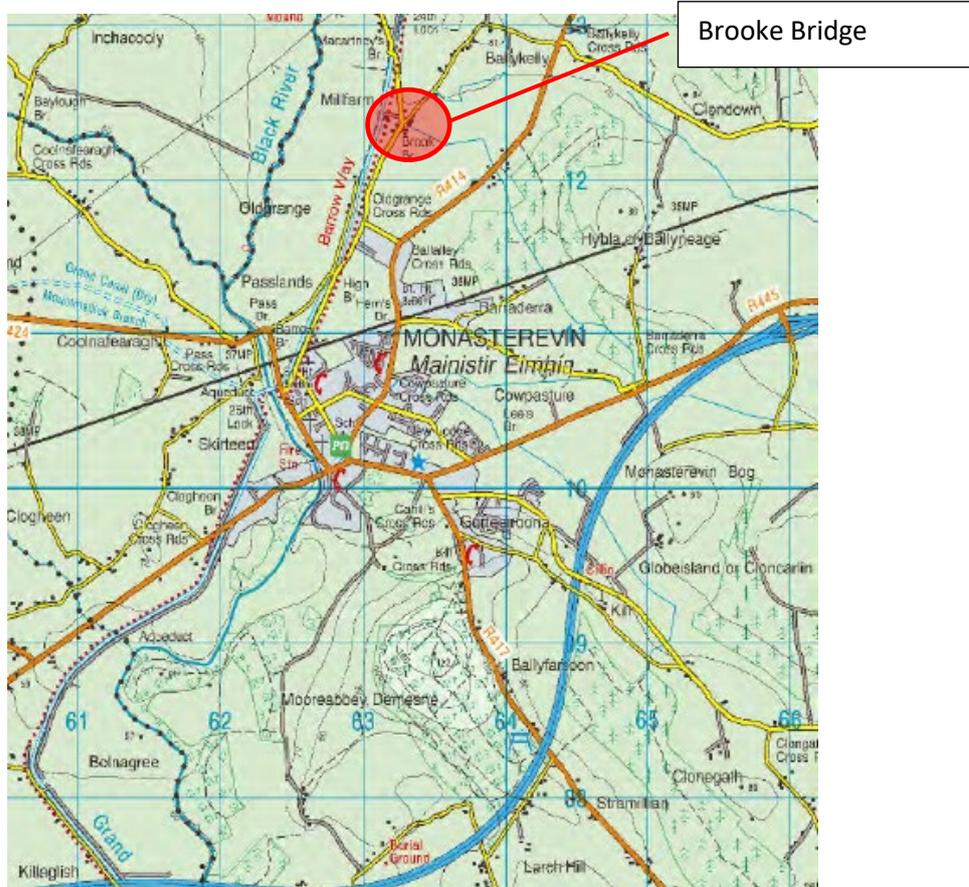
Brooke Bridge is located on the local road (L7049) North of Monasterevin in County Kildare.

Brooke Bridge spans an un-named river which is approximately 1.5m wide and is used by vehicular/pedestrian traffic travelling on the local road L7049. The bridge is not listed as a protected structure or on the National Inventory of Architectural Heritage. While not located within an SAC or SPA, the bridge is located circa 1.1km (1.5km via watercourse) from the River Barrow and River Nore SAC (Code 002162).
